Soil Contamination Risk Stage 1 - Preliminary Site Investigation Report

Proposed Plan Change Leeston Dunsandel Road, Harmans Road and High Street, Leeston

July 2017

Malloch Environmental Ltd

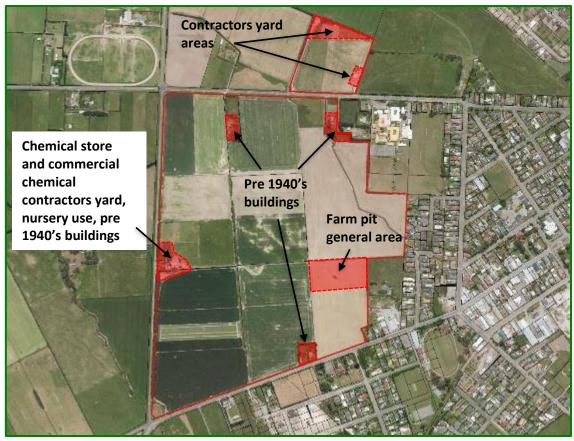
Figure 3 - Risk Area Plan

The investigations undertaken have revealed that the subject site has been used for a variety of sheep, beef, dairy and crop farming for its known history. There is evidence of pre-1940s buildings, chemical storage, fuel storage and a farm working and maintenance yard. All of these uses pose a risk of contamination of the soil that may pose a risk to human health.

It is recommended that a detailed site investigation is carried out on the risk areas outlined in the plan below, at the subdivision stage.
