SUBMISSION ON THE PROPOSED
SELWYN DISTRICT PLAN,
EAST MADDISONS ROAD,
ROLLESTON

PRELIMINARY SITE
INVESTIGATION –
CONTAMINATION

Project No.	CH00676	Approved for Issue	
Version No.	1	Name	Sean Finnigan
Status	Final	Signature	 
Authors	S Gladwin	Date	10 December 2020
Reviewer	S Finnigan

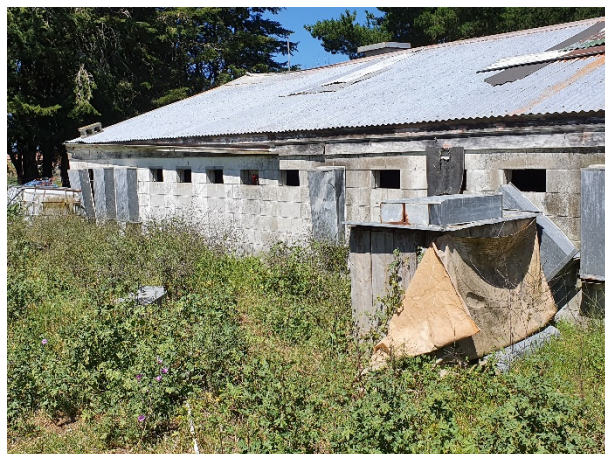
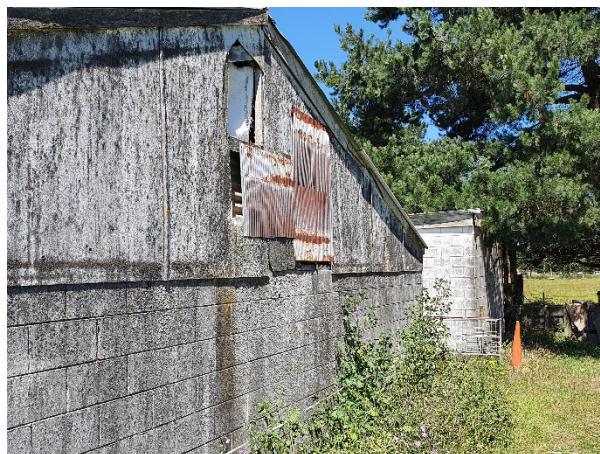
P7 & P8: Close up of fattening shed.

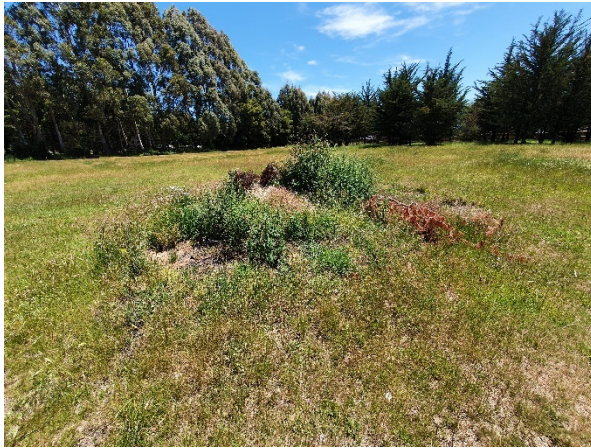
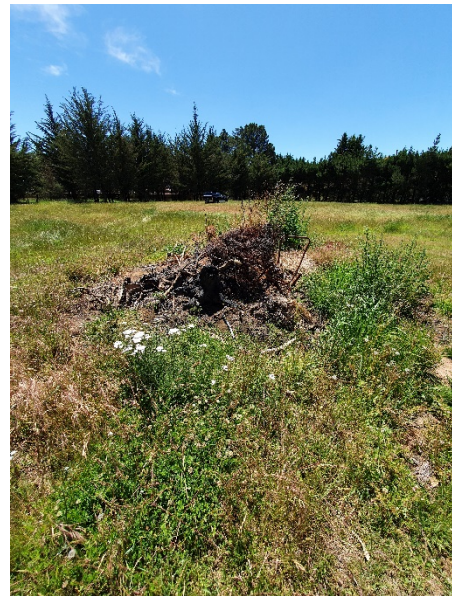
- A burn pile is located in the paddock to the east of the dwelling. A mixture of organic material and tubular metal framing was observed in the burn pile.

- Heavy metals associated with the burn pile in the eastern paddock of on Lot 2 DP 74311 - HAIL activity I.

P18 & P19: Views of burn pile located in middle of paddock mentioned above.

It is recommended that these potential/actual HAIL areas be further investigated by soil sampling as part of a future subdivision consent application and remediated, as necessary, as part of enabling (pre-construction) works prior to any bulk earthworks or other soil disturbance activities. If this is done and these areas are validated as being free of contamination, then subsequent earthworks and soil disturbance activities can be undertaken without having to consider contamination issues, other than accidental discovery protocols for unexpected contamination.

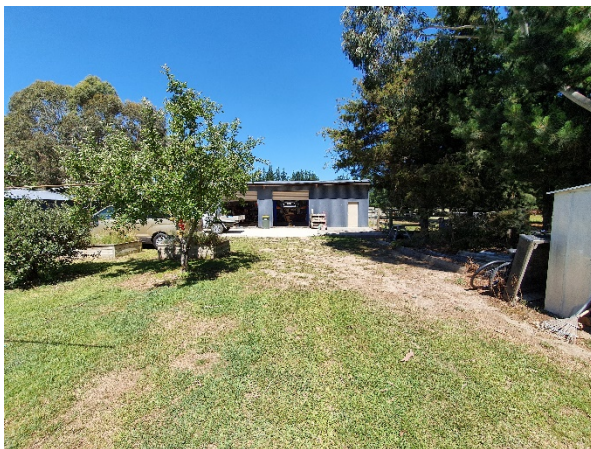
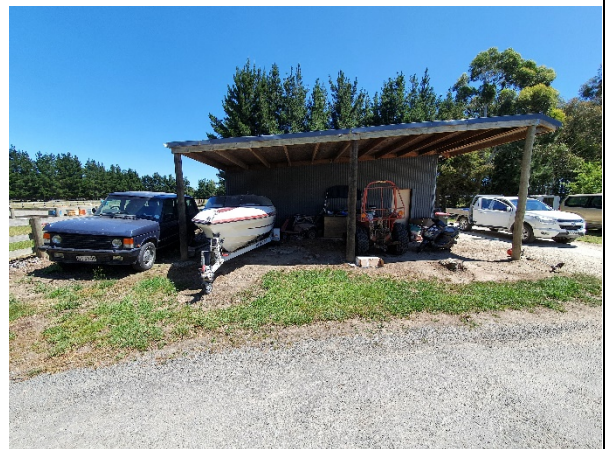
- *Activity F4: Motor vehicle workshops* This relates to the vehicle workshop and empty oil containers located in Lot 2 DP 74311.
- *Activity I: Land subject to intentional or accidental release of hazardous substances in sufficient quantity that it could be a risk to human health or the environment:* This relates to the deteriorated condition of the paint on the older existing buildings on Lot 1 DP 26880. Additionally, other activities such as burn piles may have resulted in release of hazardous substances.

P20 & 21: Views of motor vehicle workshop.

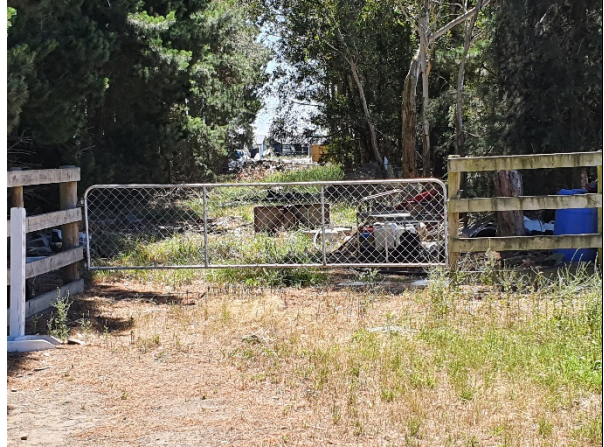
P22 & P23: Views of area in the vicinity of the workshop where oil containers are being stored on the ground.

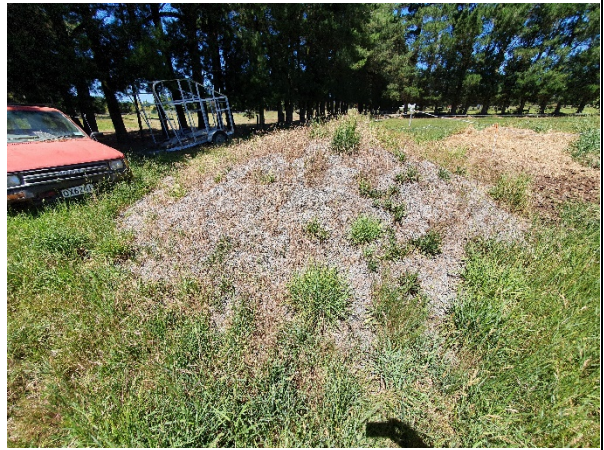
P24 & P25: View looking south across paddock behind workshop. Stockpile is gravel, assumed to be used for dressage arena located in the same paddock.
