Fraser Thomas

SUBMISSION ON THE PROPOSED
SELWYN DISTRICT PLAN,
EAST MADDISONS ROAD,
ROLLESTON

PRELIMINARY SITE
INVESTIGATION –
CONTAMINATION

Project No.	CH00676	Approved for Issue	
Version No.	1	Name	Sean Finnigan
Status	Final	Signature	 
Authors	S Gladwin	Date	10 December 2020
Reviewer	S Finnigan

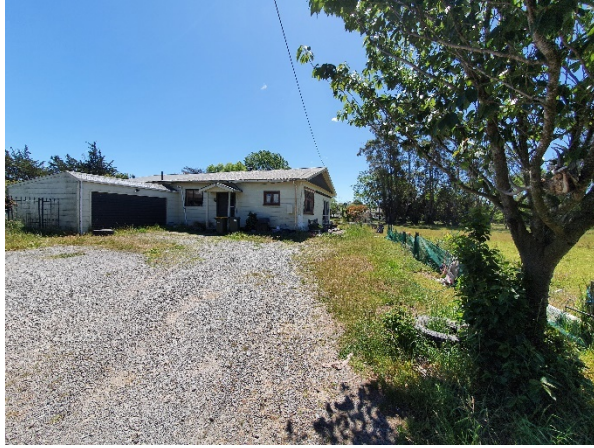
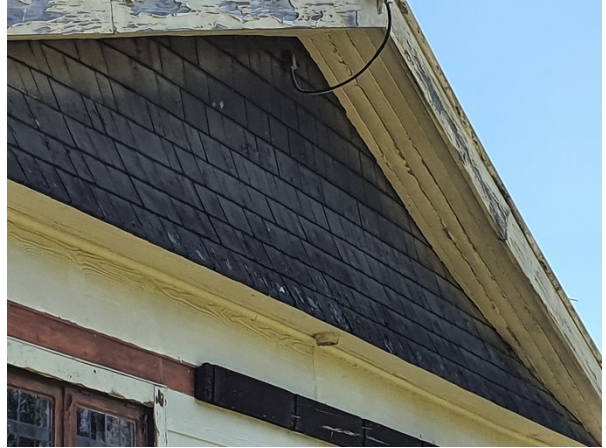
- Heavy metals and hydrocarbons associated with the motor vehicle workshop on Lot 2 DP 74311 -HAIL activity F4.
- Lead paint associated with the deteriorated condition of older buildings on Lot 1 DP 26880 – HAIL I.

P1 & P2: Dwelling located at Lot 1 26880. Close up shows paint flaking on barge boards.

It is recommended that these potential/actual HAIL areas be further investigated by soil sampling as part of a future subdivision consent application and remediated, as necessary, as part of enabling (pre-construction) works prior to any bulk earthworks or other soil disturbance activities. If this is done and these areas are validated as being free of contamination, then subsequent earthworks and soil disturbance activities can be undertaken without having to consider contamination issues, other than accidental discovery protocols for unexpected contamination.

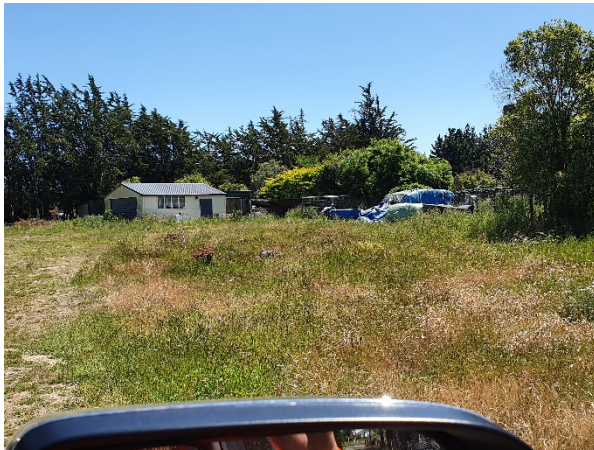
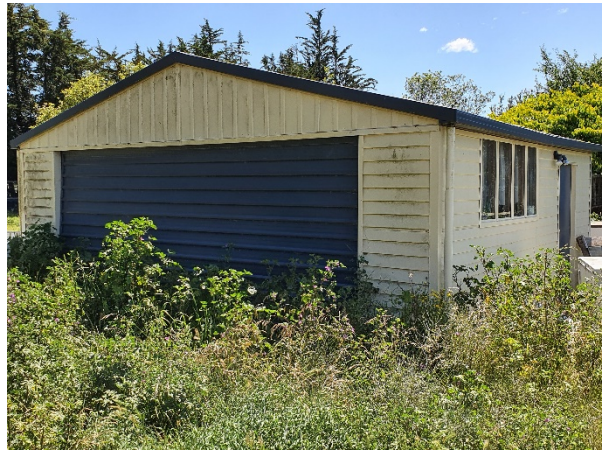
P3 & P4: View looking west across site towards detached garage. Hay is being stored beneath tarpaulins in background.

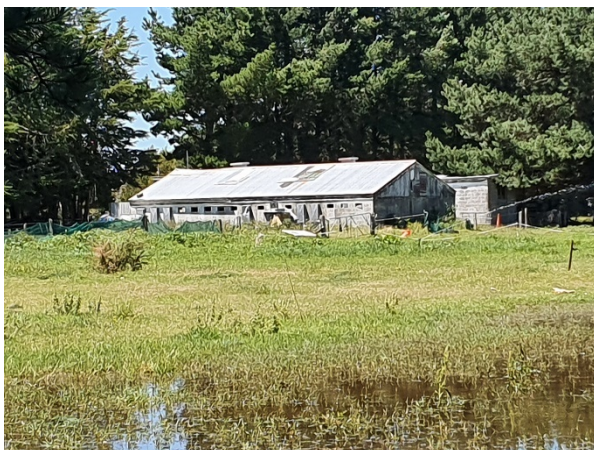
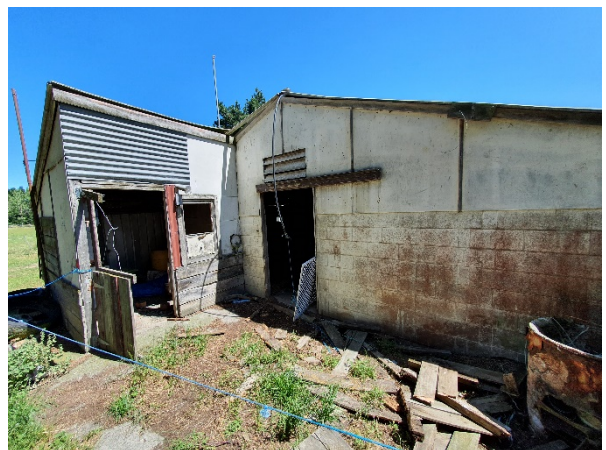
P5: View looking south across site to fattening shed. **P6:** Close up of fattening shed.

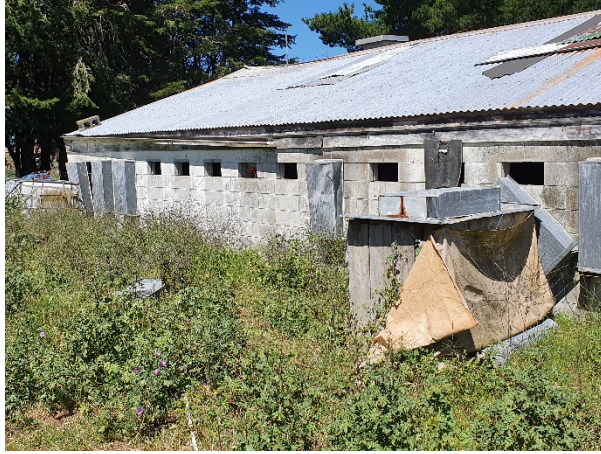
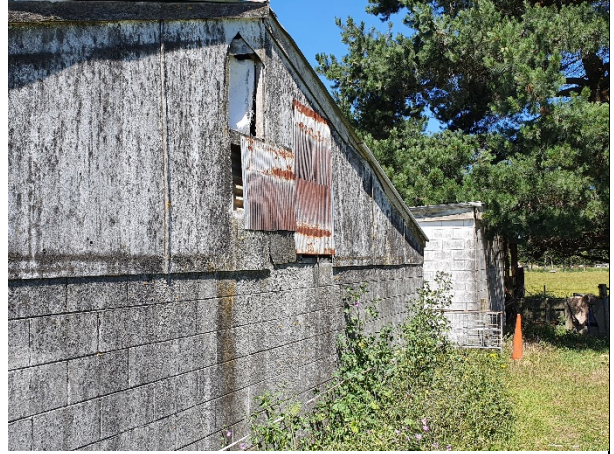
P7 & P8: Close up of fattening shed.

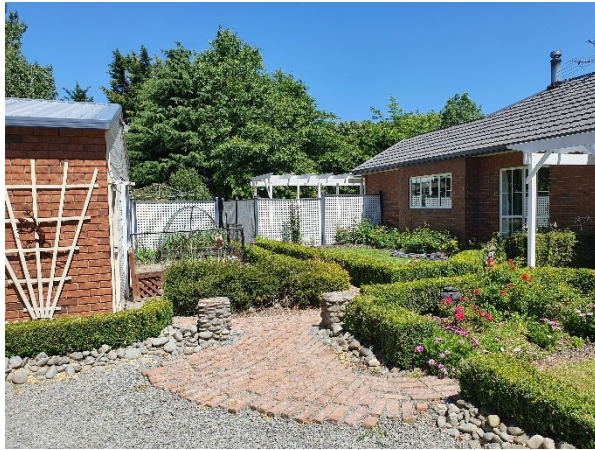
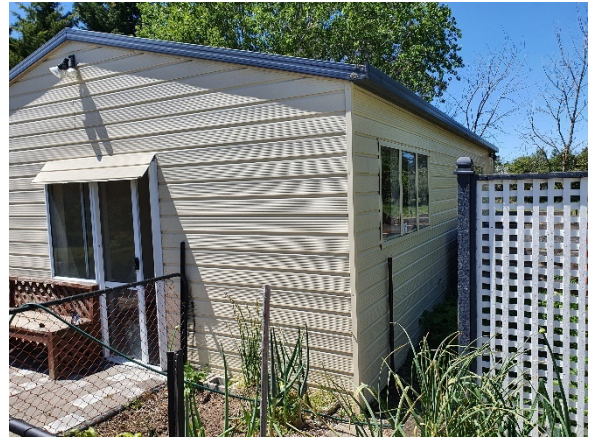
P11 & P12: Views of dwelling and detached garage.

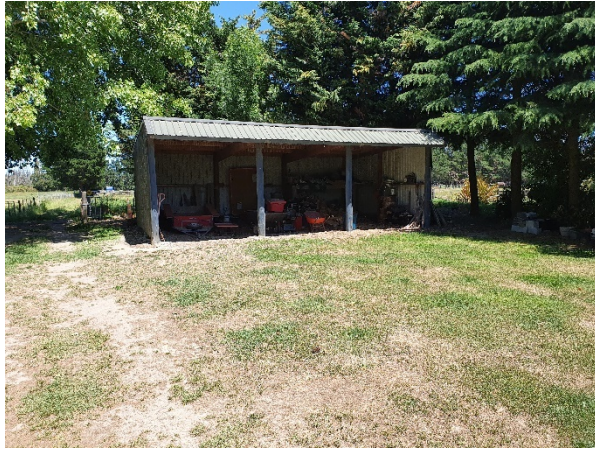
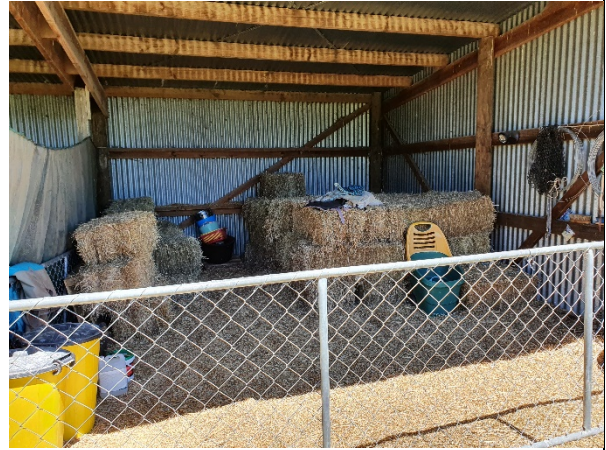
P13 & P14: Views of implement sheds.

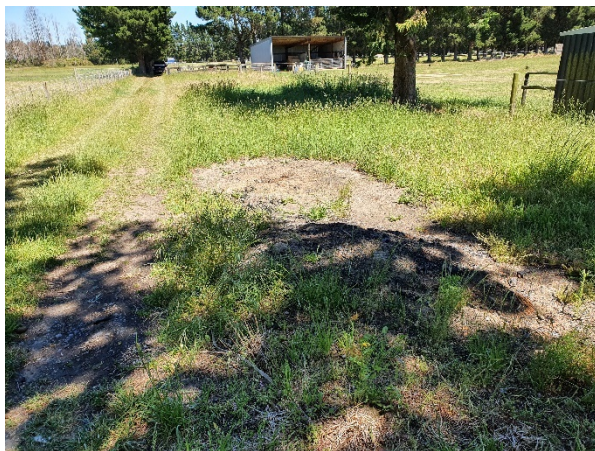
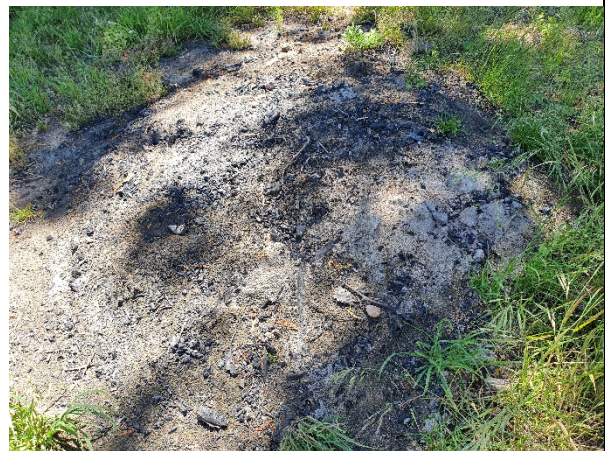
- A burn pile is located in the paddock to the west of the dwelling. The owner has indicated that only clippings and wood from the site have been burned here.

P15: Views of burn pile. The owner has indicated that only clippings from the property has been burnt.

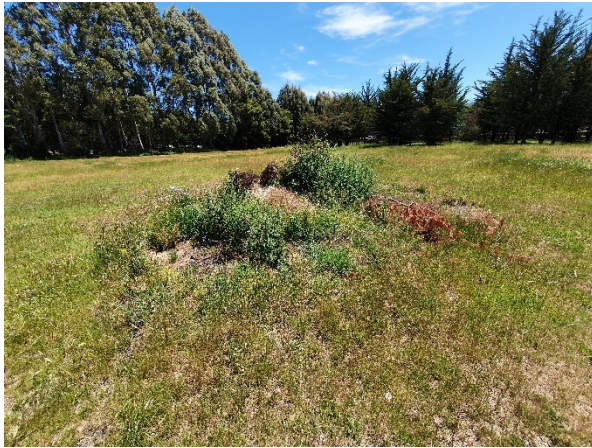
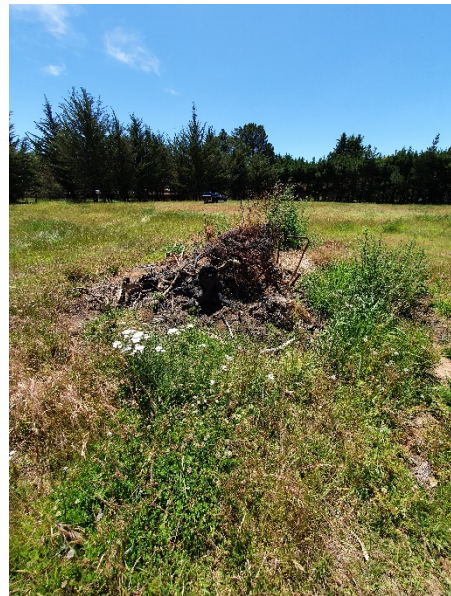
- A burn pile is located in the paddock to the east of the dwelling. A mixture of organic material and tubular metal framing was observed in the burn pile.

- Heavy metals associated with the burn pile in the eastern paddock of on Lot 2 DP 74311 - HAIL activity I.

P18 & P19: Views of burn pile located in middle of paddock mentioned above.

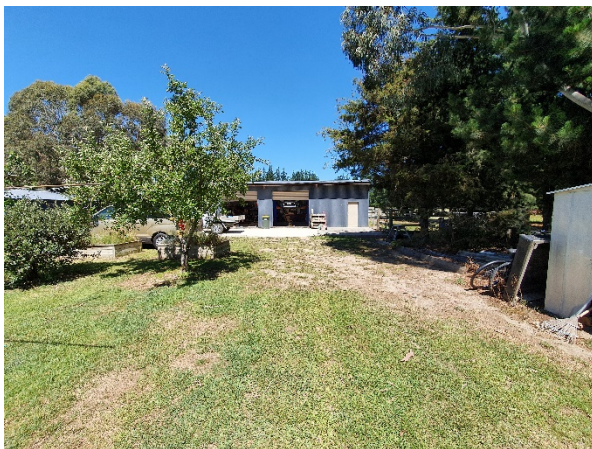
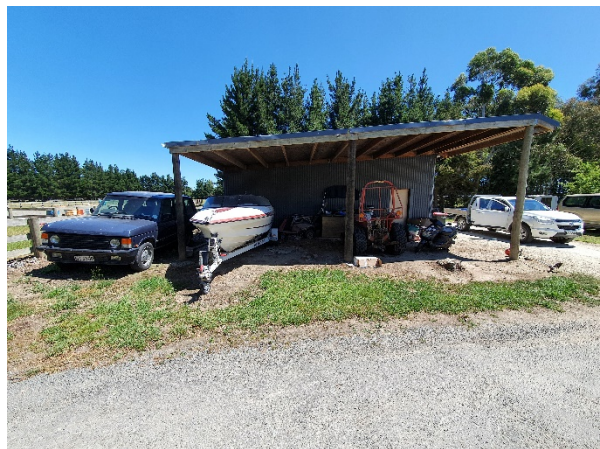
- *Activity F4: Motor vehicle workshops* This relates to the vehicle workshop and empty oil containers located in Lot 2 DP 74311.
- *Activity I: Land subject to intentional or accidental release of hazardous substances in sufficient quantity that it could be a risk to human health or the environment:* This relates to the deteriorated condition of the paint on the older existing buildings on Lot 1 DP 26880. Additionally, other activities such as burn piles may have resulted in release of hazardous substances.

P20 & 21: Views of motor vehicle workshop.

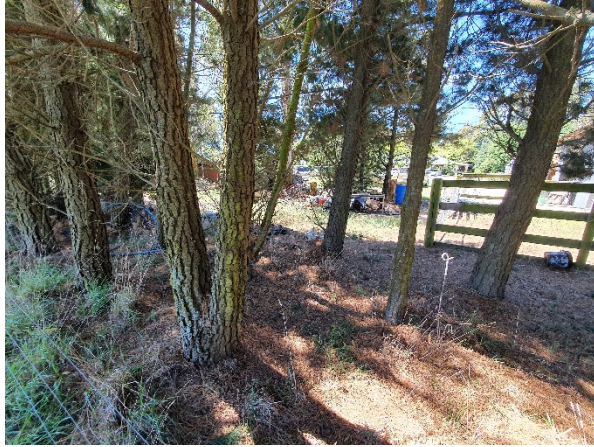
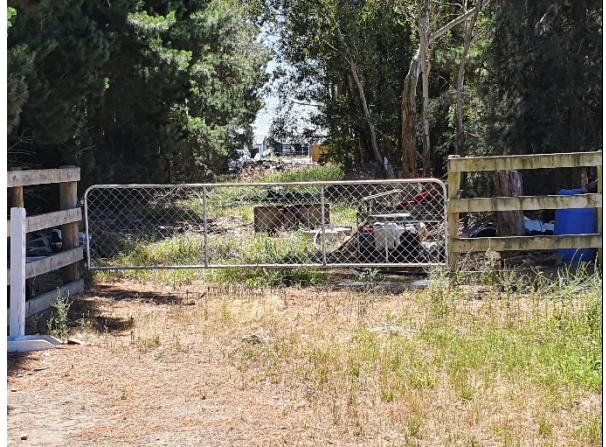
P22 & P23: Views of area in the vicinity of the workshop where oil containers are being stored on the ground.

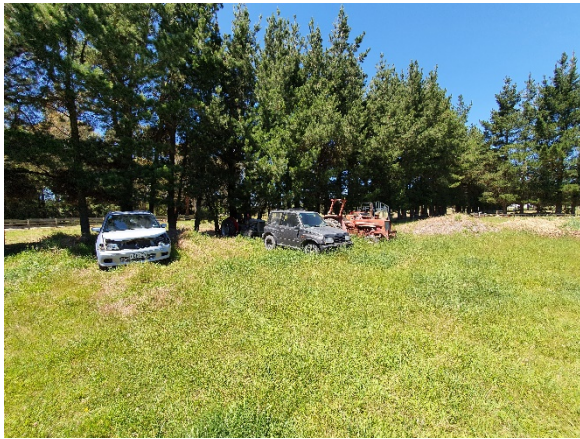
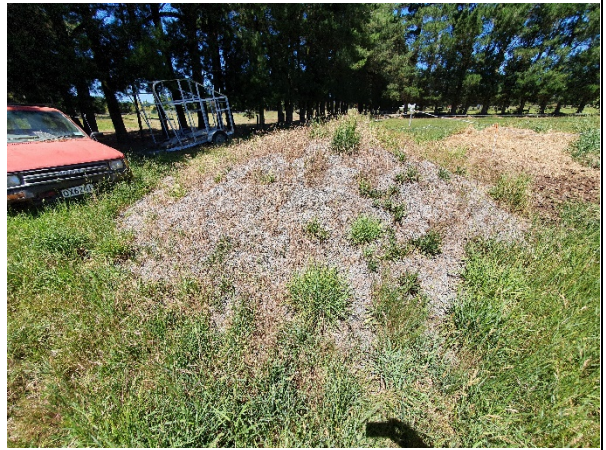
P24 & P25: View looking south across paddock behind workshop. Stockpile is gravel, assumed to be used for dressage arena located in the same paddock.

The floor of the training/dressage arena on Lot 2 DP 74311 was not directly observed in detail during the site walkover, as focus was given to the more obvious potential issues associated with the oil drums located around the arena. Review of the site walkover photo's indicate that the arena appears to be surfaced with soil, the origin of which is unknown.

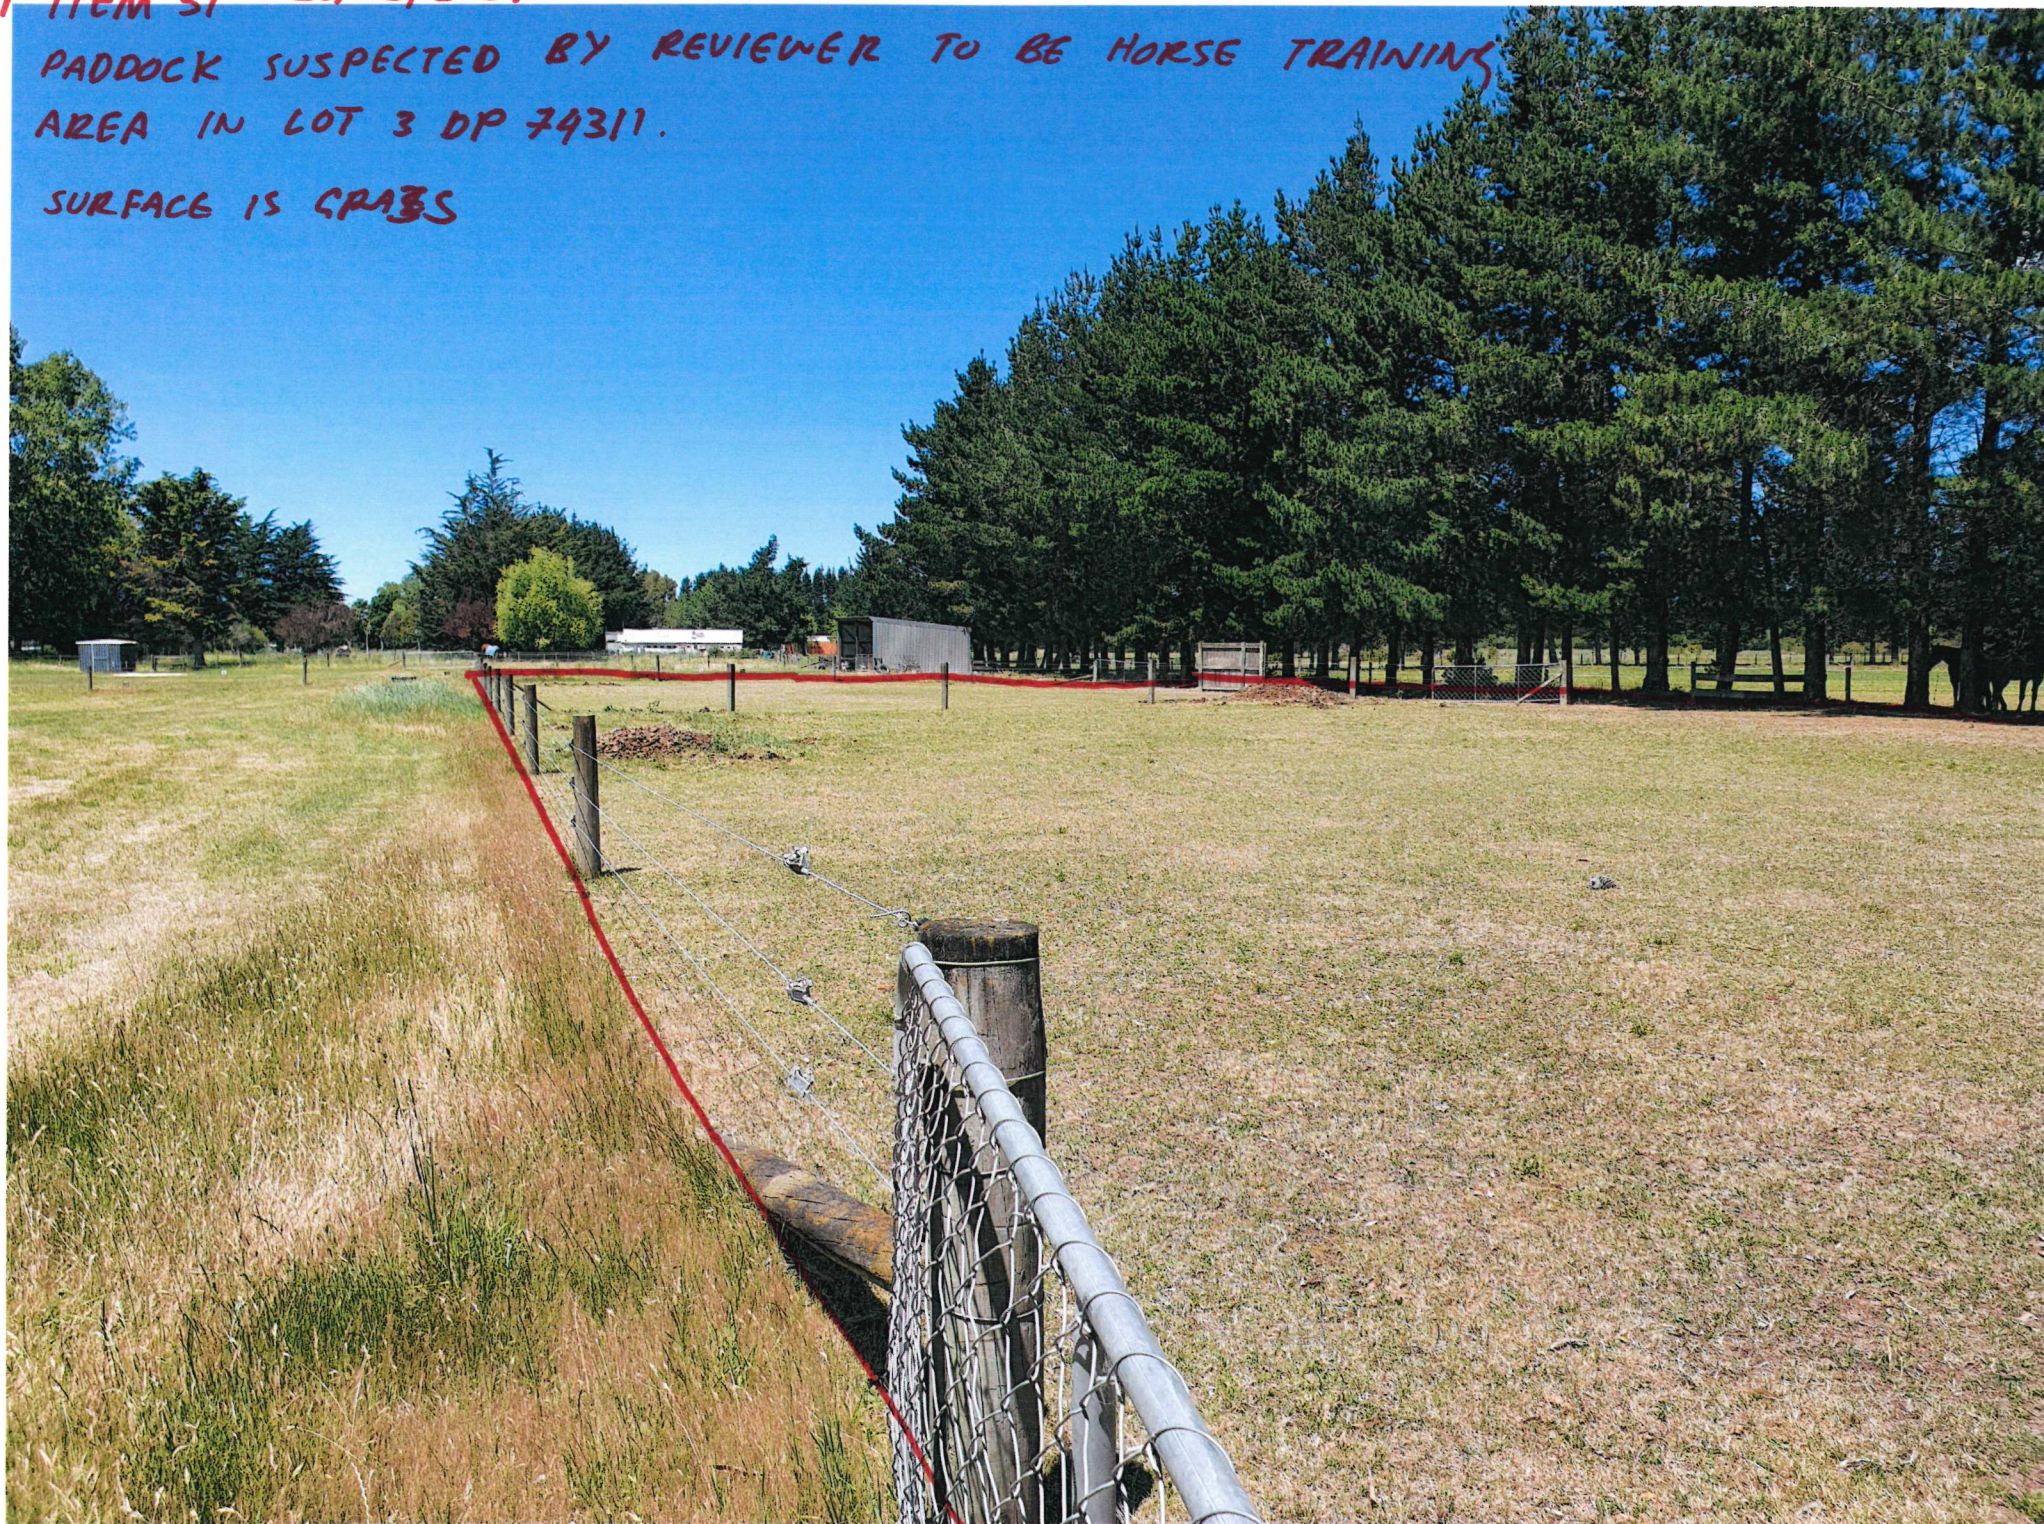
RF1 ITEM 31 23/02/2021

Paddock suspected by reviewer to be horse training
area in lot 3 DP 74311.

SURFACE IS GRASS
