20 June 2022

Jocelyn Lewes  
Strategy and Policy Planner  
Selwyn District Council  
PO Box 90  
**ROLLESTON 7643**

## **PRELIMINARY SITE INVESTIGATION – 606 SELWYN ROAD, ROLLESTON, SELWYN DISTRICT**

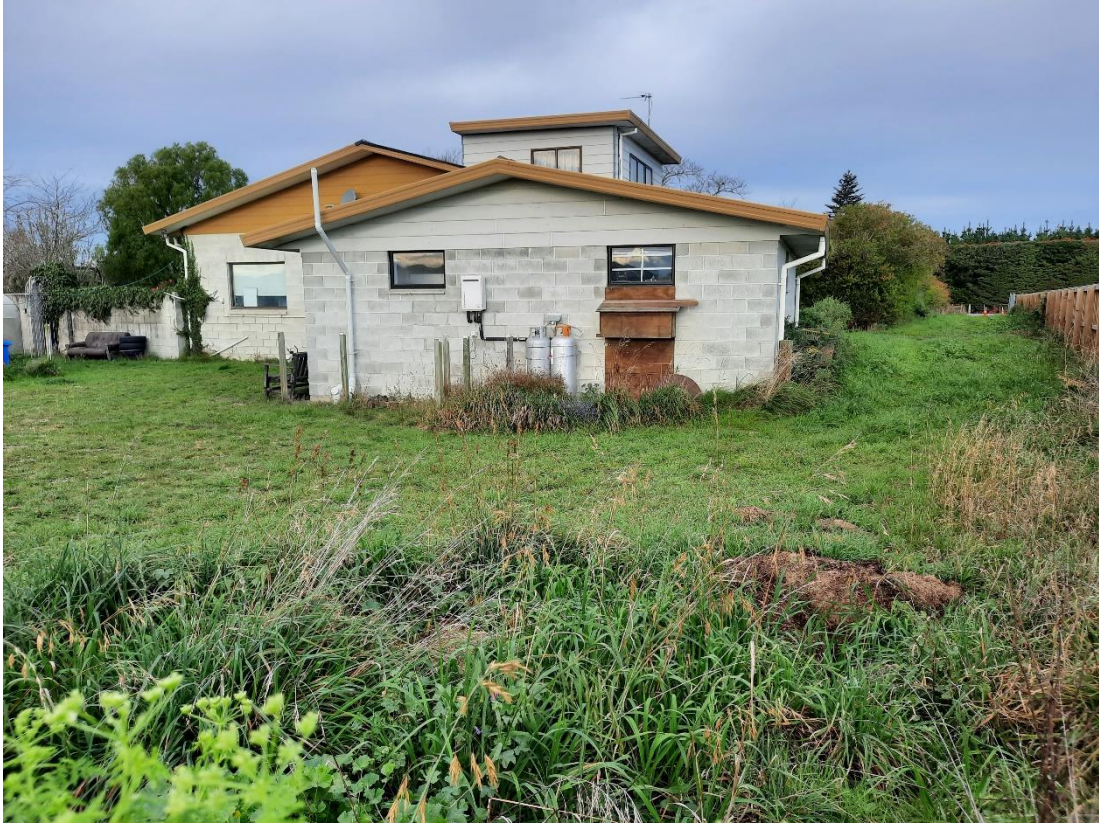
- ✧ Asbestos containing materials (ACM), including cement sheets, were observed on the exterior of the extended garage and a shed to the north-west of the swimming pool but were generally in good condition. While no obvious ACM was observed on the ground in the vicinity of these

**Photograph 3: View looking south-east at the extended garage from the north-western corner of the site.**

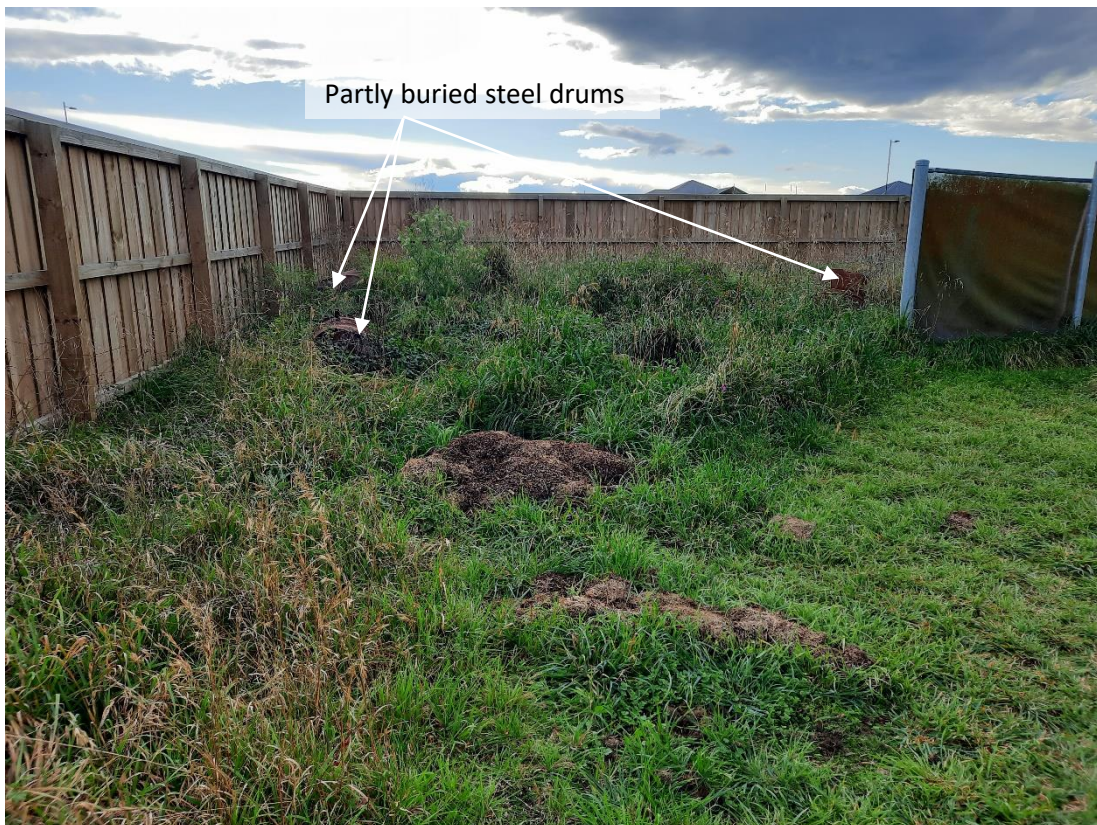
During the recent PDP site inspection, localised rubbish, including partly buried 200 L steel drums were observed near the boundary fence at the western/north-western corner of the property. The area appears to be slightly elevated from the surrounding area and was heavily vegetated. Whether more rubbish was present in the area could not be confirmed. Therefore, and as a prudent approach, HAIL Category G5 (*waste disposal to land*) is considered to be applicable in this instance to this area of the site.

**Photograph 4: View looking north-west at the overgrown area at the north-western corner of the site.**

Therefore, based on the reviewed information, HAIL activities under Categories I and G5 (i.e., potential source of contamination) have been conservatively identified over parts of the site. It is recommended that a soil sampling investigation is undertaken to confirm if these HAIL activities have resulted in soil contamination such that it could result in a potential risk to human health and/or the environment. The soil sampling investigation will also assist in confirming the completeness of potential exposure pathways to current and future receptors.

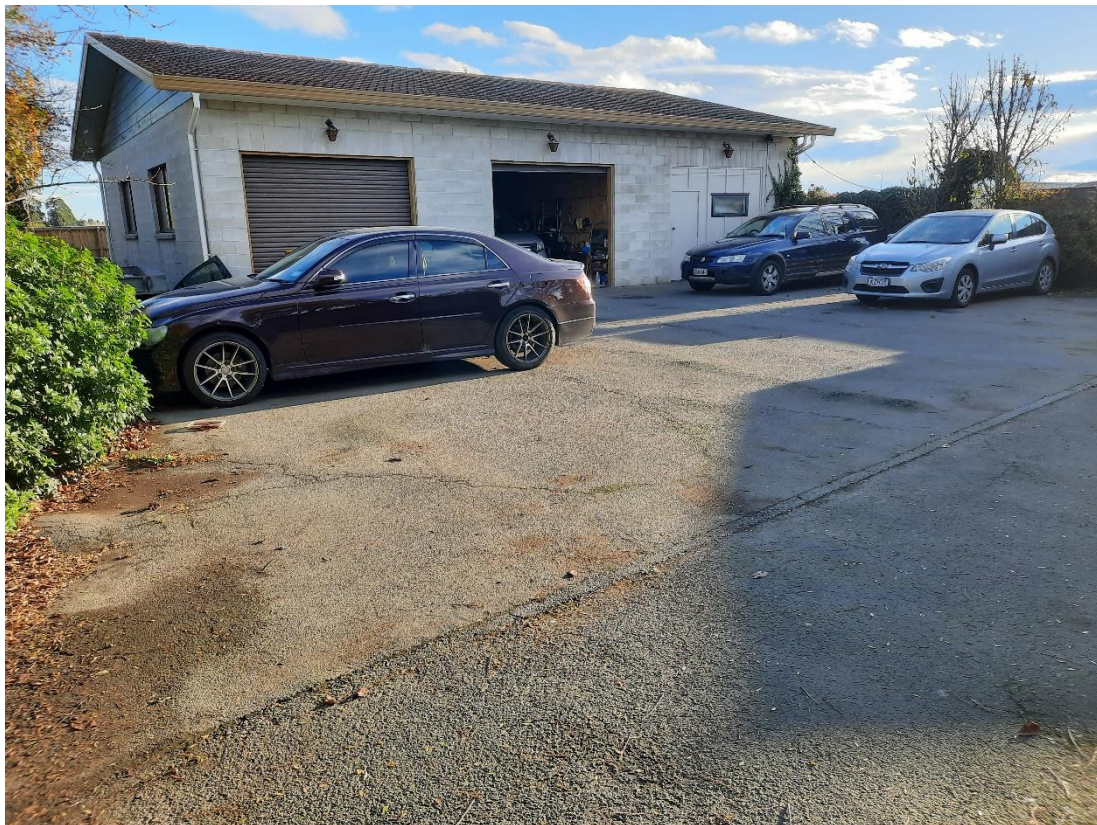
**Photograph 6: View looking west at the extended garage from the south-eastern corner of the carpark area to the east.**

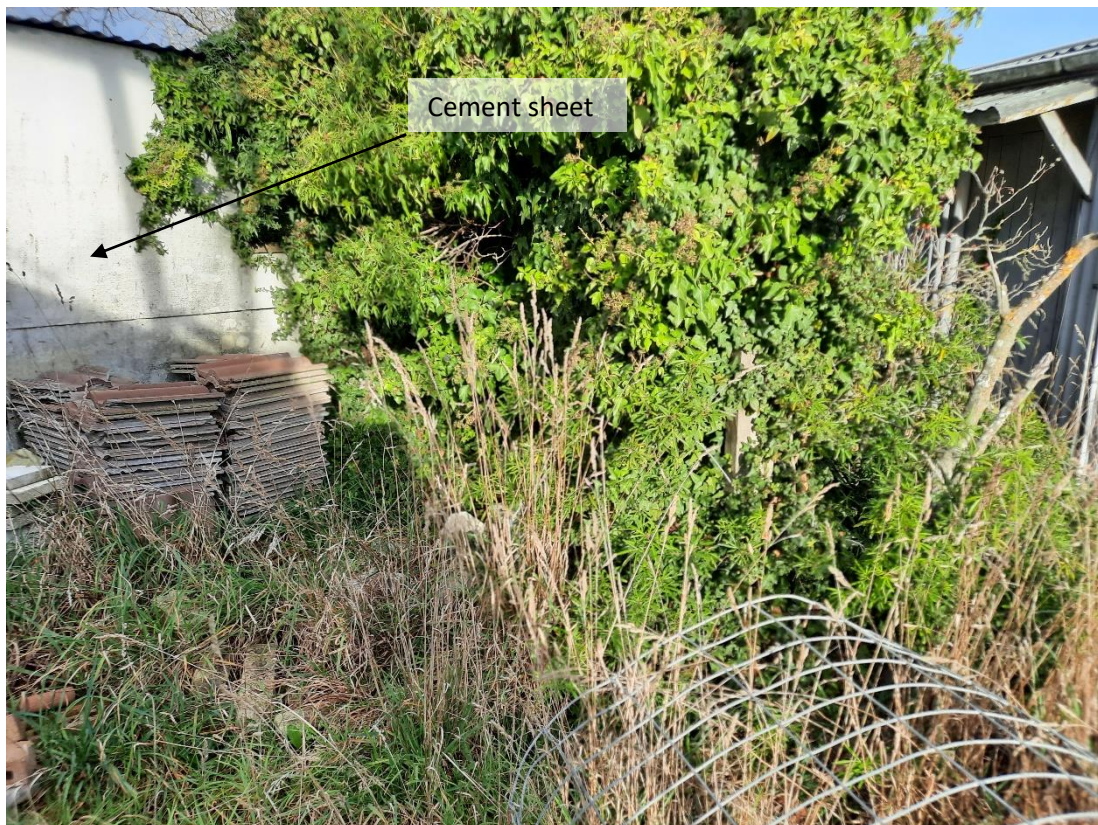
**Photograph 10: View looking south at the back of a shed near the swimming pool from the overgrown area to the north-east of the small studio. The swimming pool area and the front of the shed was not available for inspection.**

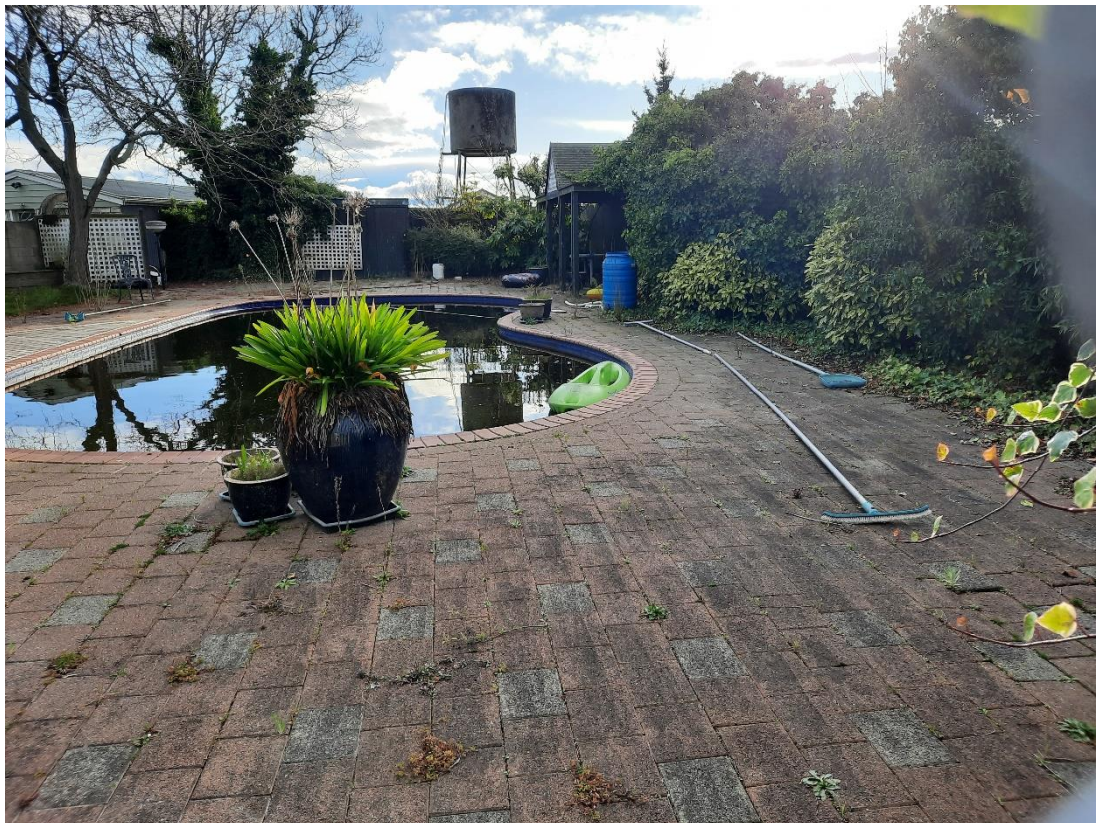
**Photograph 14: View looking north-west across the swimming pool area. The area was not fully inspected due to limited access.**

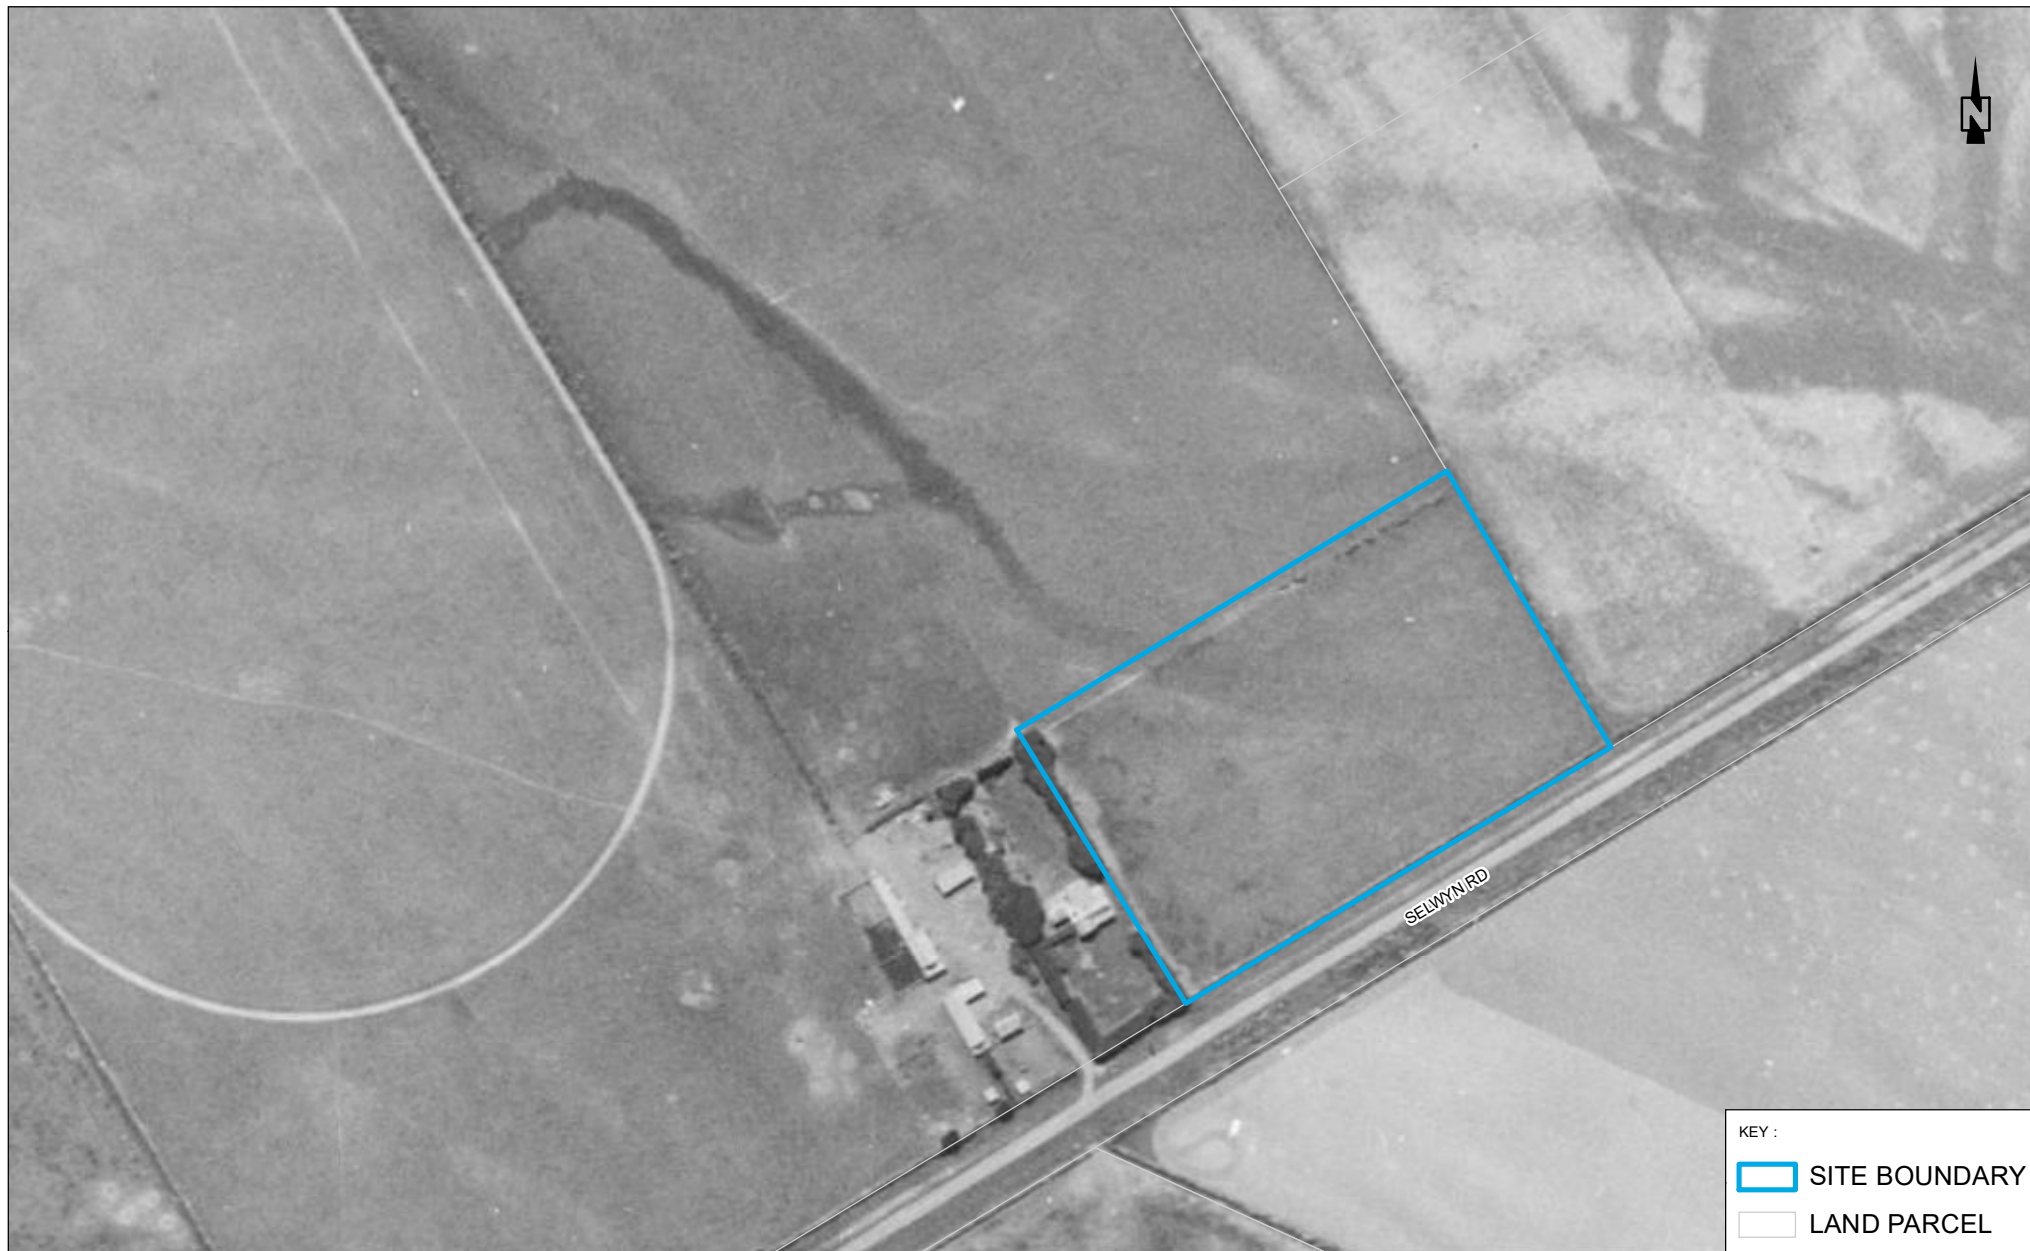
1942 AERIAL PHOTOGRAPH

- ✧ The 1942 and 1961 aerial imageries show the site was vacant rural land with no obvious structural features. The site appears to form part of a larger rural property, containing a residential type building and associated outbuildings in the south (i.e., adjacent to the west of the site's current boundary line) and a horse track in the northwest (horse track no longer present in the 1961 aerial photograph). Selwyn Road is shown in its current footprint.

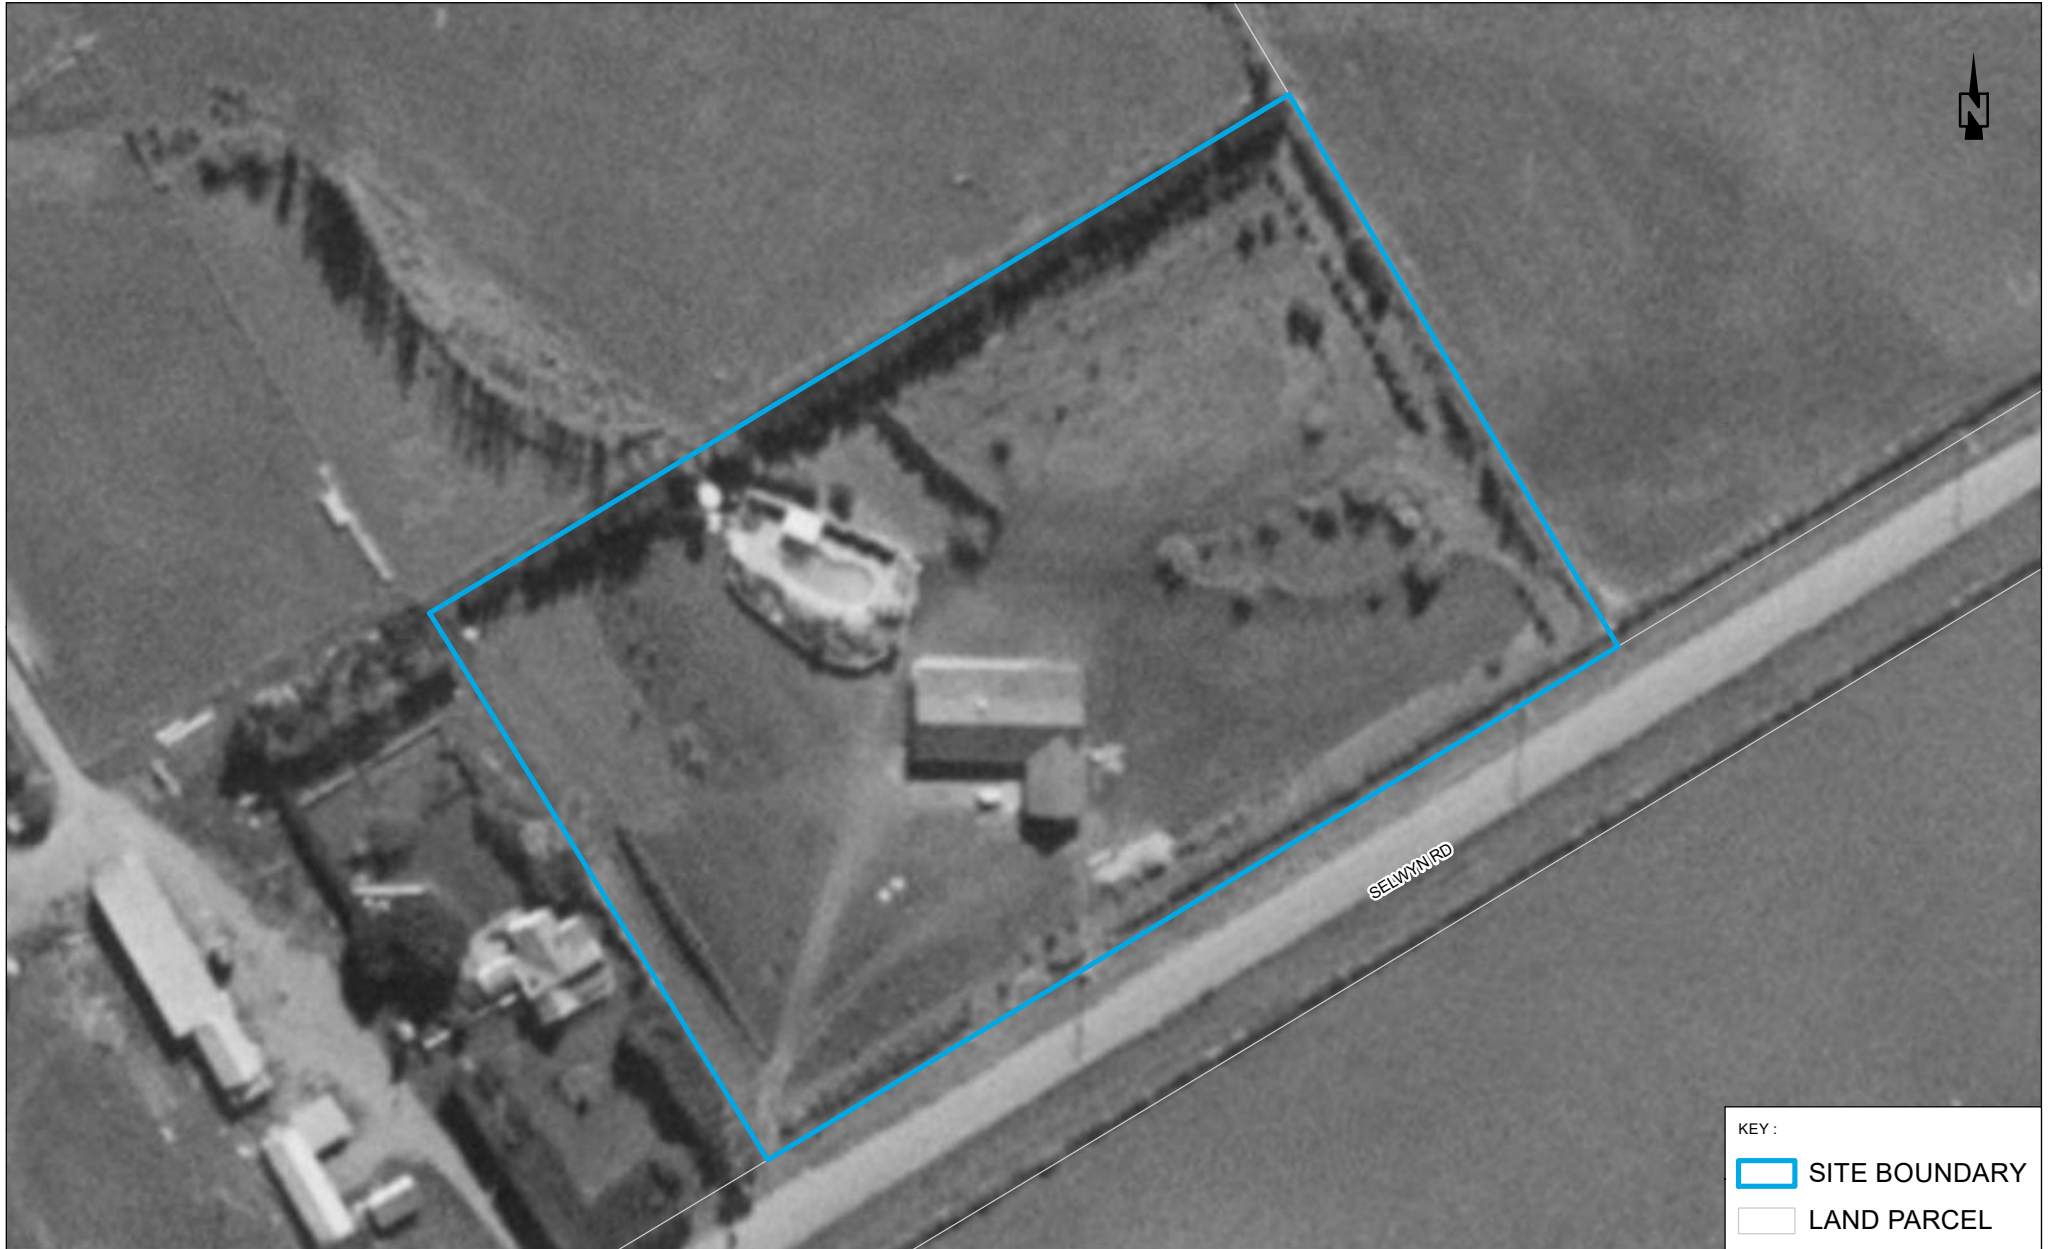
1974 AERIAL PHOTOGRAPH

- ✧ The 1974 and 1982 aerial imageries show that a residential building and outdoor swimming pool is now present in the central and northern portion of the site. The remainder of the site remains largely undeveloped. The adjoining property to the west remains largely unchanged, although additional outbuildings to the west and north are now visible.

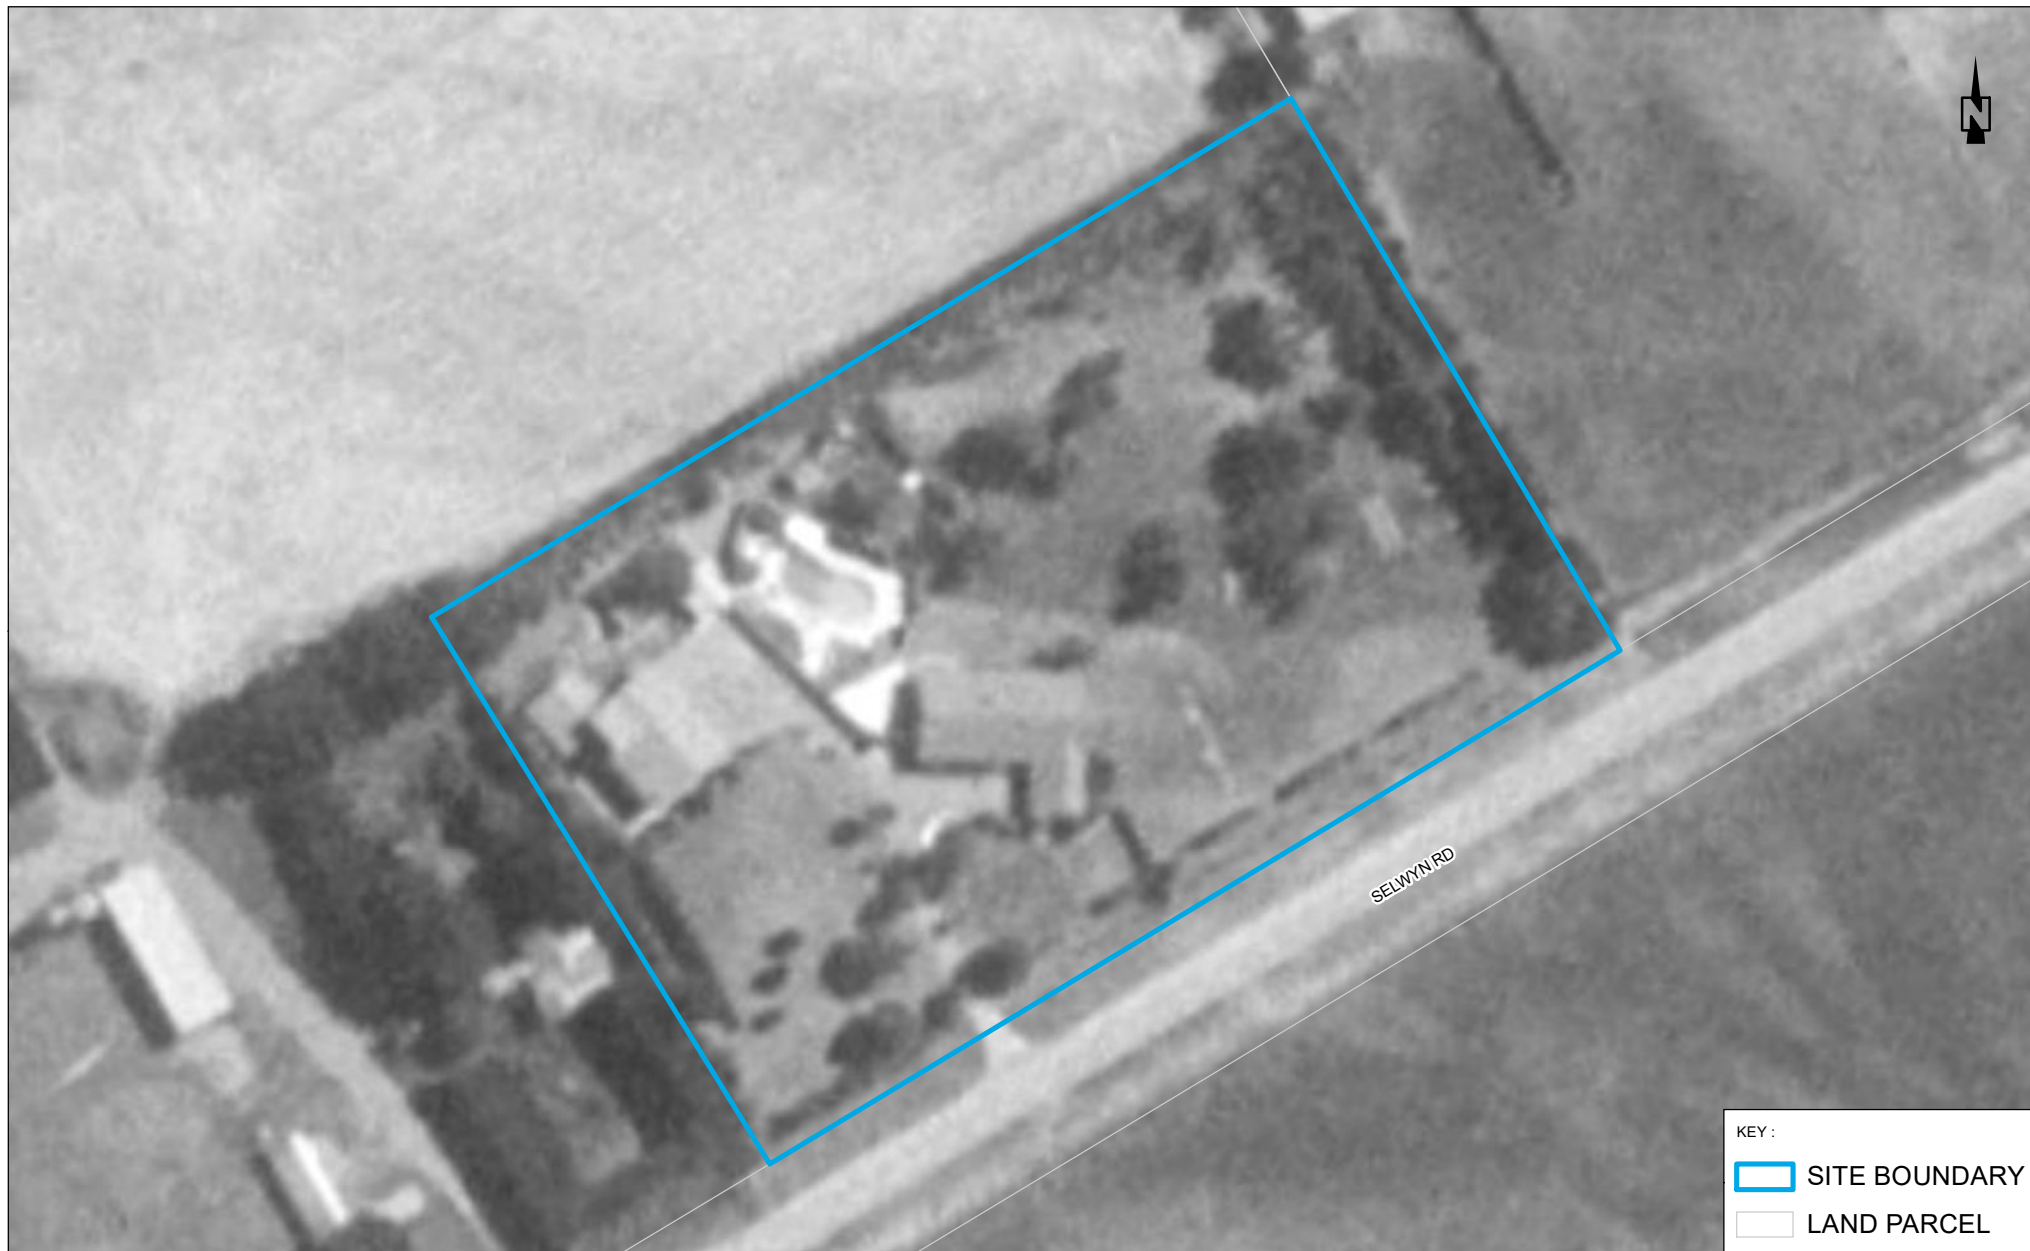
1994 AERIAL PHOTOGRAPH

- ✧ The 1994 and 2004 aerial imageries show that in addition to the existing dwelling and outdoor swimming pool, additional small buildings are now present in the western portion of the site. The remainder of the site remains largely undeveloped, although mature trees are now visible throughout the property.

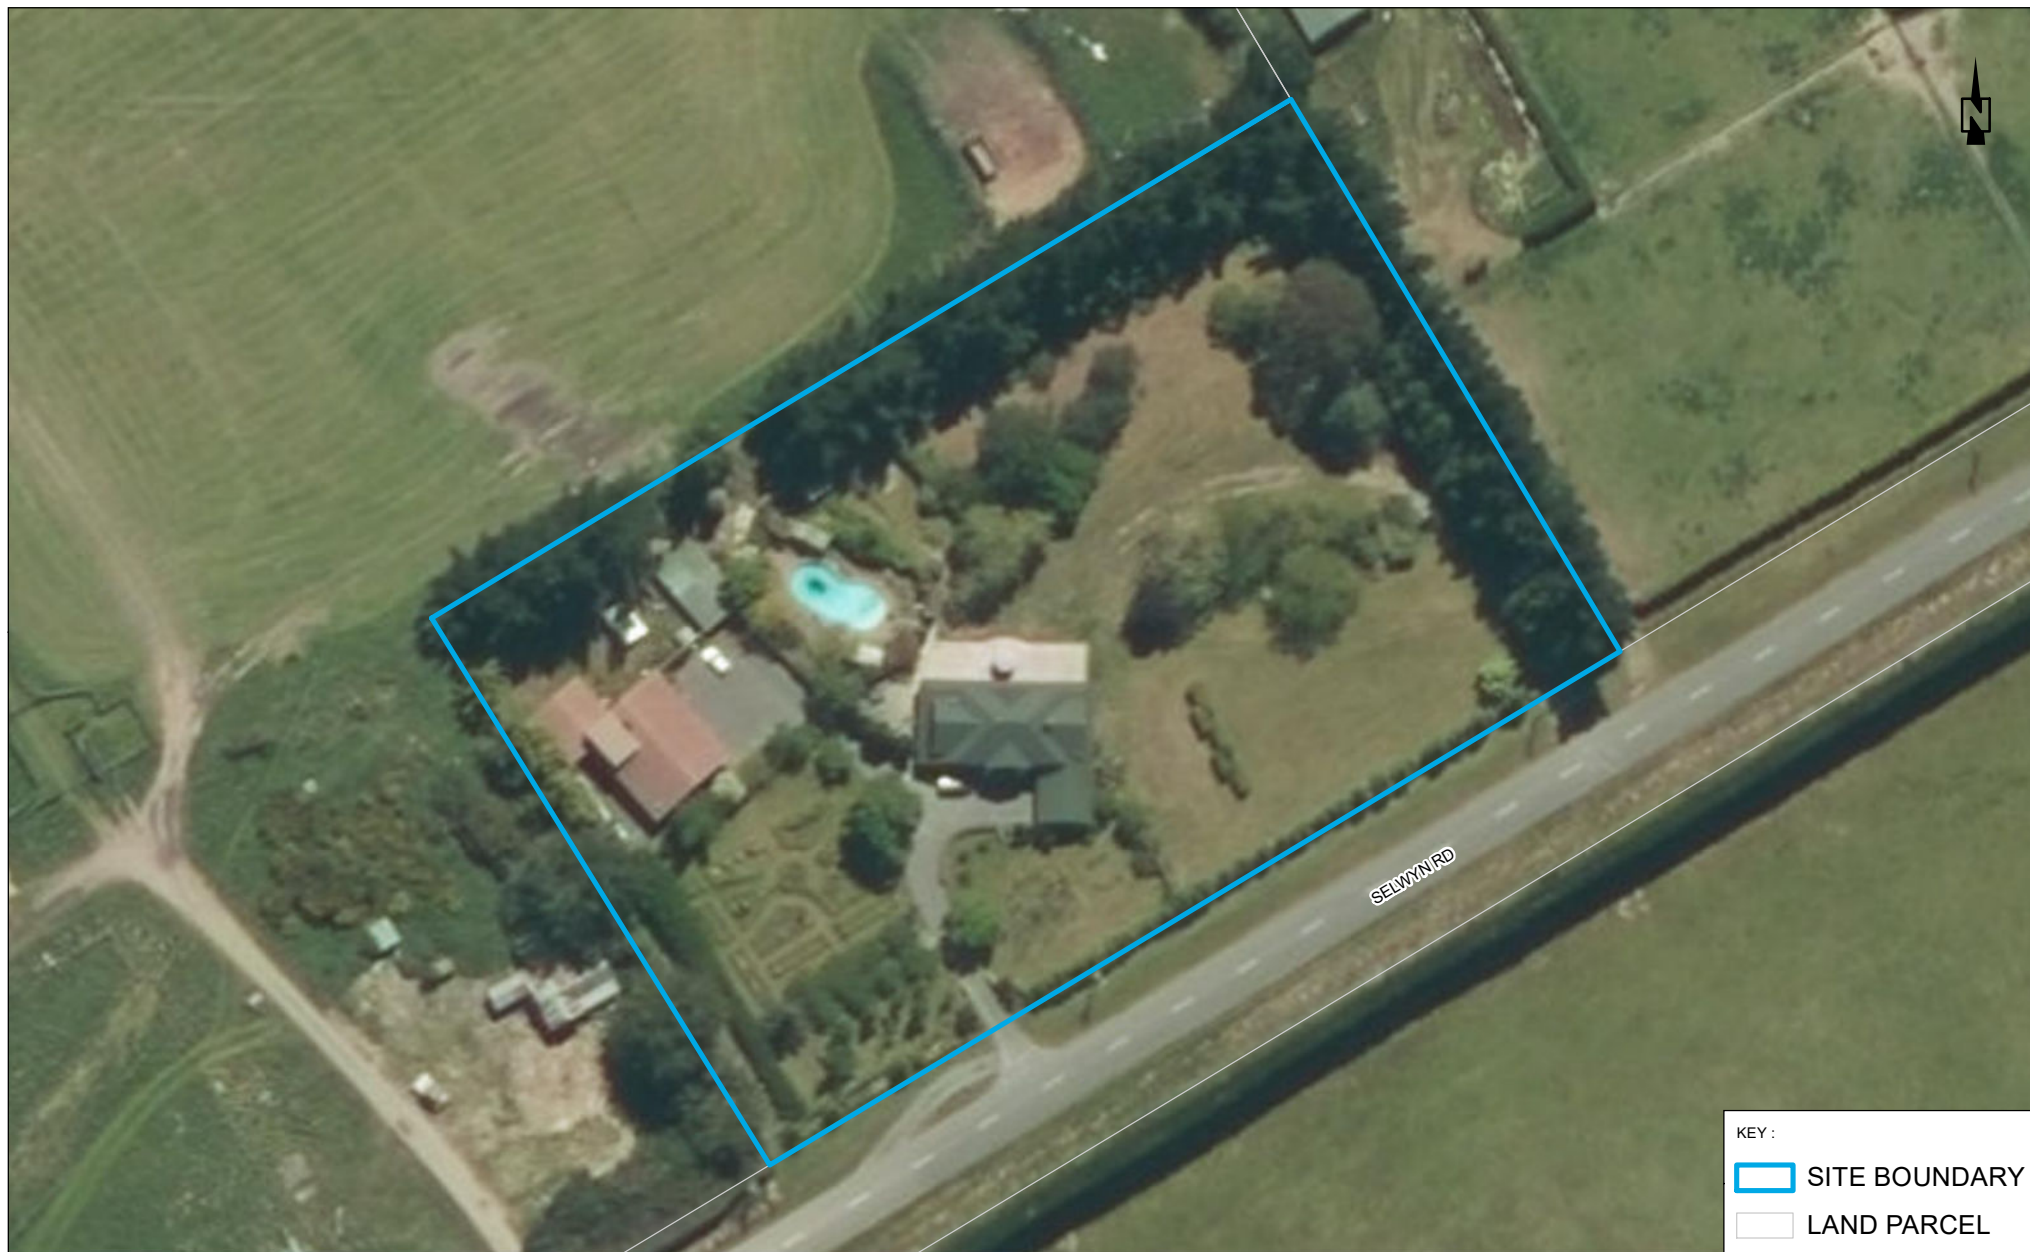
2012 AERIAL PHOTOGRAPH

- ✧ The 2012 aerial image shows the site to be largely unchanged, apart from the addition of another small building in north-western portion as well as formal-looking garden area in the southwest.

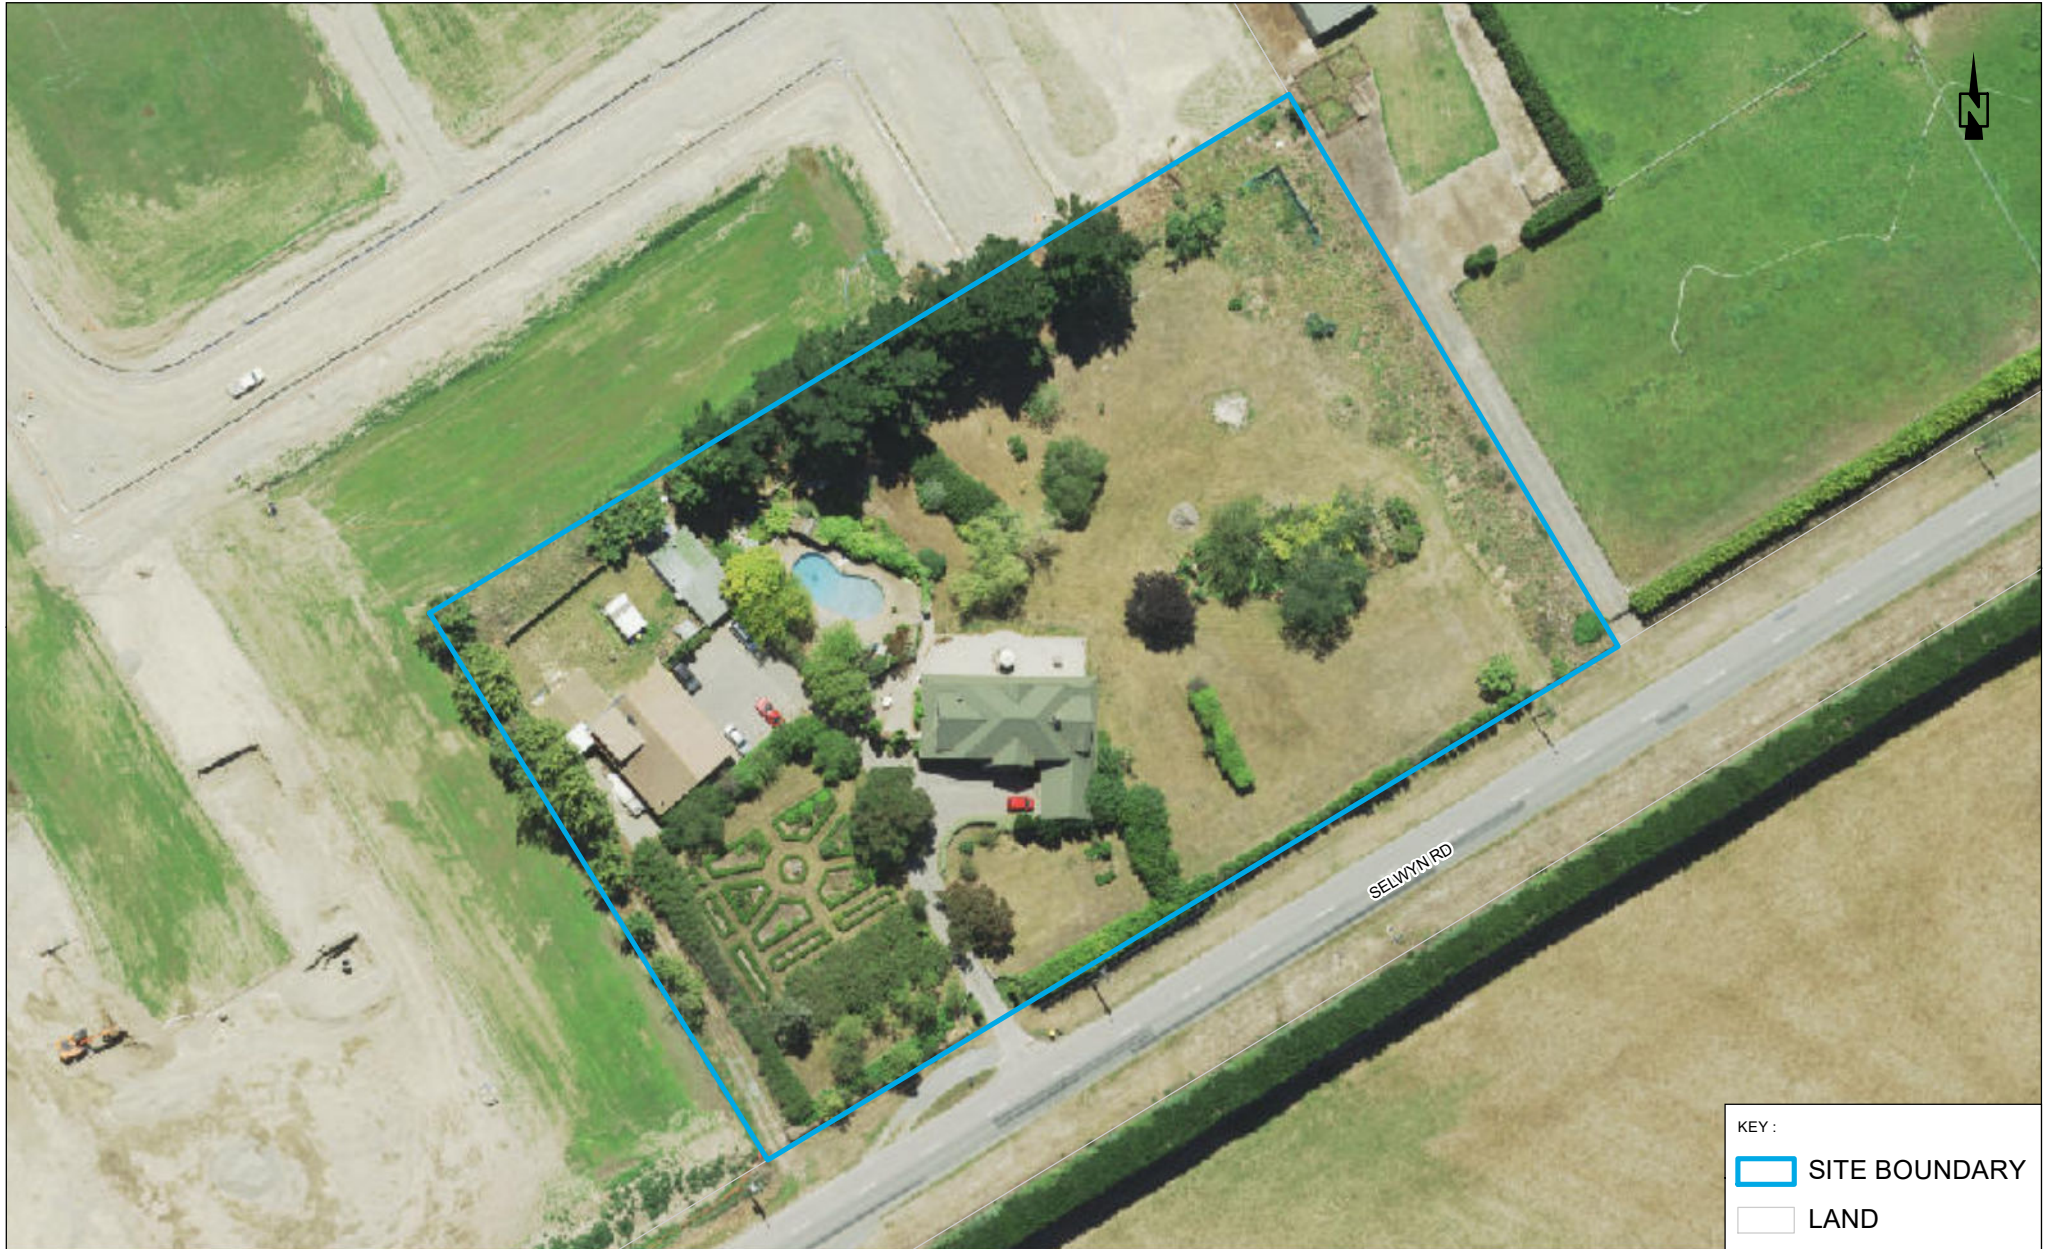
2021 AERIAL PHOTOGRAPH

- ✧ The 2021 aerial imagery shows the site in its present-day layout, which remained unchanged since 2012.
