15 June 2022

## **PRELIMINARY SITE INVESTIGATION - 890 SELWYN ROAD, ROLLESTON, SELWYN DISTRICT**

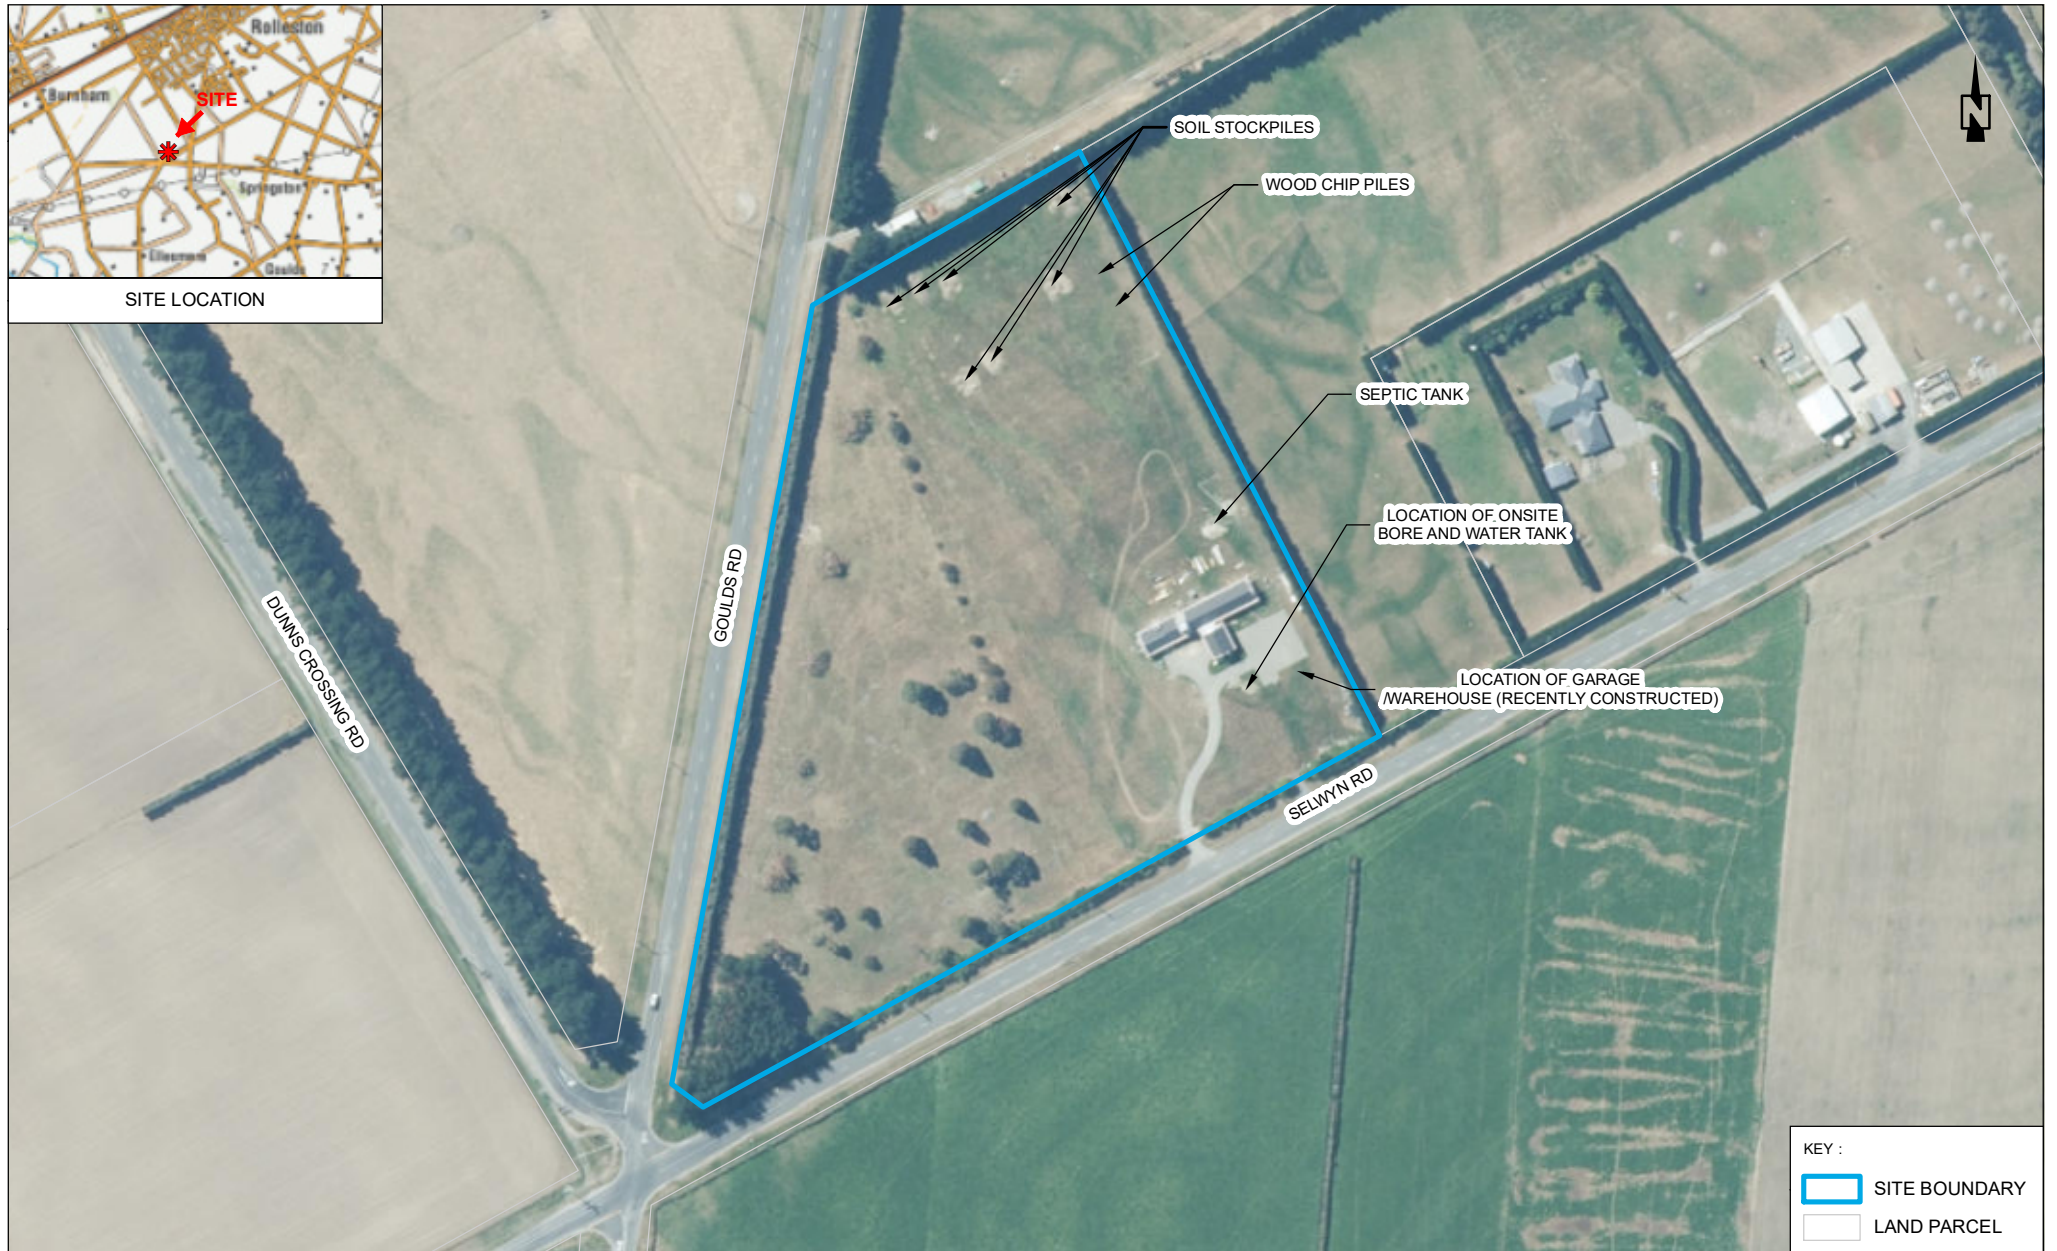
FIGURE 1: SITE LOCATION, RECENT LAYOUT AND CURRENT FEATURES

The site currently comprises a dwelling and an associated garage/warehouse building in the south-eastern part and mostly vacant paddocks across the remaining areas. Gum trees are present sporadically across the western part of the site.

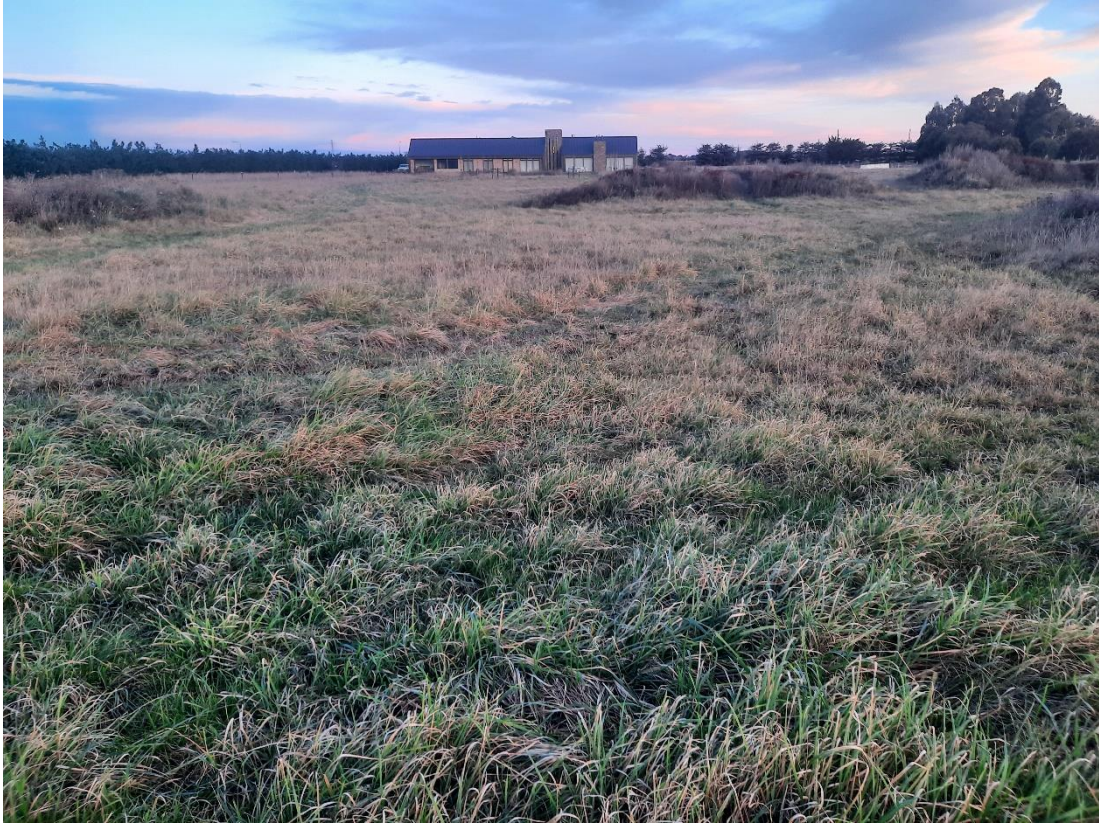
**Photograph 1: View looking south-east across the eastern part of the site from the northern site boundary.**

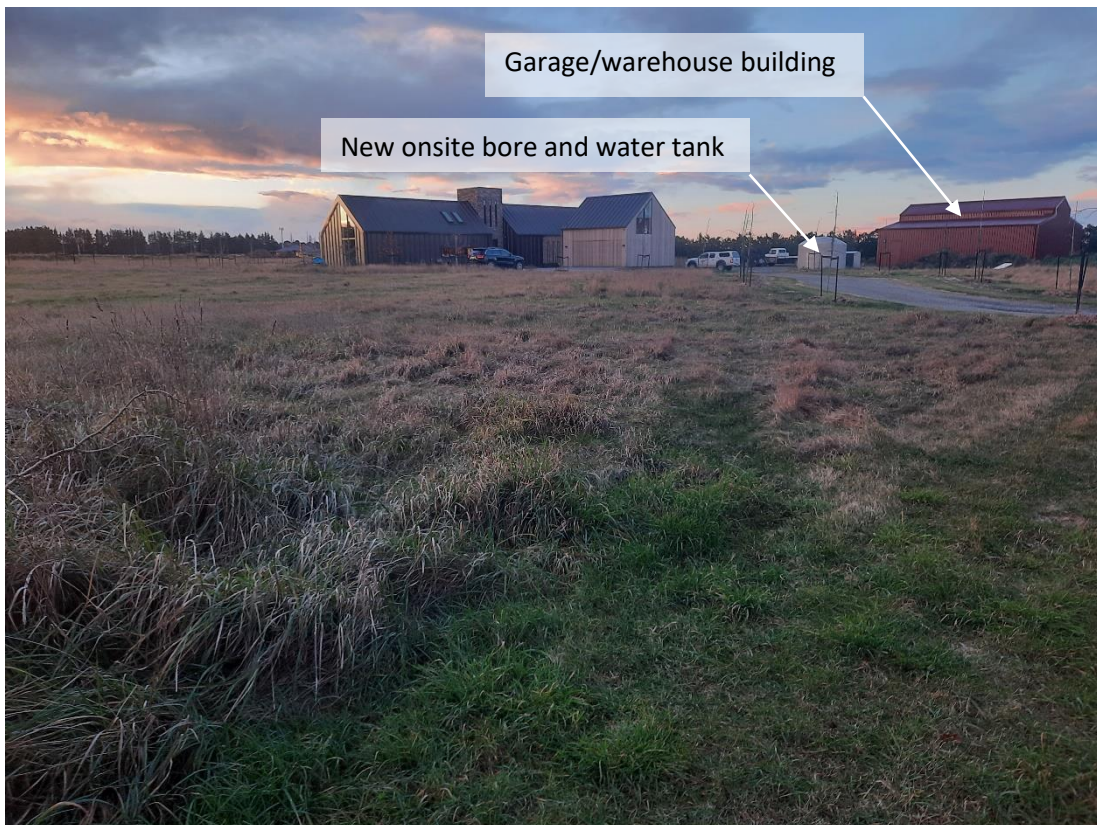
**Photograph 2: View looking north-east across the eastern part of the site from the southern site boundary along Selwyn Road.**

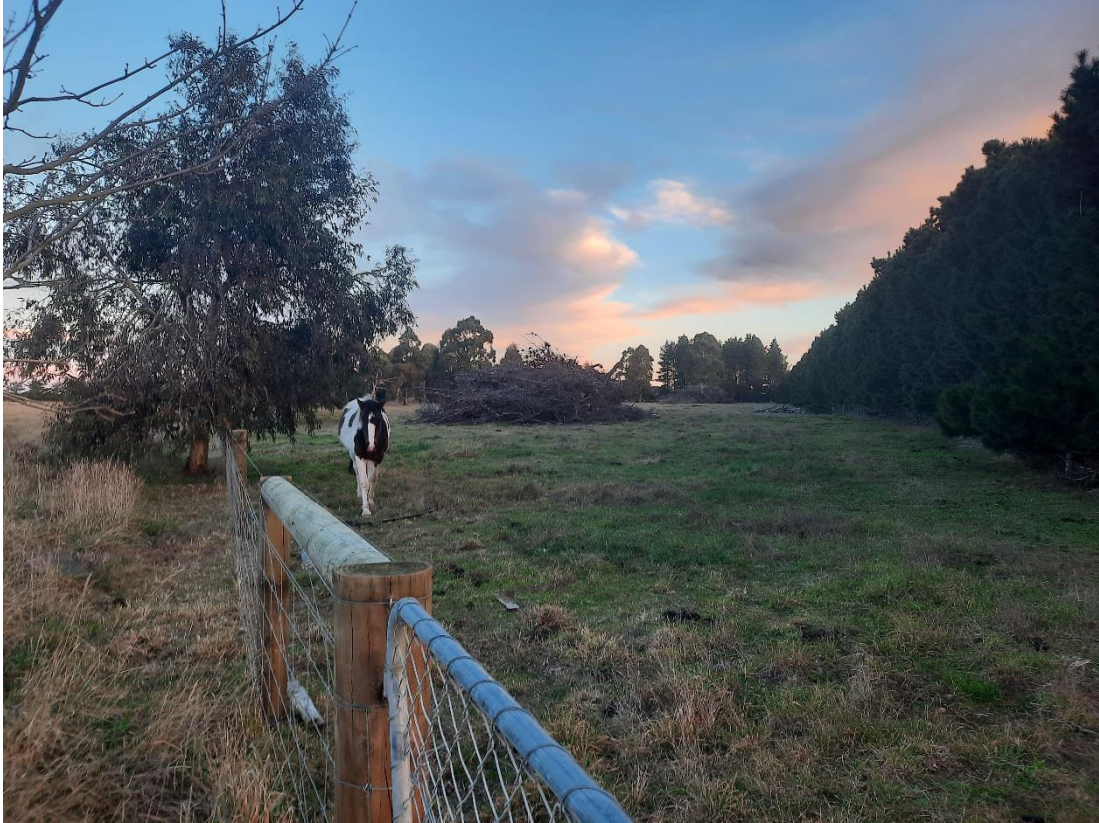
- ✧ The western part of the site was a vacant paddock and is being used for rearing horses. Gum trees and piles of chopped wood were observed sporadically across this area. According to the site owner, these trees are remnants of a previous gum tree plantation carried out by former site owners, which confirms the rows of trees evident in the 2004 aerial photograph (see Section 3.1). The specific purpose of the trees or plantation practices is unknown, but unlikely to have been subjected to any form of chemical treatment (e.g., pesticide/herbicide sprays).

**Photograph 3: View looking south-west across the western part of the site from the north-western corner.**

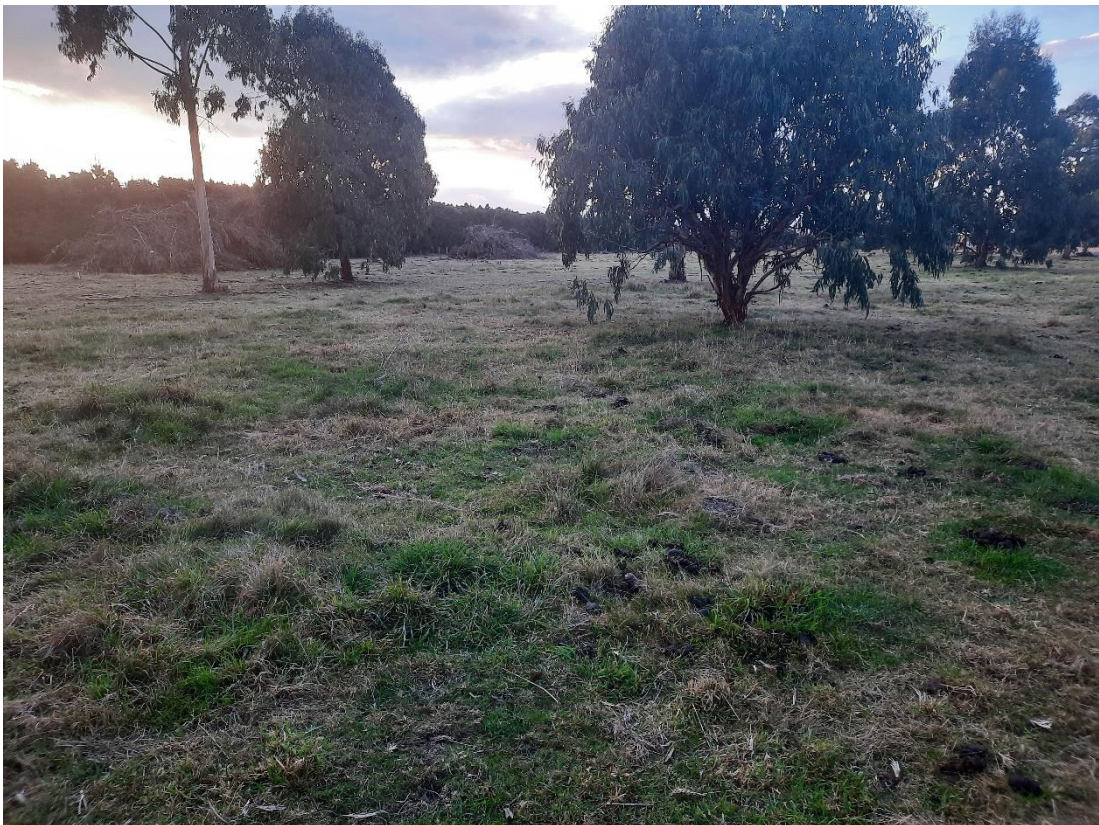
**Photograph 4: View looking north across the western part of the site from the southern site boundary along Selwyn Road.**
