Preliminary Site Investigation

545 East Maddisons Road, Rolleston

Prepared for Peter Tilling

501792

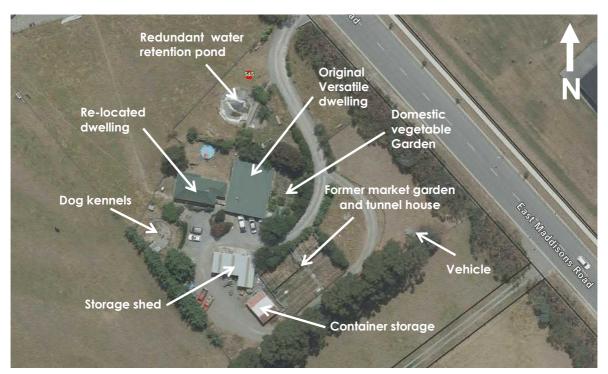
Figure 2: Area A features. Aerial photography retrieved from Canterbury Maps GIS

- A relocated timber-framed single storey dwelling with weatherboard cladding and shallow timber piles,
- A single storey "versatile" dwelling with lightweight steel cladding, roof on a concrete floor slab,
- A single storey farm shed with lightweight cladding and roofing,
- Container storage shed,
- Former market garden and tunnel house area,
- Redundant water retention pond.

- Area A: The market garden identified was previously used to grow flowers. At the time of investigation in November 2020 this area is generally vegetated with long grass and weeds. Two surface samples were screened within this area using the portable XRF analyser for priority contaminants, including arsenic and lead. Results were all below the NESCS rural-residential guidelines criteria,
- Area B: The structure is currently used as an auto-electric workshop (Autoelectrix Rolleston Ltd). The workshop comprises an intact concrete floor slab. New batteries, vehicle parts, tools, lubricants and oils are stored within the workshop.

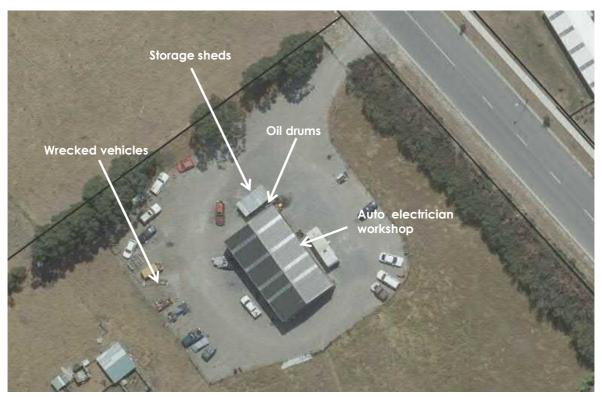
Figure 3: Area B Aerial photography retrieved from Canterbury Maps GIS

- An industrial building with an intact concrete floor specialising in vehicle electrics and car batteries,
- Compacted gravel driveway and surround,
- Oil drums (~5 observed),
- Dis-used vehicles.

- Area B: The area surrounding the building is unpaved. Dis-used drums (lubricants) were identified adjacent to the workshop, including one that is utilised for waste oil. Minor surface staining was observed in this area. Dis-used vehicles and parts were sighted adjacent to the western side of the workshop,

Due to the minor areas involved and surface impact only, we assess that there is no immediate human health risk for the existing site use. For future residential land use, we recommend that the drums are appropriately disposed of at a facility authorised to receive them, and a surface scrape of visibly impacted soil is undertaken and also disposed of at an approved facility. The volume of soil requiring disposal is not likely to exceed the permitted activity criteria specified in the NES, which states:

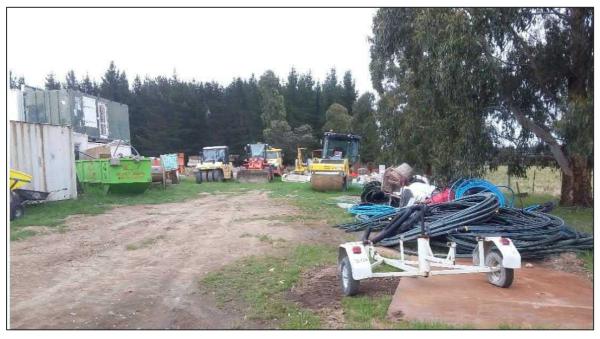
Figure 4: Area C. Photograph taken on 11 November 2020.

Refer to Figure 4. Area C is currently used for the storage of various earthworks plant, machinery and portacom buildings. Drainage materials, manhole sections and concrete blocks were also observed during the site walkover inspection. A backfilled offal pit is located in the western corner of Area C. No HAIL activities identified.

- Area C: The excavated pit evident in the 2019 aerial photography (offal pit) has been backfilled and at the time of investigation in November 2020 concrete blocks were stored in the area of the former pit.

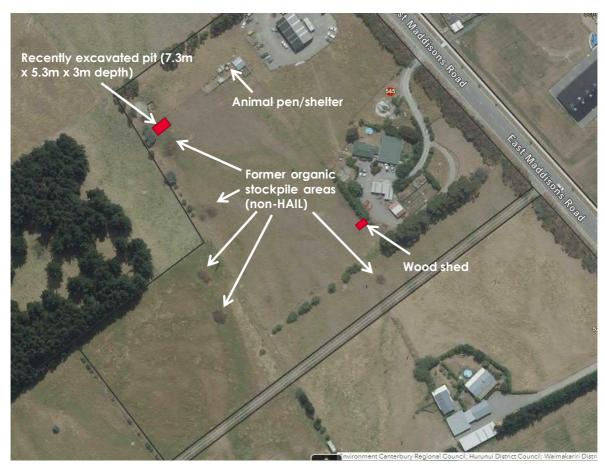
Figure 5: Area D site features. Aerial photography retrieved from Canterbury Maps GIS.

- An excavated pit that the site owner advised was to replace the former offal pit located in the western corner of the site (within Area C),
- Undulating farmland used for grazing,
- Livestock pen for calves,
- Woodshed,
- Former organic stockpile areas (tree branches).

- Area D: An excavated pit (~3m deep) was identified, as shown on Figure 5. The pit comprised a minor volume of burnt materials in the base. Gravel, branches and a single steel drum and wire was observed. Three representative soil samples were screened using a portable XRF analyser for priority contaminants, including arsenic and lead. Samples were obtained at the surface of the pit within visibly burnt soil and depths of 1m and 2.7m. Results were compared to the NESCS rural-residential guideline criteria. Results were all below NESCS rural-residential guidelines criteria as summarised below;

- i) Arsenic reported range between 3.3 and 13.1 mg/kg (NESCS guideline criteria of 17mg/kg),
 - ii) Lead reported range between 14.2 and 18.2 mg/kg (NESCS guideline criteria of 160mg/kg),

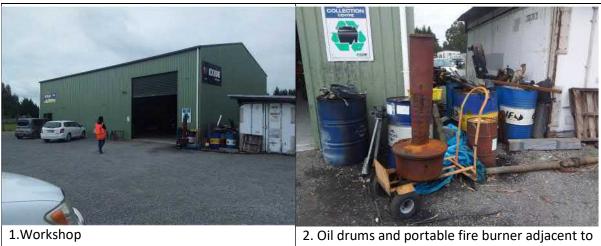
workshop
