# Soil Contamination Risk Preliminary Site Investigation Report

# 108 Yeomans Road, Darfield

February 2021

# Malloch Environmental Ltd

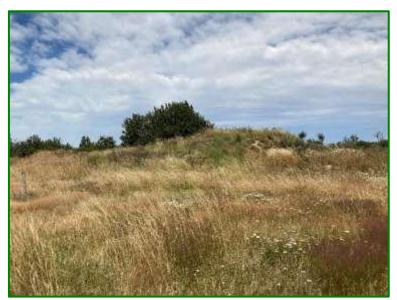
To the south of the entrance to the subject site is a large stockpile. This appears to contain stony soil similar to the soil of the subject site. However, there's nothing on the aerials or apparent during the site inspection that would explain the source of the material. At the end of the stockpile is a concrete pad, it is unclear what the pad is for.

Photo 1 – Large stockpile

A stockpile of stony soils is present on the western corner of the site and further similar fill material forms a bank next to the site entrance. There was no apparent demolition debris or

waste items within the stockpile or fill material. However, the source of the material is unknown so could potentially be contaminated. Contaminants of concern include heavy metals.

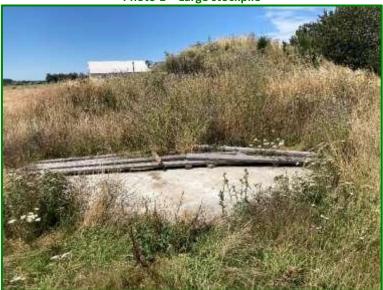
Photo 2 – Concrete pad at end of stockpile

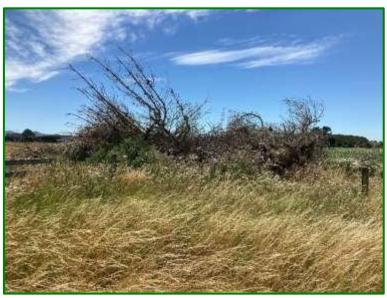
The raised bank on the north side of the entranceway appears to have been built intentionally as it is edged on one side by rocks and the other by timber. At the northern end of the bank is a slash pile. This appears to contain the remains of the hedge that was noted on the 2012 and 2016 aerials. No other items of waste were seen within the pile.

Photo 3 - Green waste slash pile

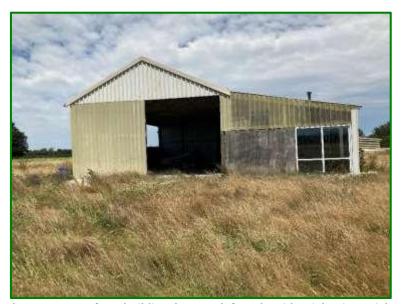
The buildings on the subject site are constructed from sheet metal, fibreglass and timber. No likely asbestos containing building materials were seen on the exterior of the buildings. The large farm building is part barn and part residential unit. It has a concrete floor. A number of old car batteries are stored within the barn. However, as these are on concrete they do not pose a risk of soil contamination. There are pieces of sheet metal and a small stockpile of stony soils at the southern corner of the farm building. A burn drum is present behind the farm building.

Photo 4 – Large farm building, barn on left and residential unit on right

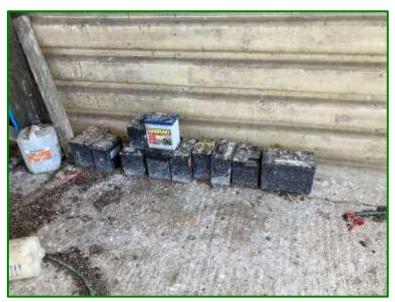
Photo 5 – Batteries stored in barn

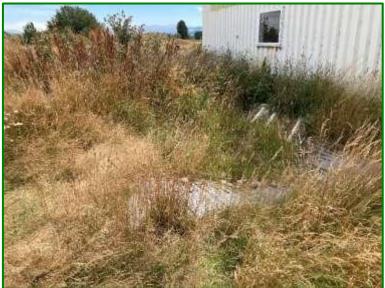
Photo 6 – Sheet metal and small stockpile

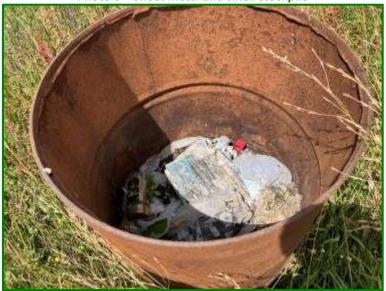
Photo 7 – Burn drum

Household waste has been burnt in a metal drum to the east of the farm building. Contaminants of concern include heavy metals and polycyclic aromatic hydrocarbons (PAHs).

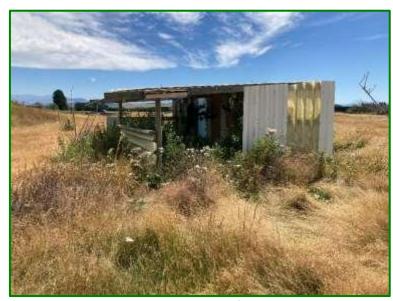
A small pump shed/animal shelter is present approximately halfway between the stockpile and the farm building. The other possible shed seen on the 2016 aerial has been removed but the concrete pad adjacent to it is still present. The circular structure seen on the 2016 aerial has also been removed and the area is now overgrown.

Photo 8 - Animal shelter/Pump shed

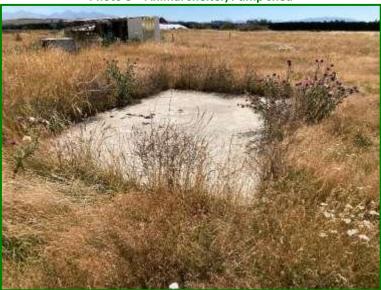
Photo 9 - Concrete pad

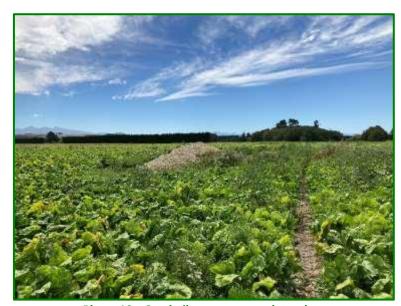
A stockpile of stony soil is present next to a farm pit adjacent to the eastern boundary of the subject site. This pit was also noted on the 2016 aerial photograph. The pit appears partially filled but burnt natural wood and partially buried metal pieces were visible.

Photo 10 - Stockpile near eastern boundary

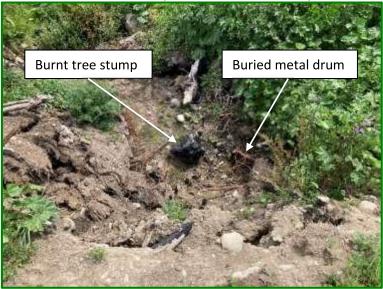
Photo 11 - Farm pit next to stockpile

There is a farm pit near to the eastern boundary of the subject site. The contents of the pit are unknown. However, a partially buried metal drum and other metal pieces were seen within the open section of the pit. This suggests that materials other than green waste have been buried within the rest of the pit. Contaminants of concern include heavy metals.

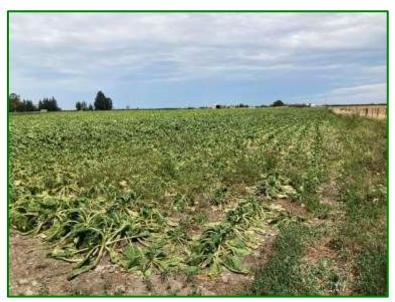
The rest of the site is currently planted with fodder beet. The hedge and the items stored along it in the 2016 aerial have all been removed. The planted area appears relatively flat with no visual evidence of burn piles or further farm pits. However, it was not possible to closely inspect the soils due to the plant cover.

Photo 12 - Fodder beet

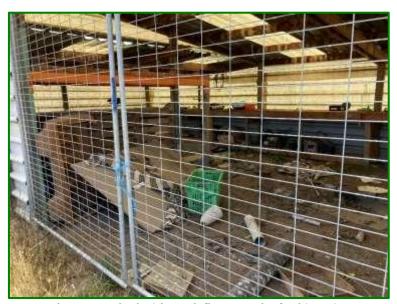
**Potential off-site risk area**: The buildings and non-pastoral area of the site extends south, beyond the boundary of the south of the subject site. Within this area is another shed also constructed from timber, sheet metal and fibreglass panels. The floor is earth. There are scrap items remaining within this shed suggesting it may have been used as a workshop. In front of the shed is an overgrown burn pile. Finally, some sheet metal and timber is being stored on the ground around this area.

Photo 13 – Shed with earth floor, south of subject site

The current area of buildings and non-pastoral use extends beyond the boundary of the subject site. The aerial photographs and the site inspection identified a shed with an earth floor that may have been used as a workshop, a burn area was present at the front of this shed and some timber and sheet metal were stored around this area. There is a risk of soil contamination within this area from these activities. However, any contamination is likely to be very localised to the potential source and is not considered likely to migrate onto the subject site.

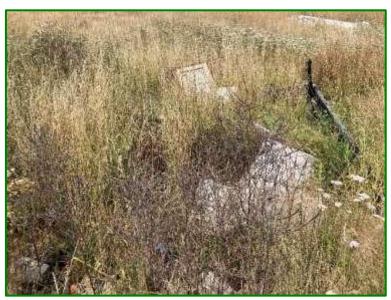
Photo 14 – Burn area not within subject site
