**Soil Contamination Risk
Preliminary Site Investigation Report**

**606 Ridge Road,
Motukarara**

July 2022

**Soil Contamination Risk
Detailed Site Investigation Report
and Remediation Action Plan**

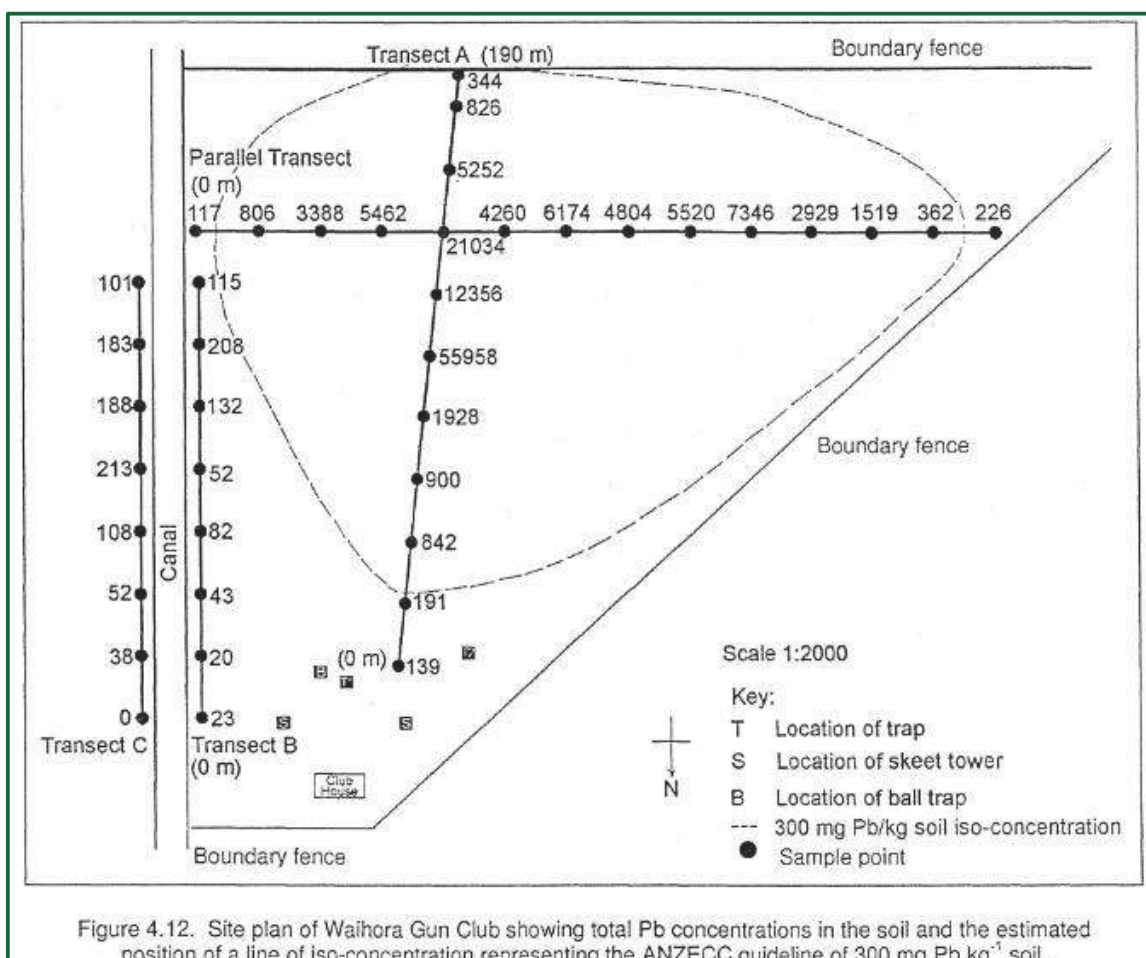
Figure 4 – Waihora Clay Target Club Sample Locations and Corresponding Lead Concentrations

Figure 4.12. Site plan of Waihora Gun Club showing total Pb concentrations in the soil and the estimated position of a line of iso-concentration representing the ANZECC guideline of 300 mg Pb kg⁻¹ soil.

The report states that the maximum lead concentrations at all three sampled sites were at a distance of 120m or 140m from the traps. The Waihora Clay Target Club was categorised as having a medium risk potential, likely to require further action. The report concludes that the shot fall zone is often the area containing the highest concentrations of lead, which extends onto neighbouring land used for agricultural purposes. The report recommends that steps be taken to further investigate and characterise contamination resulting from clay target clubs and implement suggested site management measures to mitigate potential adverse effects to human health and the environment.

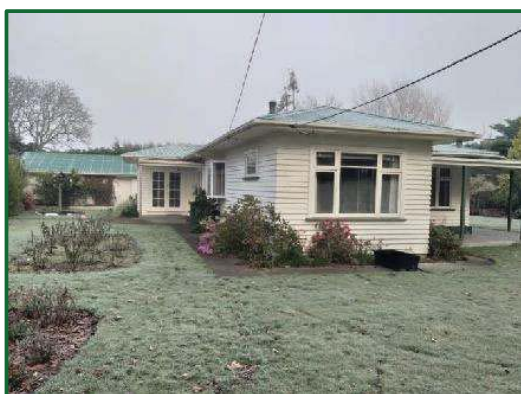
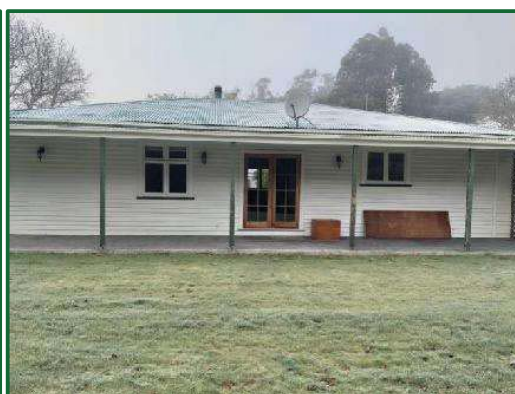
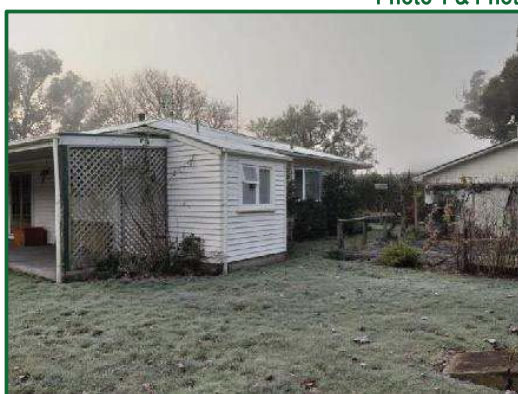
A site inspection was undertaken on 23 June 2022 to assess the likelihood of soil contamination on the site. The residential and farmyard area is located within the eastern corner of the site and accessed via Gammacks Road. The residential dwelling is a weatherboard structure and surrounded by garden beds, pathways and a patio area. A domestic vegetable garden is located to the rear of the dwelling. A concrete block garage/workshop is located adjacent to the vegetable garden. The garage/workshop has a concrete base and was empty at the time of the site inspection. Within the treeline to the rear of the dwelling is a corrugated iron and timber firewood storage shed, a small timber structure, likely an outdoors toilet and a small cottage. The cottage is painted timber and the paint is flaking and in a deteriorated condition.

Photo 1 & Photo 2 – Dwelling

Photo 3 – Rear of the dwelling

Historical CTs suggest the site has been occupied since 1893 and buildings have been present on site since at least the early 1940's. Based on the era of the buildings present it is highly likely that lead based paint products and asbestos containing materials (ACM) have been used and any natural deterioration or intentional removal may have caused contamination of the surrounding soils.

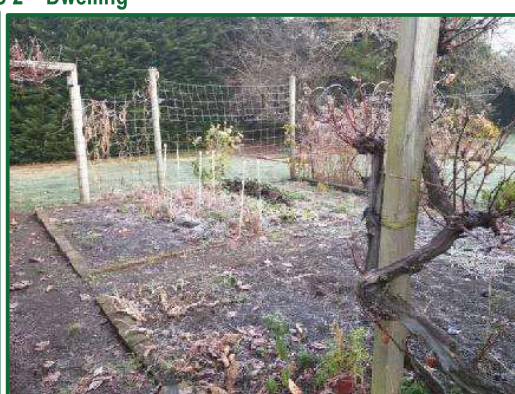
Photo 4 – Vegetable garden

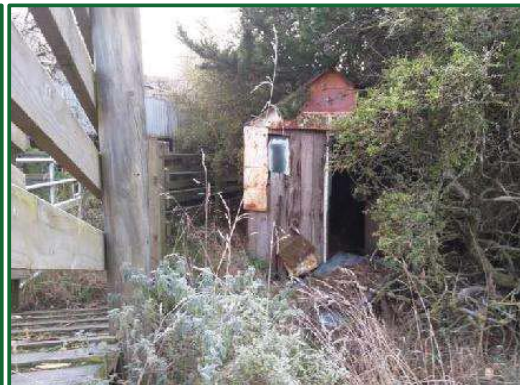
Photo 14 – Dilapidated shed

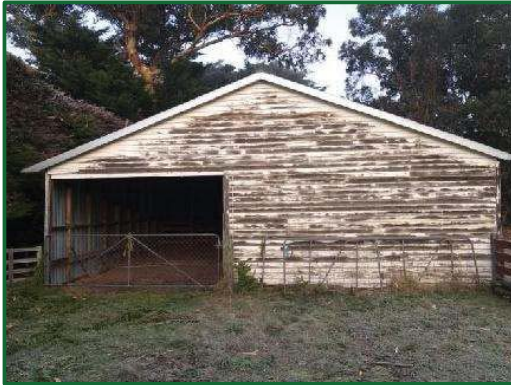
Along the southern boundary of the site is a large painted timber woolshed/shearing shed. The painted timber is flaking and in a deteriorated condition. Sheep yards are present to the rear of the shed and a potential foot rot trough is present within the yards. There are also several broken pieces of concrete within the ground surrounding the sheep yards. To the rear of the sheep yards is a 4-bay implement shed. The shed is a corrugated iron and timber structure with an earth base. There was evidence of some oil and chemical storage occurring and isolated oil spots on the shed floor. An aboveground diesel storage tank (AST) is located in the treeline to the north of the implement shed. There were no obvious signs of spills or leaks surrounding the AST.

Photo 15 – Woolshed/shearing shed

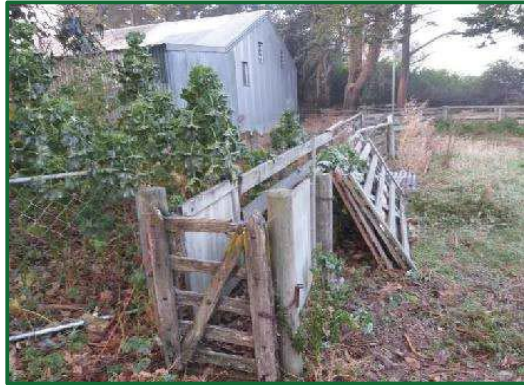
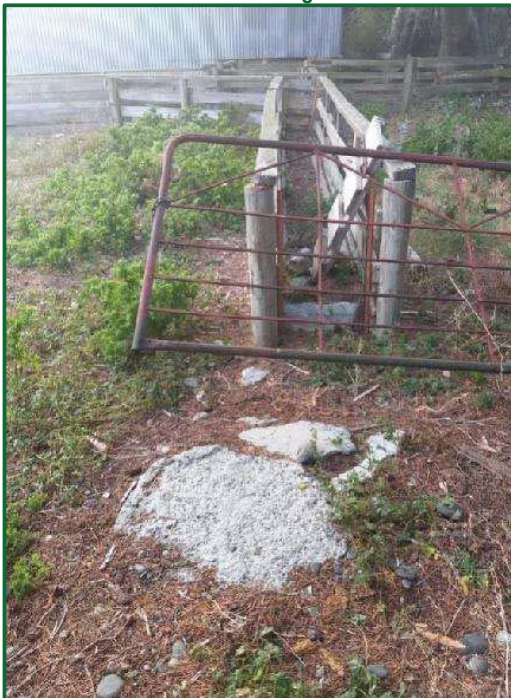
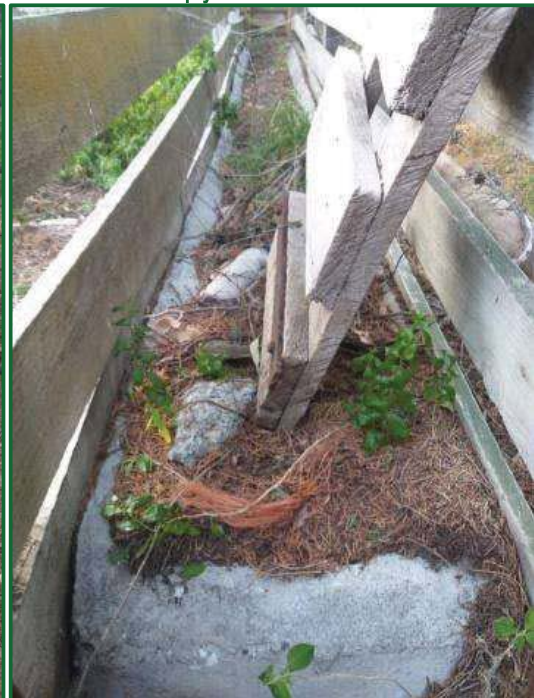
Photo 16 – Sheep yards

Photo 17 & 18 – Sheep yards and potential foot rot trough

Sheep yards and a potential foot rot trough were identified during the site inspection. In the area surrounding the foot rot trough were several broken pieces of concrete. Although a plunge dip structure cannot be seen, the use of these yards for spray treatments cannot be discounted.

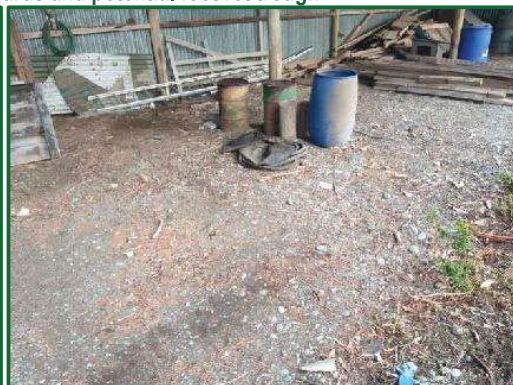
Photo 20 – Evidence of oil spots on shed floor

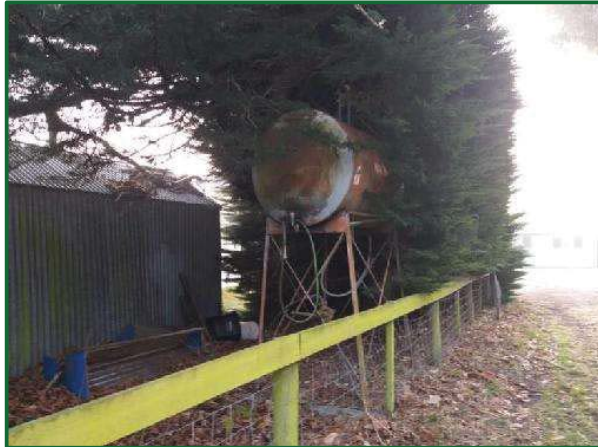
Photo 21 – AST

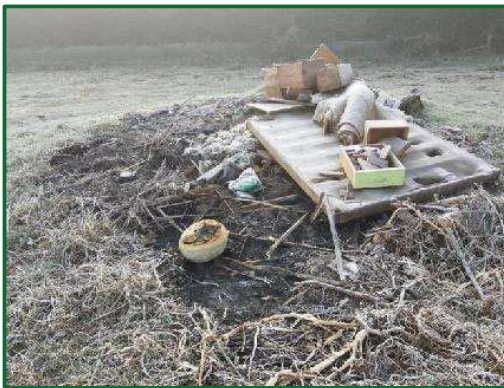
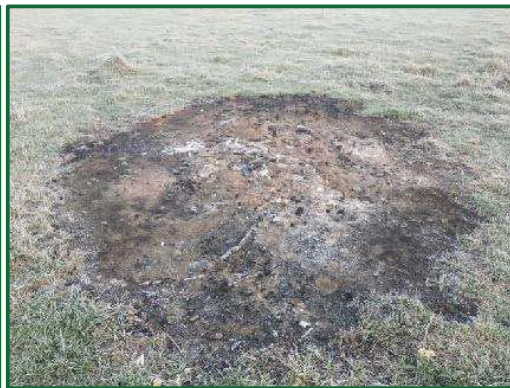
Two burn areas are present in the paddock to the rear of the residential and farmyard areas. Both burn areas contain anthropogenic material such as glass, wiring, metal, nails, timber and an oil can. A chicken hutch, farm machinery, oil drums and a stockpile of treated timber are being stored along the treeline on the southern boundary of the site.

Photo 22 & 23 – Burn areas

During the site inspection two burn areas were identified in the paddock to the rear of the residential and farmyard areas. Both burn areas contain anthropogenic material such as glass, wiring, metal, nails, timber and an oil can.

Contaminants of concern associated with burn areas is dependent on the material disposed of but could include heavy metals, asbestos and petroleum hydrocarbons.

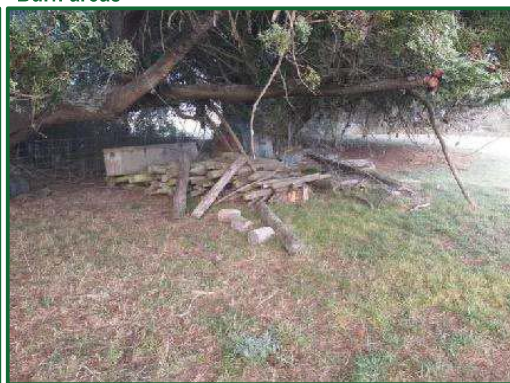
Photo 25 – Treated timber stockpile

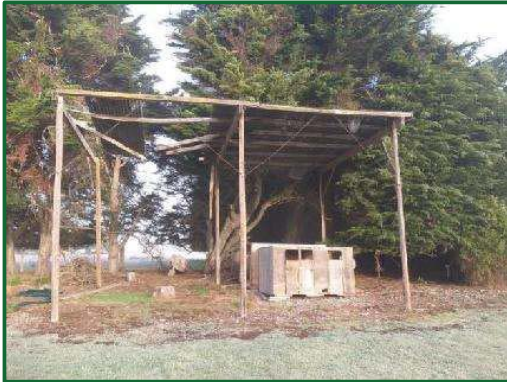
Within the paddock to the north of the residential area is a large, dilapidated implement shed and some general farm storage occurring. The remaining paddocks are being used for stock grazing and winter feed production.

Photo 26 - Dilapidated shed

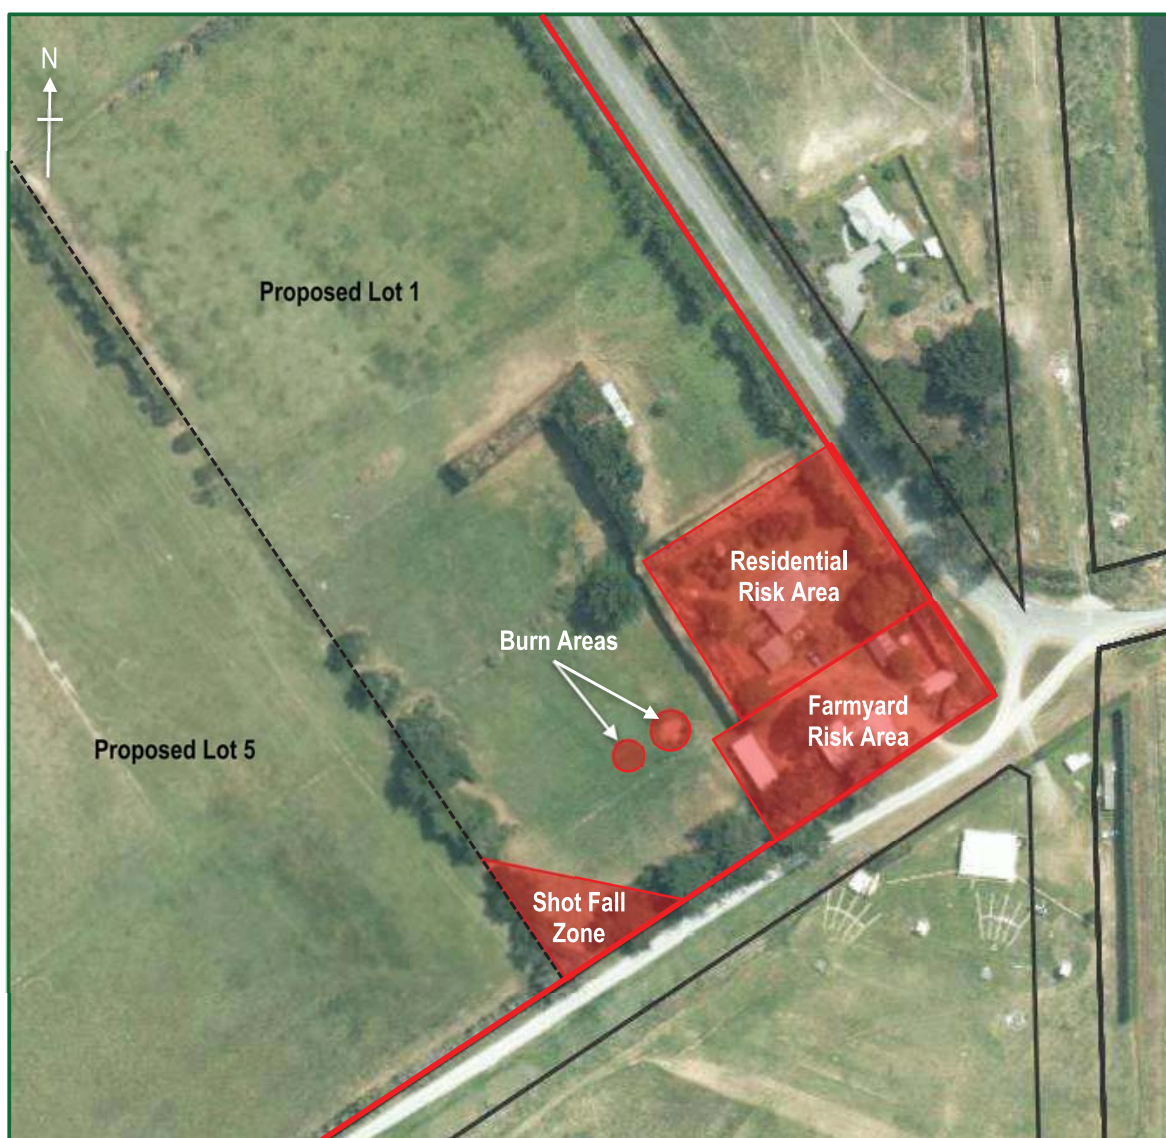
Figure 2 – Risk Areas Plan

The potential sources of contamination contained within proposed Lot 1 have been described as the residential risk area, farmyard risk area, burn areas and shot fall zone, and are shown on the plan in **Figure 5** above. Based on the potential risk to human health in a rural residential setting, it is recommended that further investigation be undertaken in the form of a Detailed Site Investigation.

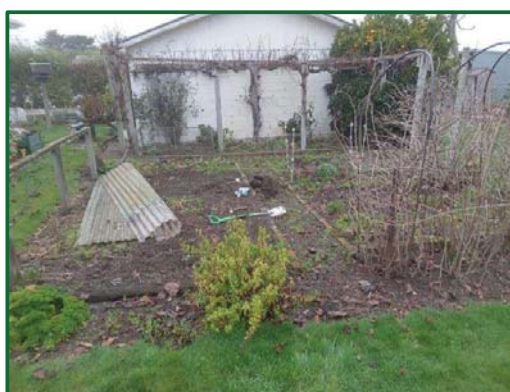
Based on the moderate risk to human health associated with the lead contamination, it is recommended the soils adjacent to and within the vegetable garden are remediated prior to the reoccupation of the dwelling and ongoing use of the area for residential purposes.

Photo 3 – Existing vegetable garden and approximate location of SS4 & SS5

The recommended remediation option is excavation and relocation on-site into a managed bund or similar. This is considered a logistically feasible option given the space available within the

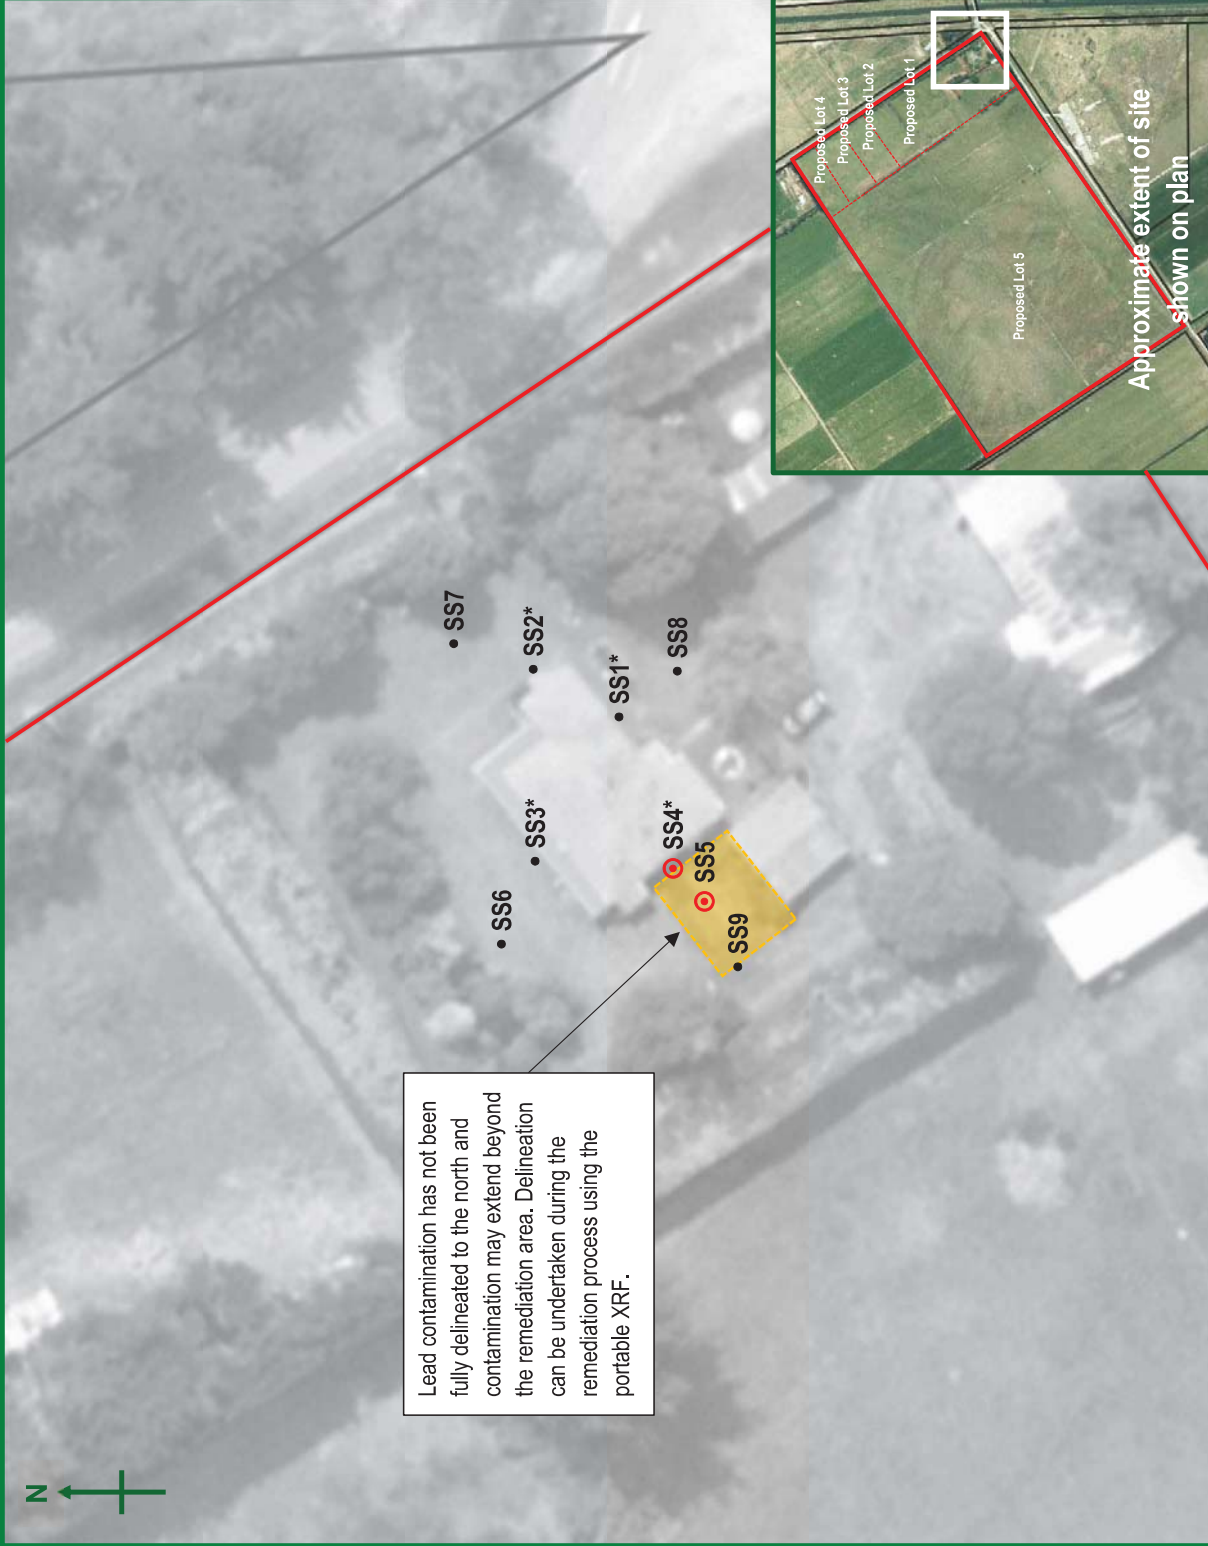
Appendix B – Sample Location Plan

Lead contamination has not been fully delineated to the north and contamination may extend beyond the remediation area. Delineation can be undertaken during the remediation process using the portable XRF.
