## **Pattle Delamore Partners Preliminary Site Investigation**

24 June 2024

## **PRELIMINARY SITE INVESTIGATION – 660 ROBINSONS ROAD, ROLLESTON, SELWYN DISTRICT**

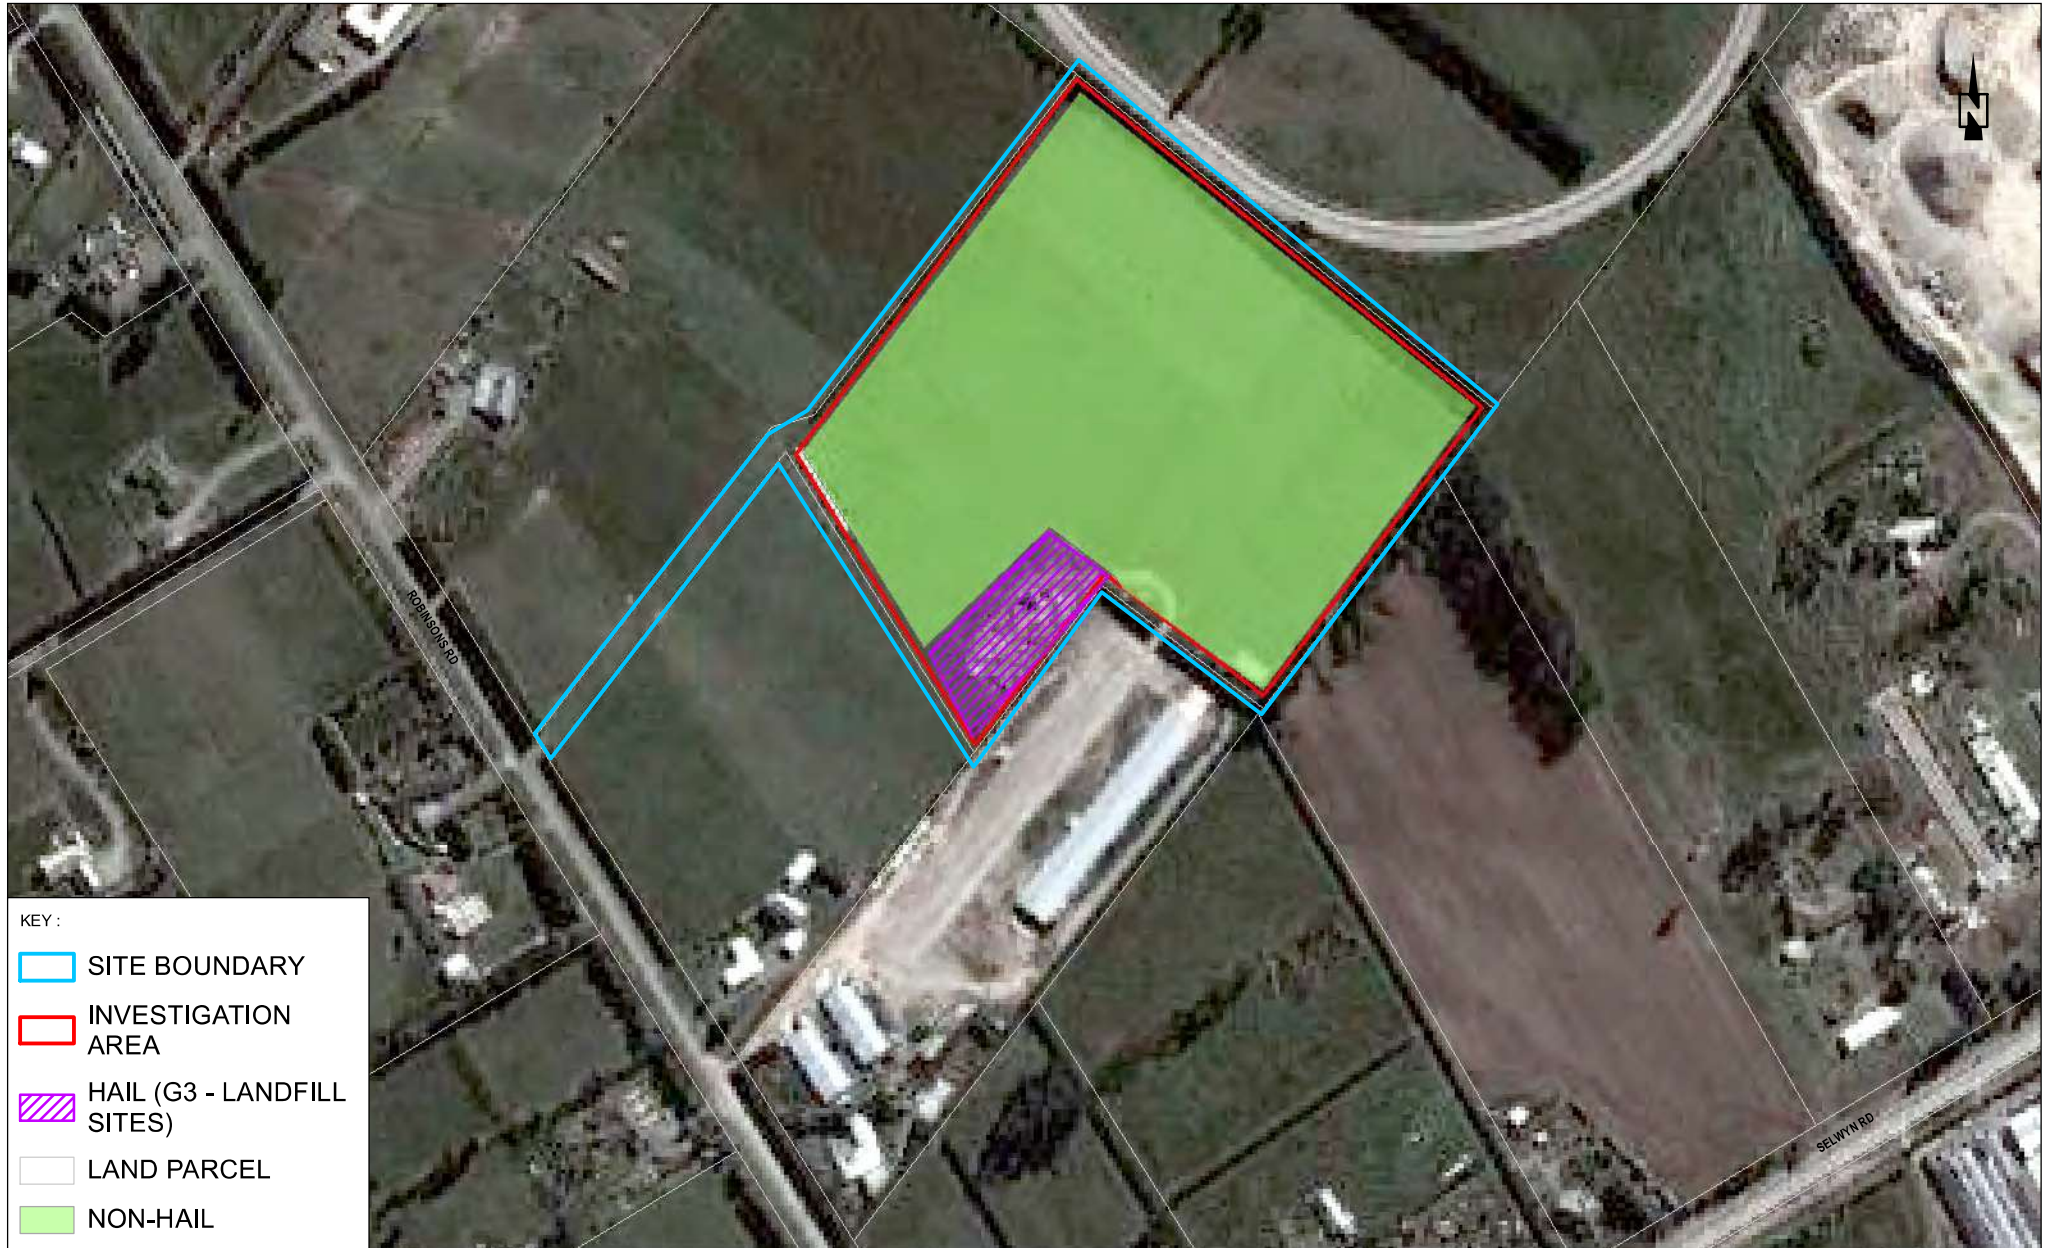
FIGURE 2 : INVESTIGATION AND HAIL AREA

- ∴ **HAIL category G3** (Landfill sites) - related to the partially backfilled pit located on the site where uncontrolled filling of potentially hazardous materials/contaminated soils may have occurred. Possible contaminants of concern include, but not limited to, heavy metals and ACM. Note this is unverified and based on aerial photos only.

The suspected HAIL area (piece of land) based on this desktop review is shown in Figure 2.

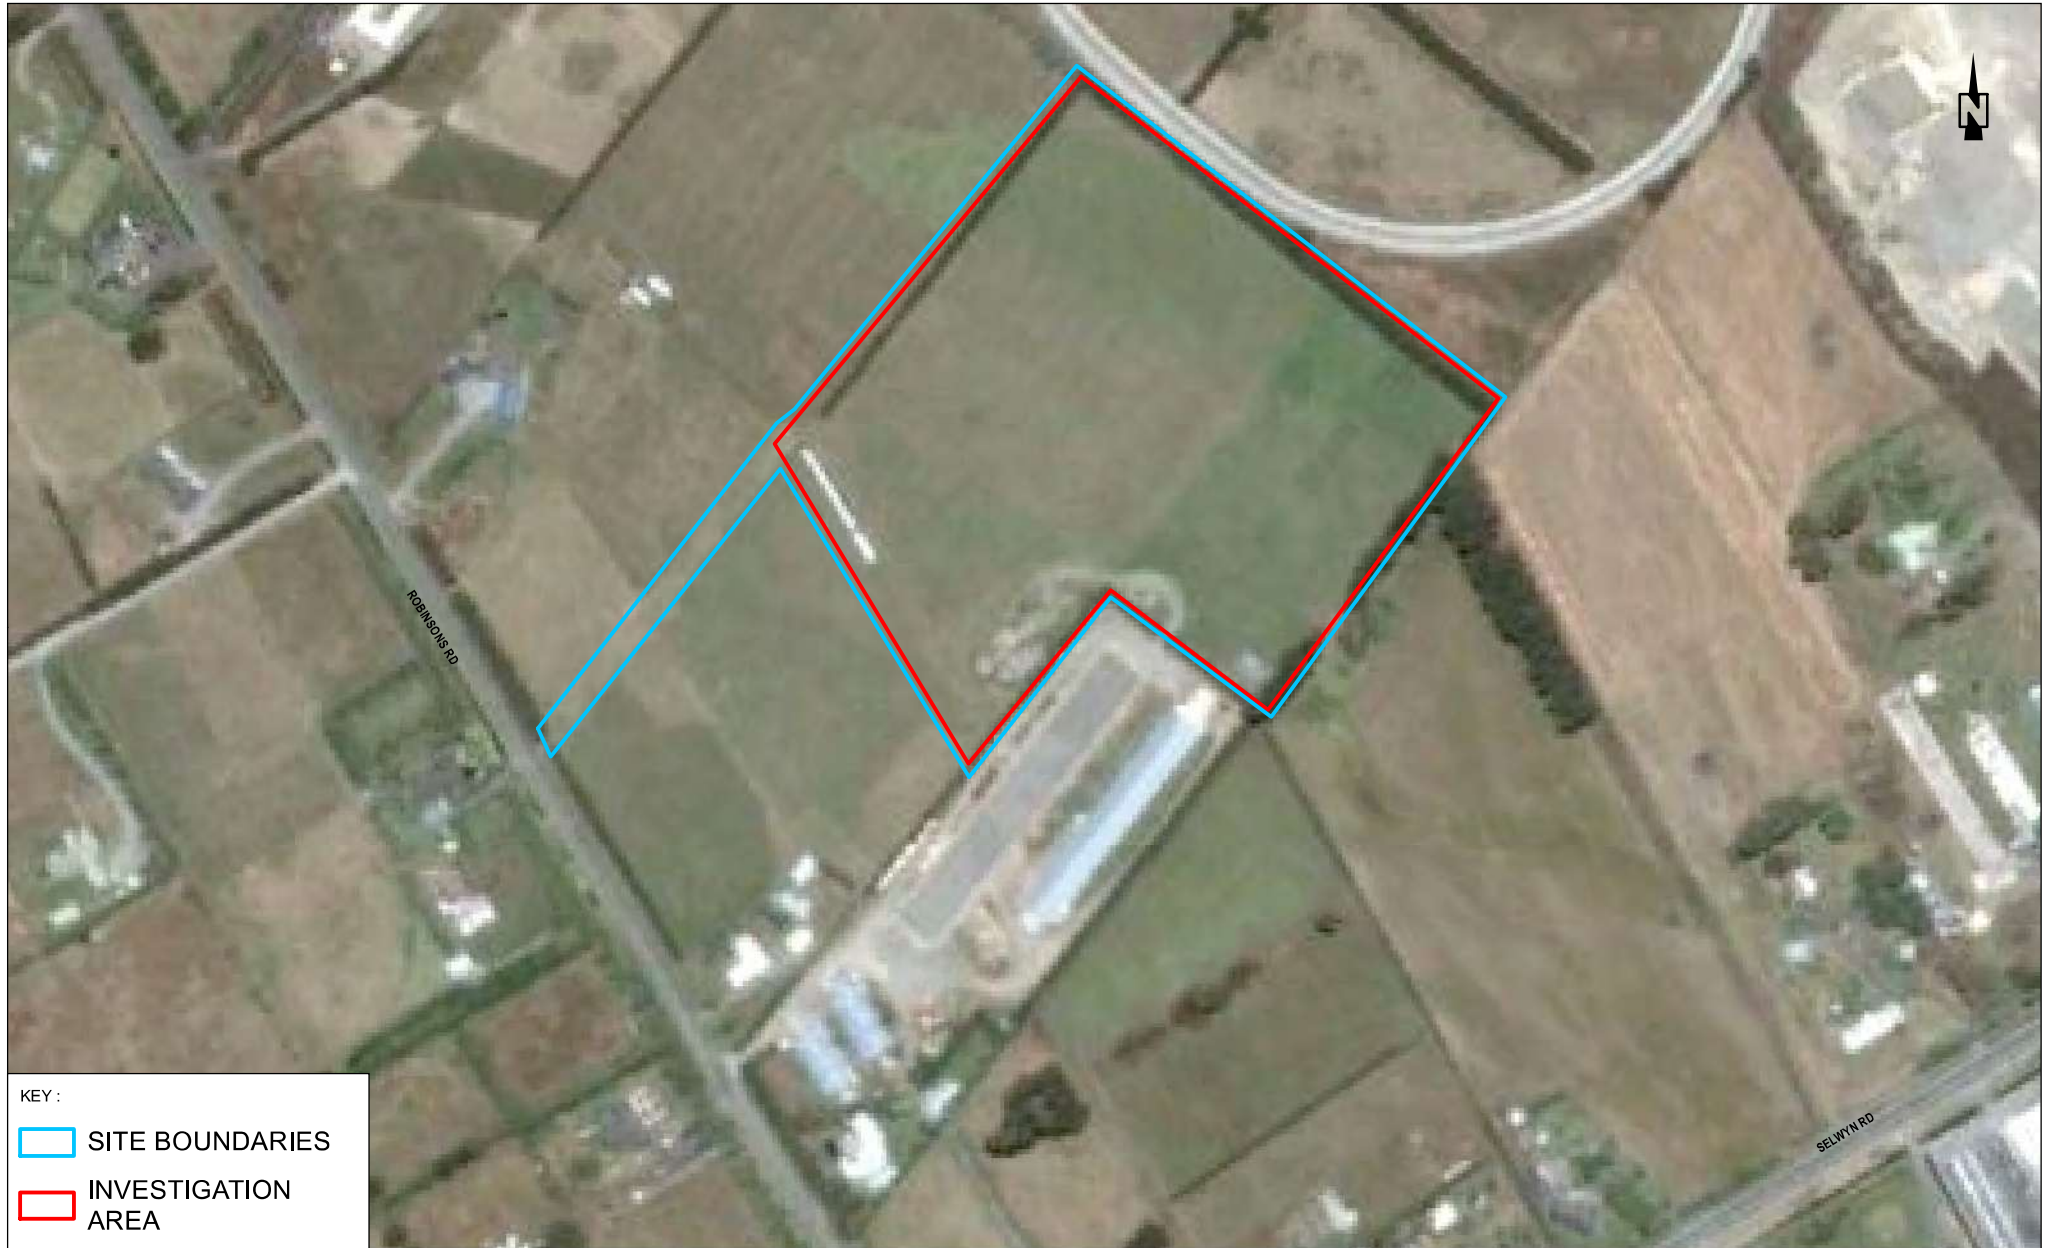
2013 AERIAL PHOTOGRAPH

- ✧ The 2013 and 2014 aerial images show what appears to be the excavation of a large pit in the southeastern corner of the investigation area as well as stockpiling of material. There is an obvious vehicle track between the pit/stockpiling and the neighbouring property to the south where there is significant redevelopment in progress where the former commercial buildings are being progressively demolished and reconstructed; and
- ✧ The 2019 and 2024 aerial photographs show the stockpiles have been removed, however there is still evidence of the pit while the rest of the investigation area remains unchanged. The land immediately to the northeast and west shows the development of the quarry. There is still evidence of a vehicle track between the commercial property to the south and the pit (possible waste pit).

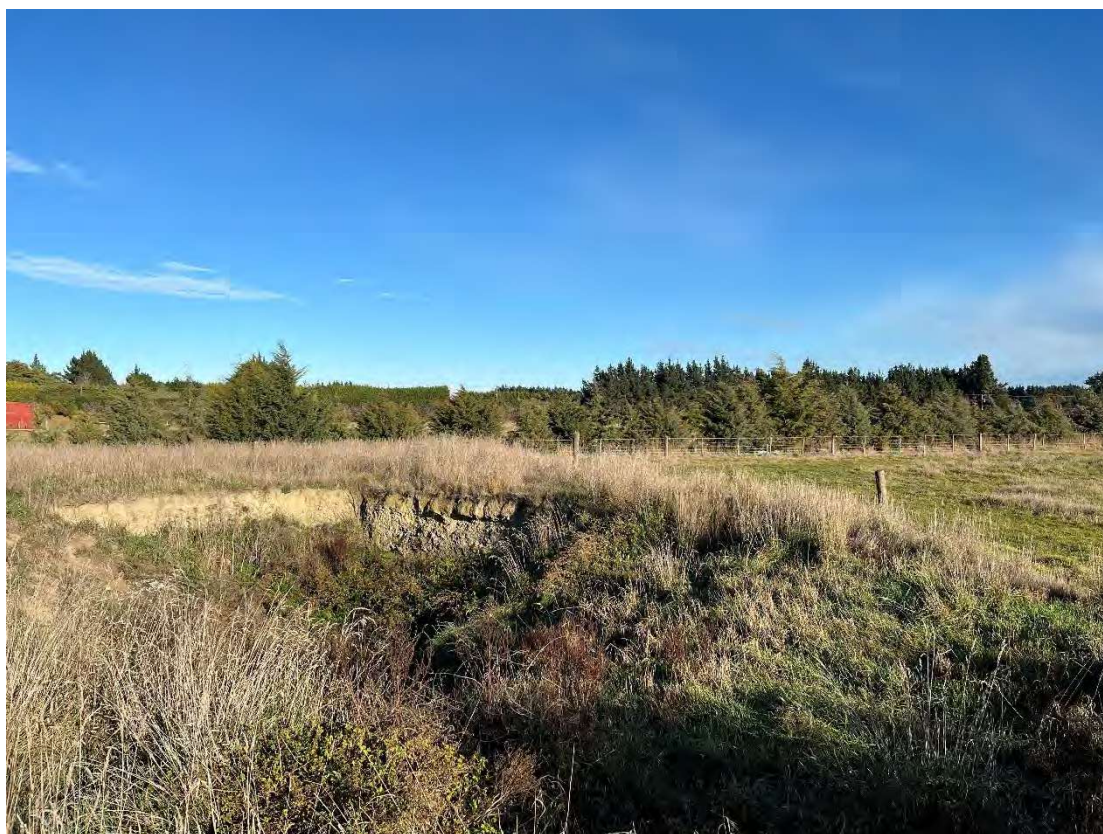
material in the pit. Inspection of the surrounding ground area suggested the original pit was much larger. Apart from the open pit area, there was no indication as to what the filled-in portion of the original pit was backfilled with; and

**Photograph 2: Extent of the pit facing south-east**

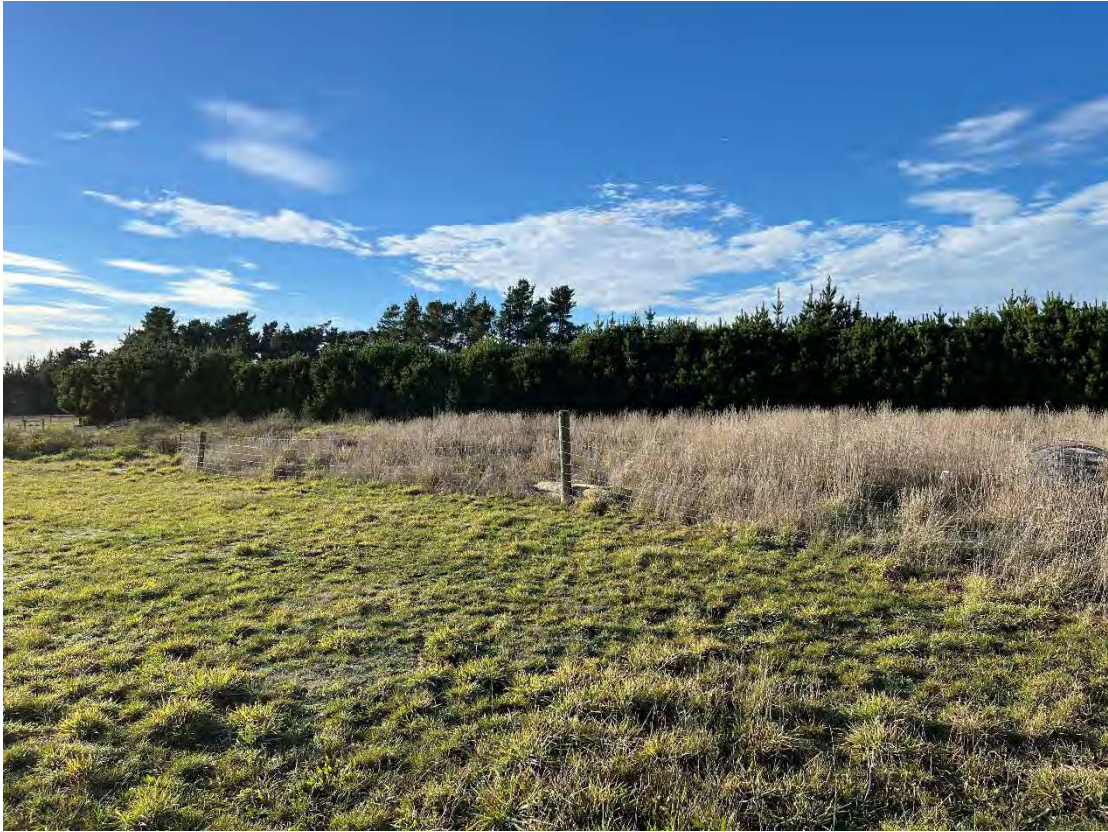
**Photograph 3: Fenced area covering the pit.**

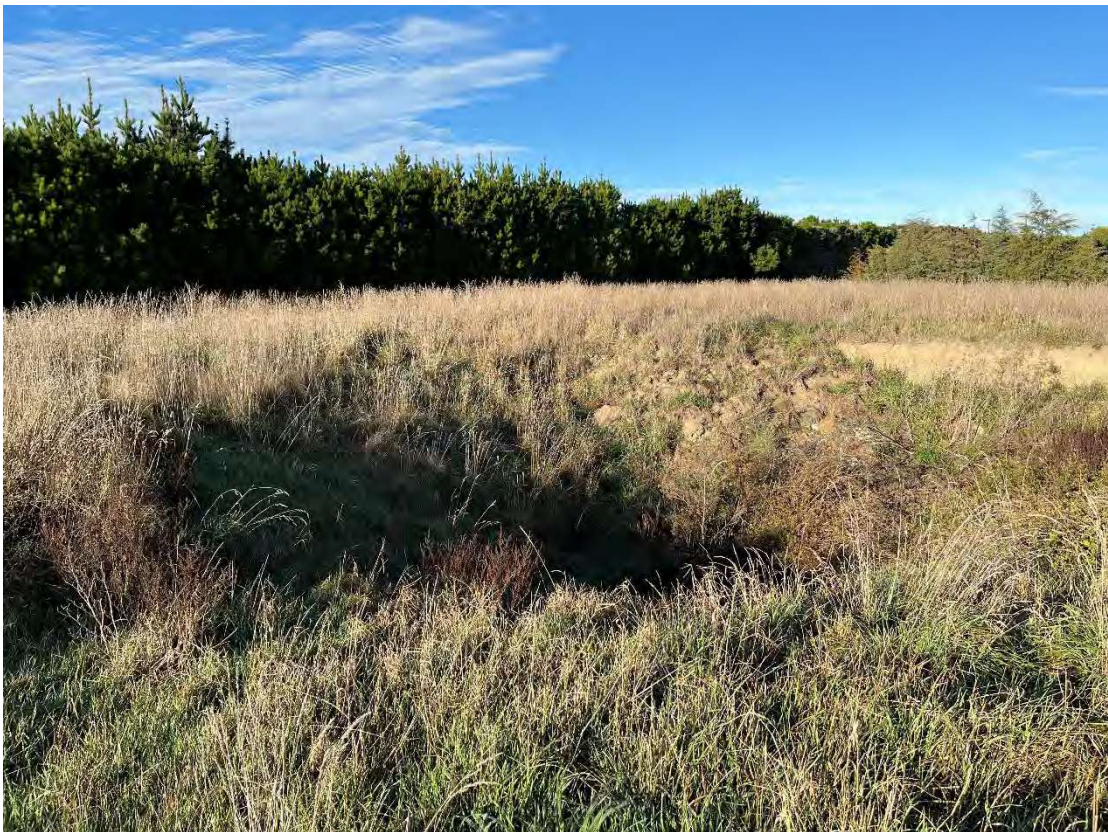
**Photograph 4: Pit area**

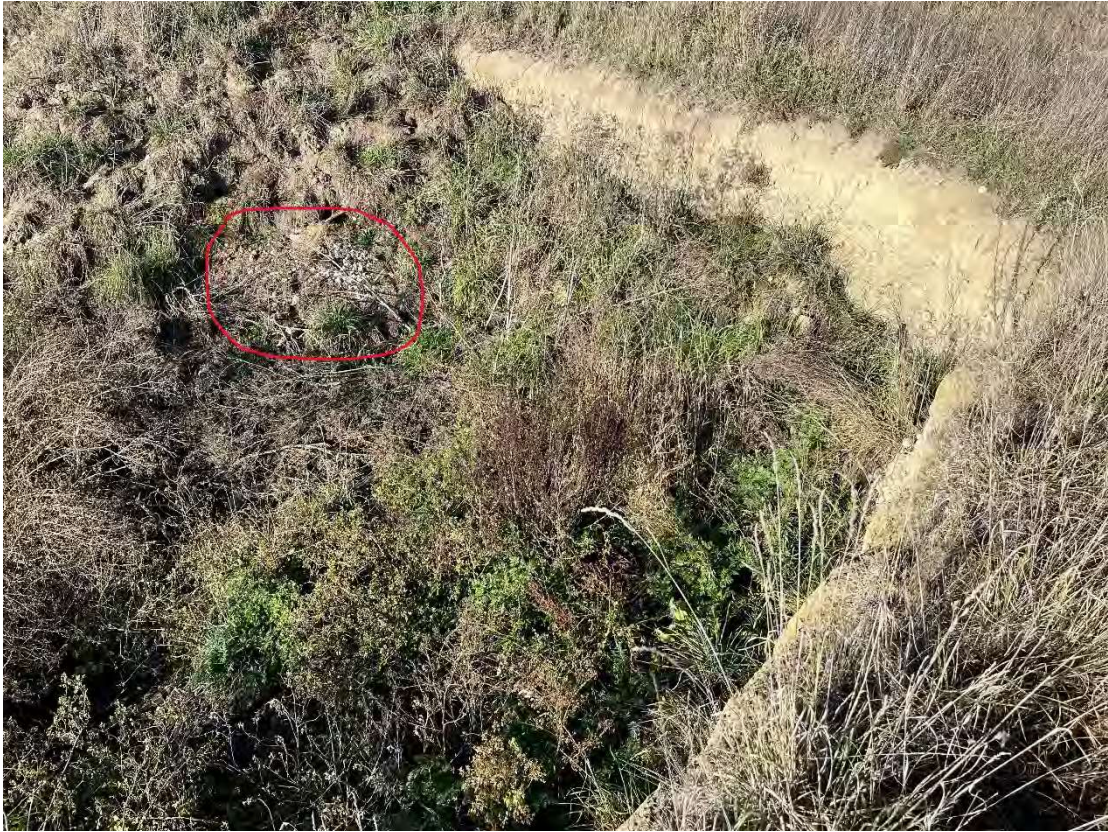
Evidence of an old pit partially backfilled was identified in the southern-eastern corner of the investigation area. This was excavated at the same time as the redevelopment of the chicken farm in the adjacent property to the south and a vehicle access track between the two areas was visible linking the two areas. It is possible that the pit was excavated to source suitable gravel material for the foundations/pavement surfaces as part of the redevelopment works as large stockpiles of material was observed. The pit was originally much larger than it currently is, so it has been partially backfilled. The exact extent of the pit is unknown, however, a reasonable estimate based on site observation and aerial photos has defined it to the southeastern corner (refer Figure 2). The material used to partially backfill the pit is also unknown. Given the pit was partially backfilled at the same time of the neighbouring redevelopment and this work involved the demolition of the former commercial buildings constructed between 1970 and 2000, there is the potential for hazardous material to have been dumped in the pit at the time (i.e. lead paint and/or ACM). There is also anecdotal information that the chicken farm may have more recently used the pit as a waste dump. During the site inspection some domestic waste and construction material was identified within the pit.

**Photograph 5: Content of pit, presence of some construction material (circled in red)**

If in the future the 'piece of land' is to be disturbed or the land use change, then then Regulation 5(4) - *soil disturbance* and Regulation 5(6)) - *change of land use* would need to be considered and consent may be required for the works. It is recommended that an intrusive investigation (Detail Site Investigation) be conducted to better understand the nature of the infilled material at to assist with this process.

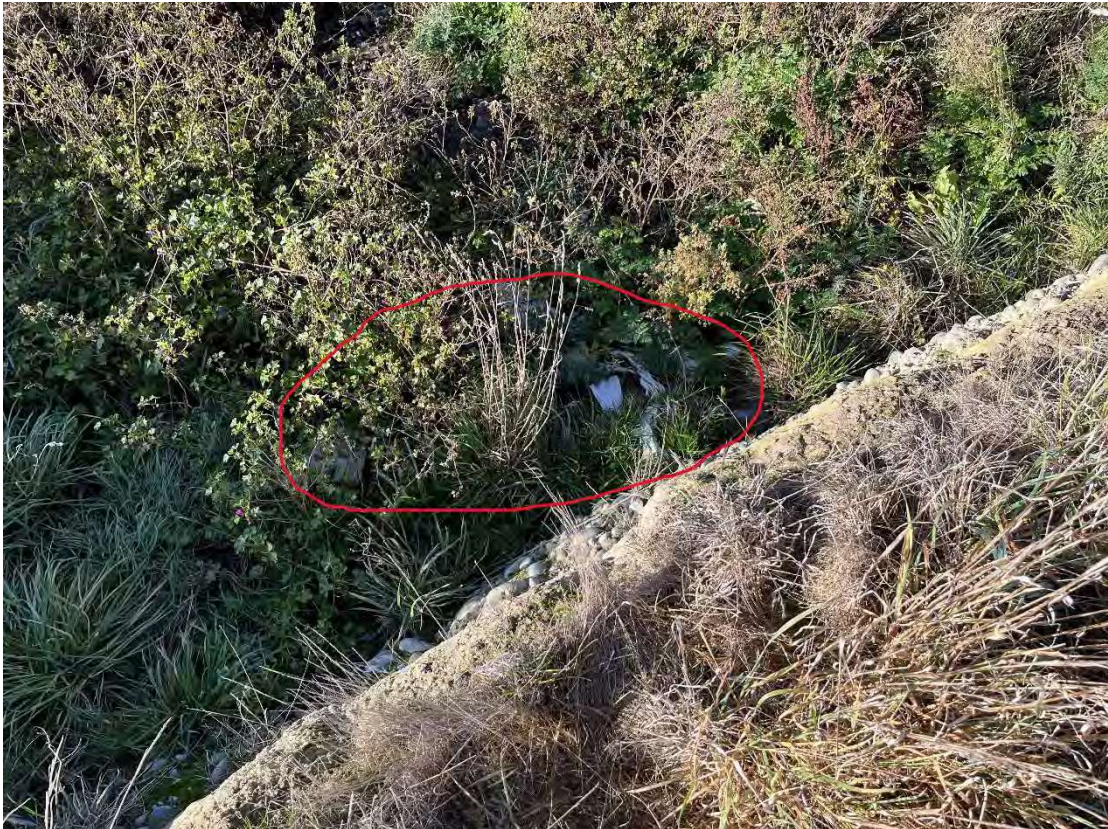
**Photograph 6: General rubbish present in pit (circled in red)**

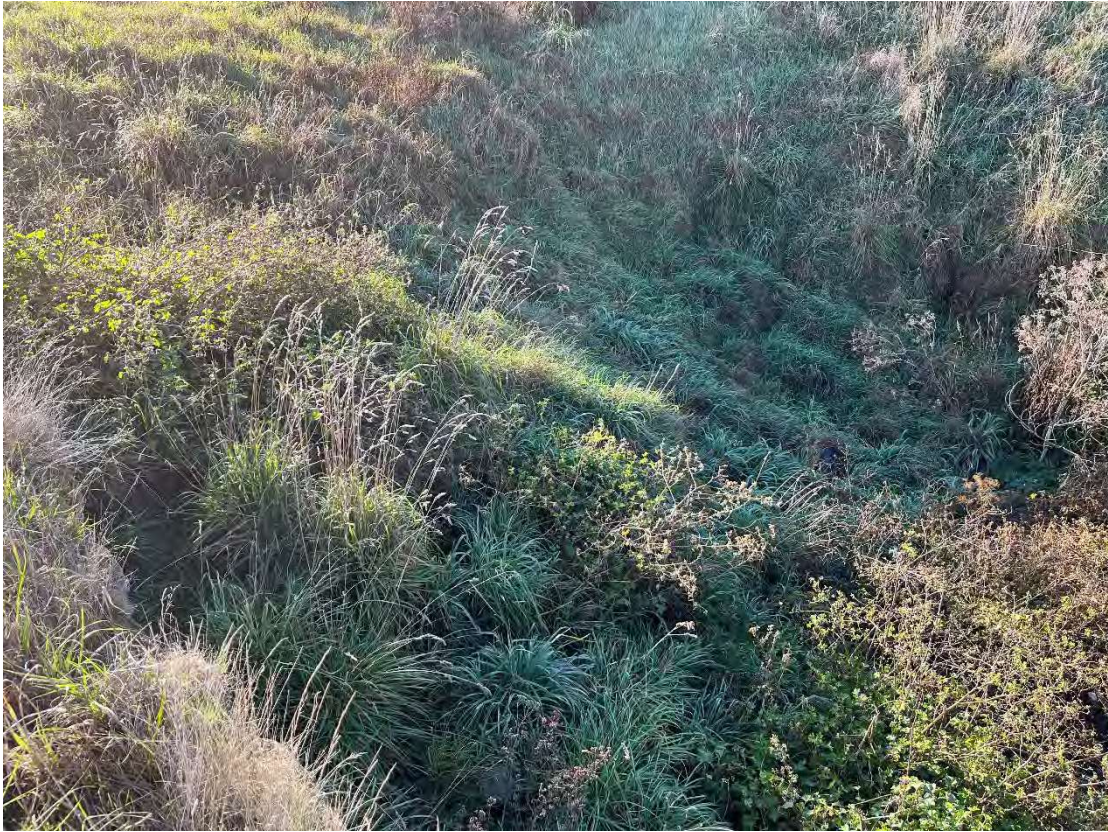
**Photograph 7: Vegetated portion of pit**

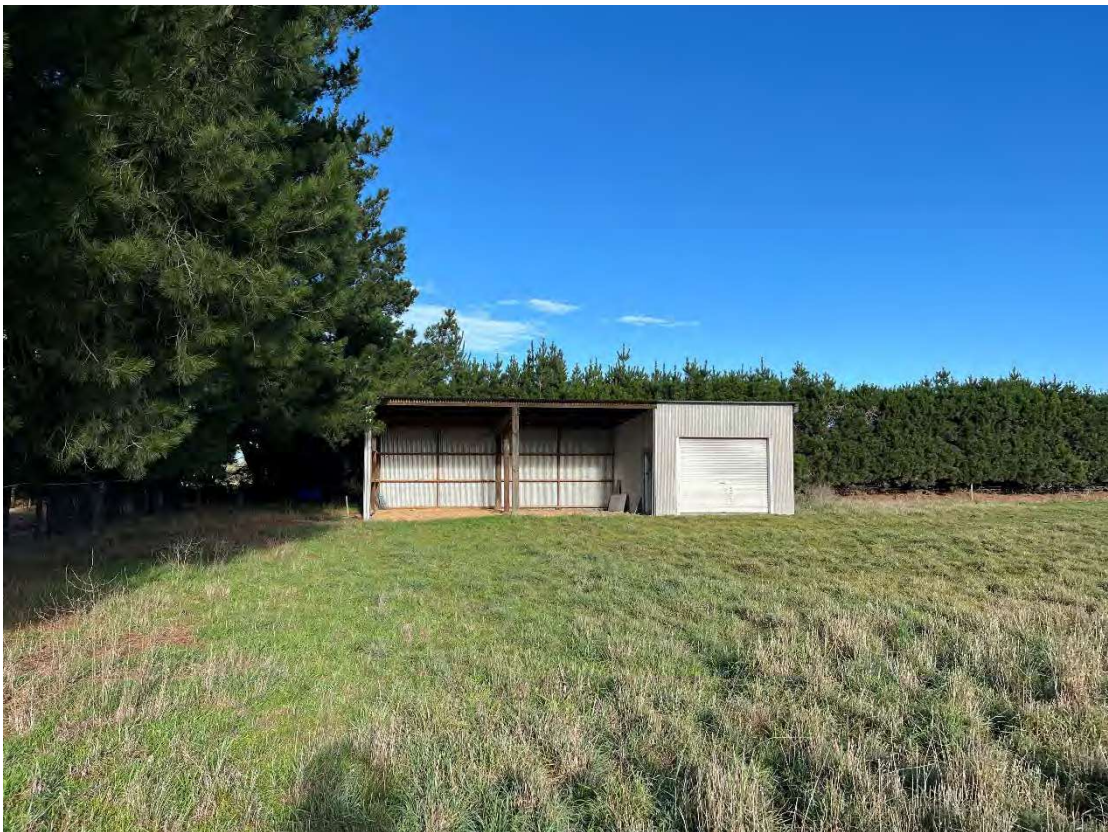
The only structure on site is a haybarn in the eastern corner. This was constructed post 2000 and there was no evidence of any asbestos containing material (ACM) in its construction.

**Photograph 8: Haybarn located in the eastern property boundary**
