August 2016

ENVIRONMENT CANTERBURY

# Arthur's Pass Village Slope Stability Assessment

Report Number: 1525119\_7407-002-R-Rev0

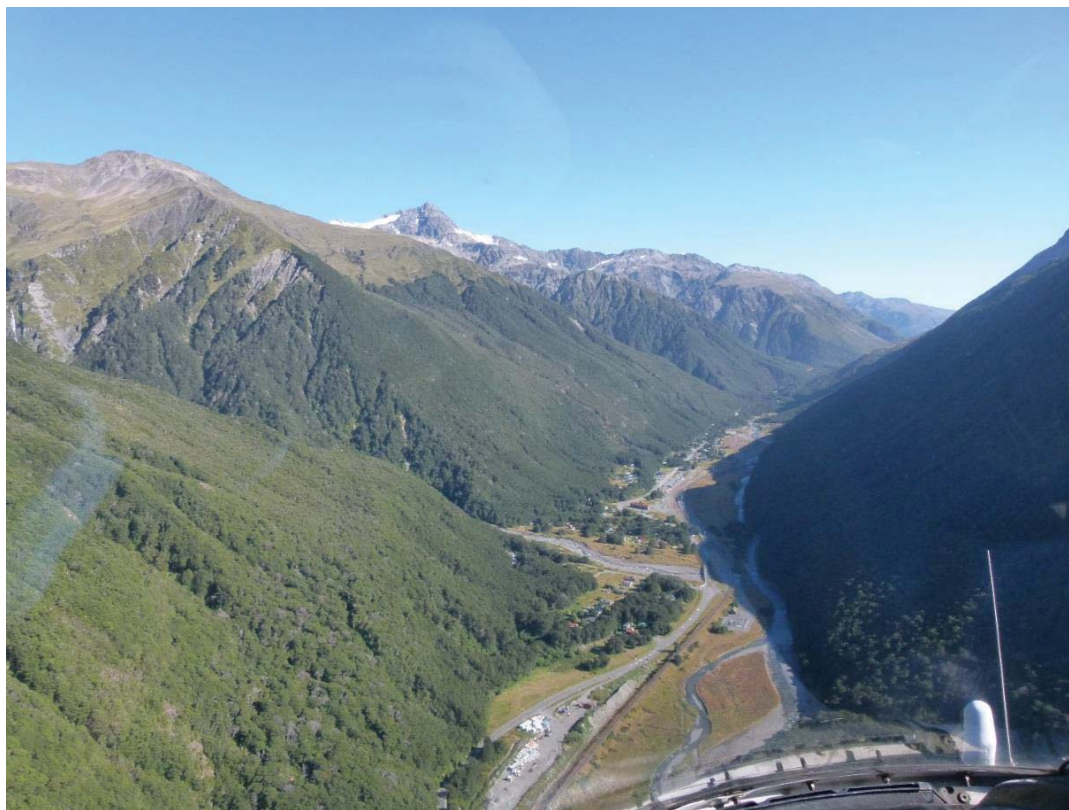
*Figure 1: Arthur's Pass Village viewed from the south. Rough Creek catchment is in the foreground entering from the west (left of view).*

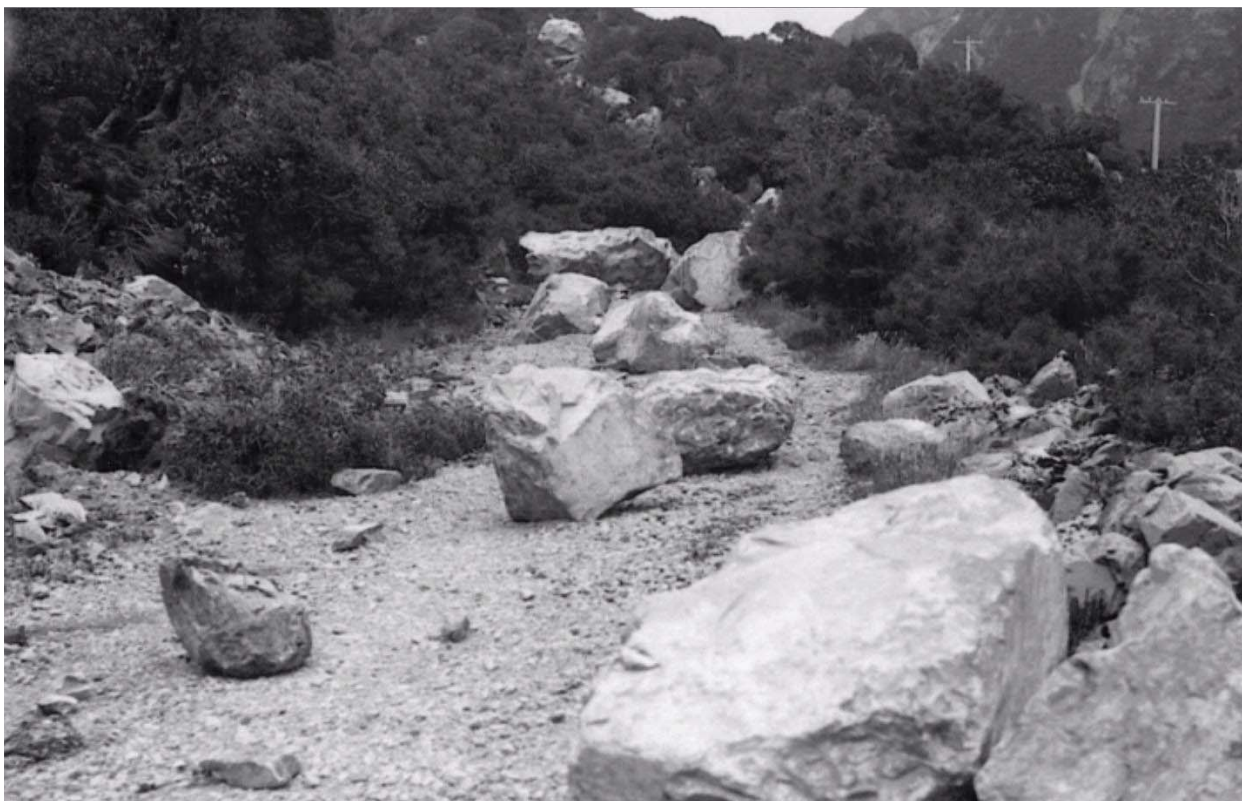
*Figure 4: Rockfall onto SH73 at the Zig Zag (Otira side of Arthur's Pass) as a result of the 1929 Arthur's Pass earthquake.*

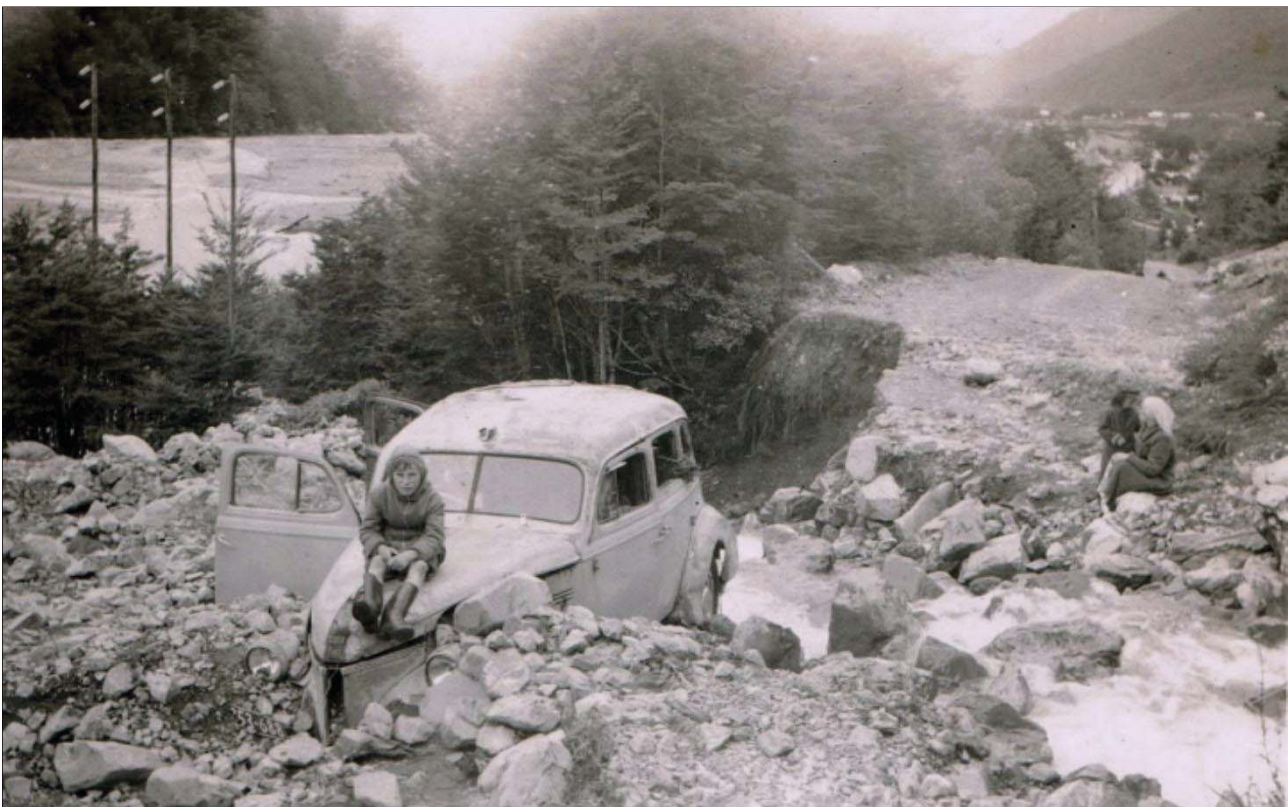
Figure 5: Aggradation/debris flow in Wardens Creek (1957).

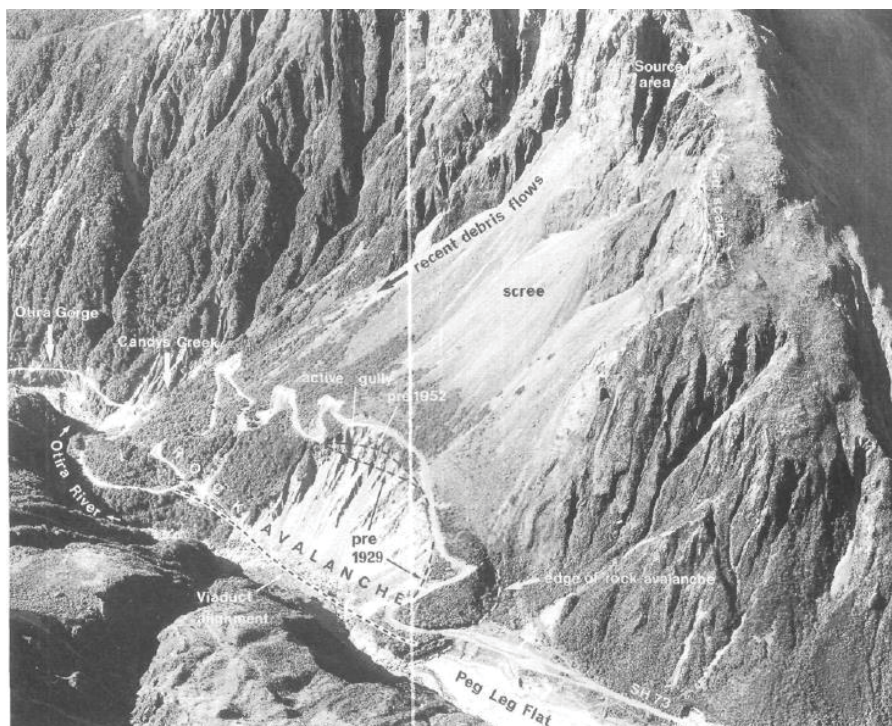
Figure 6: Otira rock avalanche deposit (after Paterson, 1996).

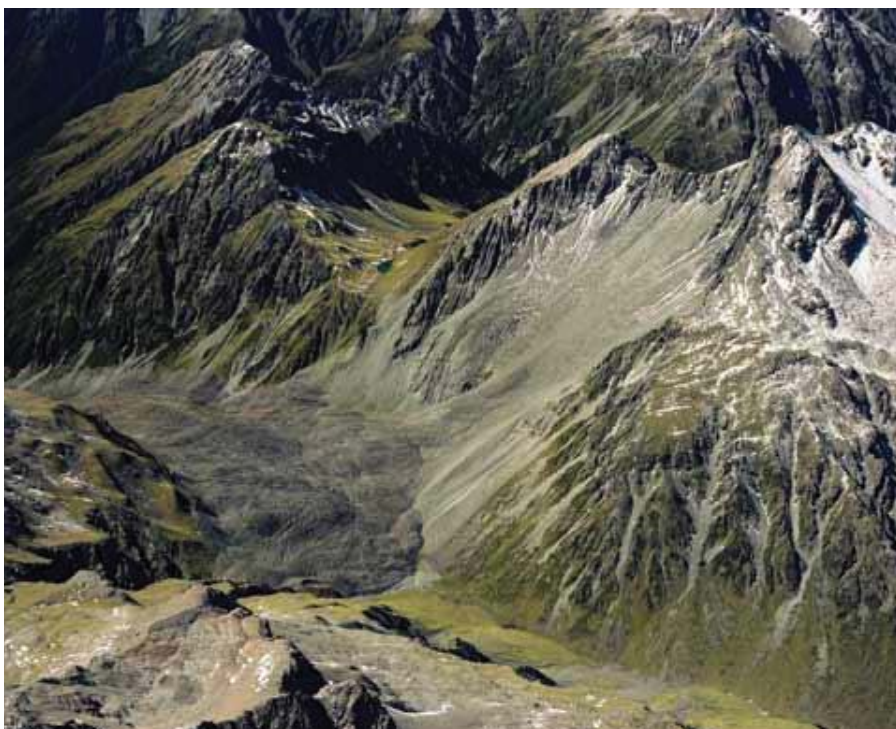
Figure 7: Falling Mountain landslide at Taruahuna Pass – it was triggered during the M7.1 Arthur's Pass earthquake of March 1929 (GNS Science, Ref CN06370/2).

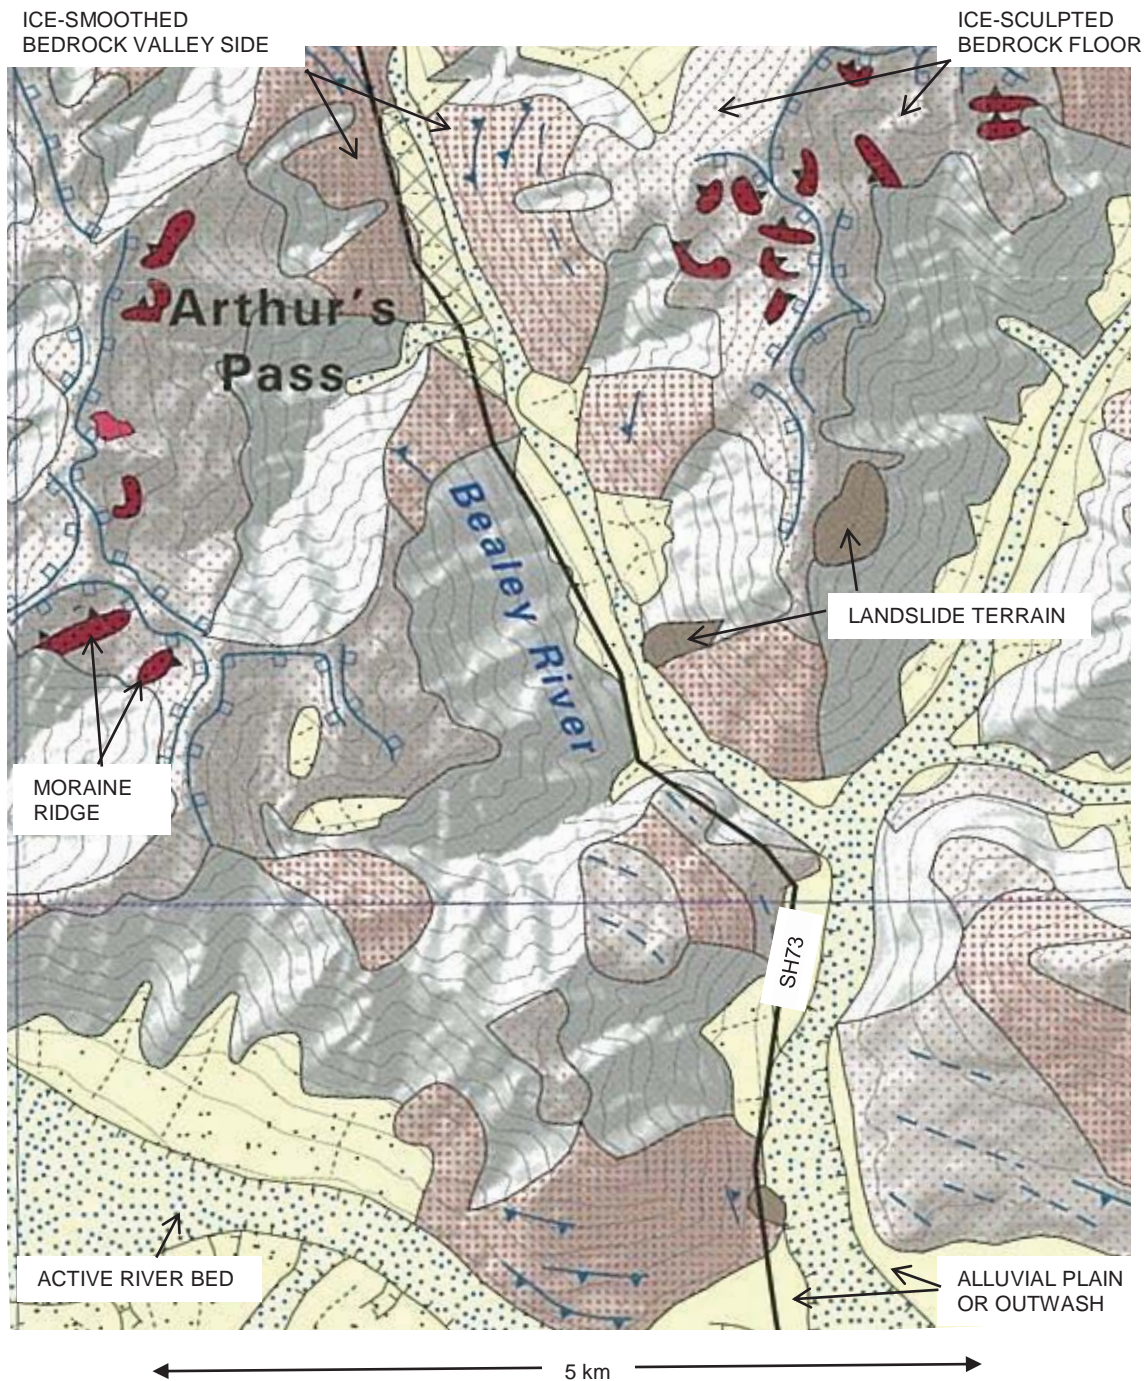
Figure 8: Glacial geomorphology of Arthur's Pass area (from Barrell et al., 2011). Diagonal hatch is Arthur's Pass Village, unhatched is general bedrock terrain.

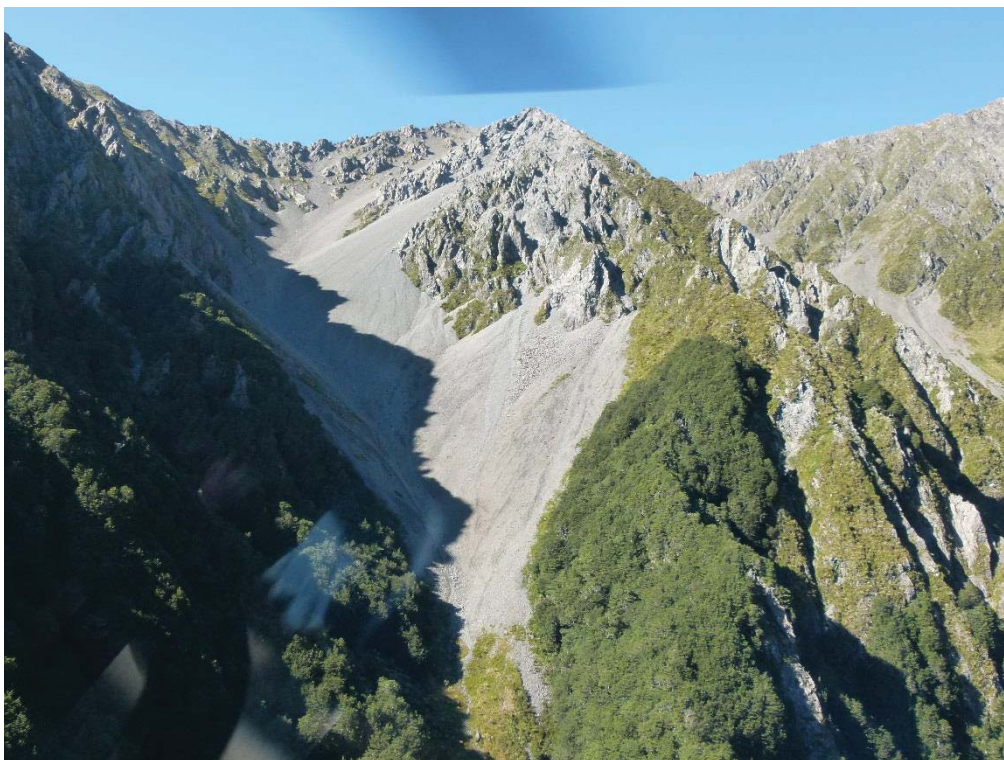
*Figure 9: Rough Creek catchment showing steep eroding rock slopes and scree development.*

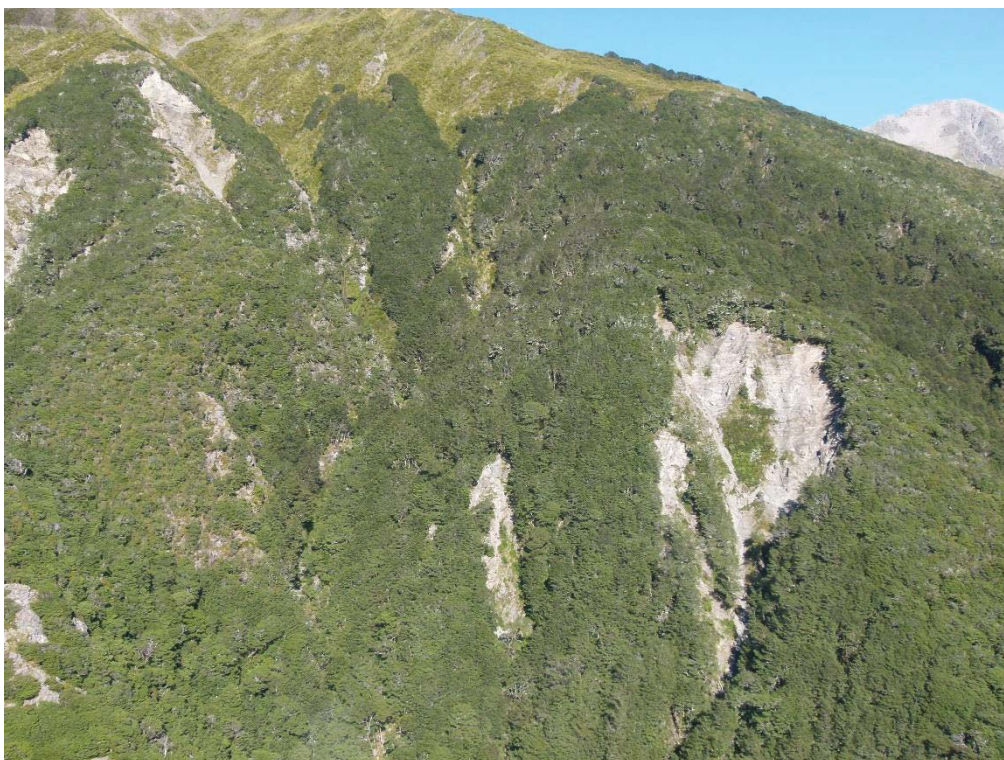
*Figure 10: Minor slope failures in small catchments above Arthur's Pass village.*

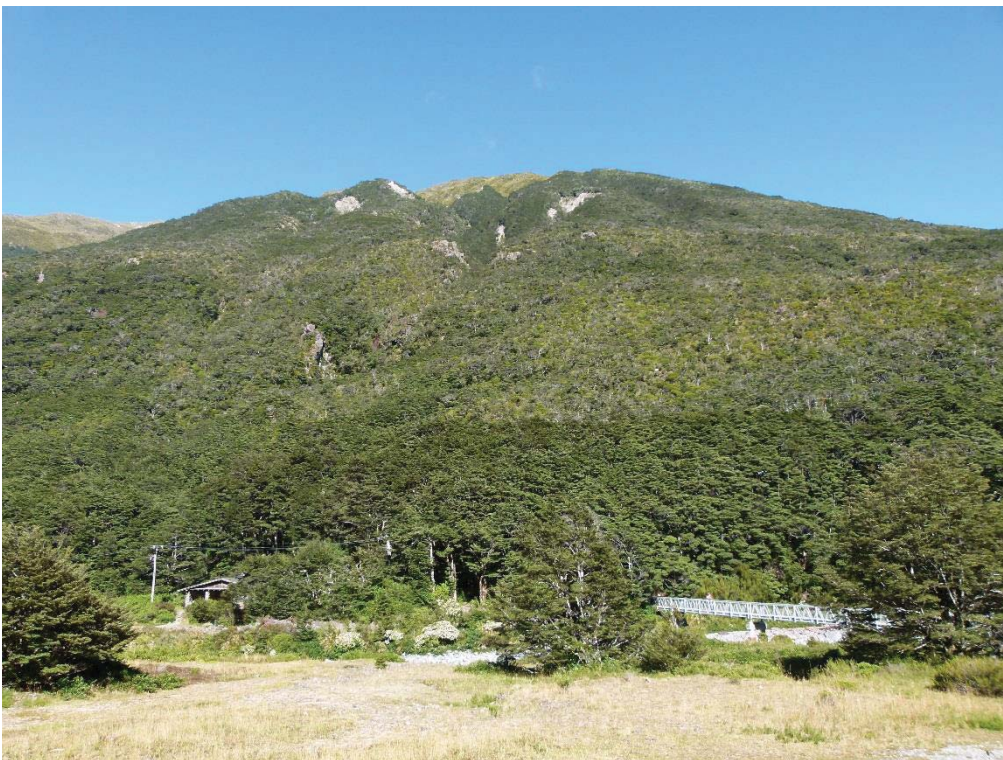
- While most of the valley slopes are covered in mature beech forest, some areas above Arthur's Pass appear to be covered with lower vegetation species. On the slopes above the village, particularly on the northwestern side of the valley, these do not appear to be the result of forest damage by slope instability and are believed to reflect variations in substrate rather than age of vegetation. Historical aerial photographs indicate localised, small-scale slope failures are not unusual throughout the Arthur's Pass area. The vegetation appears to re-establish in these areas with a decade or two. Small scale failures have occurred occasionally but the consequences have been minor (temporary inundation). Most of west side of the village is exposed to this hazard. The life risk associated with these small scale failures is likely to be acceptably low as the housing structure has historically offered sufficient protection. The burial and subsequent deaths of four campers (see Item 12 in Table 4) may not have happened had the victims been in a building.

*Figure 12: Slopes above north end of Arthur's Pass showing variation in vegetation.*

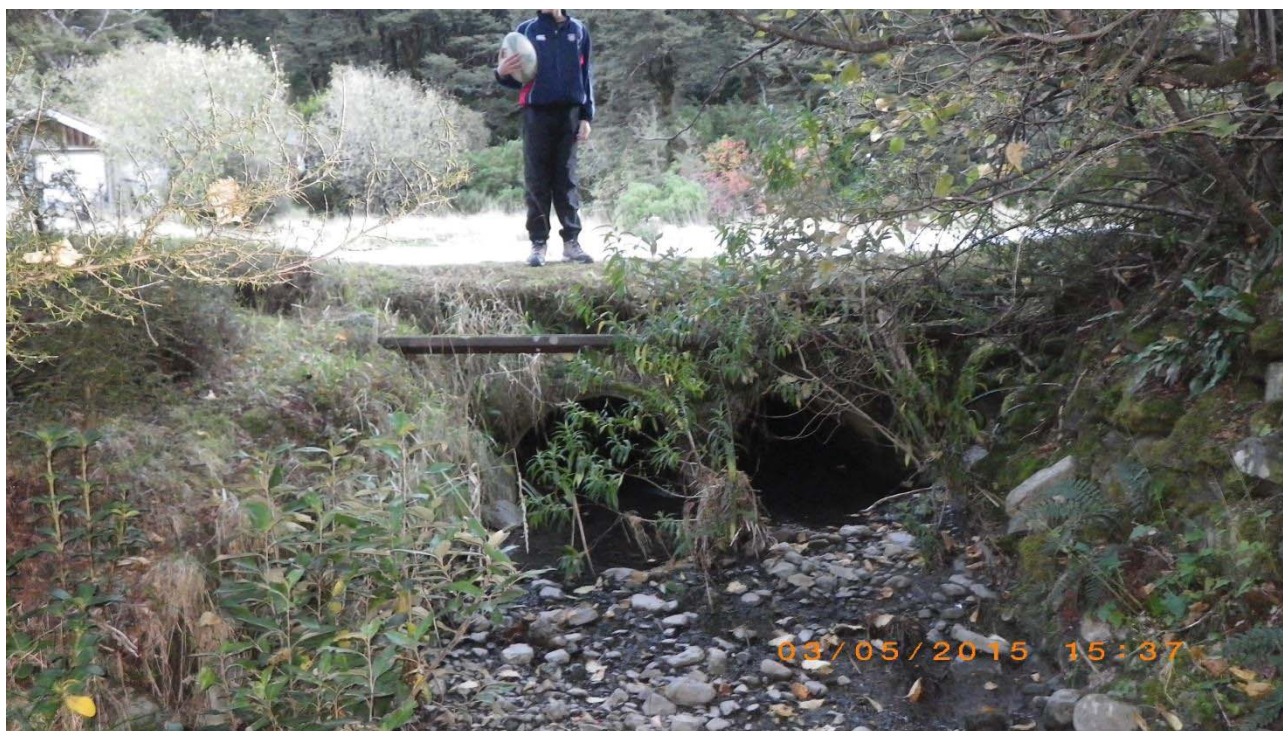
Despite the hazards that are present, the relative lack of historical damage to dwellings and infrastructure at Arthur's Pass indicates that the hazards can be adequately mitigated. Existing maintenance of culverts, river channels and flood protection for infrastructure are an important flood and stream avulsion mitigation measure for the buildings in Arthur's Pass village. However, drainage channels within the village that were once regularly cleared seem not to be maintained and some drains have been built over by residents wanting to extend the useable area (pers. comm. J Charles, 2015; see Figure 13, Appendix B).

Figure 13: Culverts of un-named stream crossing SH73 in Arthur's Pass village showing gravel lag and vegetation in channel.

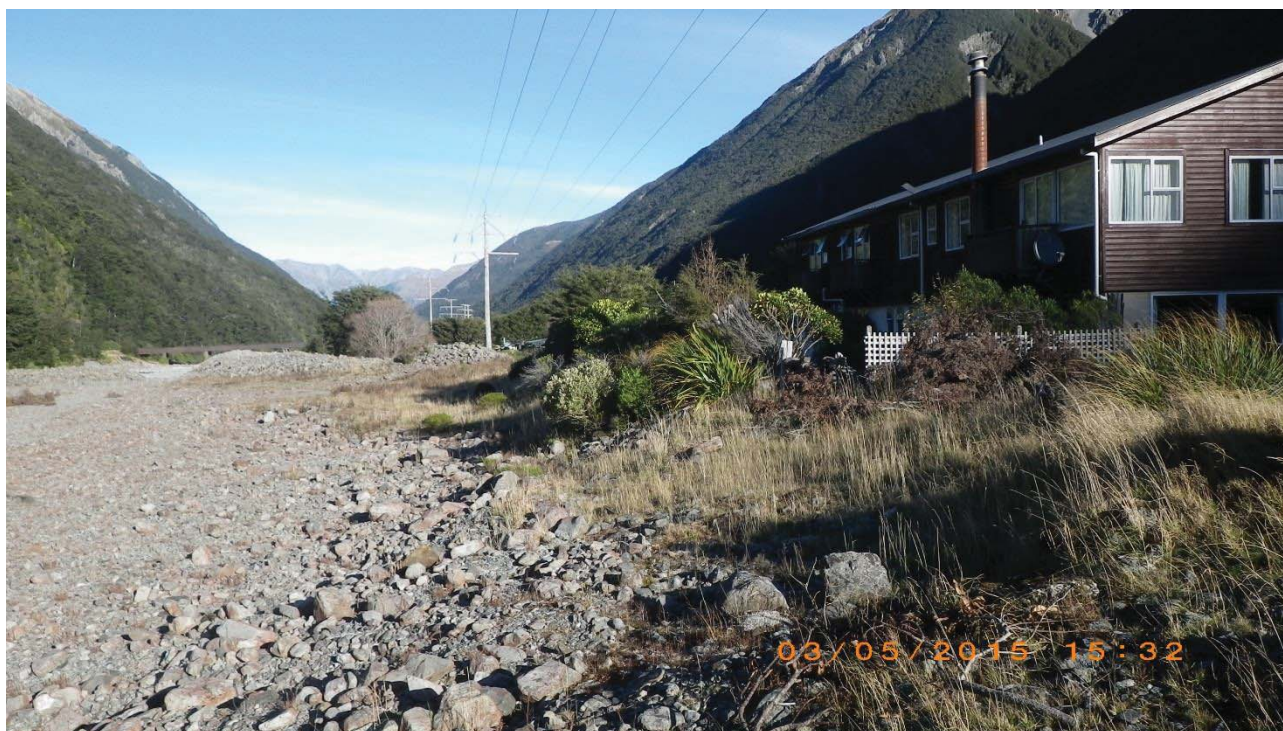
03	Upper Bealey River (north end of Arthur's Pass) Refer Figure 15, Figure 16, Figure 17	Flooding – house washed off foundations; erosion of gravel undermined garage foundations at Chalet Restaurant.	1961	During a storm, the Bealey River changed course to the true right (west) of the valley. Flows down the Devils Punchbowl Creek were particularly high, which may have encouraged the course change. One house was washed from its foundations, floated downstream and disintegrated upon impact with the Bealey River rail bridge near the tunnel entrance. Garage/workshop at back of Chalet Restaurant was undermined by flood flow. Following this event the Selwyn District Council apportioned funds to the Bealey Flood Fund. This was used to re-contour the river bed and build groynes to force the river onto the true left side of the valley floor.
04	Avalanche Creek refer Figure 18	Flooding	-	Avalanche Creek copes well with storm events and J Charles does not know of any significant flooding that has occurred. Channel and culvert under SH73 well maintained and apparently suitably sized. The grassed, downstream, low lying areas are occasionally inundated, but this does not cause damage. In the early days of the village's development, water from Avalanche Creek flowed uncontrolled to the Bealey River.

Figure 15: Bealey River flood plain in the area of flood damage near Chalet Restaurant.

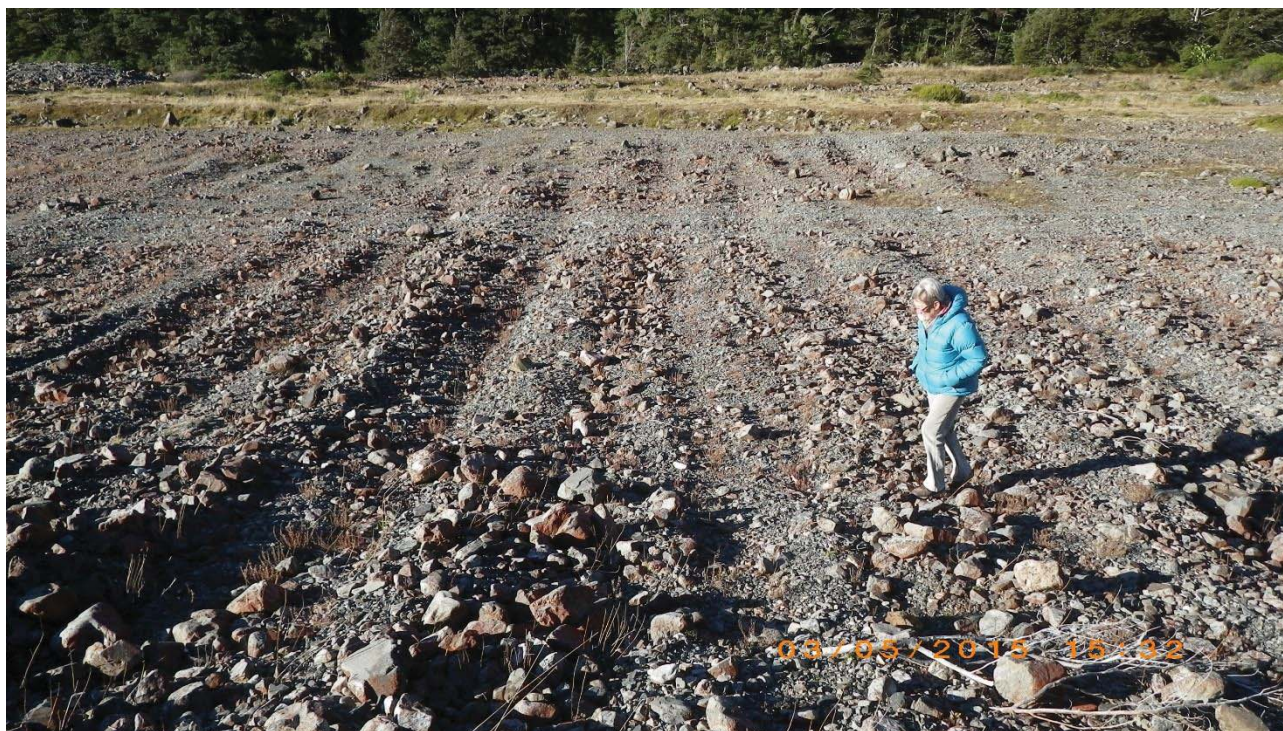
Figure 16: Channel contouring in the flood plain of the Bealey River.

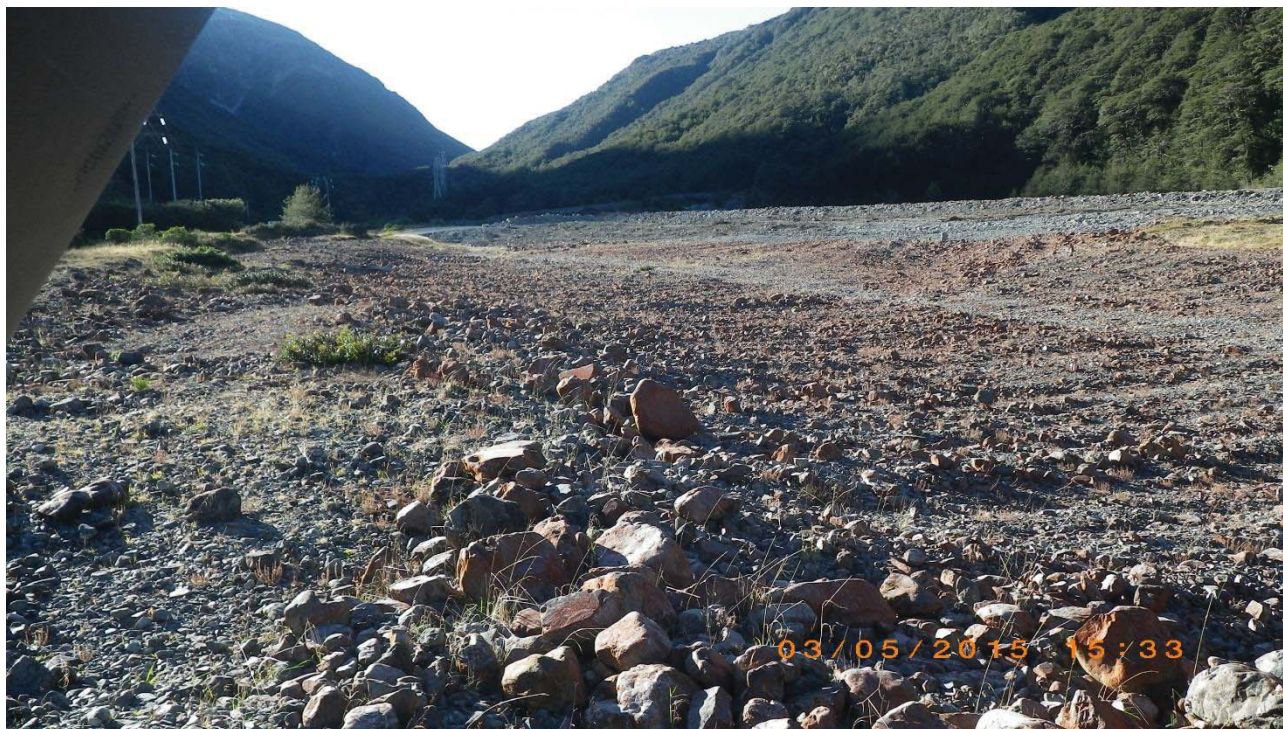
Figure 17: Contoured flood channel for the Bealey River.

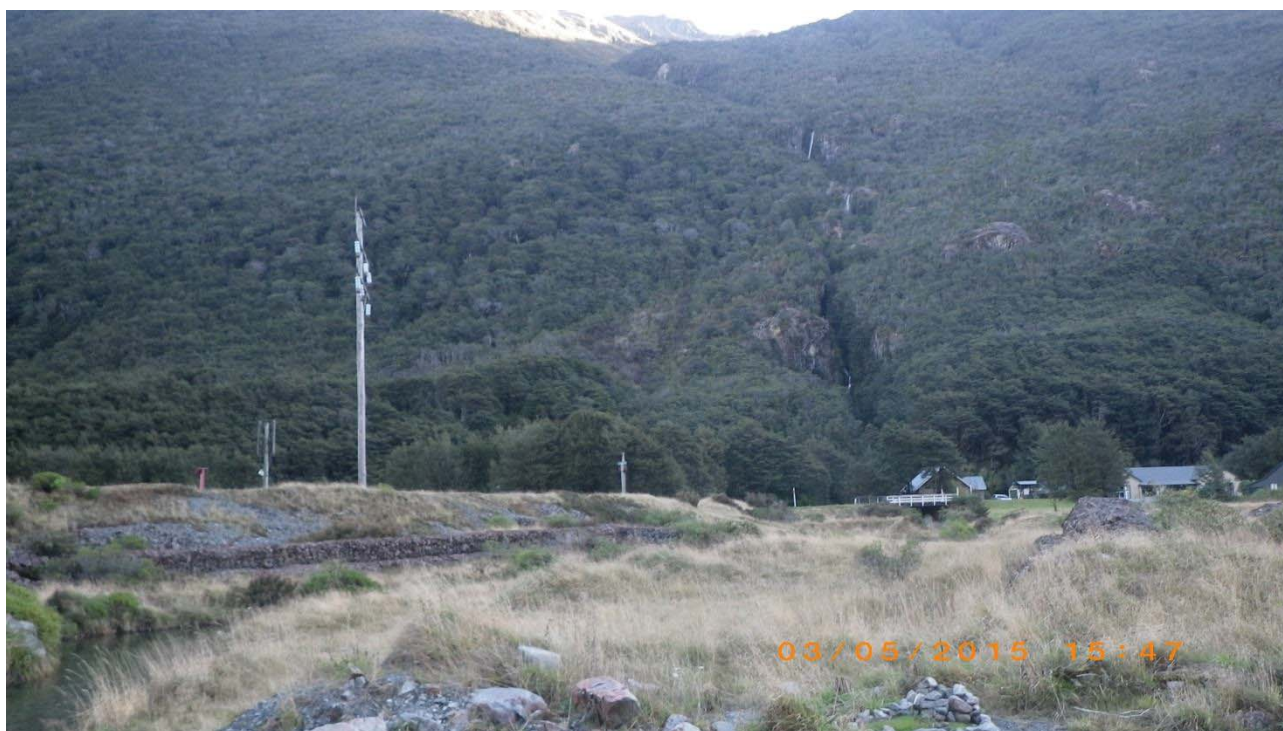
Figure 18: Flood channel for Avalanche Creek.

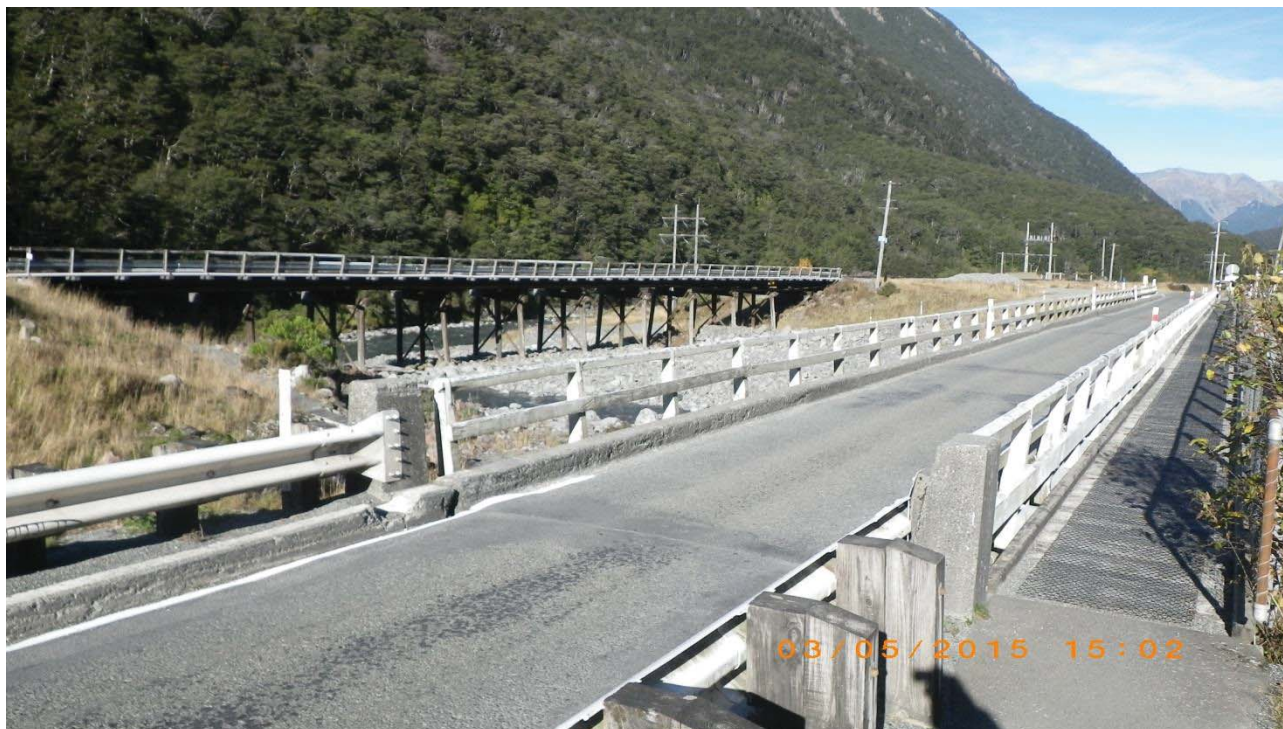
05	Rough Creek refer Figure 19, Figure 20	Aggradation – Following a storm, Rough Creek was mostly filled with sediment and rock.	1970s	No damage, but capacity of creek and height to bottom of bridge reduced. Earthmoving equipment used to push material to either side of Rough Creek. Rail bridge has shallow piles, so earthworks cannot over-excavate in that area, or piles will be undermined. Removal of debris maintains river flow away from houses.
06	Power Station (east and	Flooding – none recorded; present protection sufficient.		River protection works (probably by the owner) provide adequate protection from scouring. Well maintained.

Figure 19: Rough Creek bridge SH73 with rail bridge in background.

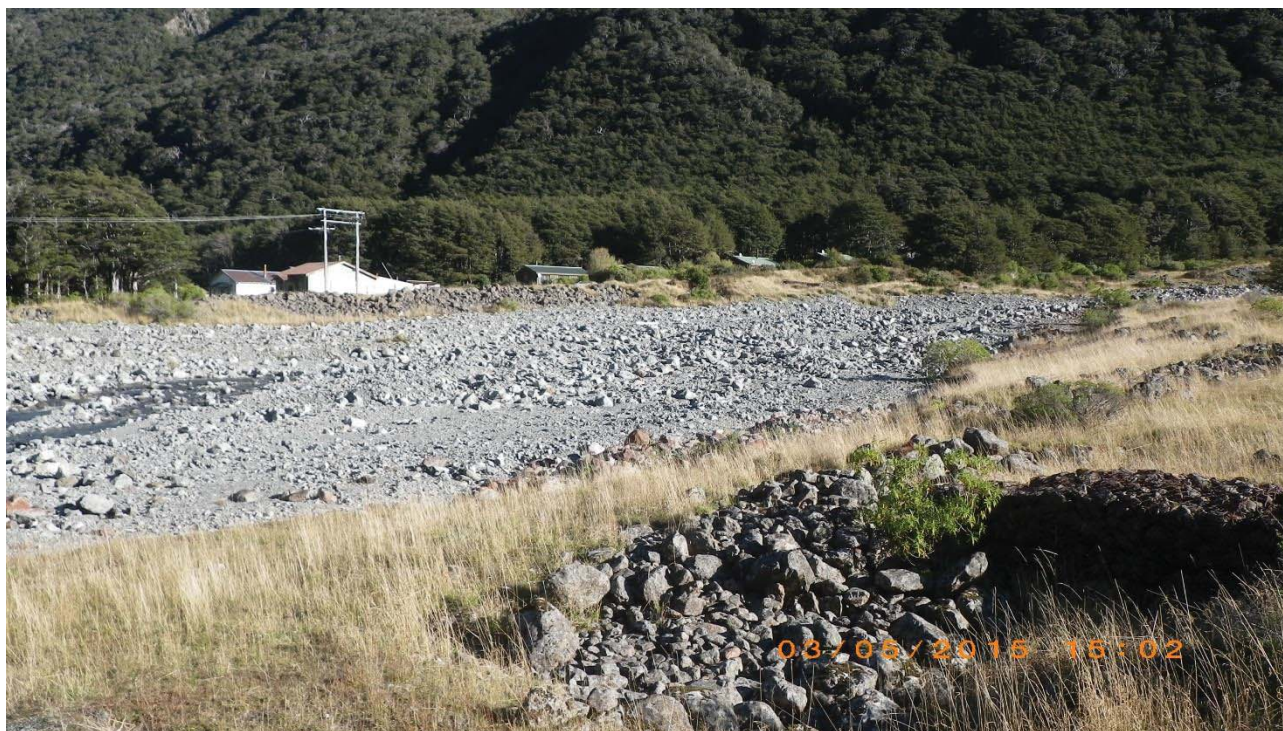
Figure 20: Channel of Rough Creek showing flood protection banks.

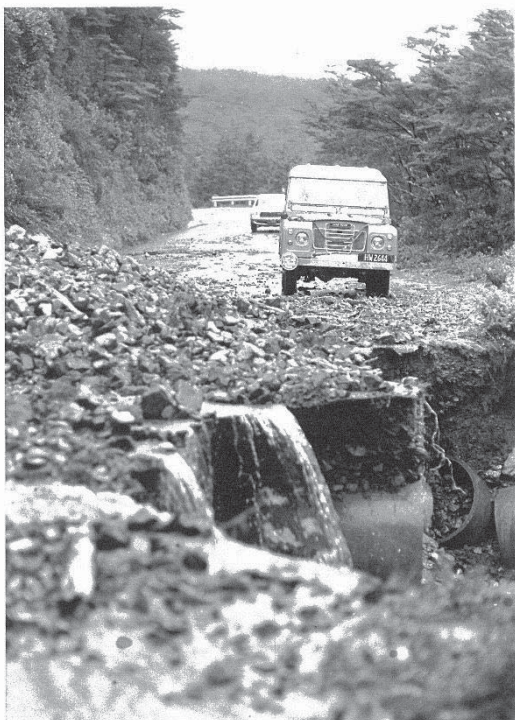
Item #	Location	Hazard and consequences	Date	Details
	downstream of Rough Creek)			
07	Snow Creek refer Figure 21, Figure 22	Flooding – storm caused flooding of SH73	3 Dec 1979	-
08	North of Halpin Creek refer Figure 23, Figure 24	Debris Flow – erosion of railway ballast and debris on road	Dec 2013	Area was previously not known to cause problems during storm flows
09	Mt O'Malley	Rockfall – flyrock at SH73	1994	Rockfall was the result of 1994 Arthur's Pass earthquake.
10	Halpin Creek refer Figure 25, Figure 26	Debris Flow – previous flooding	3 Dec 1979	Prior to the existing bridge being built in the 1980s, regular debris flows and floods blocked the road and caused rail damage. Due to large catchment it carries a large volume. Substantial rock armouring has taken place on the upstream side of Halpins Creek. Major bridge upgrade in 1980s has largely eliminated road flooding
11	River scour near Halpin Creek Figure 27	Erosion – scour of railway embankment	3 Dec 1979	Scour west of Halpin Creek due to Bealey River changing course

Figure 21: Flood and debris flow damage to SH73 at Snow Creek, 3 December 1979.

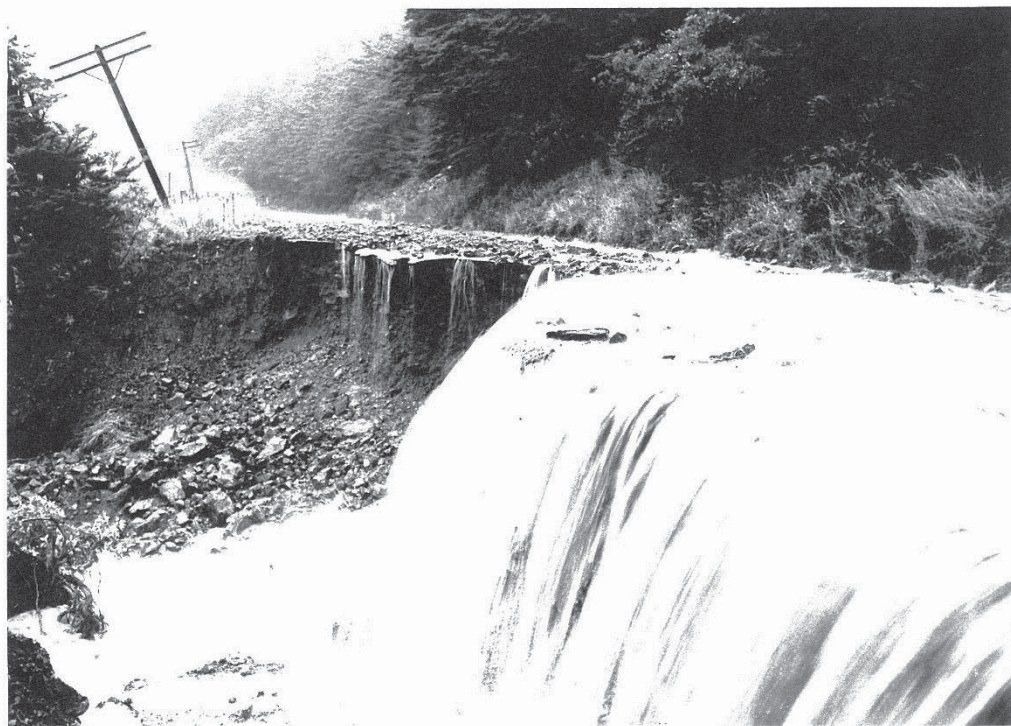
Figure 22: Erosion of road formation due to flooding near Snow Creek, 3 December 1979.

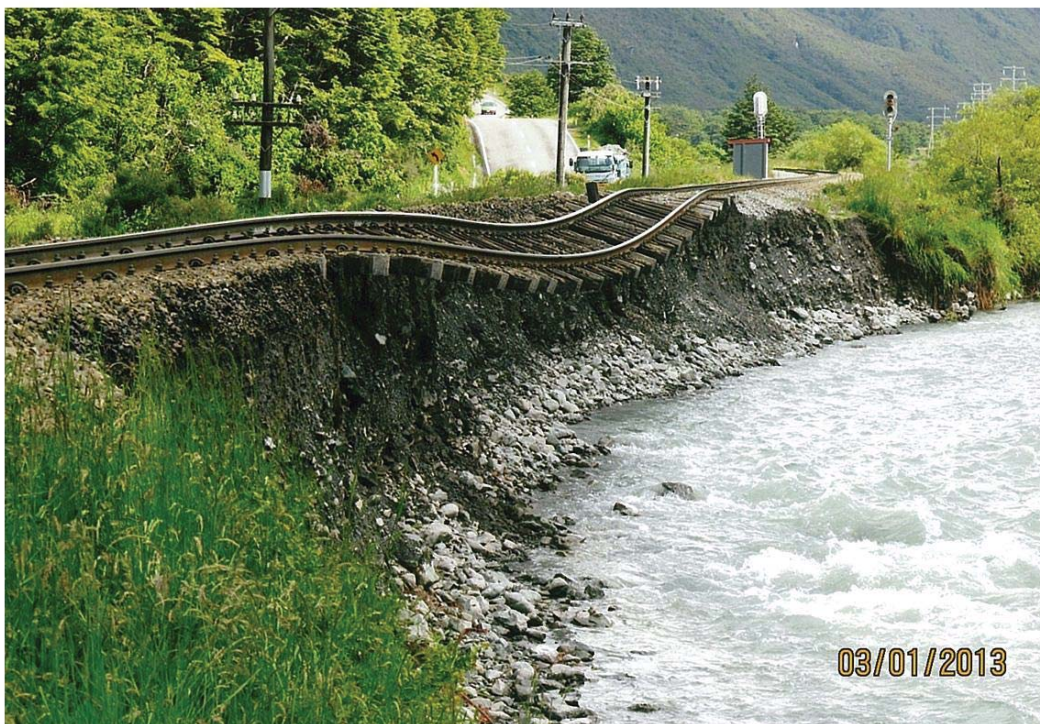
Figure 23: Erosion of railway formation by Bealey River north of Halpin Creek.

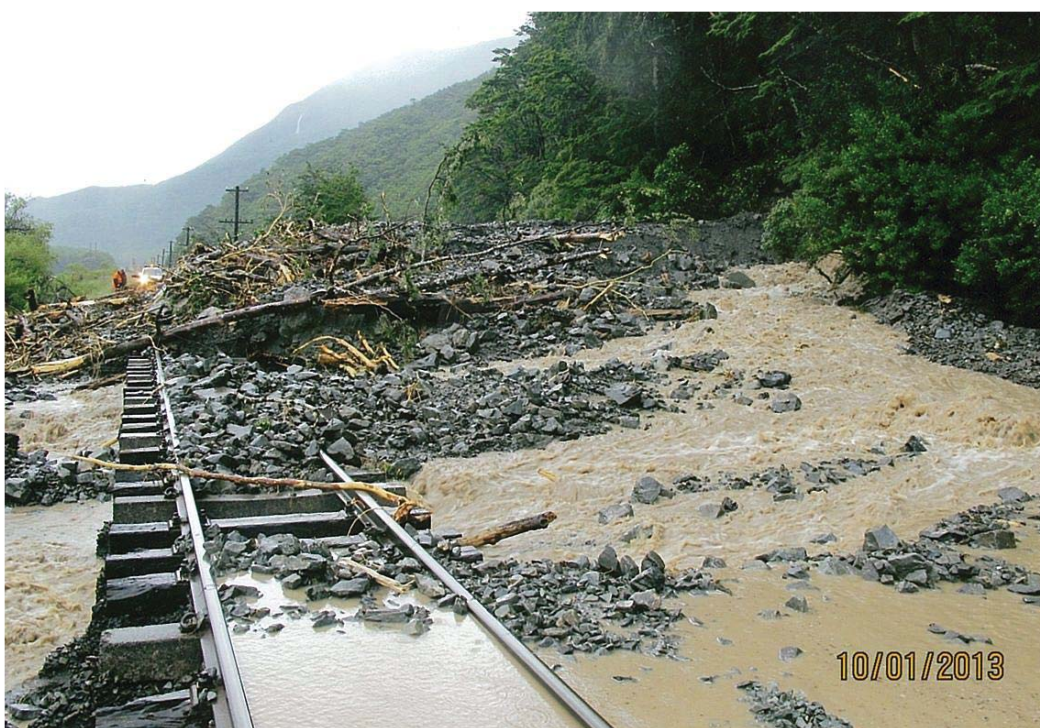
Figure 24: Debris flow in rail formation north of Halpin Creek.

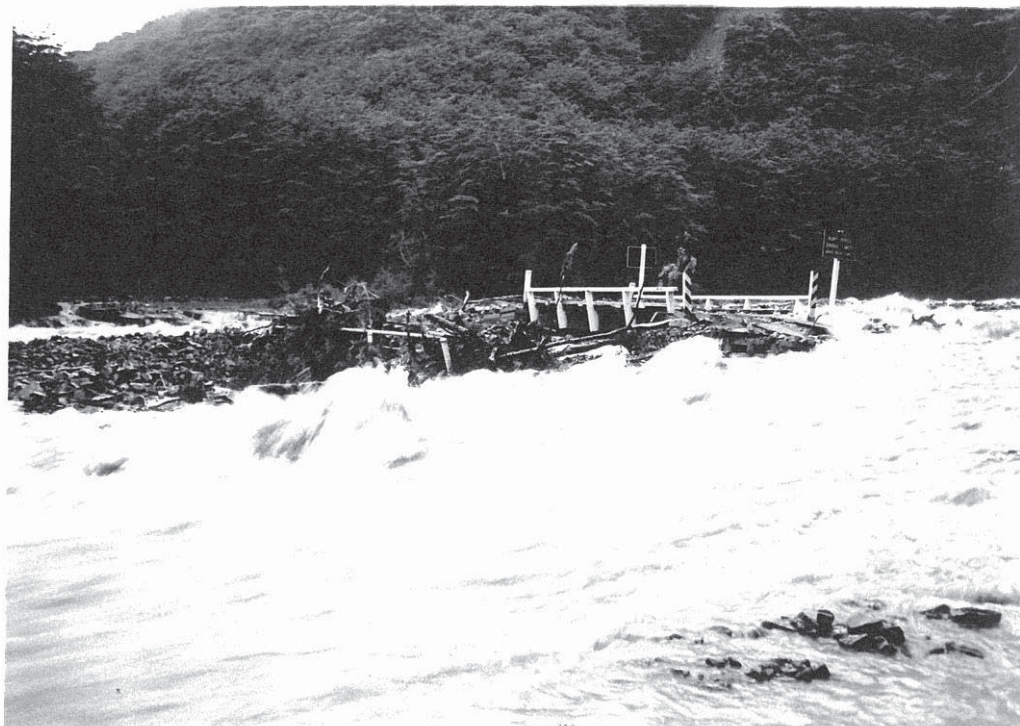
*Figure 25: Flood aggradation and debris flow damage at Halpin Creek, 1979.*

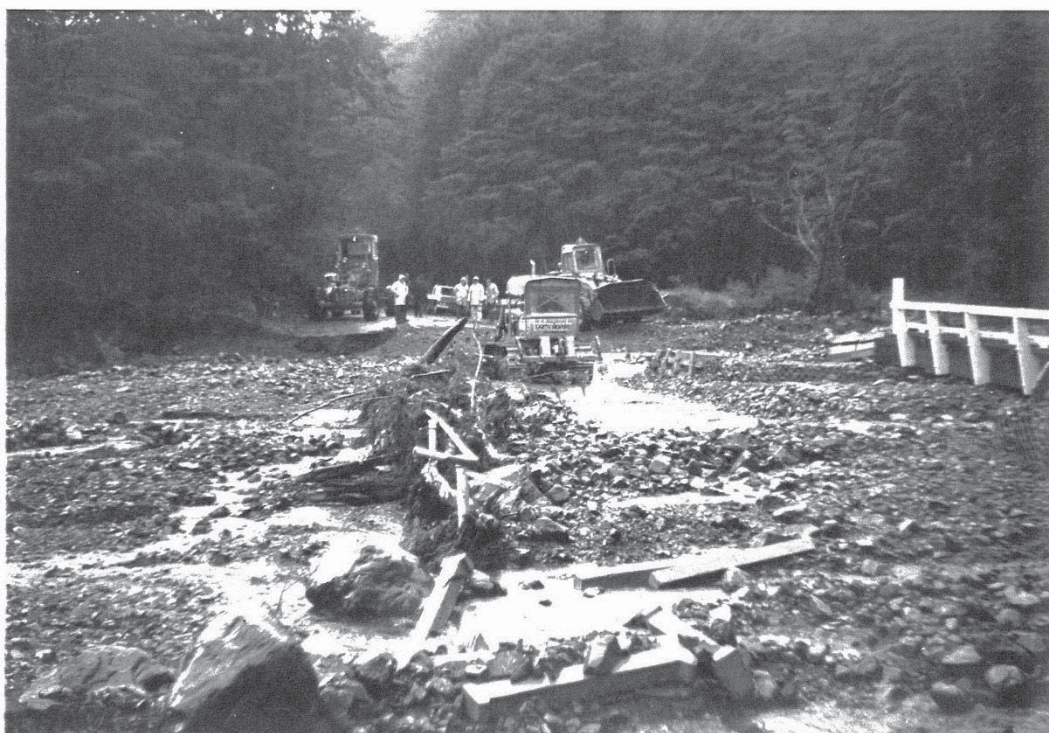
*Figure 26: Clean-up of damage to bridge and channel capacity reduction at Halpin Creek, 1979.*

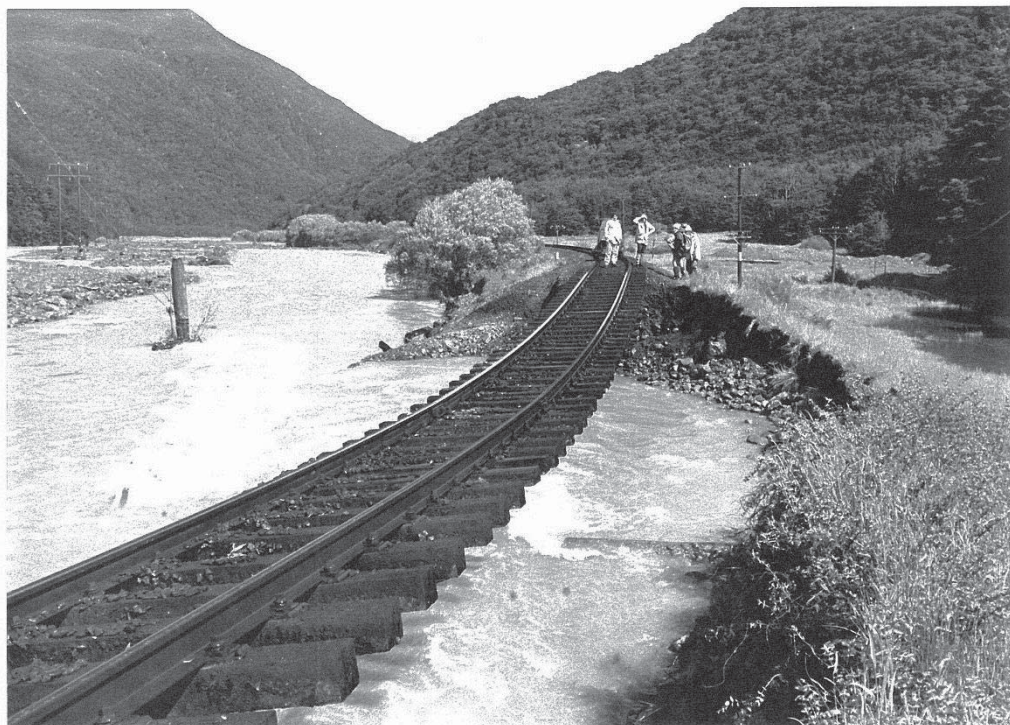
*Figure 27: Erosion of rail formation by Bealey River near Halpin Creek.*

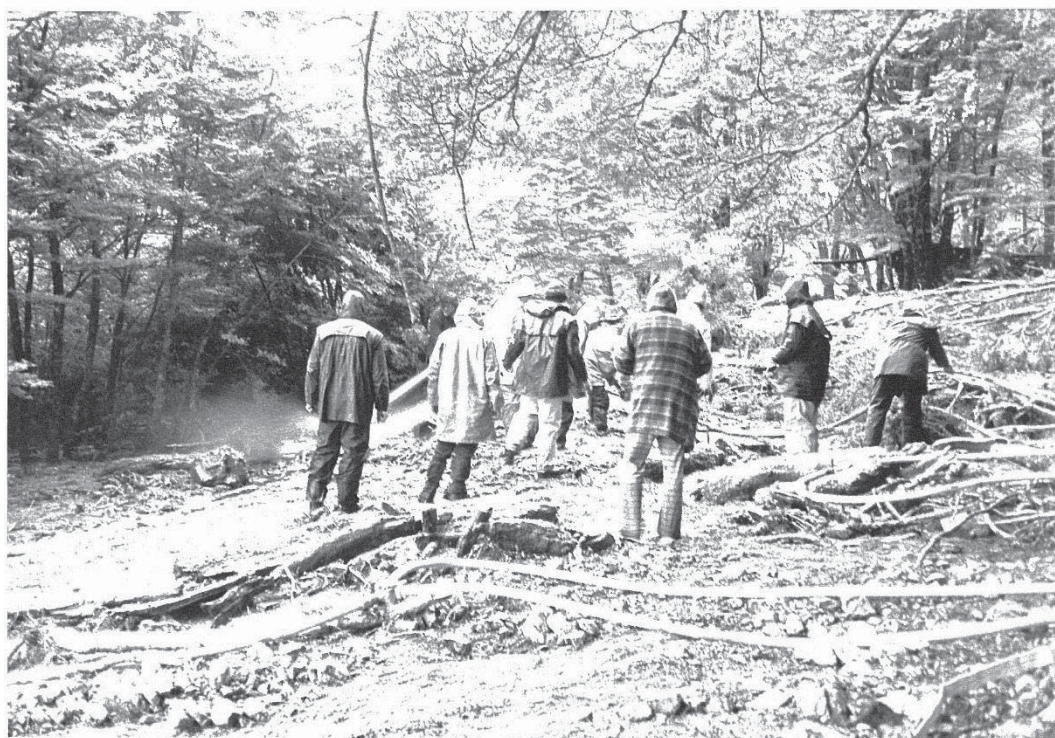
*Figure 28: Slucing of debris flow material at site of buried camp near Klondyke Corner, 1979.*

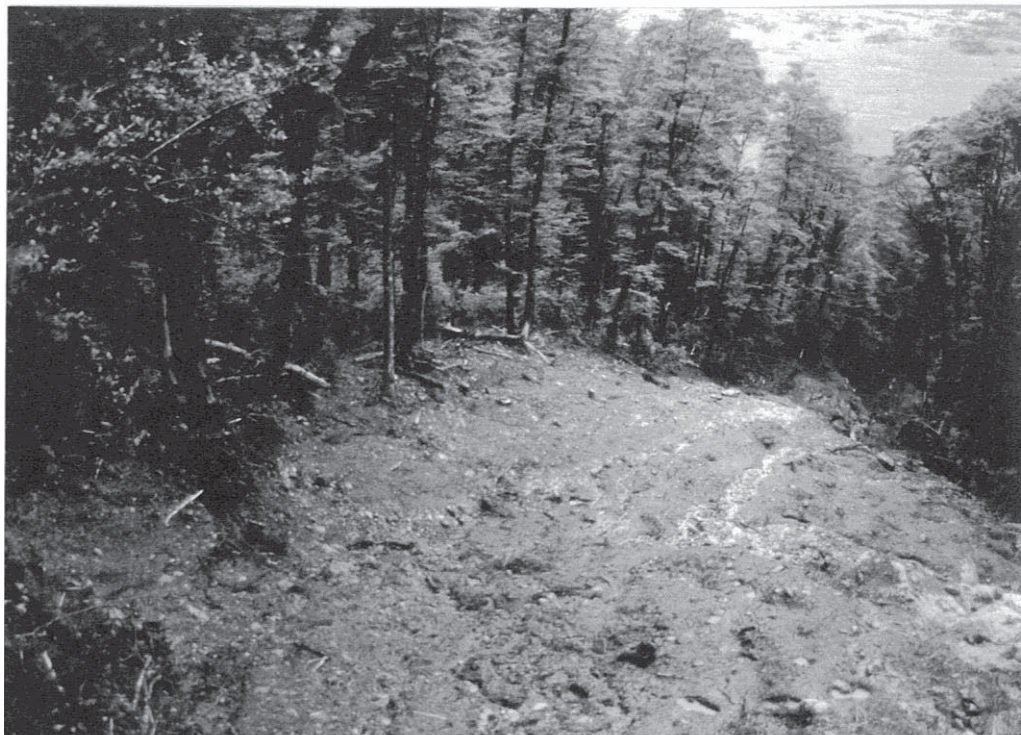
*Figure 29: Debris flow material near Klondyke Corner.*
