Gillian Logan
160 Bangor Road, Darfield, Canterbury.

Project No. 42198040

Letter report - Geo-environmental desk study to support private plan change, 160 Bangor Road, Darfield – Revision 1.

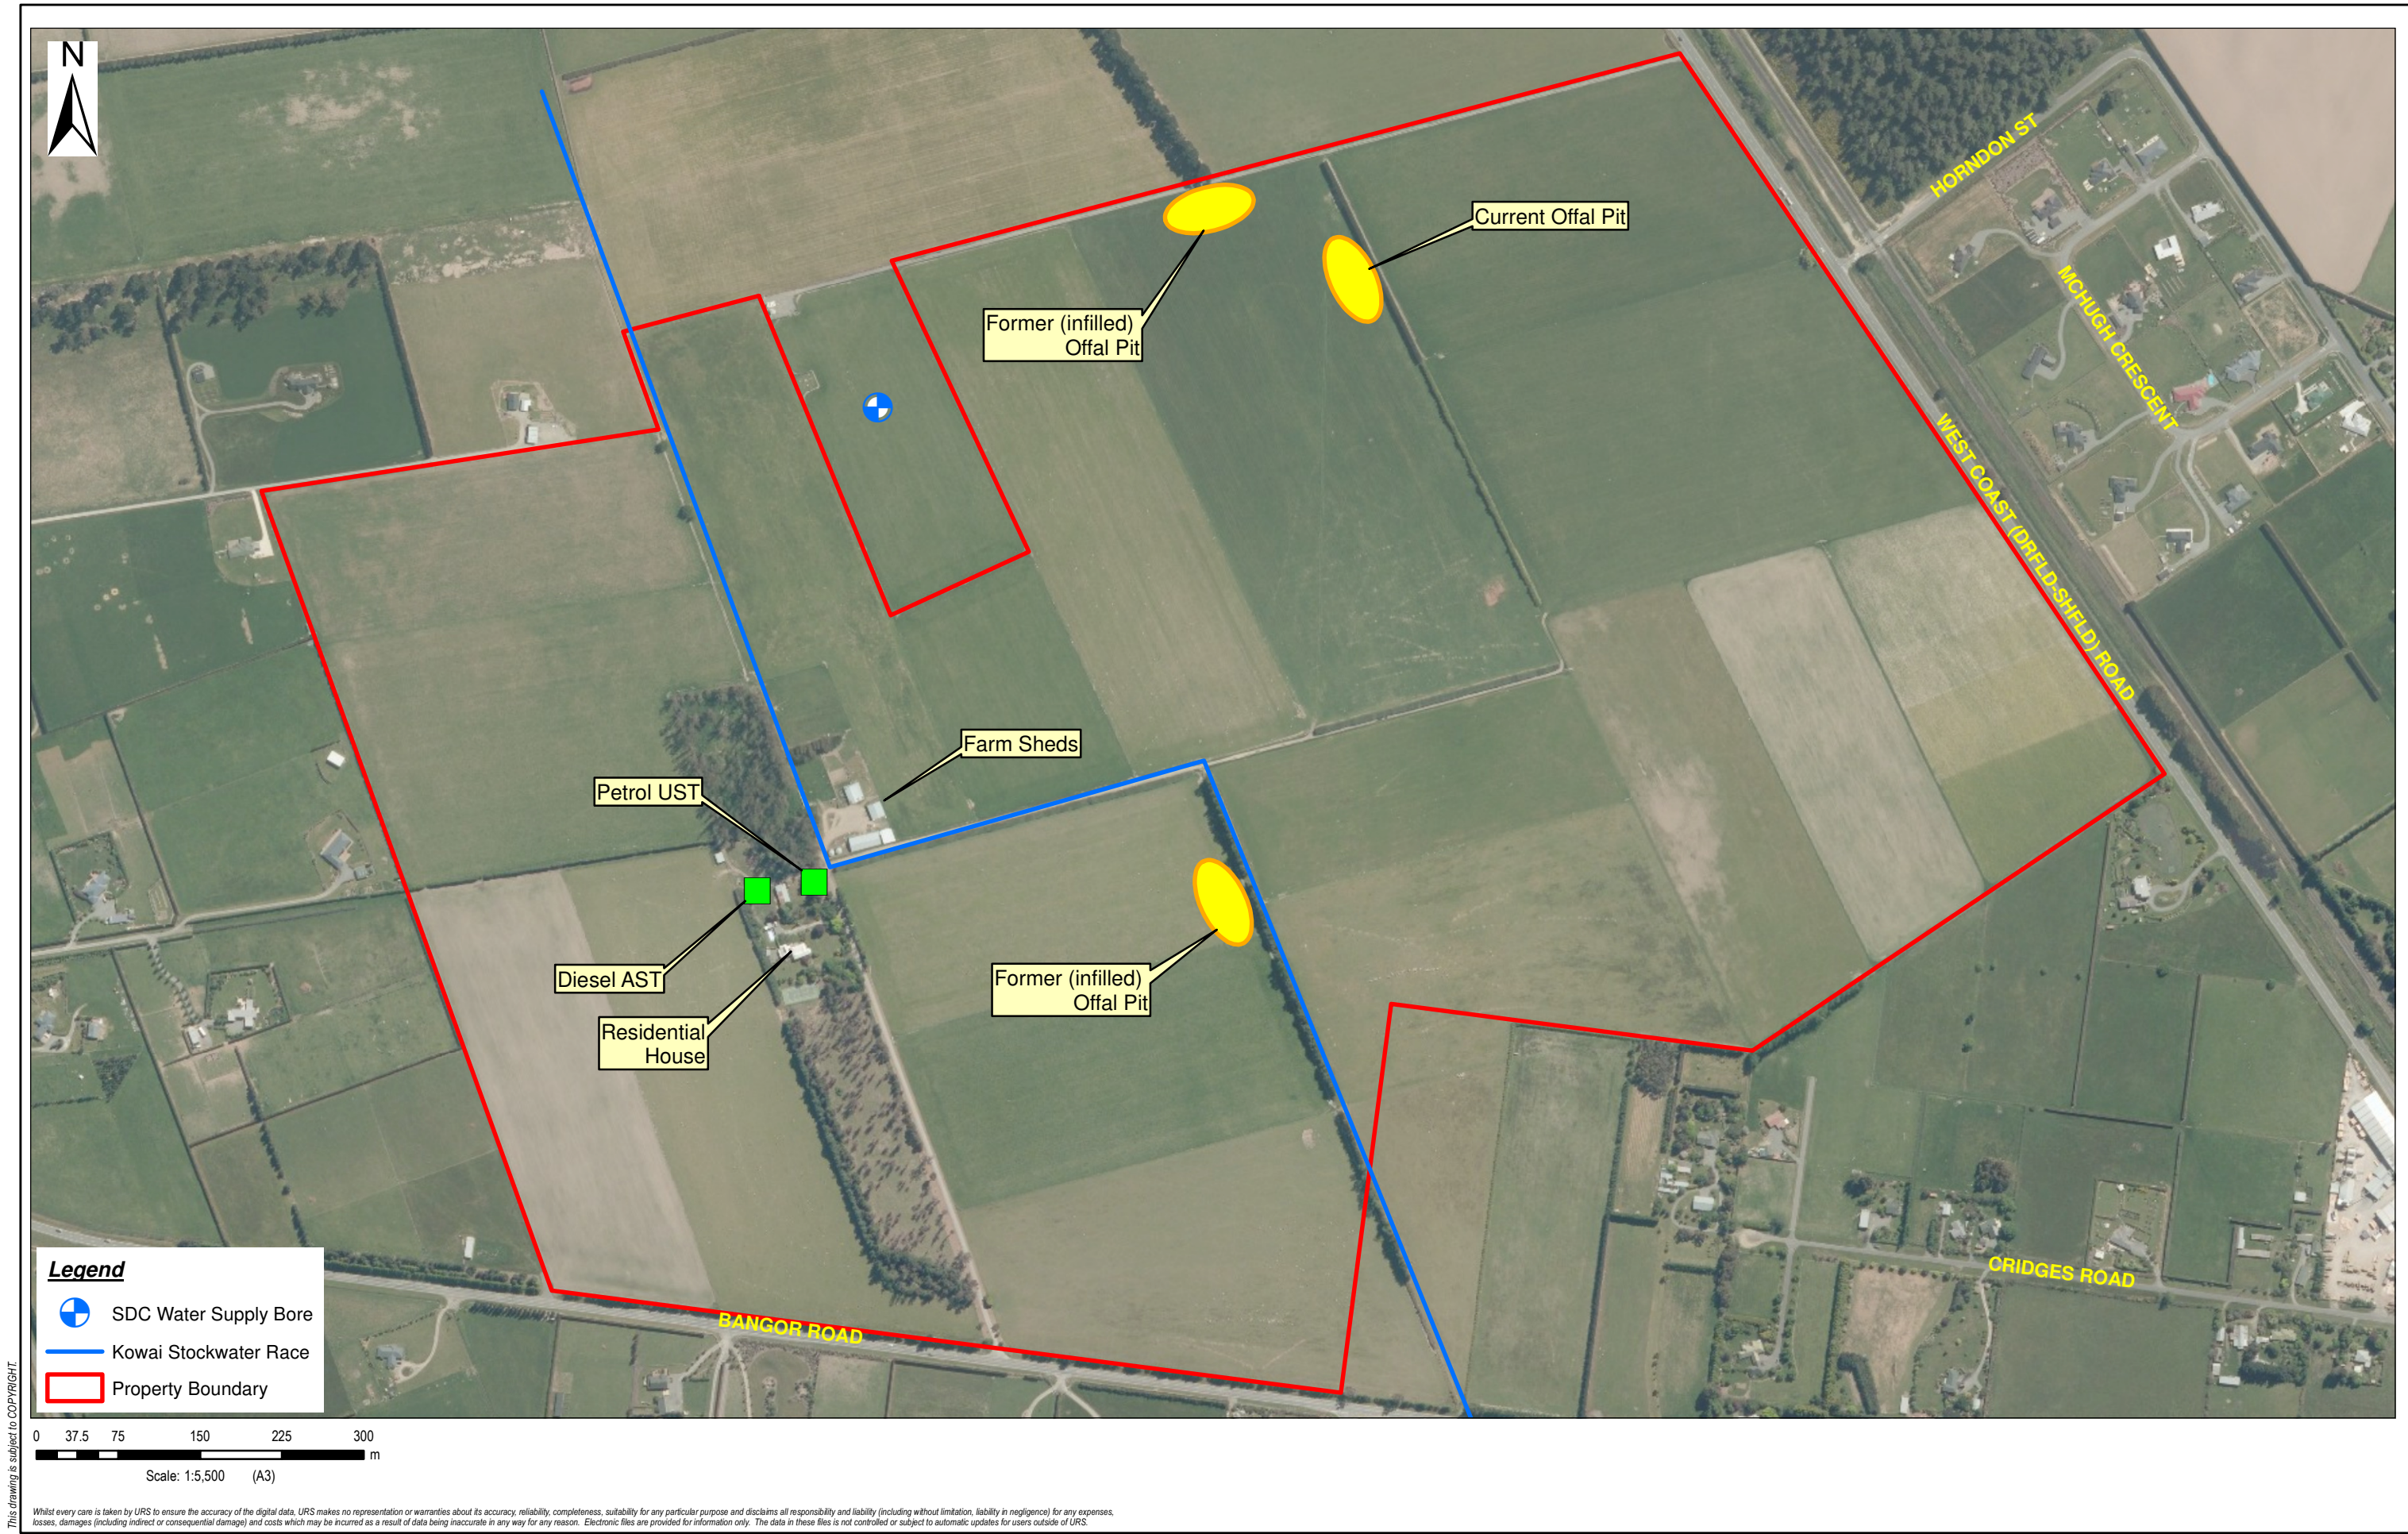
An existing burial pit was observed along the north-eastern boundary of the property (see **Figure 2**); the excavation exposed ~20-30cm of topsoil above ~30-50cm of loess, which overlies Q2a gravels. These observations are consistent with published geological mapping and the ECan well log from the subject property (attached in **Appendix A**).

There are active burial pits along the north-eastern boundary of the property, and other burial pits were identified at selection locations across the property, typically along existing fence lines. These likely contain organic waste, farm debris, and other fill material which is likely to be unsuitable for building foundation. If encountered during foundation earthworks during development, unsuitable fill should be removed and replaced with compacted hardfill.

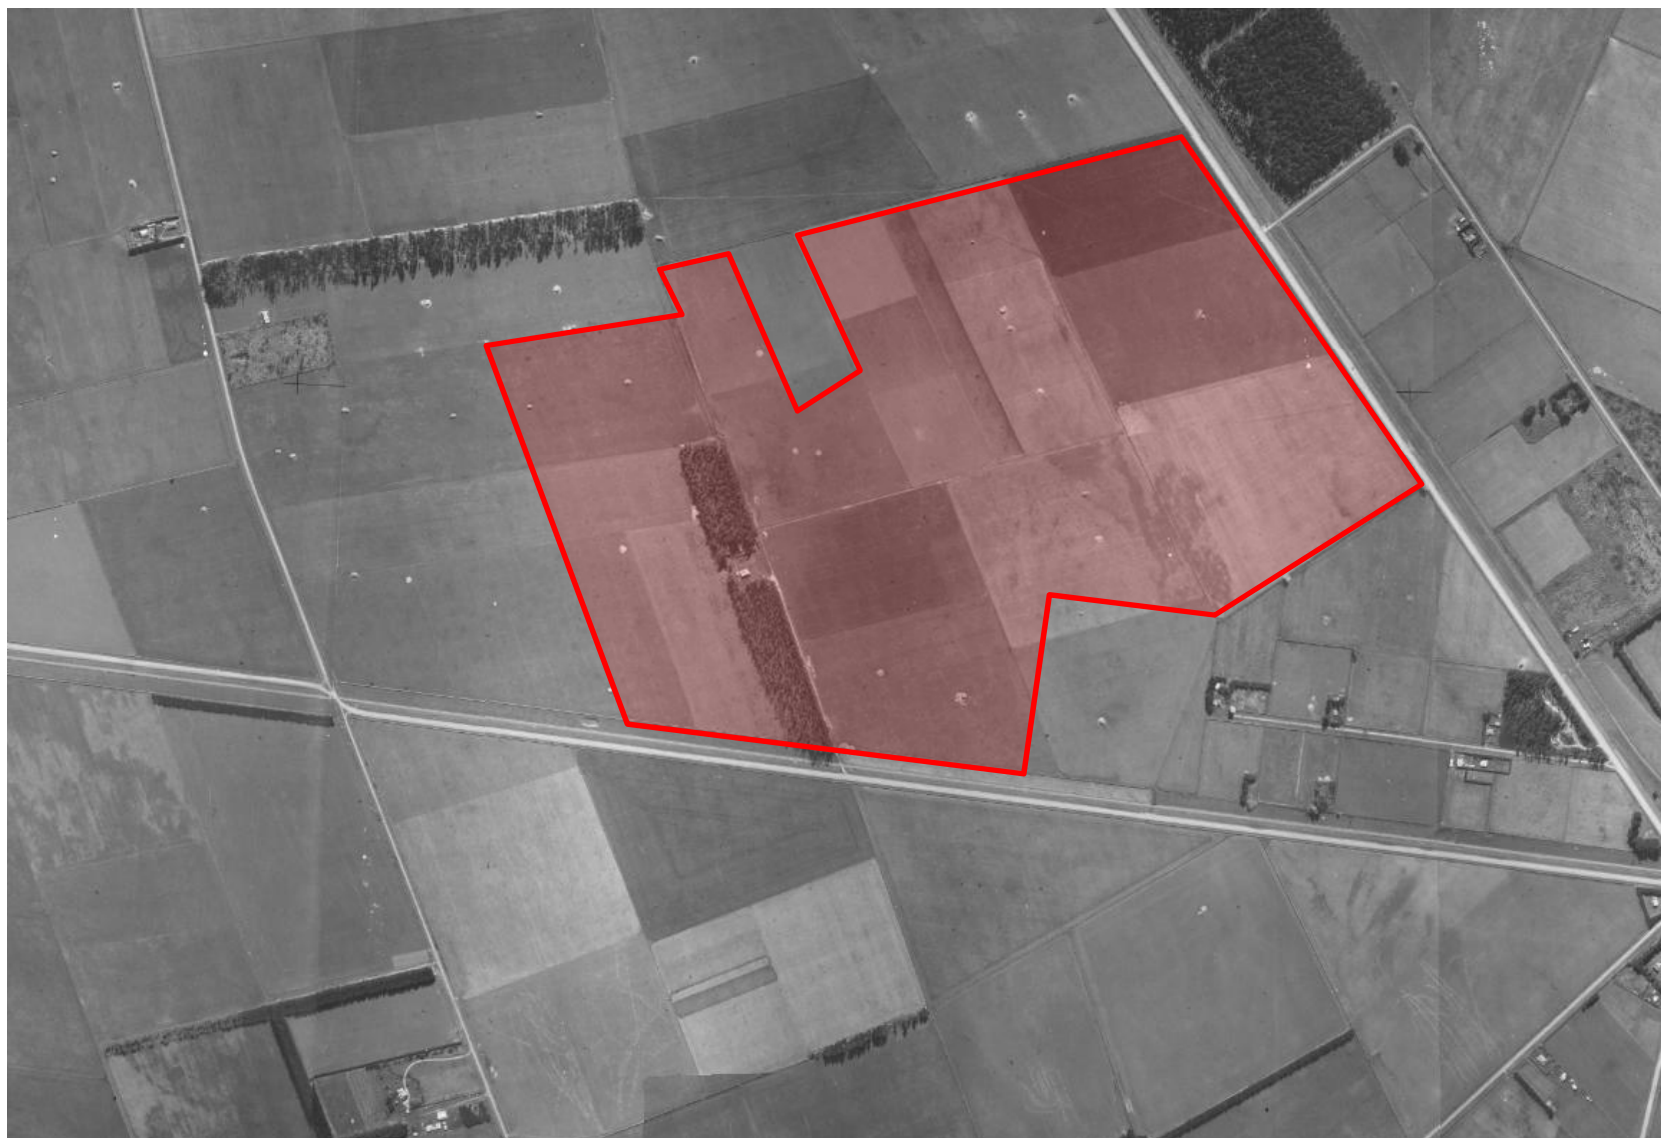
Appendix B - Environment Canterbury Aerial Photograph, 1941

URS has reviewed historical aerial photographs of the property and surrounding area captured in 1941 and 2004 (**Appendix B**). Both photographs show the property to comprise agricultural land. The current residential dwelling is present in the 1941 image, but has been significantly expanded by 2004 and in addition, a tennis court and swimming pool has been constructed at the property. Also, by 2004 several large shed-like structures have been constructed together with two circular above ground storage silos. Relatively little other change is apparent.

The 1941 appears to show several feeding troughs indicating that the property was likely being used for sheep/cattle at the time. No evidence of sheep dips sites are noted, however the scale of the image would not necessarily allow the identification of such features and so the presence of dip sites on the property cannot be discounted.
