# GEOTECHNICAL REPORT FOR PLAN CHANGE AND PROPOSED SUBDIVISION

32571 / LOT 1 & LOT 2 DP 436571, TAI TAPU

/ J WILLIAMS AND Z & S CROFTS

**Date:** 07 April 2016

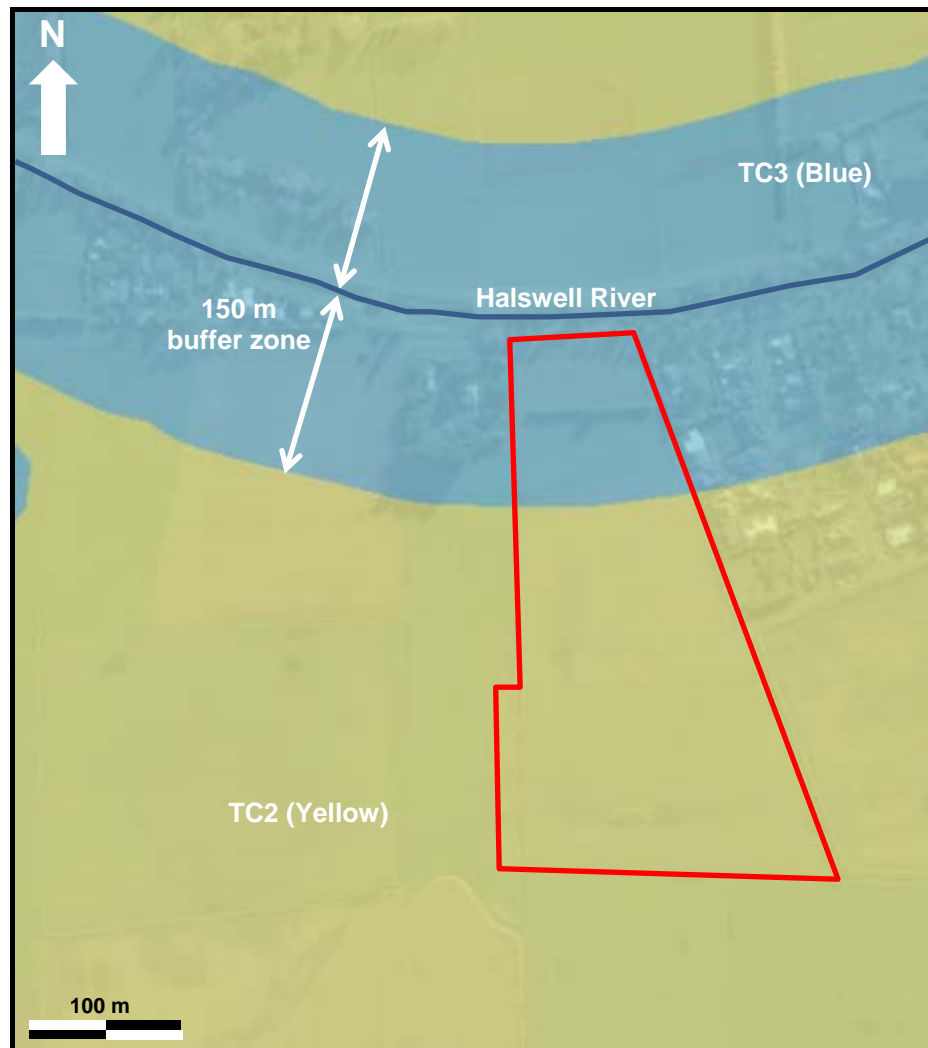
Following the Canterbury earthquake series, the majority of the Tai Tapu area has been assigned a MBIE Technical Category of TC2 which indicates minor to moderate land damage from liquefaction is possible in future large earthquake events. Approximately 150 m either side of the Halswell River has been zoned TC3 which identifies that moderate to significant land damage from liquefaction is possible in future large earthquake events, refer Figure 3. This 150 m “buffer zone” either side of the Halswell River was created to identify the risk of moderate to severe liquefaction and lateral spread towards the river in future large earthquake events, and was based on the damage observed following the Canterbury earthquake series.

**Figure 3: Technical Land Categories in the vicinity of the site (shown in red). TC2 areas are shown in yellow and TC3 areas in blue.**

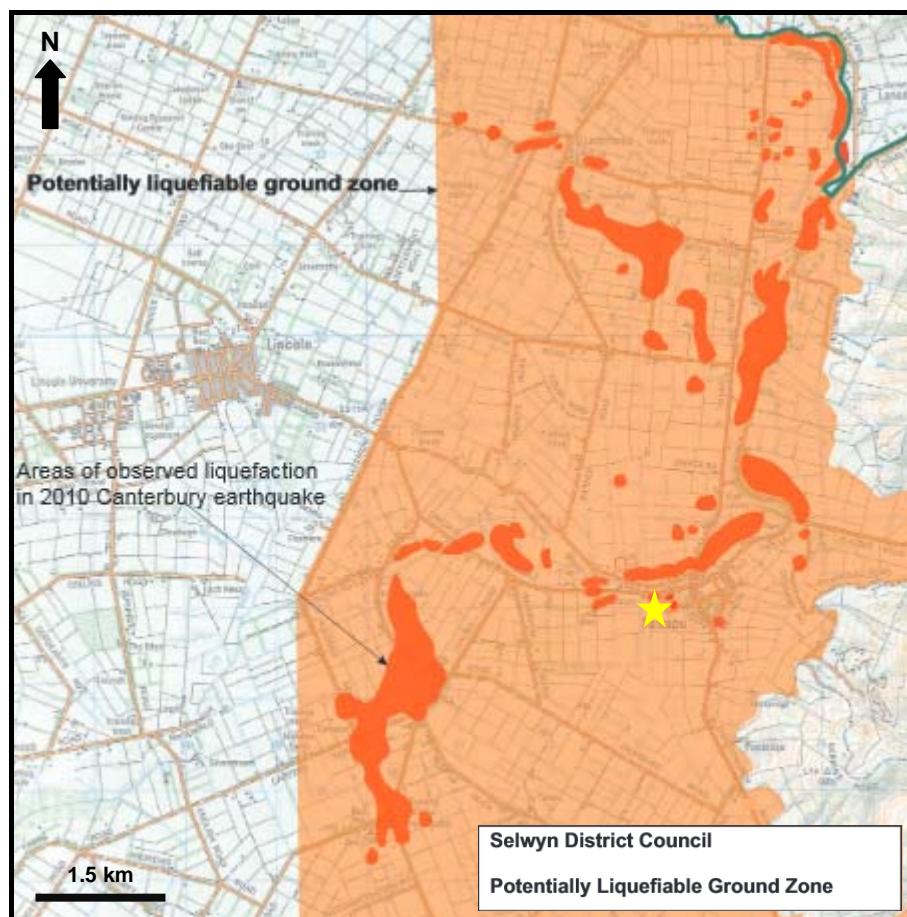
Geotech Consulting Limited produced a report<sup>7</sup> for the Selwyn District Council dated February 2011 stating that following the September 2010 earthquake event “*liquefaction was confined to a strip of land 0.5 to 1.5 km wide that followed the Halswell River*”. The map shows an area of liquefaction on the northern section of the site, with observed liquefaction mapped north, west and east of the site following the Halswell River, (refer Figure 4).

**Figure 4: Geotech Consulting Ltd - Liquefaction assessment of the Selwyn District (February 2011).**

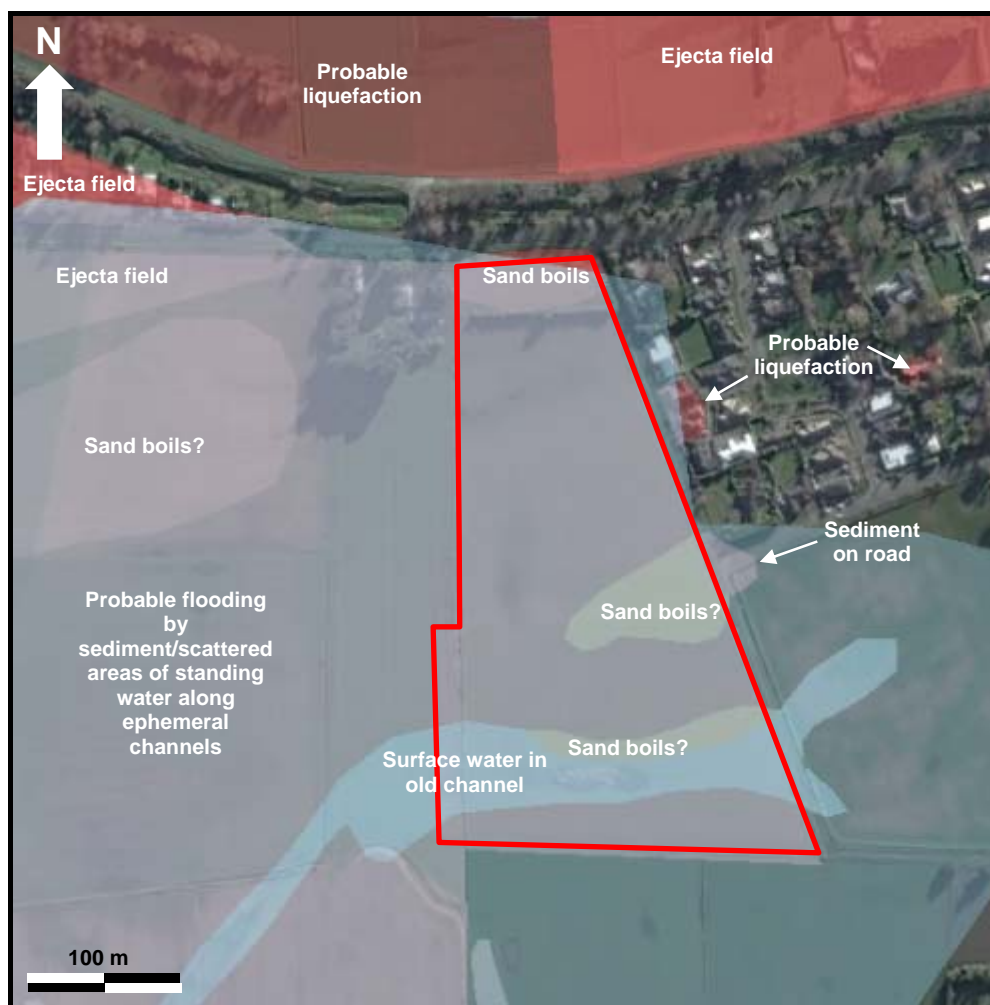
Following the September 2010 event GNS Science<sup>8</sup> undertook detailed mapping of Canterbury as part of a review of areas affected by the September 2010 Darfield earthquake. GNS identified the presence of surface water in an old channel, flooding by water, and sand boils in some areas of the site, (refer Figure 5).

**Figure 5: GNS Science Liquefaction observations following the September 2010  $M_w$  7.1 Darfield earthquake. The site is shown in red.**

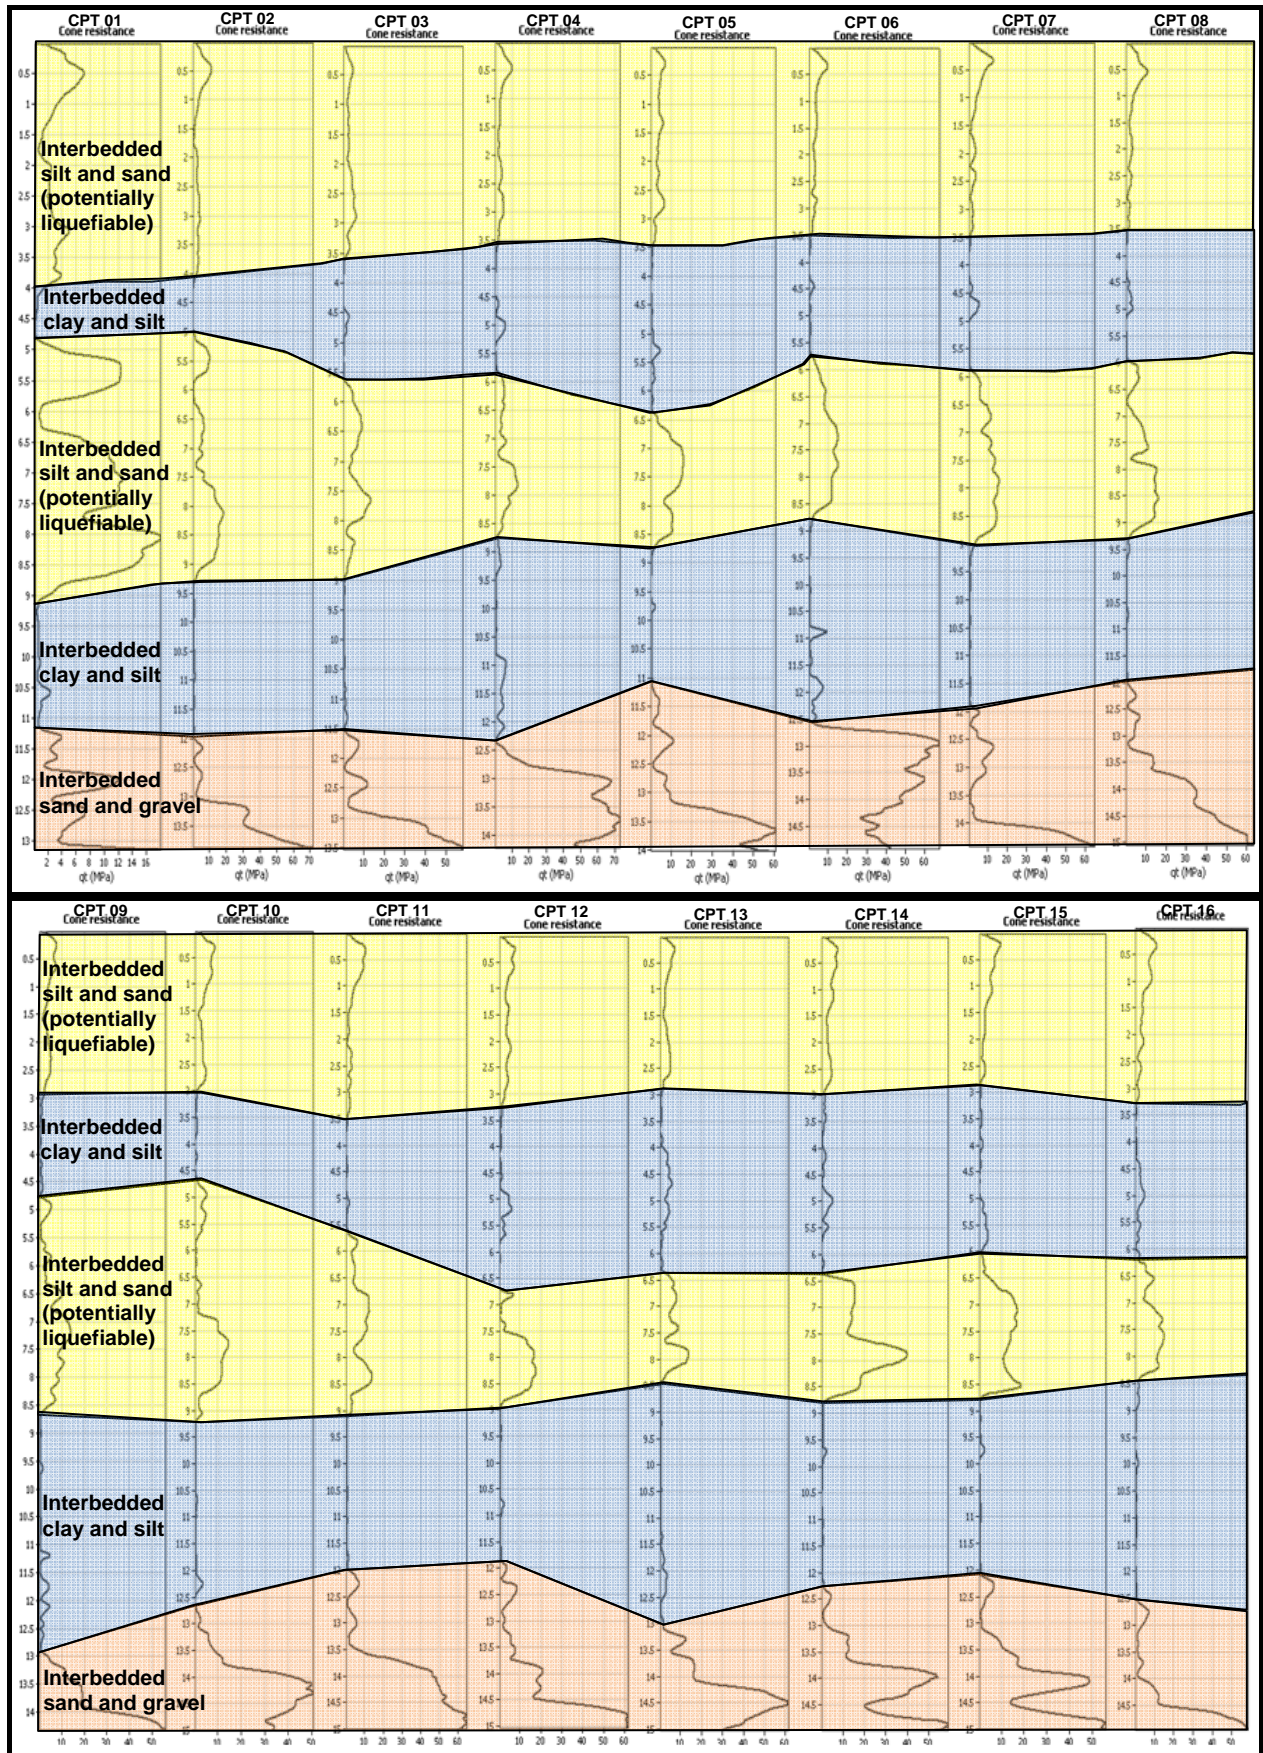
Table 3: Summary of Soil Profiles from Deep Investigations				
Test (Depth)	Description	Depth (m) below EGL*	Cone Tip Resistance (qc, MPa)	Relative Density
<b>CPT 1 – 16</b>	Interbedded Silt and Sand	0.0 – 4.0 m	0.9 – 7.0	Stiff – hard/very loose to medium dense
	Interbedded Clay and Silt	4.0 – 6.5 m	<0.2 – 2	Very soft – stiff
	Interbedded Silt and Sand	6.5 – 9.0 m	0.4 – 10	Firm – hard/very loose – medium dense
	Interbedded Clay and Silt	9.0 – 12.5 m	0.2 – 2.0	Soft – stiff
	Interbedded Sand and Gravel**	12.5 – 15.0 m	2.5 – >20	Loose – very dense
* Note the depths referred to in the table are approximate and averaged for the 16 CPTs				
** Note there are some lenses of silt within the interbedded sand and gravel unit

**Figure 6: Graphical presentation of CPTs 1 – 16 cone tip resistance and an interpretation of the underlying geology. Liquefaction is predicted from the silt and sand units indicated in yellow.**

The CPT analysis suggests that for the purposes of subdivision for future development the site, the site can be considered as having the potential for moderate to major land damage from liquefaction in future large earthquake events. The results of the analysis are broadly consistent with the GNS Science mapping undertaken following the September 2010 earthquake event and the land damage described in Section 3.2 of this report.

- Ground improvement to meet a minimum TC2 performance criteria (see below)
- A raised fill platform to mitigate flood hazard
- Specific engineering design of foundations
