### Private Plan Change Request – Hughes Developments Limited Appendix B – Geotechnical Investigations

20.07.2018

15184.000.000 01

Report Title	Geotechnical Investigation - 1066 V	Vest Coast Road, V	Vest Melton	
Project No.	15184.000.000	Doc ID	01	
Client	Hughes Development Ltd	Client Contact	Kelvin Back	
Distribution (PDF)	Kelvin Back – kelvin@hughesdevel	opments.co.nz		
Date	Revision Details/Status	WP	Author	Reviewer
20/07/2018	Final	BK	НВ	DB

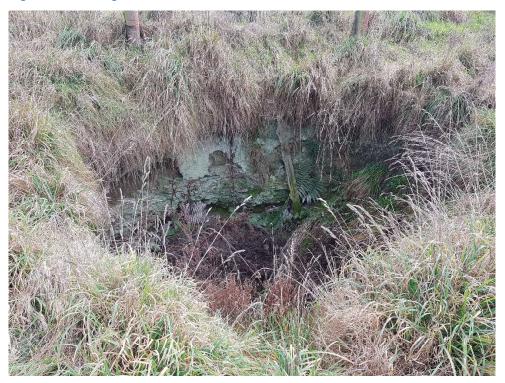
Figure 3: Drainage Excavation

During our site walk over on 10 July, ENGEO observed an excavation roughly 4 m wide by 4 m long by 3 m deep on the eastern side of the property, in the pasture area within the race track. Through conversation with the property owner, we understand that this was excavated as a drainage pit approximately 30 years ago (Figure 3). From the fence line surrounding the excavation, we observed collapsed topsoil and vegetation in the base of the excavation. The extent of this pit should be further investigated during construction and be appropriately remediated.

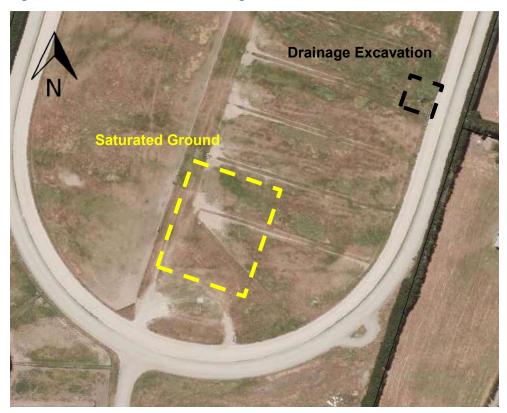
Figure 4: Saturated Ground and Drainage Excavation

An area of saturated soil was observed to the southwest of the drainage excavation, near the southern most end of the horse track. Running water could be clearly heard beneath the surface in this location, though no source was visible. Through discussion with the home owner, we understand that an irrigation pipe had broken in this area. We performed a hand auger borehole (HA07) in this location, and inferred that sandy gravels could be found approximately 0.3 m below ground level. We advise this area be investigated during the construction phase and appropriately remediated.

Approximate locations of both the drainage excavation and the area of saturated ground are outlined in Figure 4.
