Private Plan Change Request – Hughes Developments Limited
Appendix F – Geotechnical Investigations

Geotechnical Investigation

1066 West Coast Road
West Melton
Canterbury

15184.000.000_01

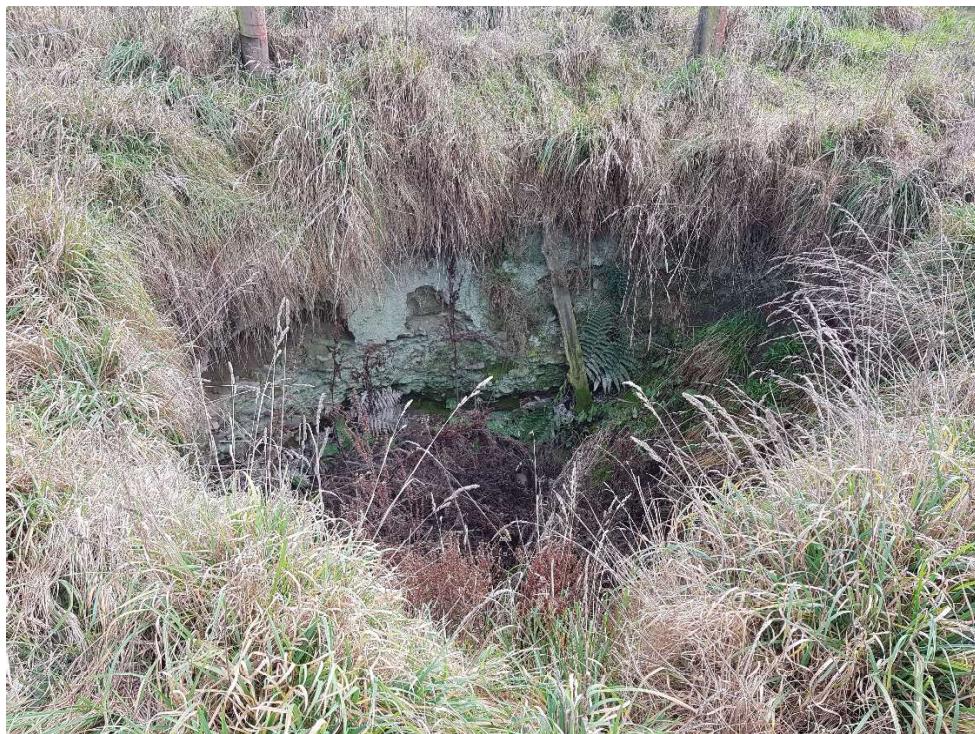
Figure 3: Drainage Excavation

During our site walk over on 10 July, ENGEO observed an excavation roughly 4 m wide by 4 m long by 3 m deep on the eastern side of the property, in the pasture area within the race track. Through conversation with the property owner, we understand that this was excavated as a drainage pit approximately 30 years ago (Figure 3). From the fence line surrounding the excavation, we observed collapsed topsoil and vegetation in the base of the excavation. The extent of this pit should be further investigated during construction and be appropriately remediated.

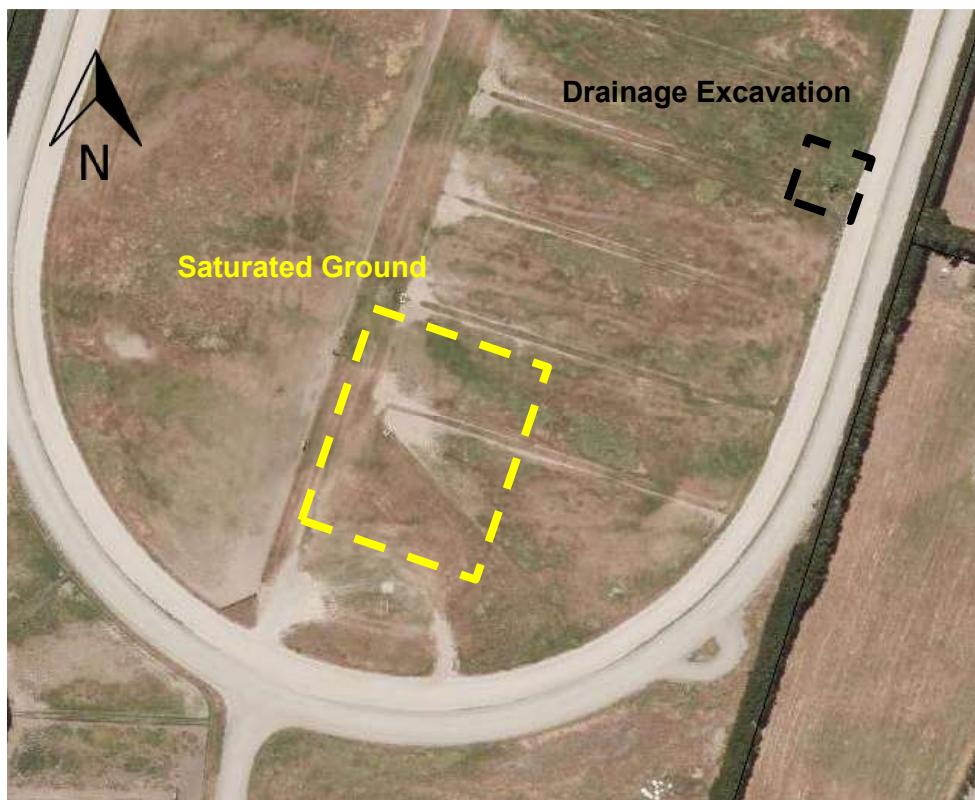
Figure 4: Saturated Ground and Drainage Excavation

An area of saturated soil was observed to the southwest of the drainage excavation, near the southern most end of the horse track. Running water could be clearly heard beneath the surface in this location, though no source was visible. Through discussion with the home owner, we understand that an irrigation pipe had broken in this area. We performed a hand auger borehole (HA07) in this location, and inferred that sandy gravels could be found approximately 0.3 m below ground level. We advise this area be investigated during the construction phase and appropriately remediated.

Approximate locations of both the drainage excavation and the area of saturated ground are outlined in Figure 4.
