## **GEOTECHNICAL INVESTIGATION REPORT**

### **FOR PROPOSED LAND USE CHANGE**

1234 West Coast Road, West Melton

Date: 16 December 2020

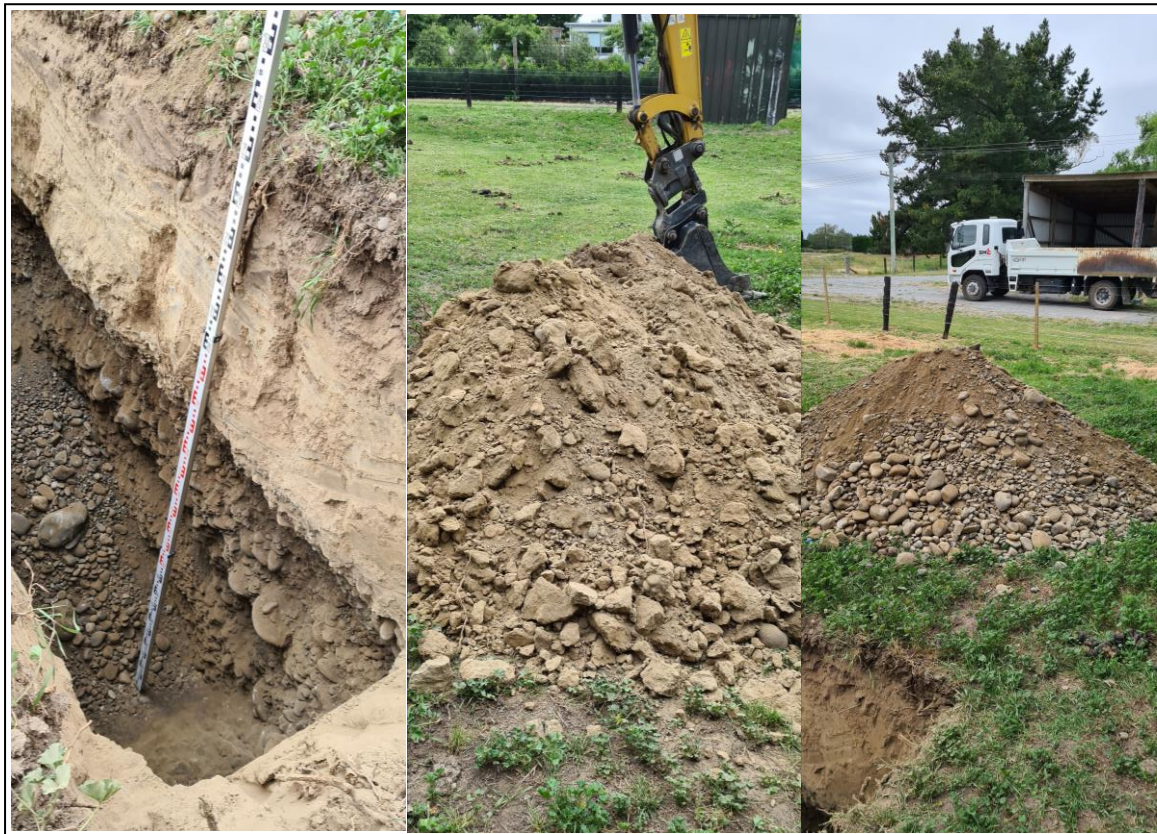
River Deposits were encountered below the surficial layer of sands, silts or topsoil to the termination depth of all test locations (TP01 – TP08). The River Deposits generally comprised sandy fine to coarse subrounded gravel. The gravel deposits were typically described as moist in the test locations, while larger cobbles were also encountered at depth.

Scala penetrometer testing was unable to penetrate the gravels with refusal typically being achieved in contact with the underlying gravels.

**Photos 1: from left to right (1) Shows typical Test Pit excavation (2.6m deep), with loess and topsoil capping. (2) shows blocky excavated loess soils. (3) shows excavated river gravels.**
