Under	the Resource Management Act 1991
In the matter of	an application by KeaX Limited to construct and operate a 111ha solar array at 115 & 187 Buckleys Road, Leeston (RC235464).

BRIEF OF EVIDENCE OF HADEE THOMPSON-MORRISON

23 February 2024

Assessment of soils in the vicinity of solar panels in Brookside, Canterbury

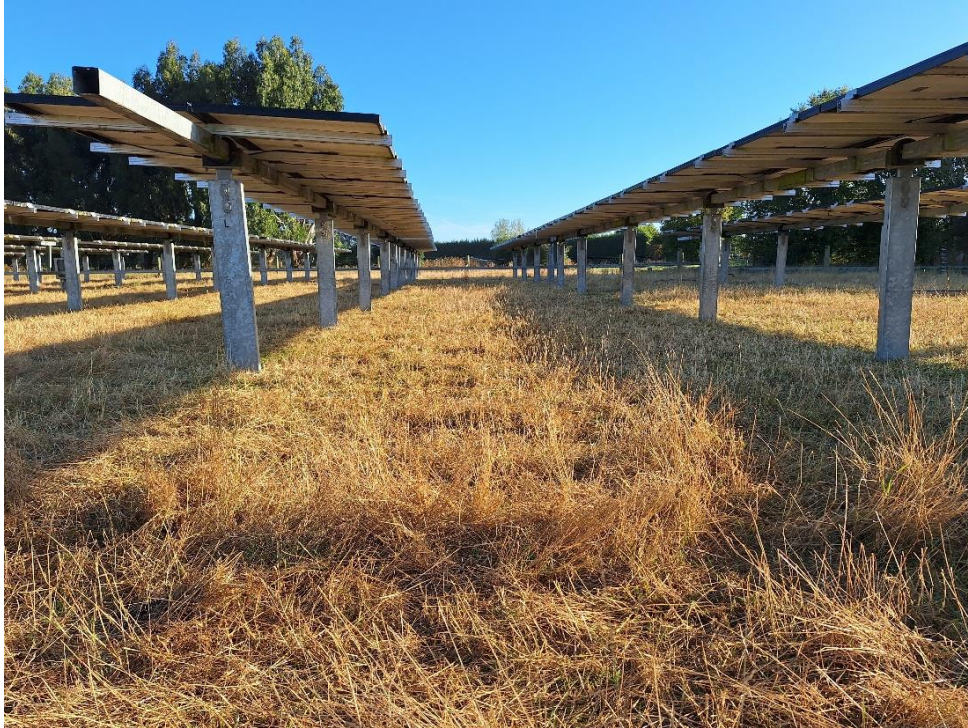
All soil in the vicinity of the solar panels was non-irrigated and overlain by pasture vegetation. It was grazed at the time of assessment by sheep. The soil here was very dry as was all overlying vegetation (Fig 1). A full soil order assessment was done in a pit dug to ~80 cm deep, situated ~4.7 m east of the edge of the existing panels (Fig 2 and 3). The soil was classified as a Mottled Argillic Pallic soil. The topsoil was ~23 cm deep comprised of silt loam. The topsoil had very fine, medium structure with polyhedral peds. Some clumps/clods were present in the topsoil. The consistence of the topsoil was very hard, i.e. the soil had to be crushed underfoot to be broken apart. Beyond this depth, the soil transitioned into a heavily mottled silty clay, with no discernible structure and very firm consistence. Mottles are areas of soil with reddish colouring, indicating oxidised iron, usually from periods of wetness followed by periods of dryness. The colour of the soil around the mottles had low chroma (i.e., pale/grey), which together with the heavy mottling in this soil indicates that the water table at this site likely rises and falls, reaching up to ~20 cm below the soil surface. The drainage class of the soil was poorly drained. There were no rooting barriers observed in the soil profile, with few roots (defined as between 1-10 microfine roots <1 mm in diameter per 100 mm²) extending down to the lower horizons.

Figure 1. Vegetation underneath and between rows of solar panels

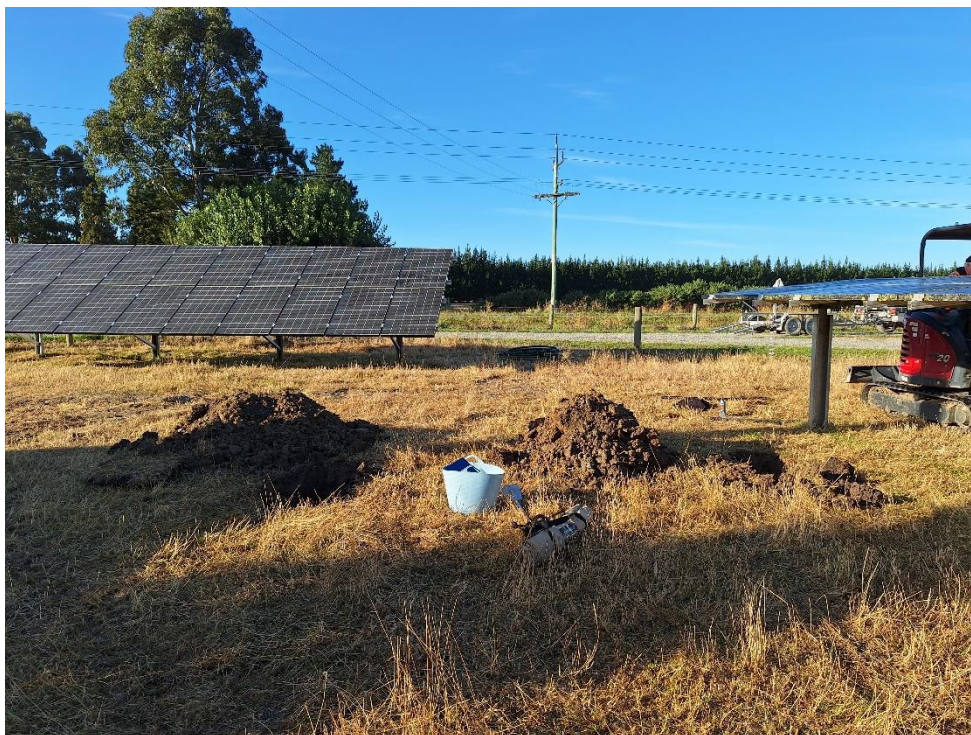
Figure 2. Soil pits dug both outside the solar panelled area (left pit) and underneath the dripline of solar panels (right pit). The soil description was determined from the left pit.

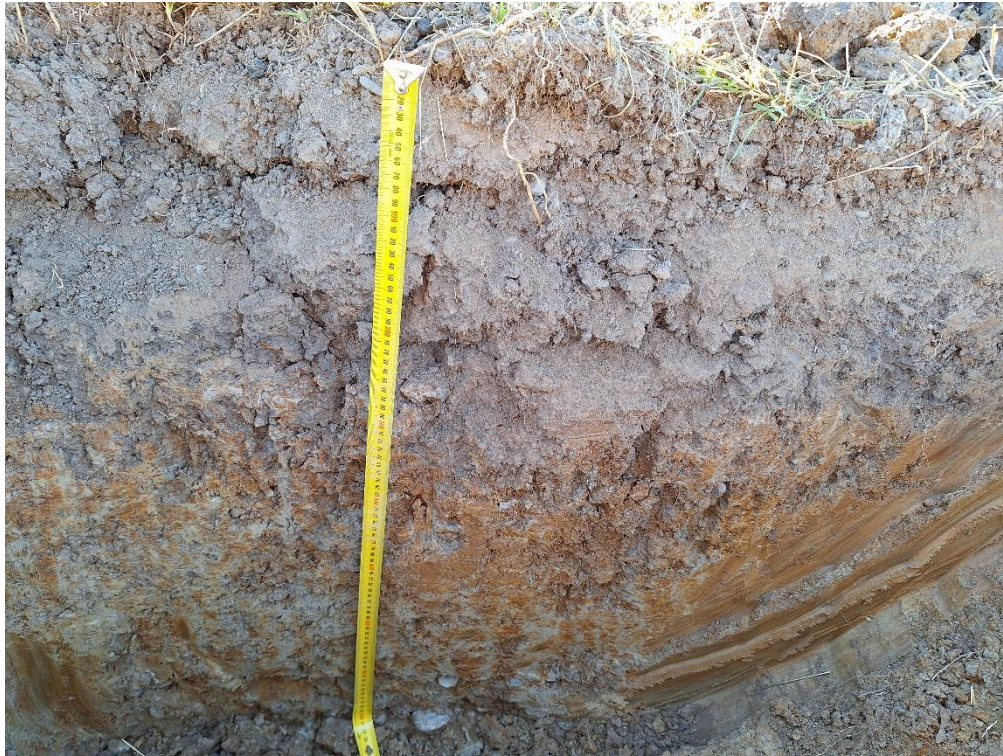
At approximately 70 cm deep, the soil transitioned into an earthy, sandy loam horizon containing coarse gravels.

Figure 3. Soil profile of the pit used for soil description

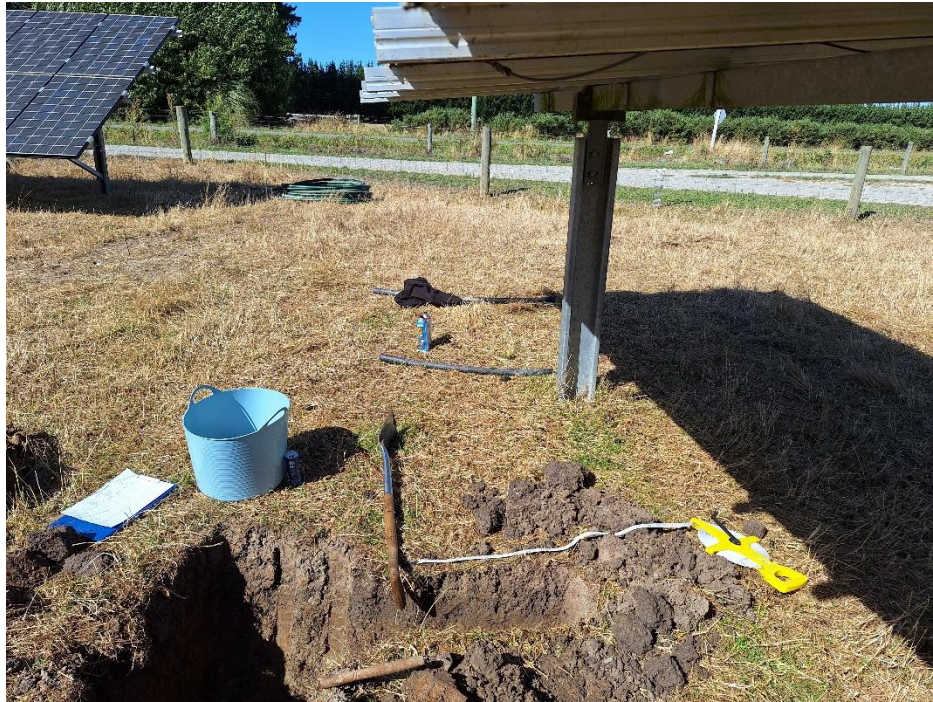
The topsoil structure and depth was assessed in the other soil pits and small holes underneath the panels, under the dripline of the panels and outside the edges of the solar panelled area (Fig 4 and 5). Pasture outside the edges of the solar panelled area appeared to be taller than pasture underneath the panels and between the rows of panels (Fig 6), it was observed that sheep graze in this area, which may contribute to observed differences. Most soil pits and holes underneath the panels, under the dripline of the panels and outside the edges of the solar panelled area were concluded to have similar topsoil depth, horizon depth and mottling to the pit from which the full soil order description was done. In several of these pits, the topsoil was divided into two layers, with the top layer between 6-10 cm thick and the underlying layer extending to between 20-23 cm from the soil surface (Fig 7). The upper layer was silt loam texture and was firm to very hard with medium structure, while the lower layer had a different consistence than the overlying layer and was less structured. The soil texture varied between the two layers in some of the pits/holes, with the underlying layer a loamy clay. In one of the pits located between solar panel rows near the centre of the area under solar panels, the topsoil showed wide cracking (Fig 8). The separation of the topsoil into two layers in areas may be the result of historic management of the soil, e.g. ploughing or pugging by livestock.

Figure 4. Soil pit dug under the dripline of solar panels, with a shallow hole extending to underneath the panels

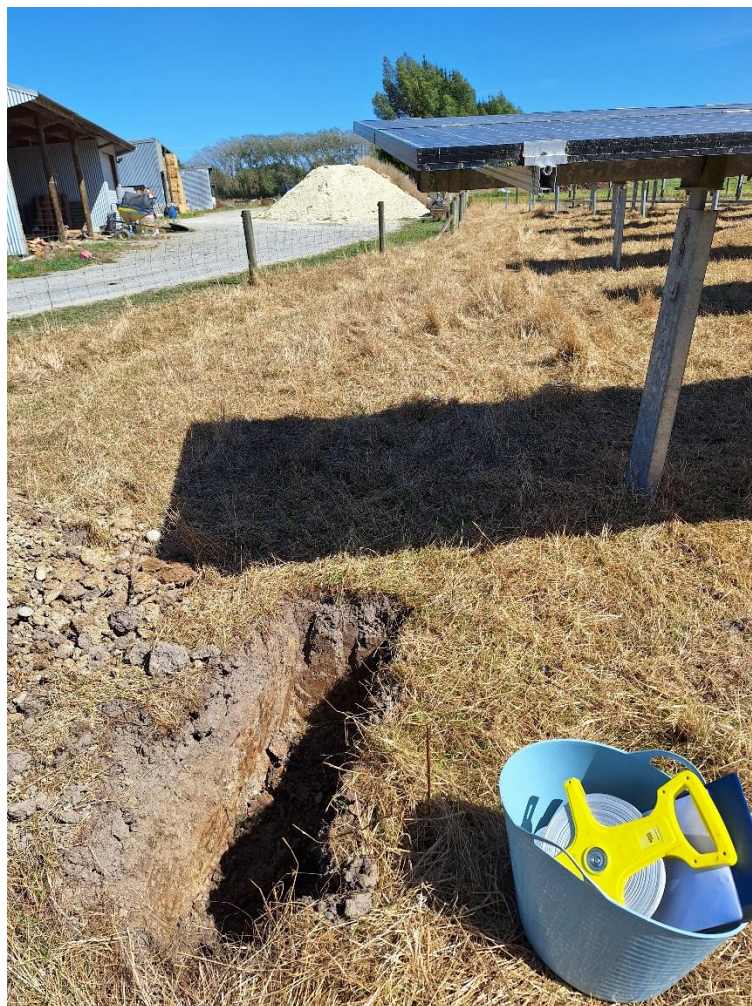
Figure 5. Soil pit dug underneath the dripline, extending out to the area around the solar panels

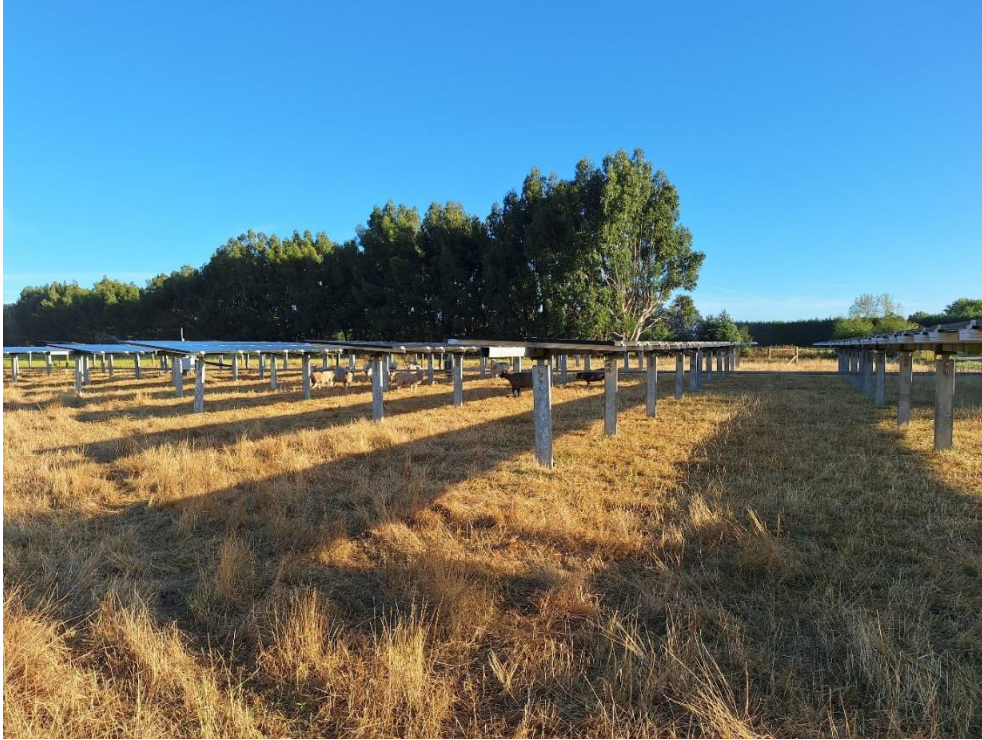
Figure 6. Differences in vegetation height visible between the area outside of the solar panels (foreground) and areas underneath panels and between the rows of panels

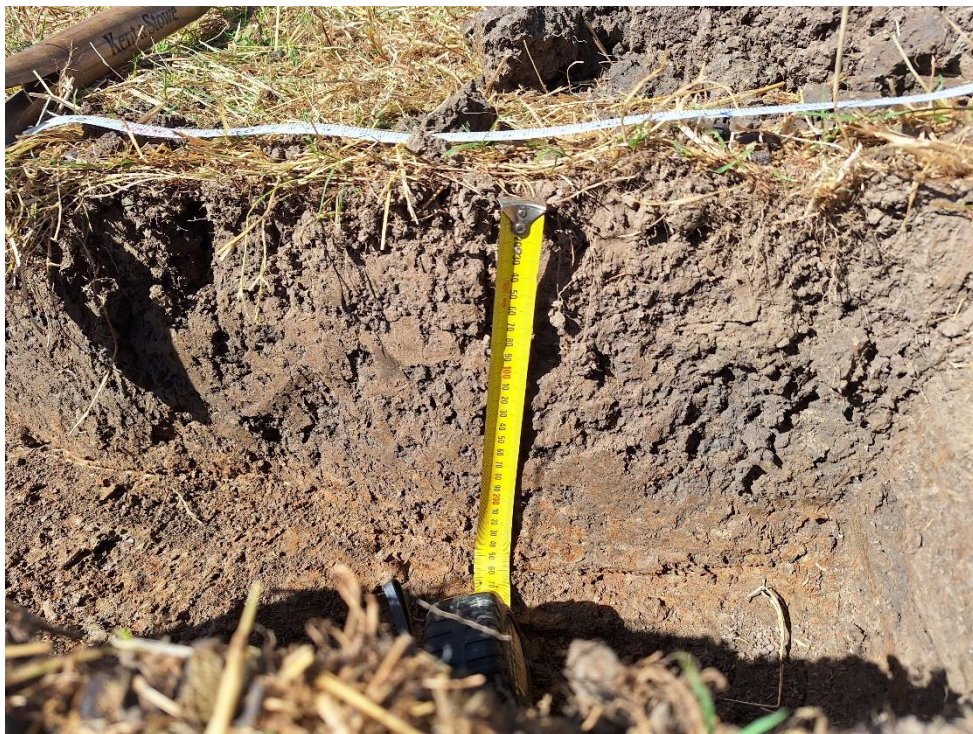
Figure 7. Two topsoil layers present, with a silt loam layer between 0-10 cm and a loamy clay layer between 10-22 cm

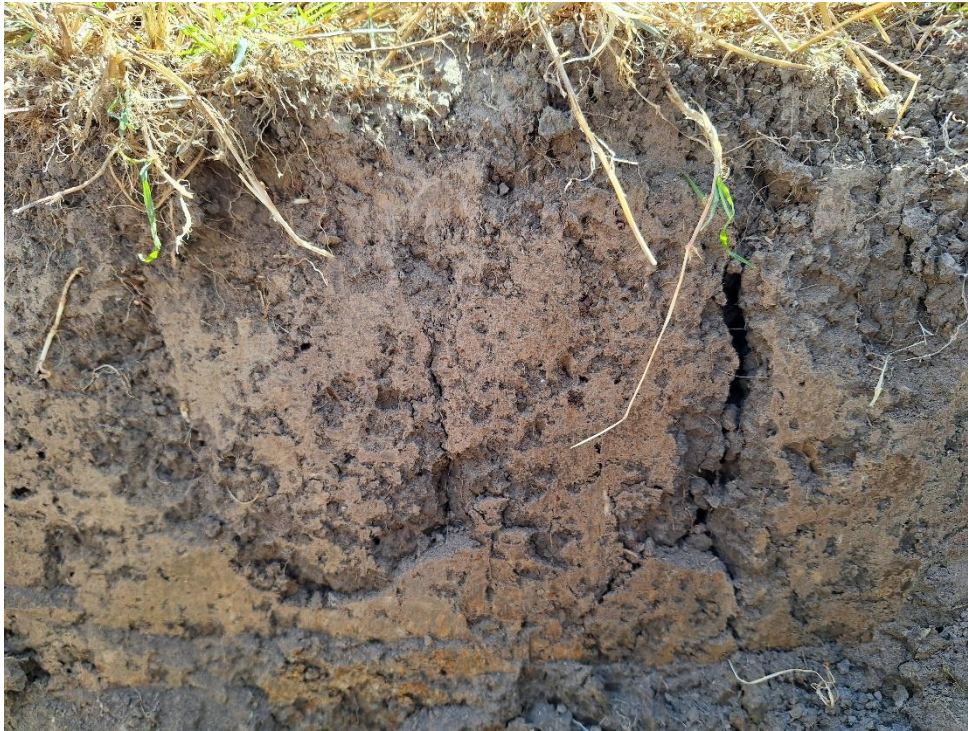
Figure 8. Wide cracks present in topsoil of a soil pit between solar panel rows

was non-irrigated while the dairy pastures were irrigated. There were stark differences in pasture condition in these different locations, with soils in the area around the solar panels being substantially harder and dryer. It is possible that the cracking and consistence of soils under the solar panels were due to the dryness in this area. Specifically, it cannot be concluded whether is the apparent difference in soil structure is due to the presence of the solar panels or to the differences in management of the two areas (i.e. irrigated and grazed vs. non-irrigated).

It would be useful to assess the structure of soils near to solar panels when they are moist, to allow a robust comparison between these soils and soils under surrounding irrigated pasture in order to determine whether there are any notable differences that may be due solely to the presence of panels.

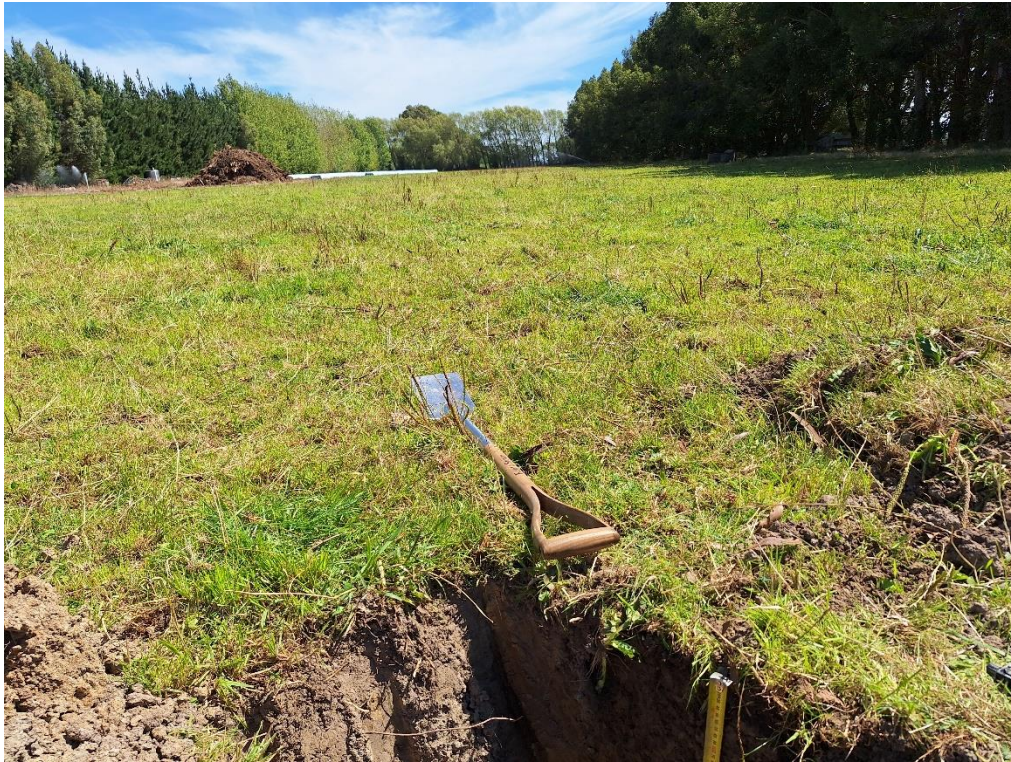
One pit in an adjacent irrigated dairy pasture was assessed as a form of control, to determine any differences between soils near to the solar panels and soils under surrounding pasture (Fig 9 and 10). However, this soil was assessed as being of a different soil order - likely an Argillic Orthic Gley – to the soil under the solar panels. It should be noted that the soil order classification here is indicative only, as this pit was only dug to ~40 cm, rather than the specified 90 cm for this soil classification, so assessment of the lower horizons was not possible. The soil here had recently been irrigated and was overlaid by green pasture. This soil displayed less mottling in the visible soil horizons than the soil around the solar panels, and was more heavily reduced with a higher proportion of pale colours. The topsoil in this pit was ~22 cm deep and was not obviously divided into two layers. The topsoil had medium, fine, polyhedral structure and was a hard consistence. Mottles were present in all horizons however there were substantially more in the subsoil horizons below 22 cm than in the topsoil. The subsoil horizons were a loamy clay texture with no discernible structure.

Figure 9. Soil pit in pasture adjacent to the solar panel area

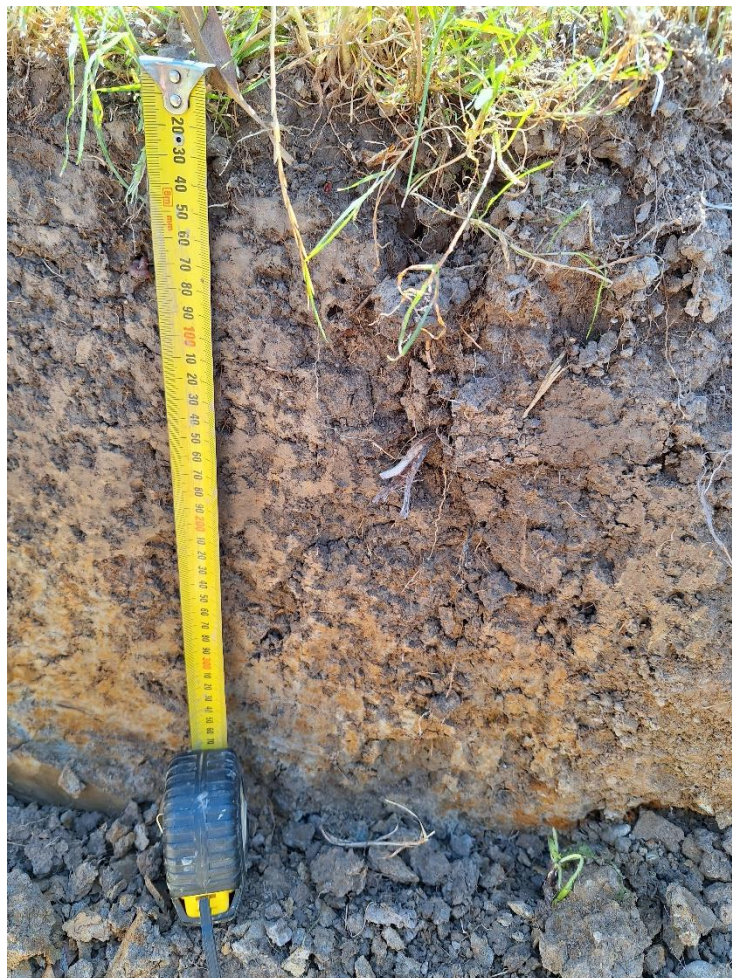
Figure 10. Soil profile of pit in the pasture adjacent to the solar panel area

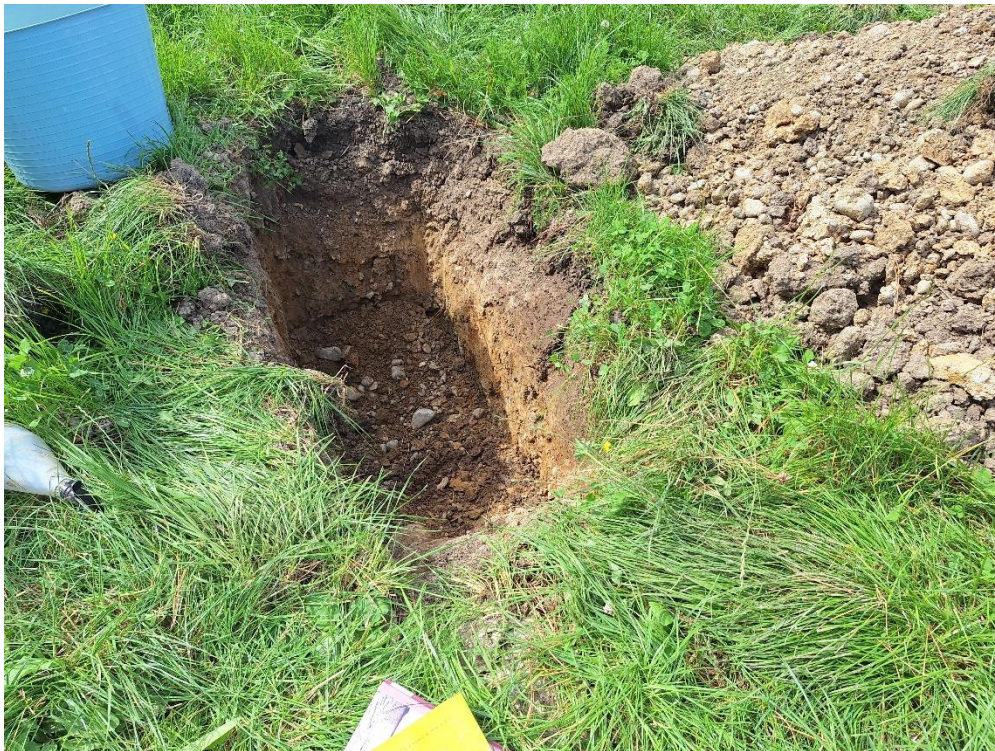
One 60 cm deep pit was assessed in an area of irrigated dairy pasture ~300 m south of the existing solar panels, adjacent to the proposed solar farm site (Fig 11 and 12). This pit was approximately 20 m from the fence line, across a hedge, fence and track from the neighbouring property where the solar farm is proposed (Fig 13). The pasture overlying the soil was green and the soil was less dry than the soil under the solar panels. The soil here, like the soil around the solar panels, was classified as a Mottled Argillic Pallic soil. The topsoil extended to 18 cm below the soil surface with a transitional horizon from 18-32 cm. The topsoil was divided into two layers, similar to some of the topsoils under the solar panels. There was an abrupt boundary (between 0.5-2 cm thick) between these layers. Here, both layers had silt loam texture. The topmost layer was more strongly structured than the underlying layer and was of semi-firm consistence, while the underlying layer was of very firm consistence (i.e. was harder than the underlying layer). Both had very fine polyhedral structure. The transitional horizon also had silt loam texture however contained more clay than the topsoil horizons. It had medium structure and very fine polyhedral peds. This horizon had semi-firm consistence and approximately 15% fine mottles. The subsoil horizon from 32-50 cm was a loamy clay texture and was earthy and apedal, with ~70% mottles. Below this, the soil became a sandy skeletal layer consisting of loamy sand and ~50% coarse gravels, with ~20% mottling.

Figure 11. Soil pit dug in irrigated dairy pasture adjacent to the site of the proposed solar farm

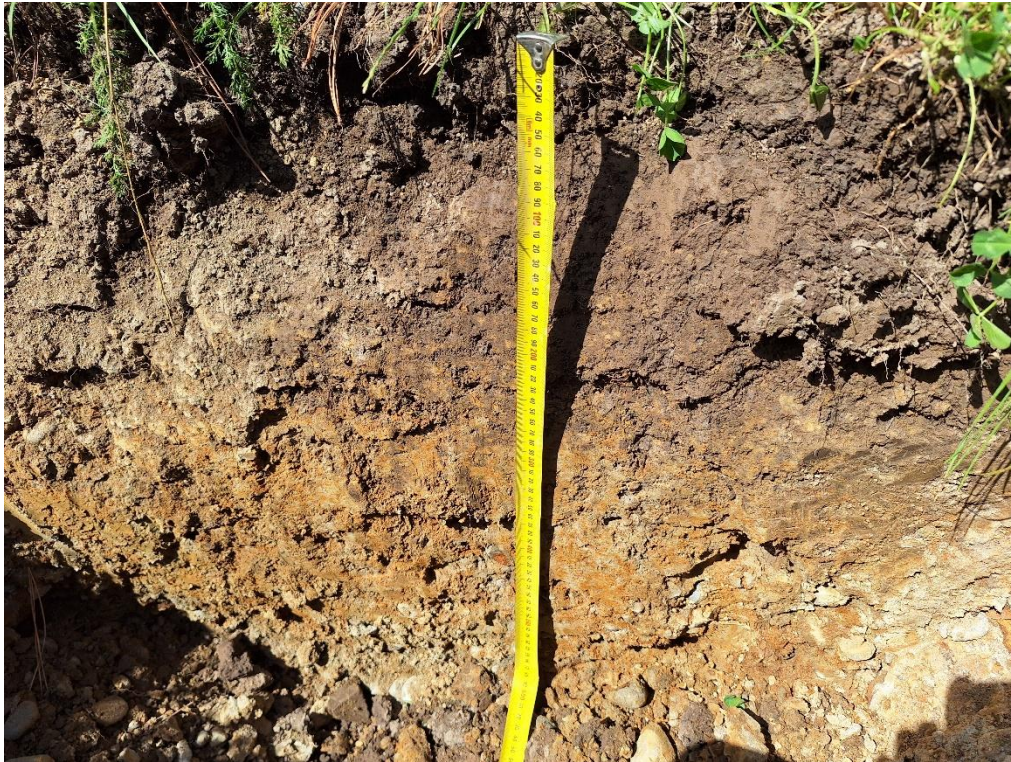
Figure 12. Soil profile of pit in irrigated pasture adjacent to the site of the proposed solar farm

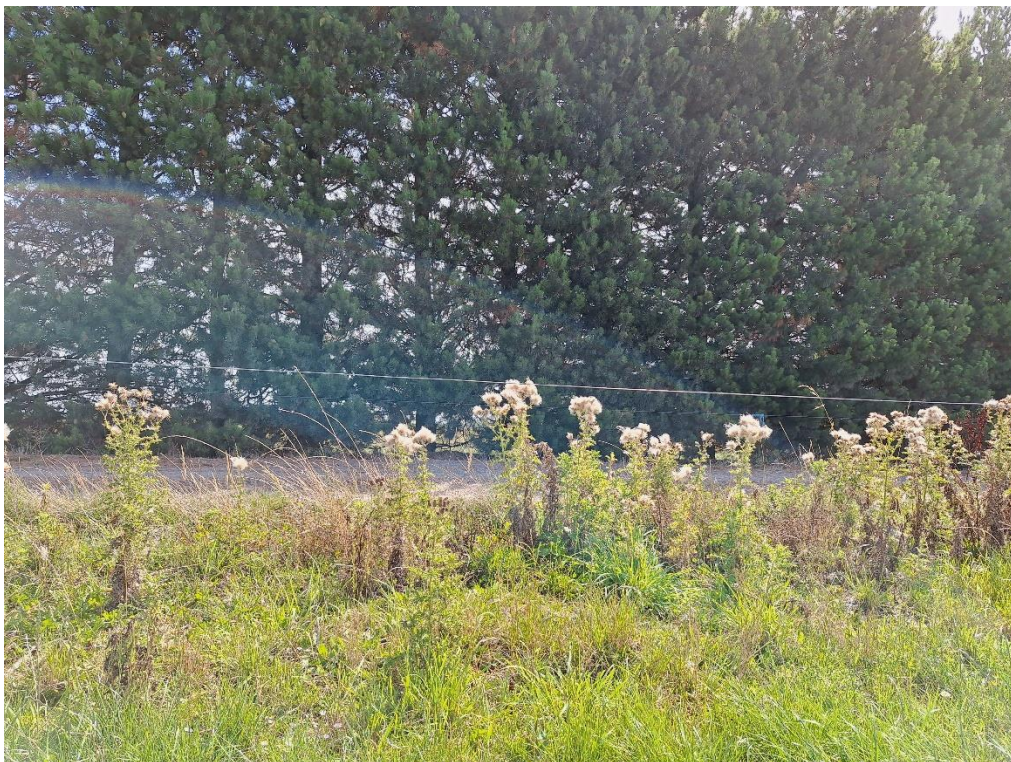
Figure 13. Proximity of the pit shown in Fig 11 and 12 to the neighbouring property where the solar farm is proposed
