CASE STUDY

Lake Kaituna ("B") 22ha and Lake Komakorau ("C") 8ha

CONTROLLING GREY WILLOW AT LAKES KAITUNA AND KOMAKORAU

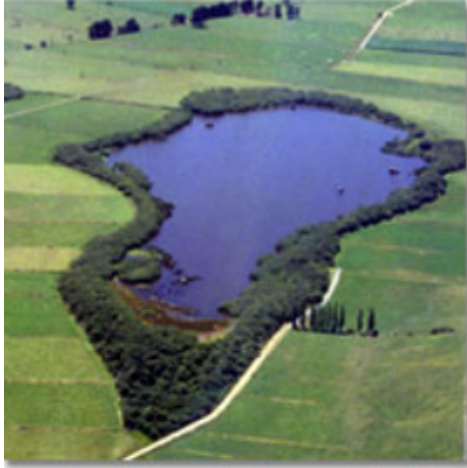
Lake Kaituna prior to willow removal.

Beginning upwind to avoid reinfestation of cleared areas, grey willow was felled and stumps painted with 4 parts diesel and 1 part Roundup™. These works were carried out Dec–Jan to take advantage of low water levels. A digger then stacked the willow in piles working from the margins further into the wetland. Willow rots quickly and this

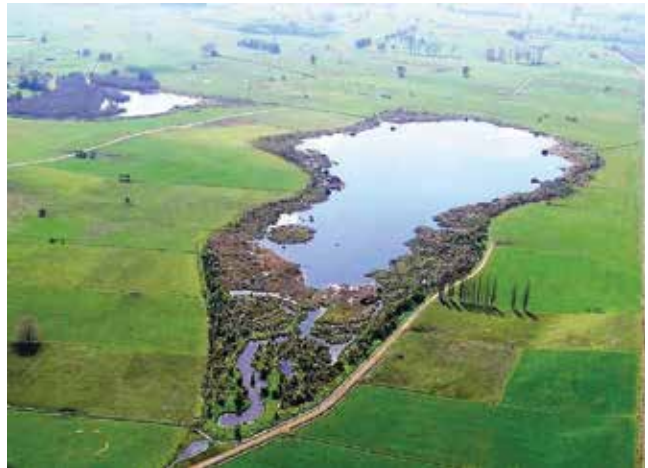
Willows completely cleared from Lake Kaituna and regeneration well underway. The grayish stands of willow on the adjacent lake (Komakorau) have since been removed. Photo: Environment Waikato

Native sedges, rushes and shrubs naturally regenerated and flourished once free of the willow stranglehold.

method allowed native sedges and eventually other wetland species to reestablish quickly. After 3–5 years, the felled willow has almost entirely rotted away, with the area now largely colonized by native sedges.

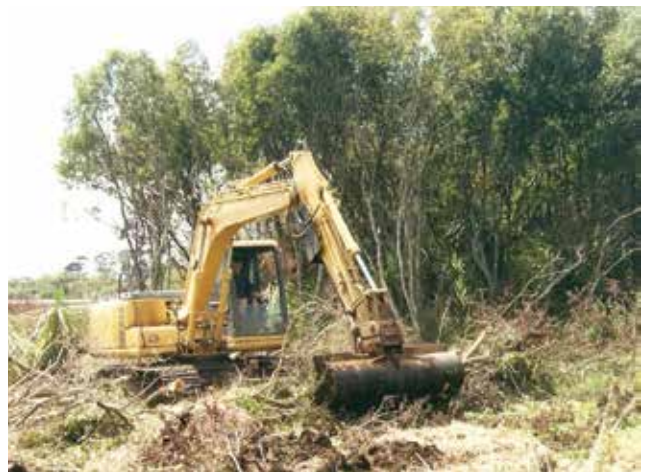
Large-scale restoration takes large-scale approaches: a digger was necessary to remove the dense stands of grey willow.

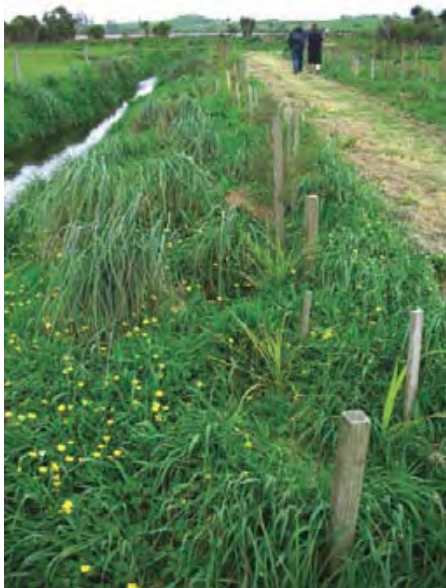
Some drain margins are grassed while others incorporate walking tracks and native plantings.
Photo: Monica Peters

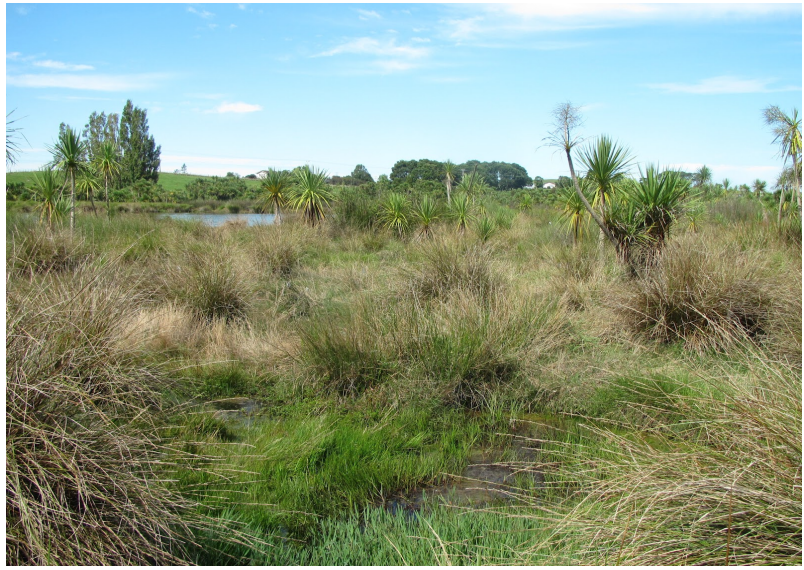
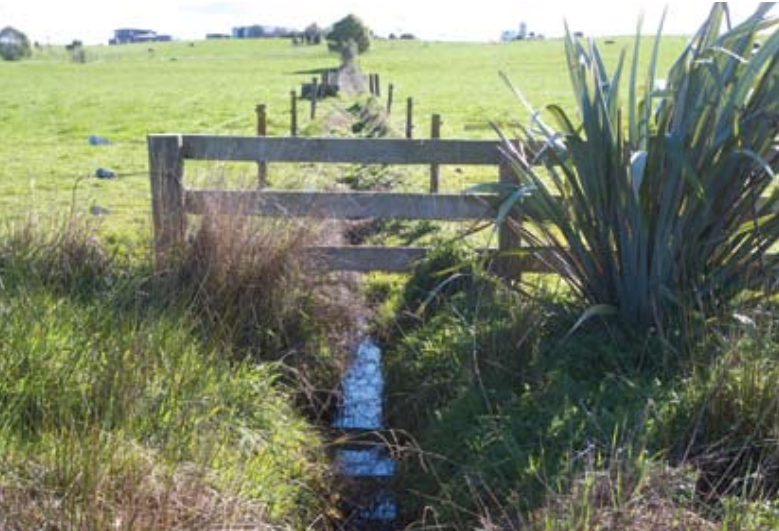
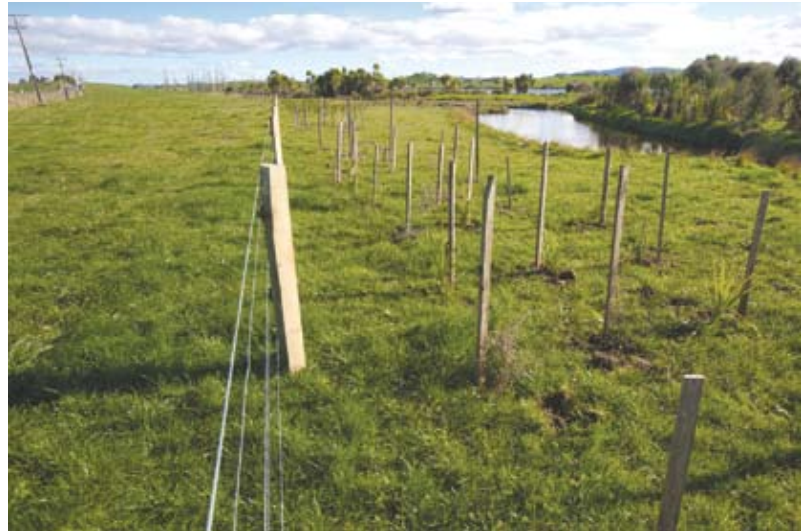
Silt traps slow the water, allowing sediment to settle out before the water enters the lake.

- Installed sediment traps on all inlet drains to both lakes
- Cleared away 30 truckloads of household rubbish from the lake edge
- Dealt to privet, blackberry and other weeds
- Controlled animal pests including possums and feral cats
- Re-planted native species
- Developed areas for wading birds
- Installed teal nesting boxes
- Created a walkway around both lakes
