TĀREREKAUTUKU / YARRS LAGOON RESERVE

SCOPING REPORT
Prepared for Living Water

19 December 2017

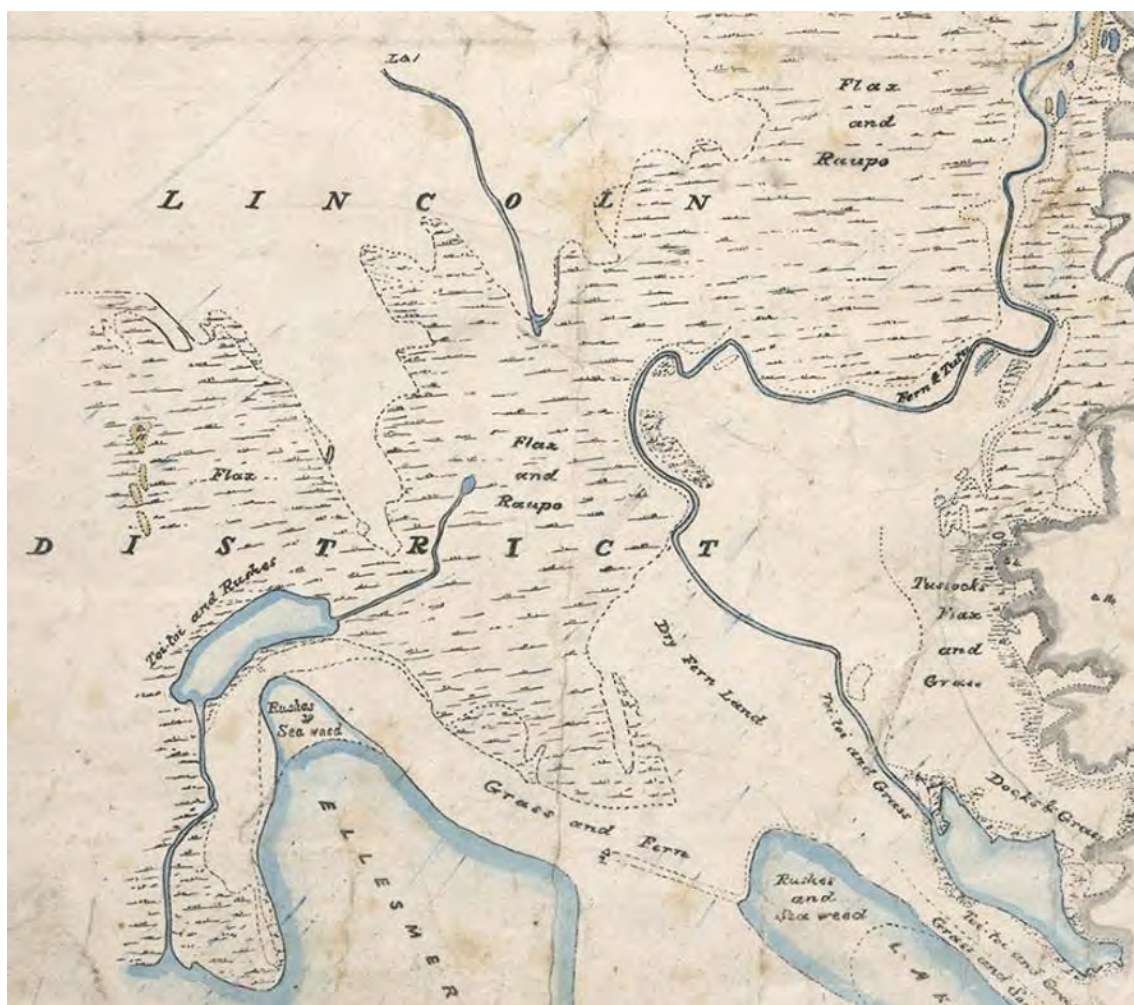
Figure 2: 1850 map showing Tārekeautuku/Yarrs Lagoon as an open body of water surrounded by wetland. Sourced from the 1850 trigonometrical survey of Christchurch.

Early survey maps (Figure 2) show the Ararira River broken into several parts, with a defined upper portion (called the L1 River), flowing into a large harakeke/raupō swamp, and then a lower section (called the LII or No.2 River) flowing into Tārerekautuku/Yarrs Lagoon and on to Te Waihora/Lake Ellesmere. Makonui or Clay Bar lagoon is most likely the small waterbody at the end of the L1 or start of the L11 River. The former open water body of Tārerekautuku is clearly seen on these maps, as well as the former upper level of Te Waihora. Information from Council minutes and reported in newspapers from the 1870s, describes how both Tārerekautuku and Makonui were drained and modified, as well as the details of the L1 and LII drainage scheme, approved in 1945.

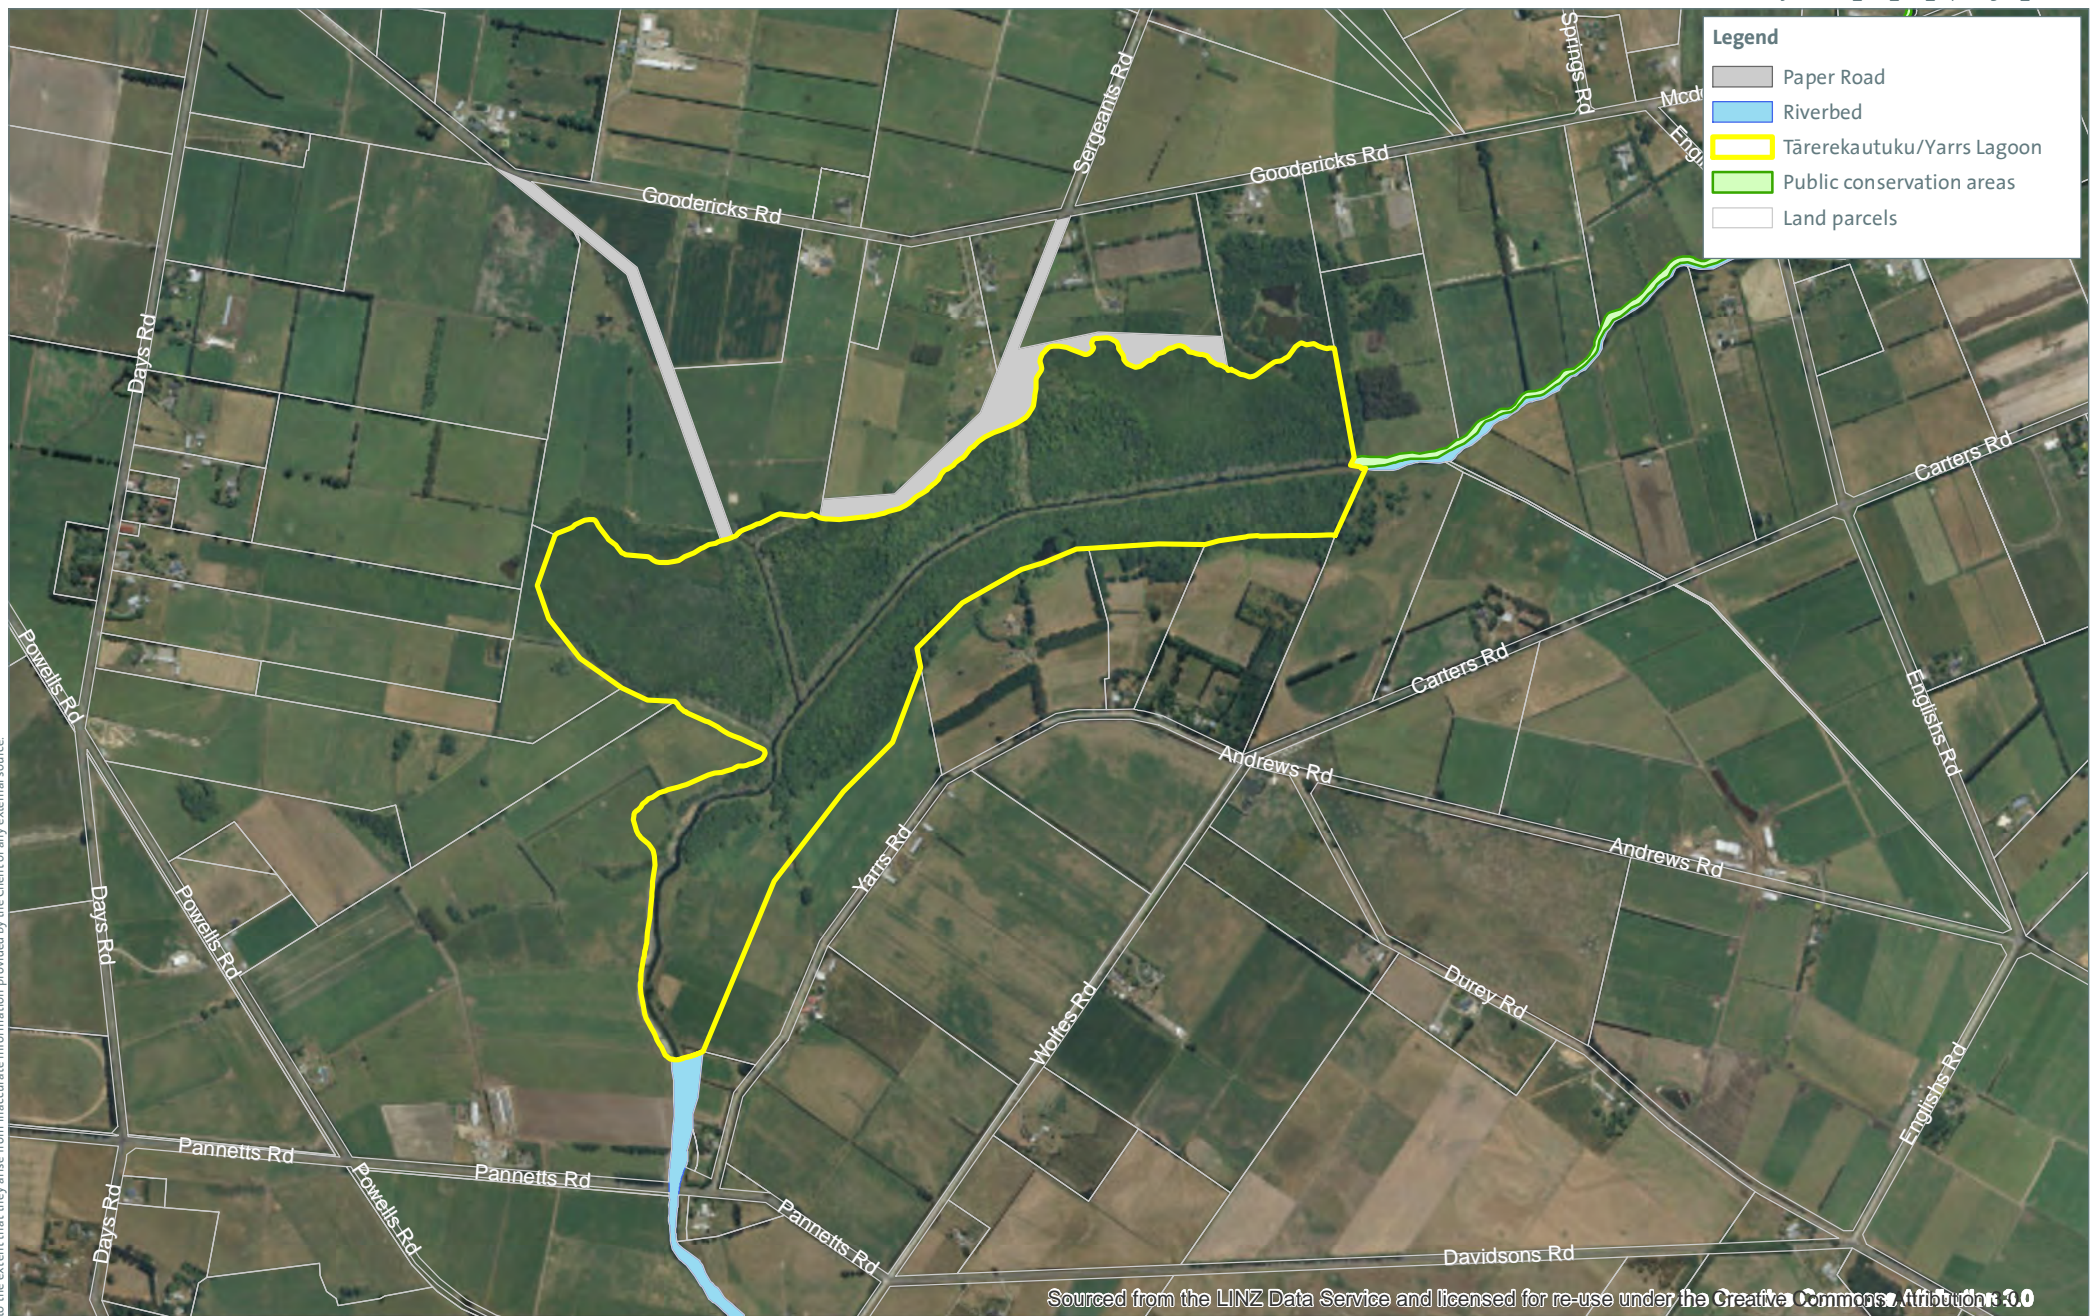
The legal boundaries of the Reserve appear to follow the former extent of the open water body of Tārerekautuku/Yarrs Lagoon. However, this legal boundary does not follow the boundary of the current extent of the wetland (Figure 3). There are areas where parts of the Reserve are cultivated pasture, that are farmed by adjoining landowners, while in other places parts of the wetland are outside the Reserve boundary. Rationalisation of the reserve boundary could be considered. This could potentially involve land swaps or land purchase.

At the southern end of the Reserve, approximately 9.1 ha of land within the Reserve boundary is cultivated and farmed by the adjoining landowners (Figure 3). From aerial images (Canterbury Maps) it appears that the largest area of cultivated pasture within the Reserve boundary (on the true left side of the Ararira/LII) was once wetland that was progressively drained and converted to pasture between 1960-64 and 1975-1979.

Tārerekautuku/Yarrs Lagoon Reserve is predominantly surrounded by privately owned land (Figure 3). There are 14 different private properties that border the Reserve³ (comprised of 16 different land parcels). There are another five land parcels in public ownership including two unformed paper roads, the LII River Conservation Area and two areas of riverbed along the Ararira/LII River (up- and downstream of the Reserve).

Tārerekautuku/Yarrs Lagoon Reserve is largely bounded by private land. Access across private land into the Reserve requires landowner permission. There are, however, four potential access points through public land into the Reserve (refer to Figure 3):

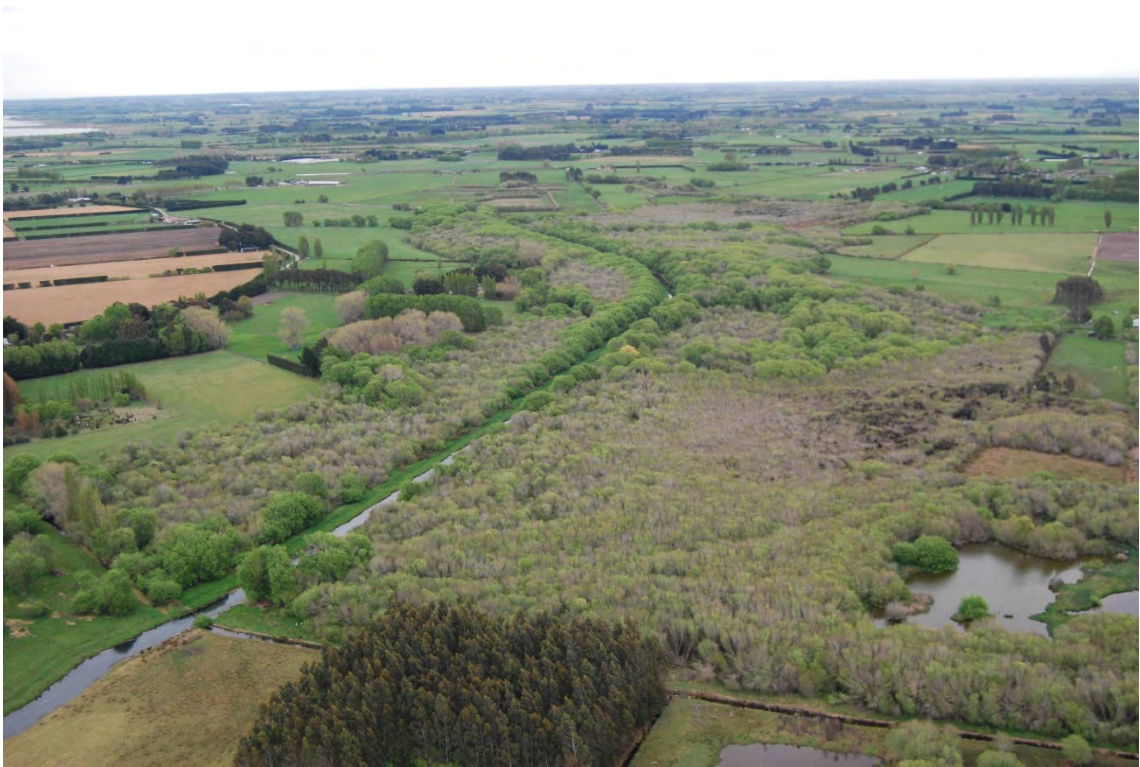
Figure 6: The extensive cover of grey and crack willow within Tārerekautuku/Yarrs Lagoon Reserve

Tārerekautuku/Yarrs Lagoon Reserve supports a range of vegetation types, which have been mapped by Parker and Grove (2013) (Figure 5). Despite the extensive cover of exotic crack and grey willow trees that dominate the canopy (Figure 6), the understory still supports a diverse range of indigenous plants, including a relatively diverse number of indigenous fern species. The vegetation types are described below (adapted from Parker and Grove (2013)). A full list of the species recorded within the Reserve, including additional species recorded by Jason Butt (J. Butt, unpubl. data), and species recorded by Parker and Grove (2013) is provided in Table A1.2 (Appendix 1).

Willows are the most abundant plant pest in the Reserve and they are the dominant canopy cover. Both crack willow and grey willow are present. Crack willows are largely distributed along the margins of the Ararira/LII River and the drains within the Reserve. Grey willow forest covers a larger area of the Reserve and is currently invading the few remaining areas of mānuka scrub and indigenous rushland within the Reserve.

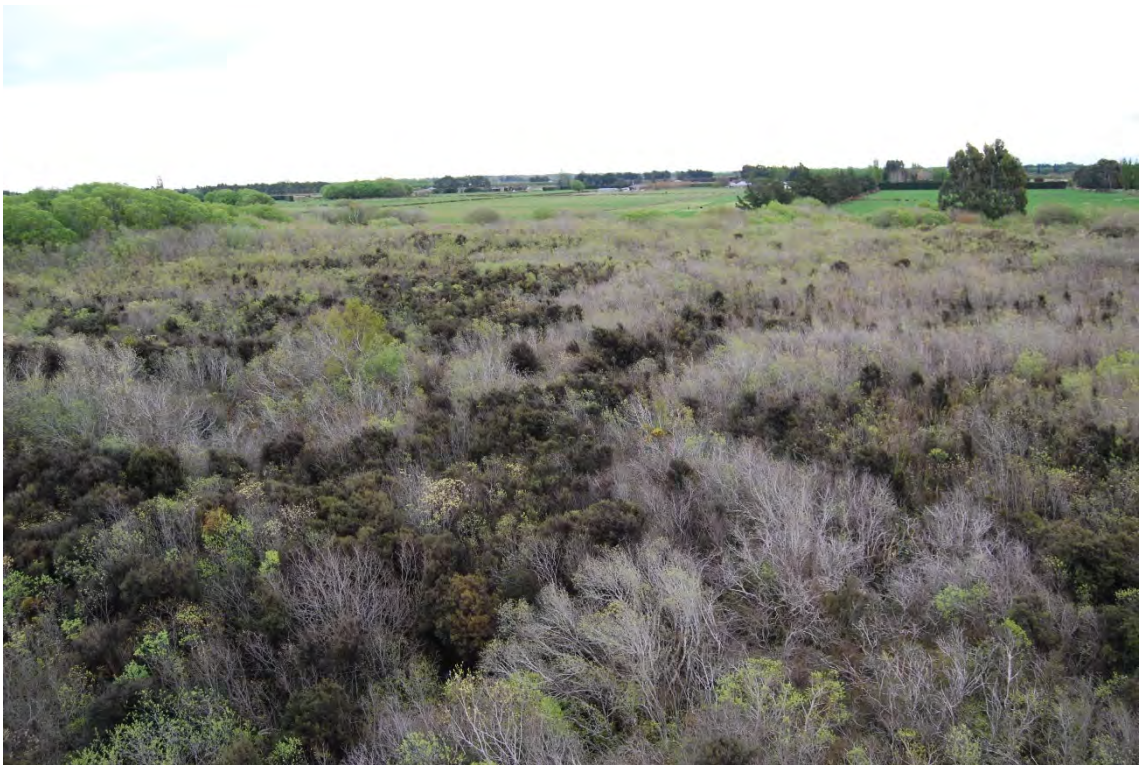
Figure 7: The eastern mānuka stand. The mānuka is the darker coloured vegetation. Source: Robin Smith.

- Swamp buttercup, which is classified as Data deficient (de Lange et al. 2012).
- Mānuka, which is present in two main sites within the Reserve, with many seedlings spreading into surrounding areas. Tārerekautuku/Yarrs Lagoon supports one of the largest remaining populations of mānuka on the Canterbury Plains (Parker and Grove 2013).

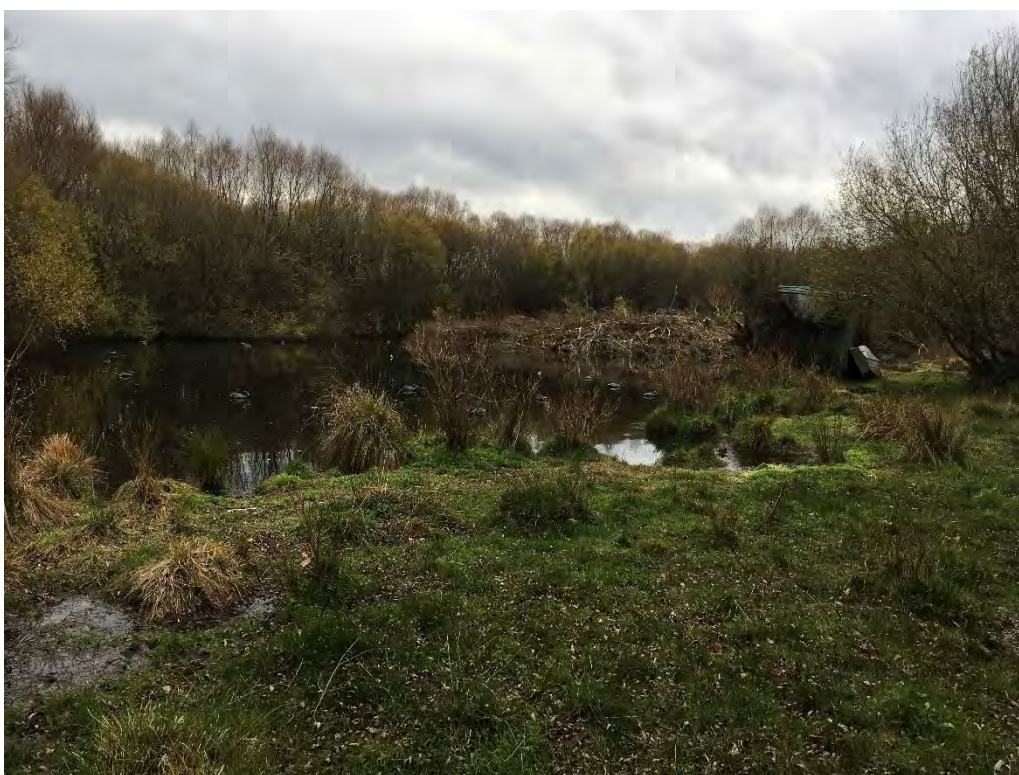
Figure 10: *The man-made pond within the Reserve on the true left of the Ararira/Lil River*

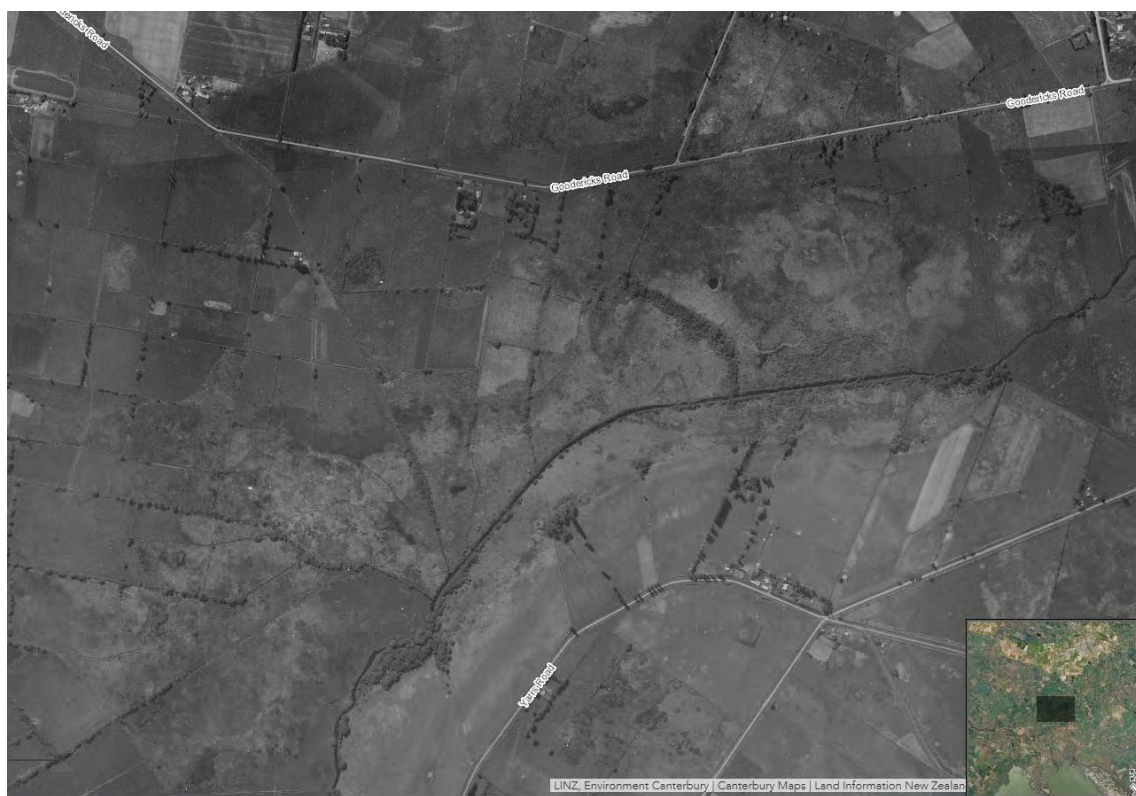
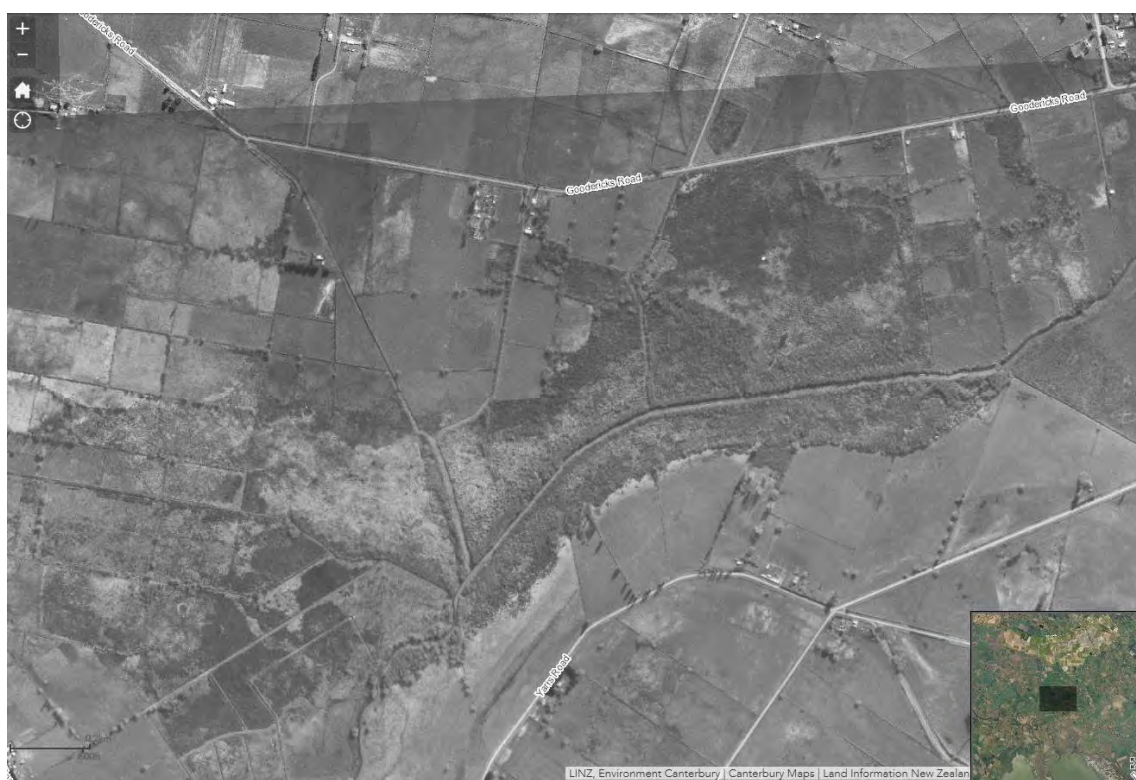
Figure A3.1 and A3.2: Aerial imagery of Tārerēkautuku/Yarrs Lagoon during 1940-1944 (top) and from 1960-1964 (bottom). Imagery sourced from Canterbury Maps.

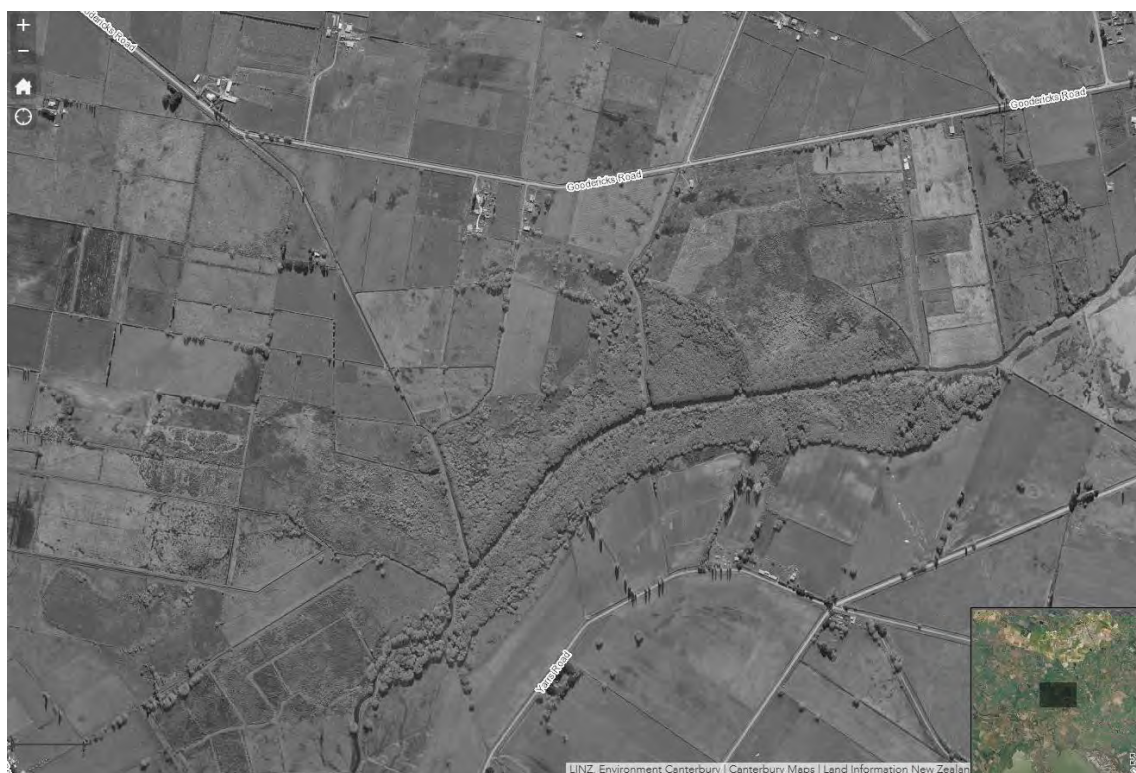
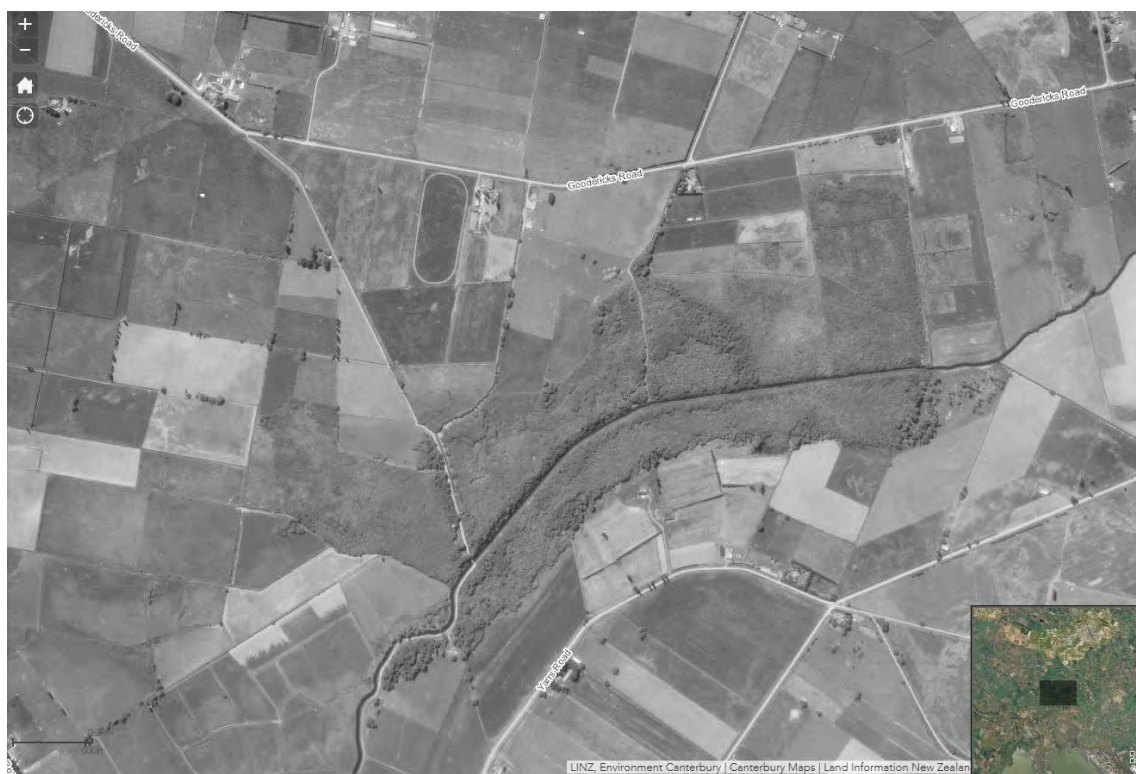
Figure A3.3 and A3.4: Aerial imagery of Tārekautuku/Yarrs Lagoon during 1970-1974 (top) and from 1980-1984 (bottom). Imagery sourced from Canterbury Maps.

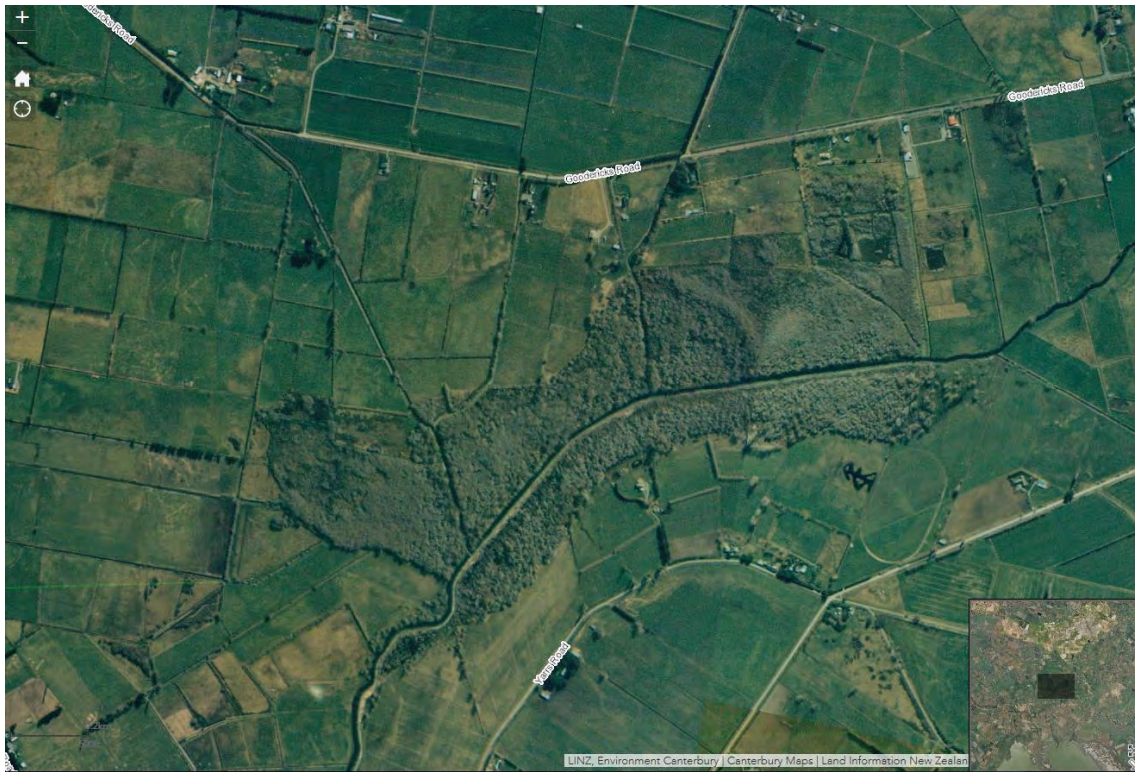
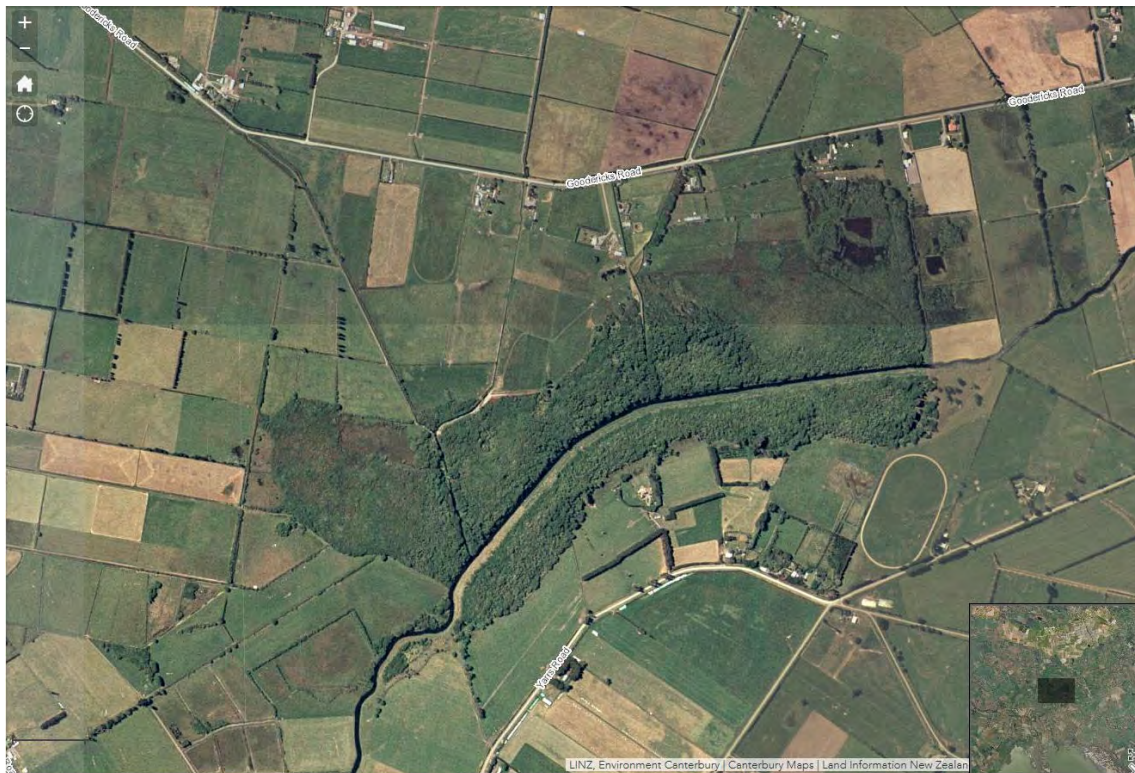
Figure A3.5 and A3.6: Aerial imagery of Tārekautuku/Yarrs Lagoon during 1990-1994 (top) and from 2000-2004 (bottom). Imagery sourced from Canterbury Maps.
