Request for a Change to the  
Selwyn District Plan

Hughes Development Limited  
163 Halkett Road and 1066 West Coast Road •  
West Melton

November 2020

# Request To Change the Selwyn District Plan under Clause 21 of the First Schedule of the Resource Management Act 1991

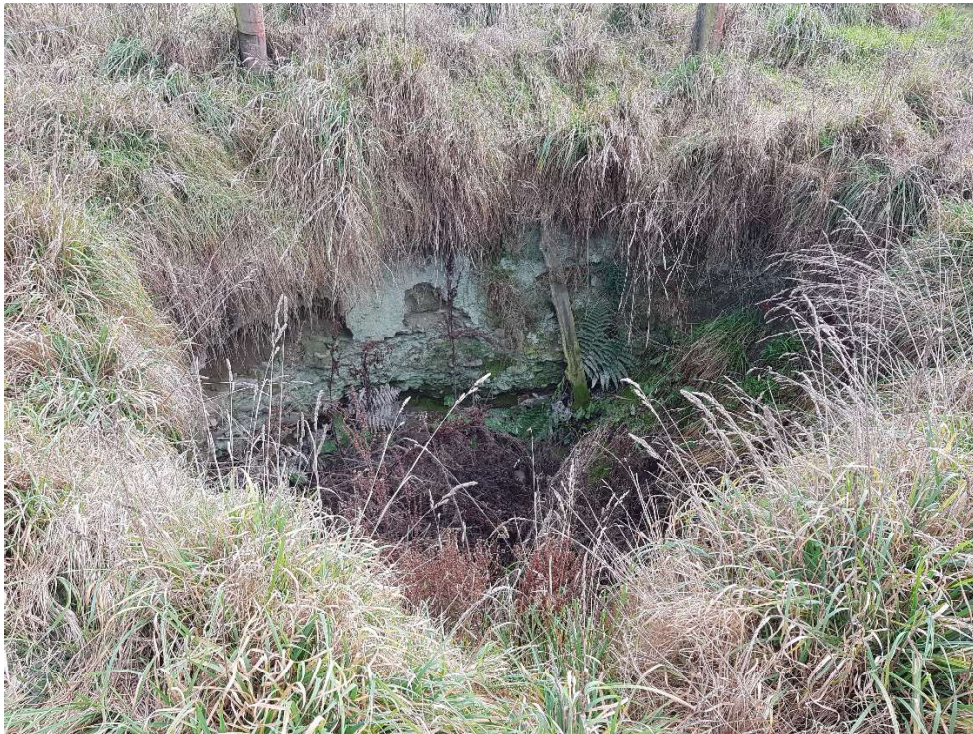
**Figure 3: Drainage Excavation**

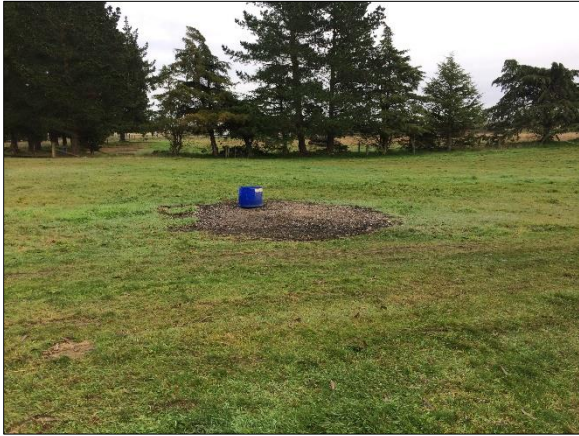
Photo 7: Burn Pit in northern paddock

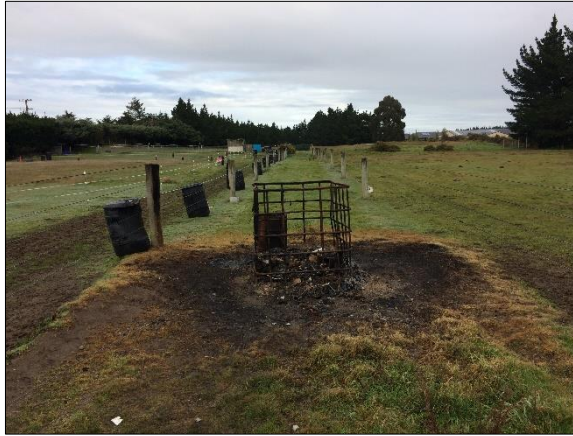
Photo 8: Burn pit next to trotting track

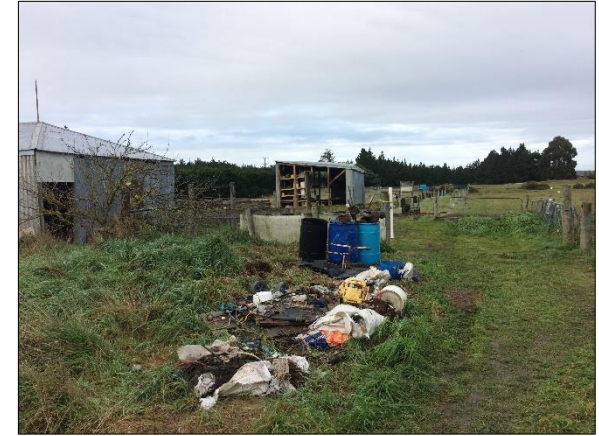
Photo 9: Household rubbish, burn pit, and materials storage shed

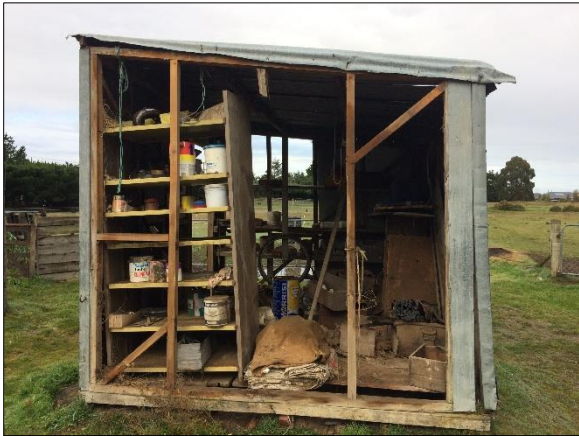
Photo 10: Materials storage shed

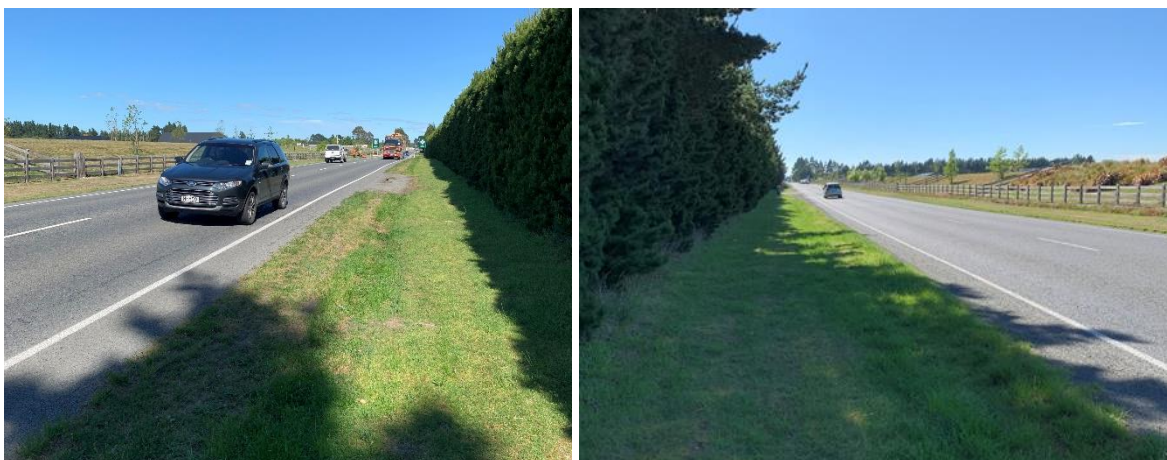
Photograph 1: SH73 Looking West (Left) & East (Right)

Photographs 1 and 2 below illustrate the sight distance and cross section elements of SH73 and Halkett Road.
