# **SH1 Rolleston Access Improvement**

Geotechnical Interpretive Report

Prepared for New Zealand Transport Agency Waka Kotahi (NZTA) Prepared by Beca Limited

7 October 2024

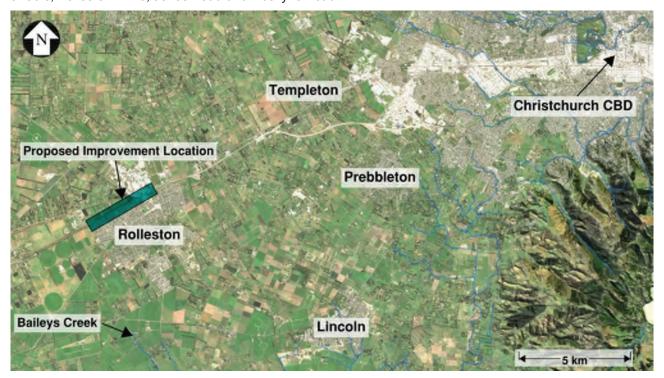
Figure 1: Site Location (Image sourced from Canterbury Maps, 2024)

Figure 1 shows the extent of the proposed improvements (highlighted blue) in relation to the wider Canterbury area. Preliminary drawings are included in Appendix A showing the works along SH1 between the proposed roundabout to the west of Rolleston and overpass to the north, as well as work on the adjoining streets; Rolleston Drive, Jones Road and Hoskyns Road.

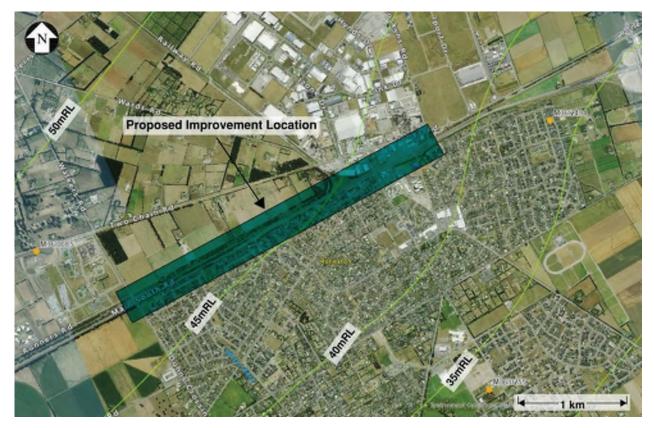
Figure 3: Groundwater Piezometric Contours (RL in terms of metres above sea level)

The subsurface conditions of the site can be described as undifferentiated gravel with no confining layers or artesian aquifers, and the hydraulic gradient slopes downward. The groundwater elevation contours for the site, sourced from Canterbury Maps (2024), are shown in Figure 3.

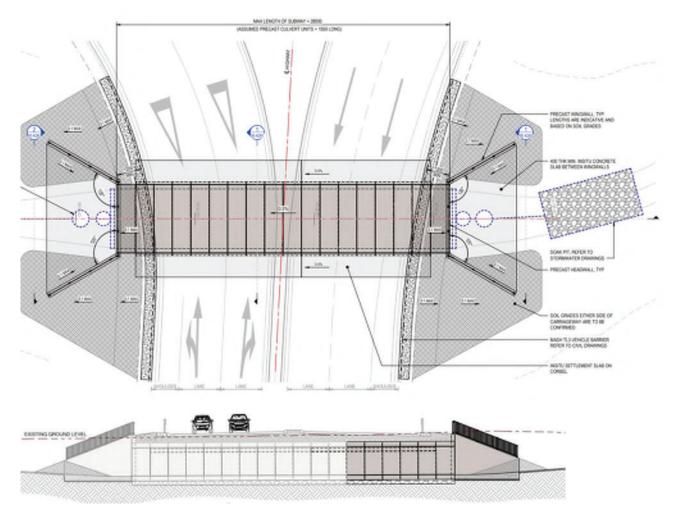
Figure 4: Subway Plan and Long Section

The chosen structure is a box culvert comprising precast concrete sections that can be segmentally constructed. Around the structure and adjacent to the approach ramps, cut slopes have adopted a batter angle of 1V:3H to accommodate planting / vegetation. If required slopes could be steepened but would need to be assessed during detailed design.

A concept sketch of the proposed subway is shown in Figure 4.

The box culvert will effectively replace the existing soil and is fully encased by the surrounding soils and proposed to be founded on 300 mm well compacted GAP65 structural fill overlying the dense to very dense gravels. As such, bearing capacity shear failure of the soils beneath the box culvert is not expected. A preliminary assessment of settlement has been carried out using the RocScience software Settle3 (version 5.023) to estimate the total settlement for static loading conditions and as a basis for estimating the modulus of subgrade reaction (soil springs).

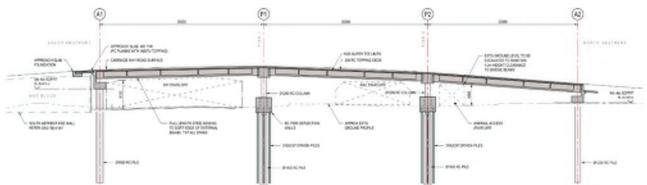
Figure 5: Overpass Long Section

The chosen foundation solution comprises 1500 mm diameter bored reinforced concrete piles at the piers and southern abutment, and a 1200 mm diameter bored reinforced concrete pile at the northern abutment to meet the structural demands. A concept sketch of the proposed long section for the site is shown in Figure 5.

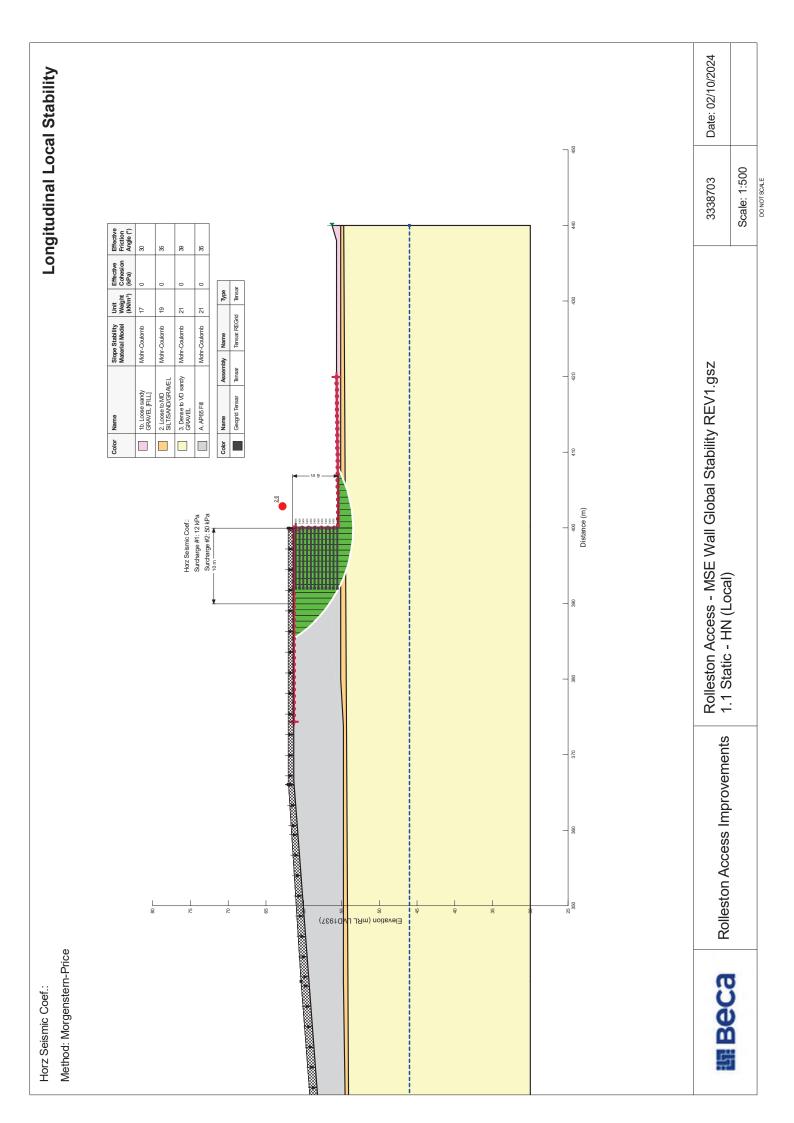
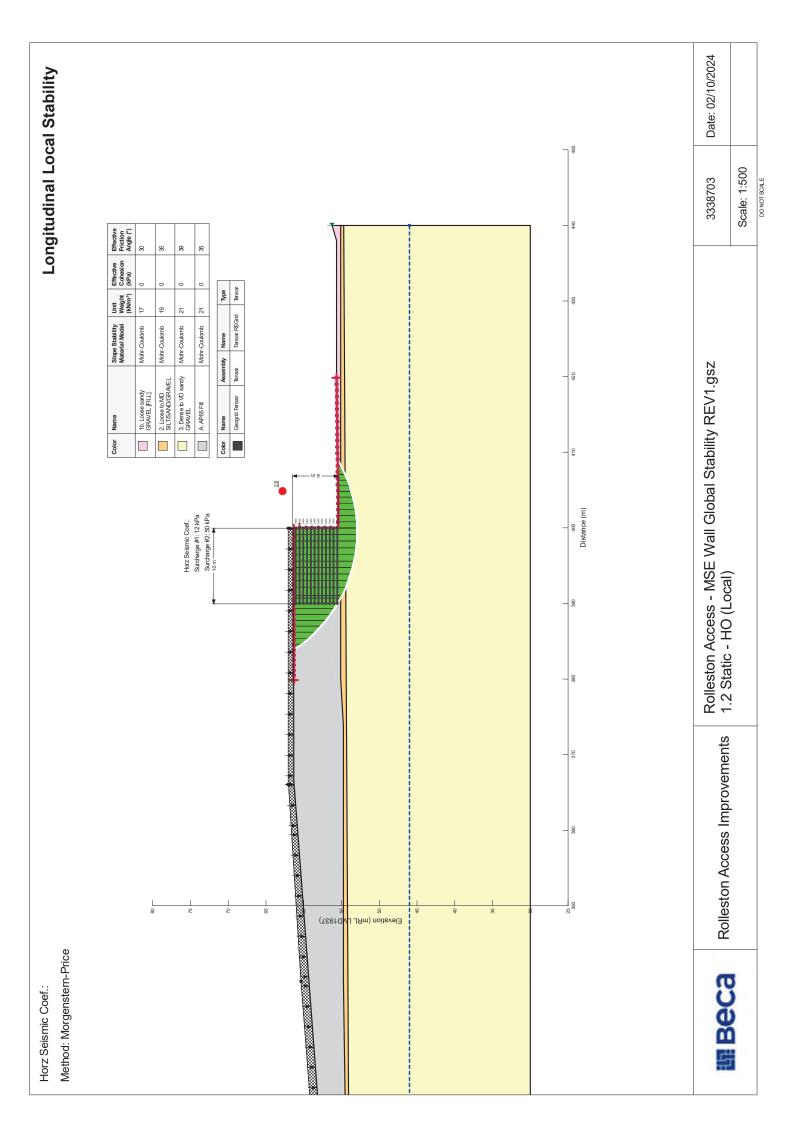
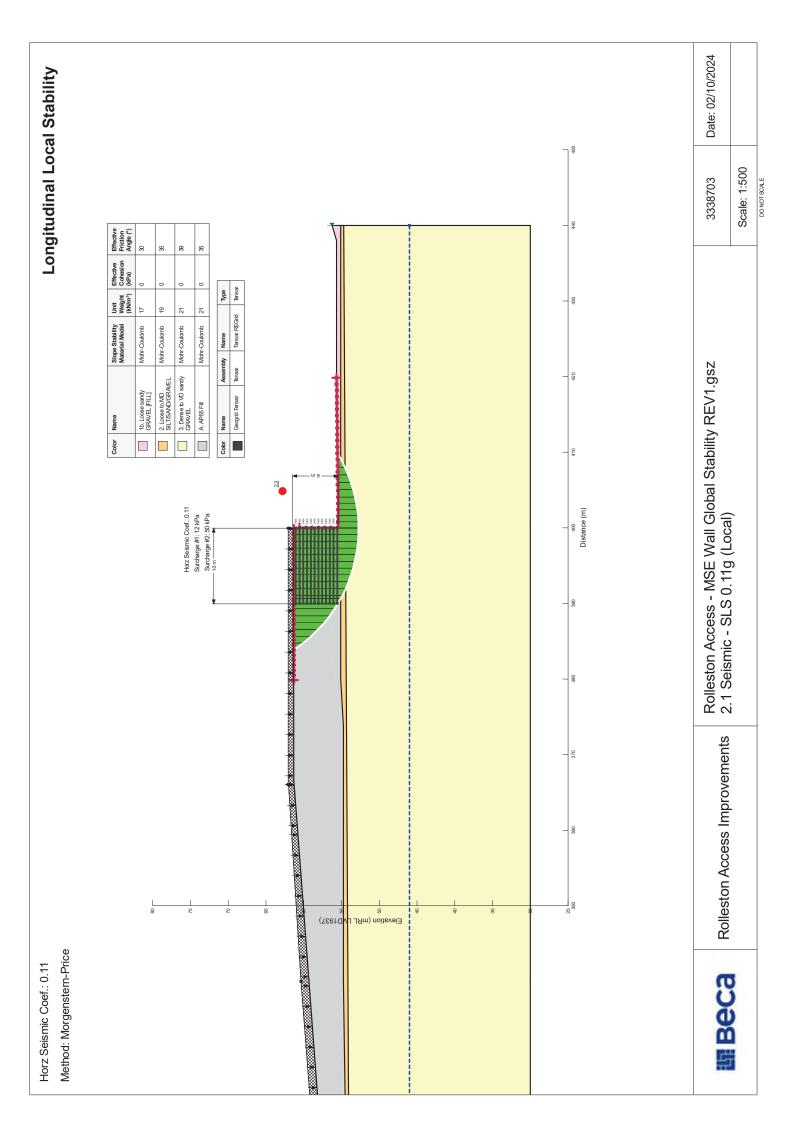
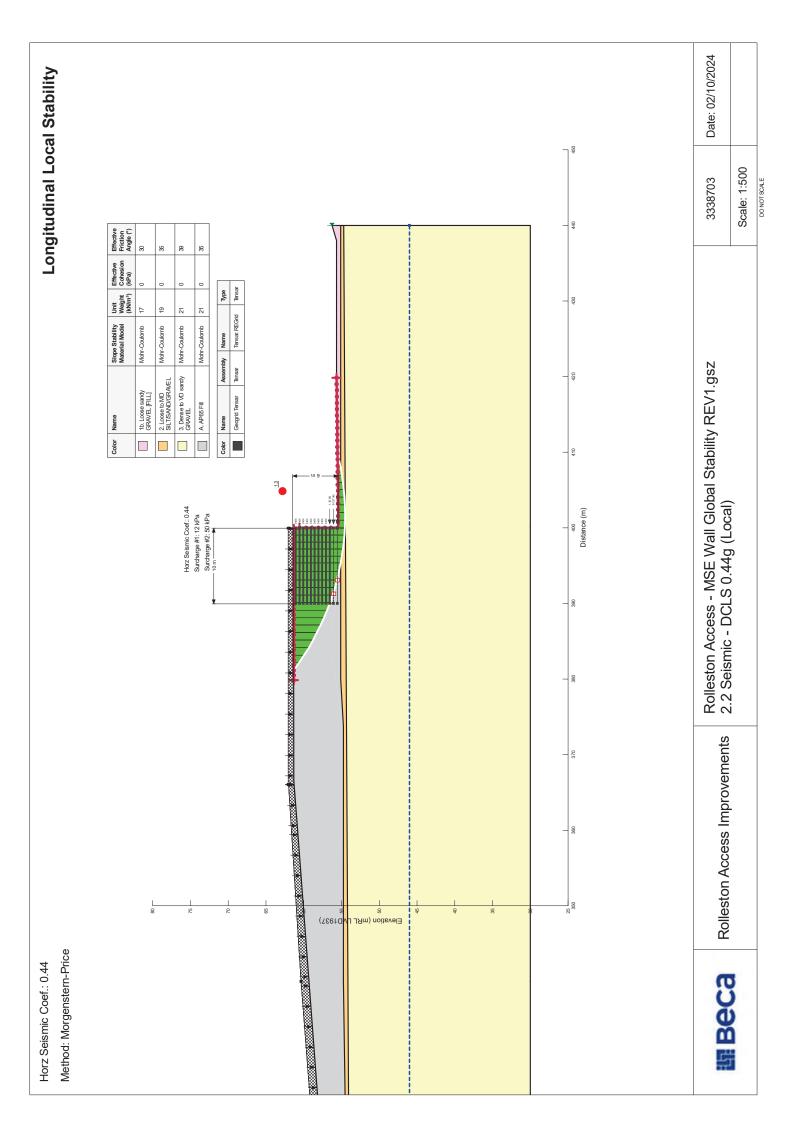
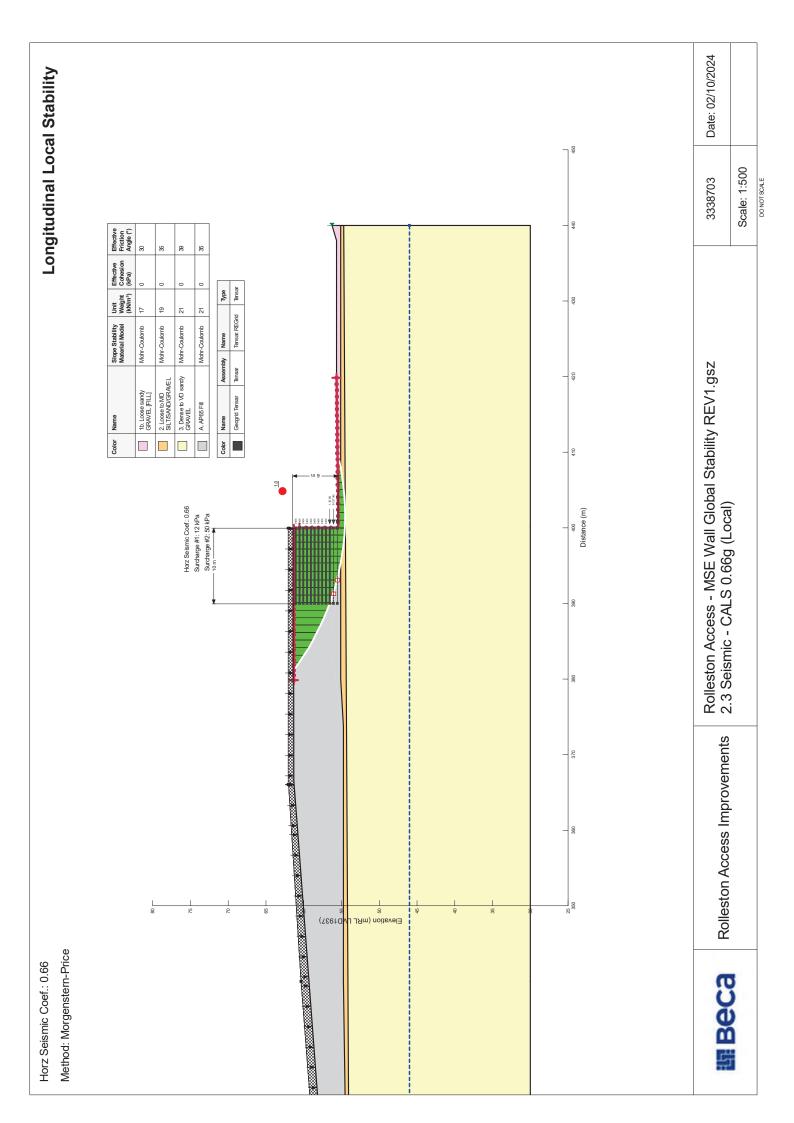
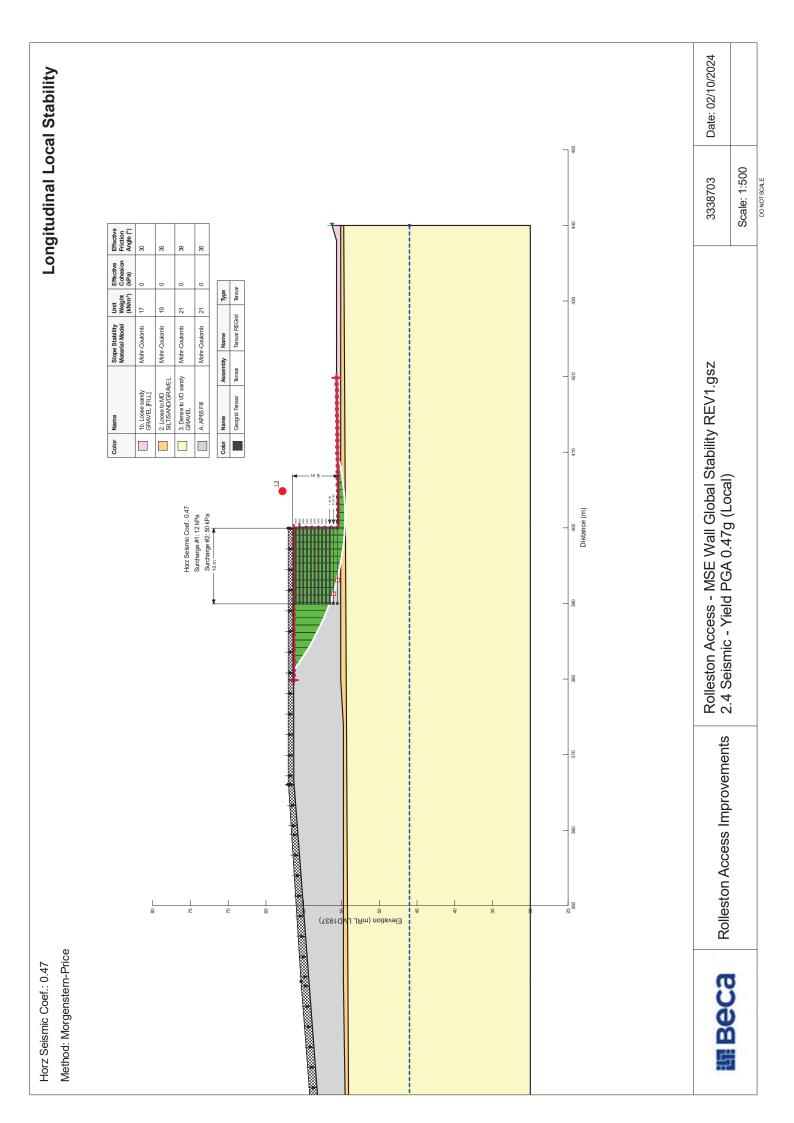
Date: 02/10/2024 **Longitudinal Global Stability** Scale: 1:500 3338703 Effective Friction Angle (°) 35 32 36 Slope Stability Unit Material Model Weight (kN/m³) Assembly Name 3. Dense to VD sandy GRAVEL A. AP65 FII 2. Loose to MD SILT/SAND/GRAVEL 1b. Loose sandy GRAVEL[FILL] Color Name
Geogrid Tensar Rolleston Access - MSE Wall Global Stability REV1.gsz 2.3 Seismic - CALS 0.66g (8m length) Name Distance (m) Horz Seismic Coef.: 0.66 400 Rolleston Access Improvements (7891a Elevation (mRL L Method: Morgenstern-Price 調 Beca Horz Seismic Coef.: 0.66

Date: 02/10/2024 **Longitudinal Global Stability** Scale: 1:500 3338703 Effective Friction Angle (°) 35 36 Slope Stability Unit Material Model Weight (kN/m³) Assembly Name 3. Dense to VD sandy GRAVEL A. AP65 FII 2. Loose to MD SILT/SAND/GRAVEL 1b. Loose sandy GRAVEL[FILL] Color Name
Geogrid Tensar Rolleston Access - MSE Wall Global Stability REV1.gsz 2.4 Seismic - Yield PGA 0.43g (8m length) Name Distance (m) Horz Seismic Coef.: 0.46 400 Rolleston Access Improvements (7891a Elevation (mRL L Method: Morgenstern-Price 調 Beca Horz Seismic Coef.: 0.46
