13 November 2024

ROLLESTON ACCESS IMPROVEMENTS (PACKAGE 1) – REVIEW OF CONTAMINATED LAND REPORTS

2.1 Stantec New Zealand (2023) – Rolleston Access Improvements Preliminary Site Investigation

2.1.2 Beca Limited (Beca) (2024) – Detailed Site Investigation (Contamination) (Package 1): Rolleston Access Improvements (Package 1)

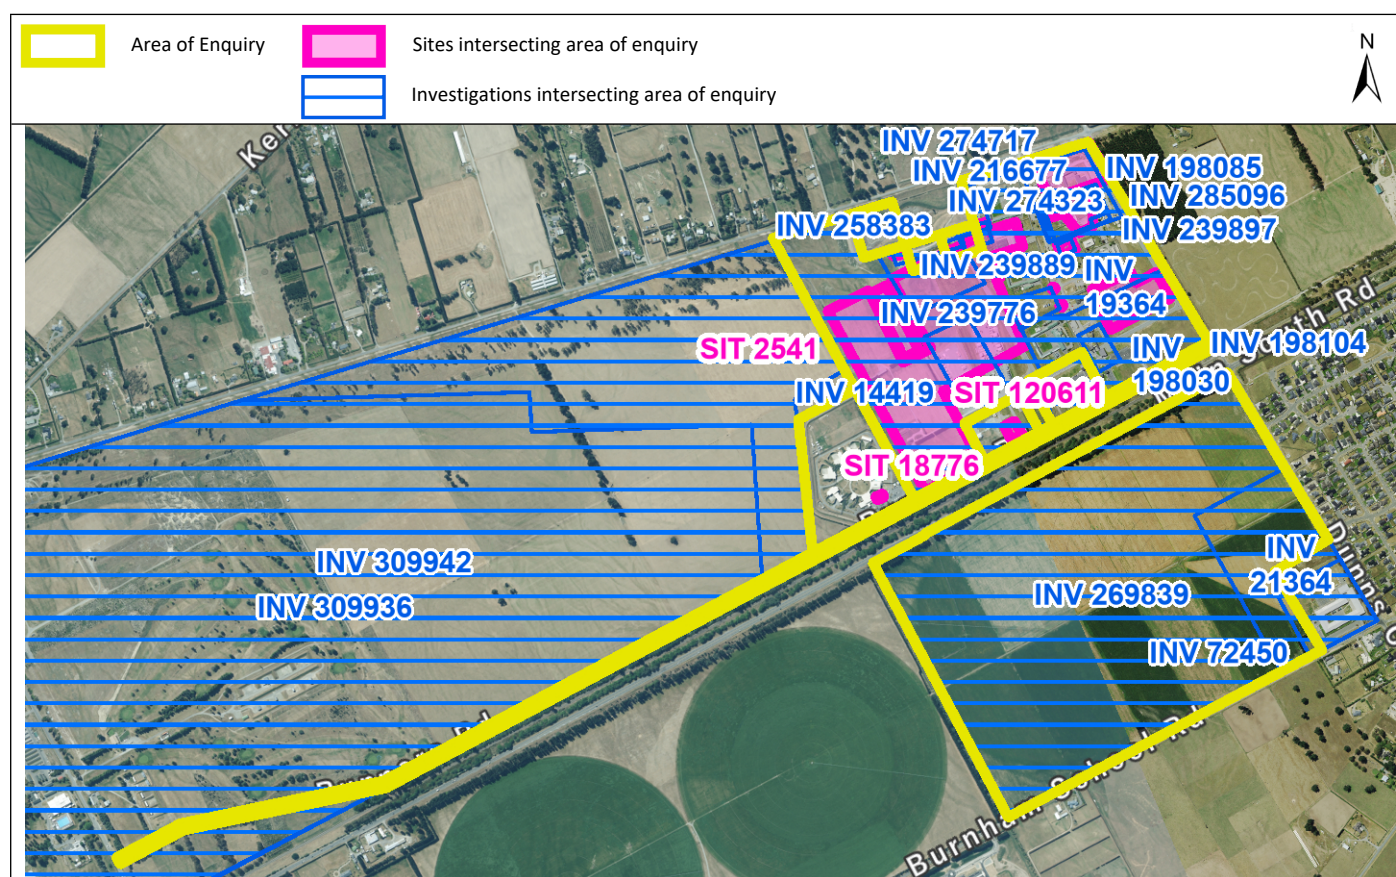
The information presented in this map is specific to the property you have selected. Information on nearby properties may not be shown on this map, even if the property is visible.
