# ***Soil Contamination Risk Preliminary Site Investigation Report***

## ***Kirwee Reserve Extension Tramway Road, Kirwee***

*January 2019*

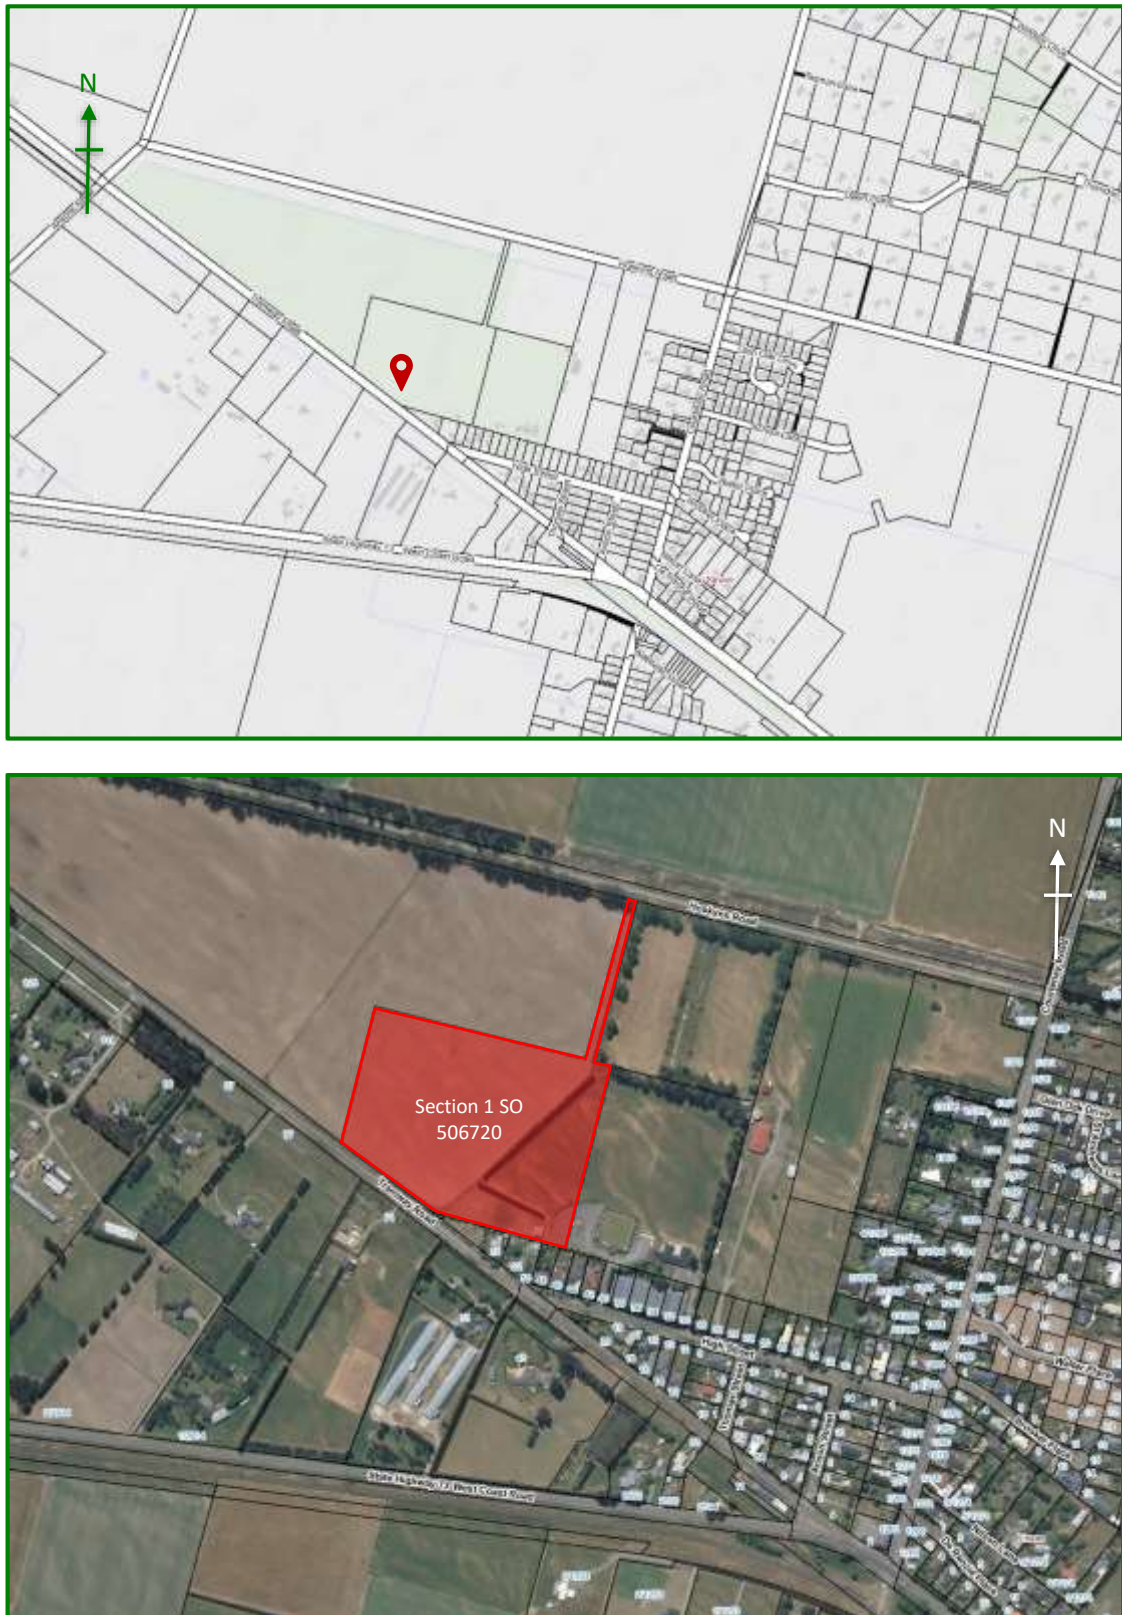
Figure 1 – Location Plan

The site is accessed from Tramway Road in Kirwee as shown on the plan in **Figure 1** below. The site is legally described as Section 1 SO 506720 and has a total area of approximately 6.5074 Ha.

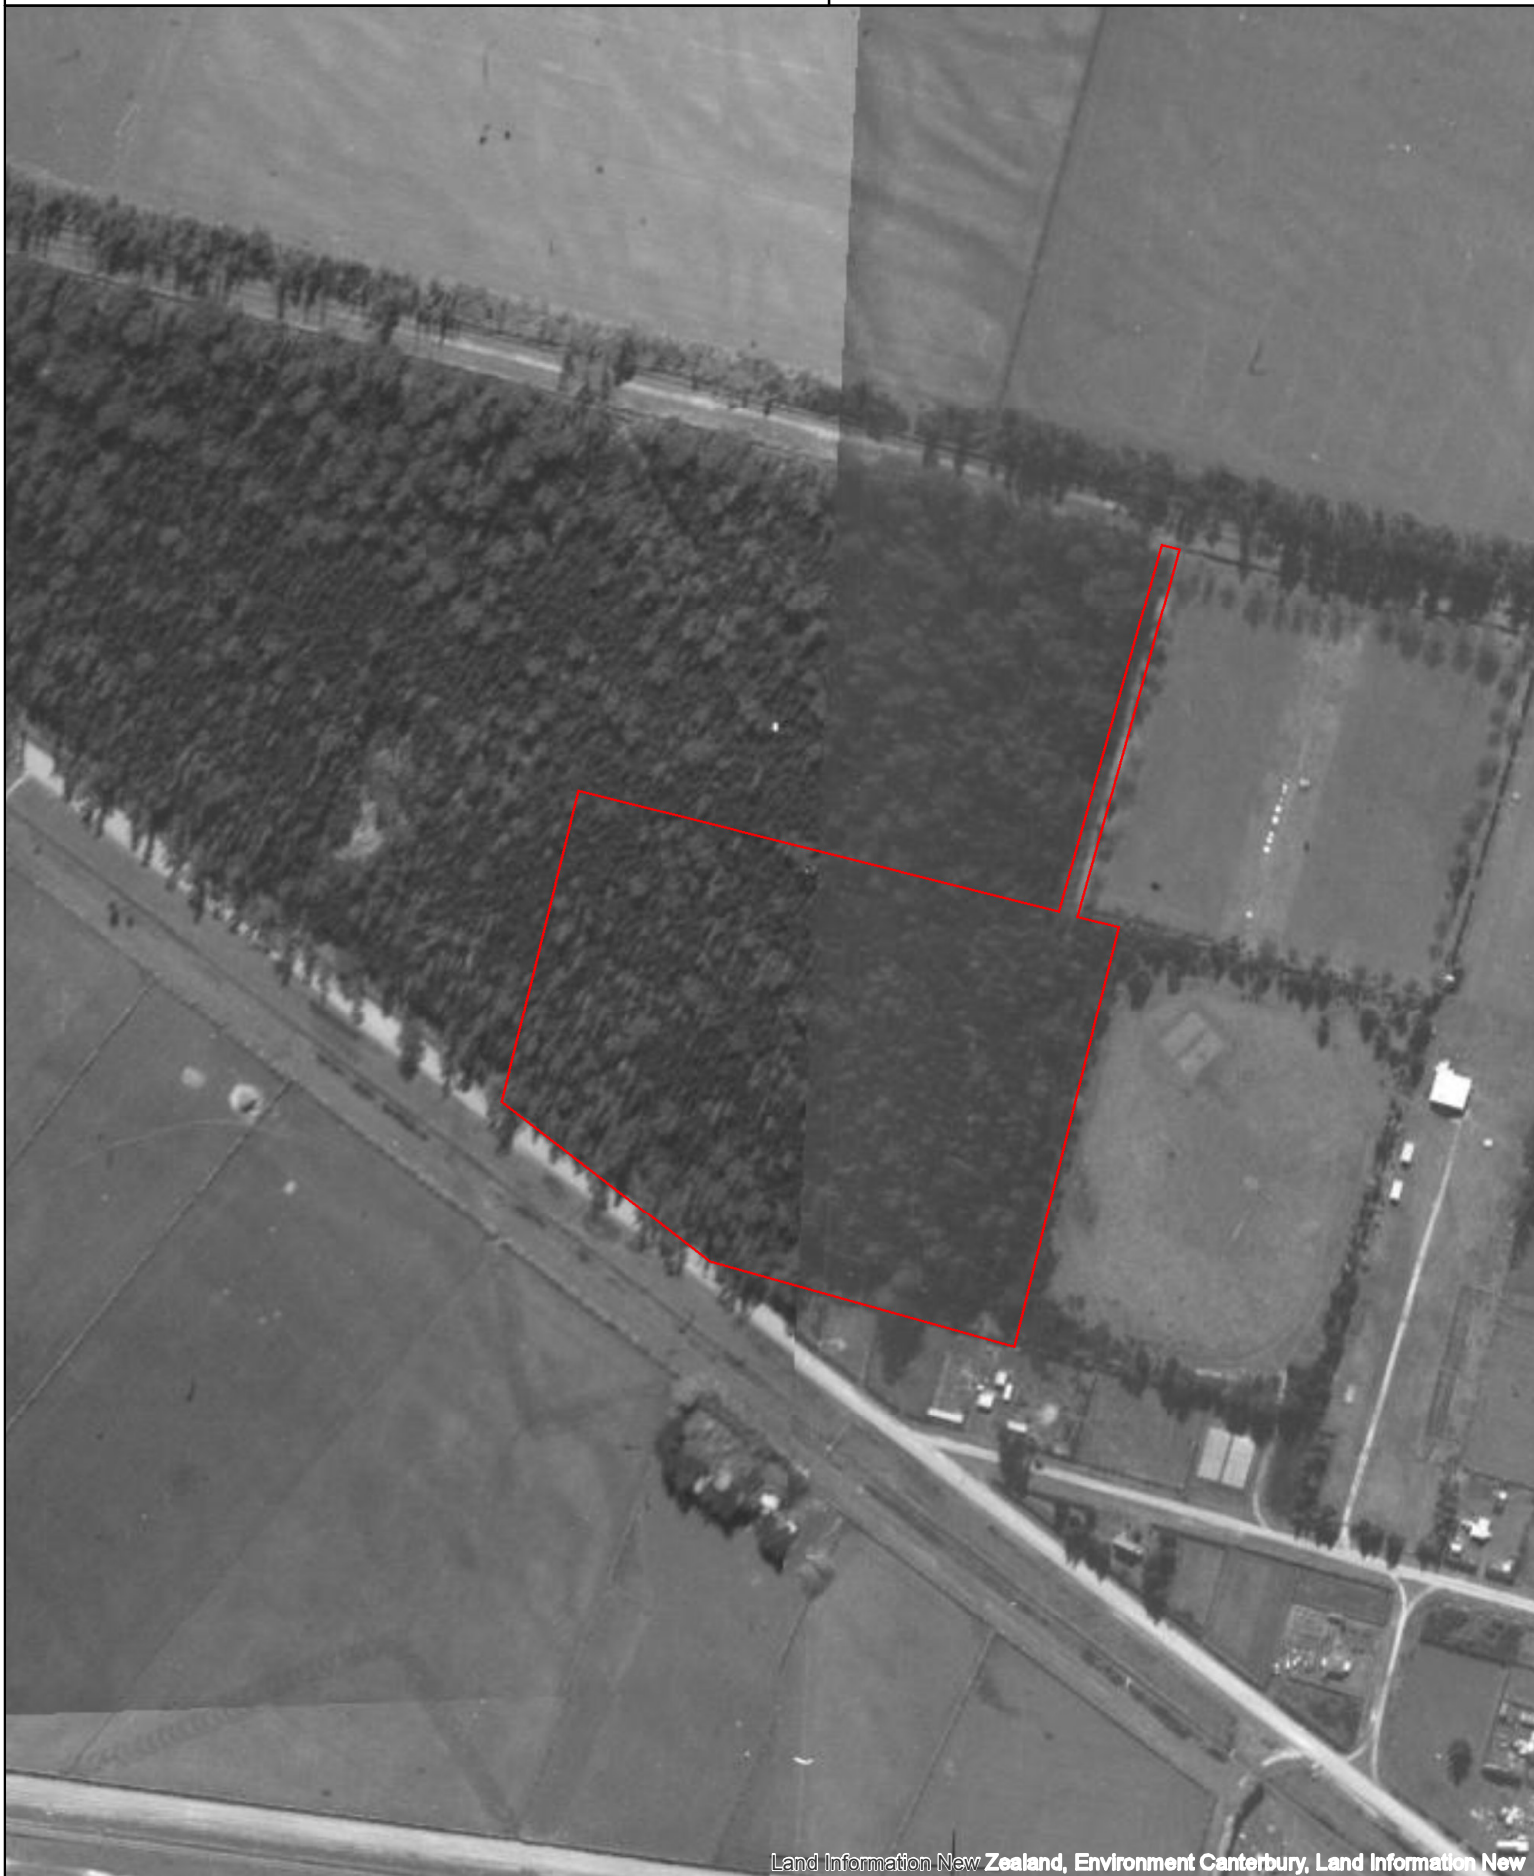
- The earliest photo is from **1941** and has been sourced from ECan's GIS. The subject site is part of a forestry block. Beyond the subject site to the north-east lies Kirwee Cemetery. Kirwee Showgrounds lies beyond the subject site to the east with animal pens and hall. There is a group of sheds to the south of the subject site.

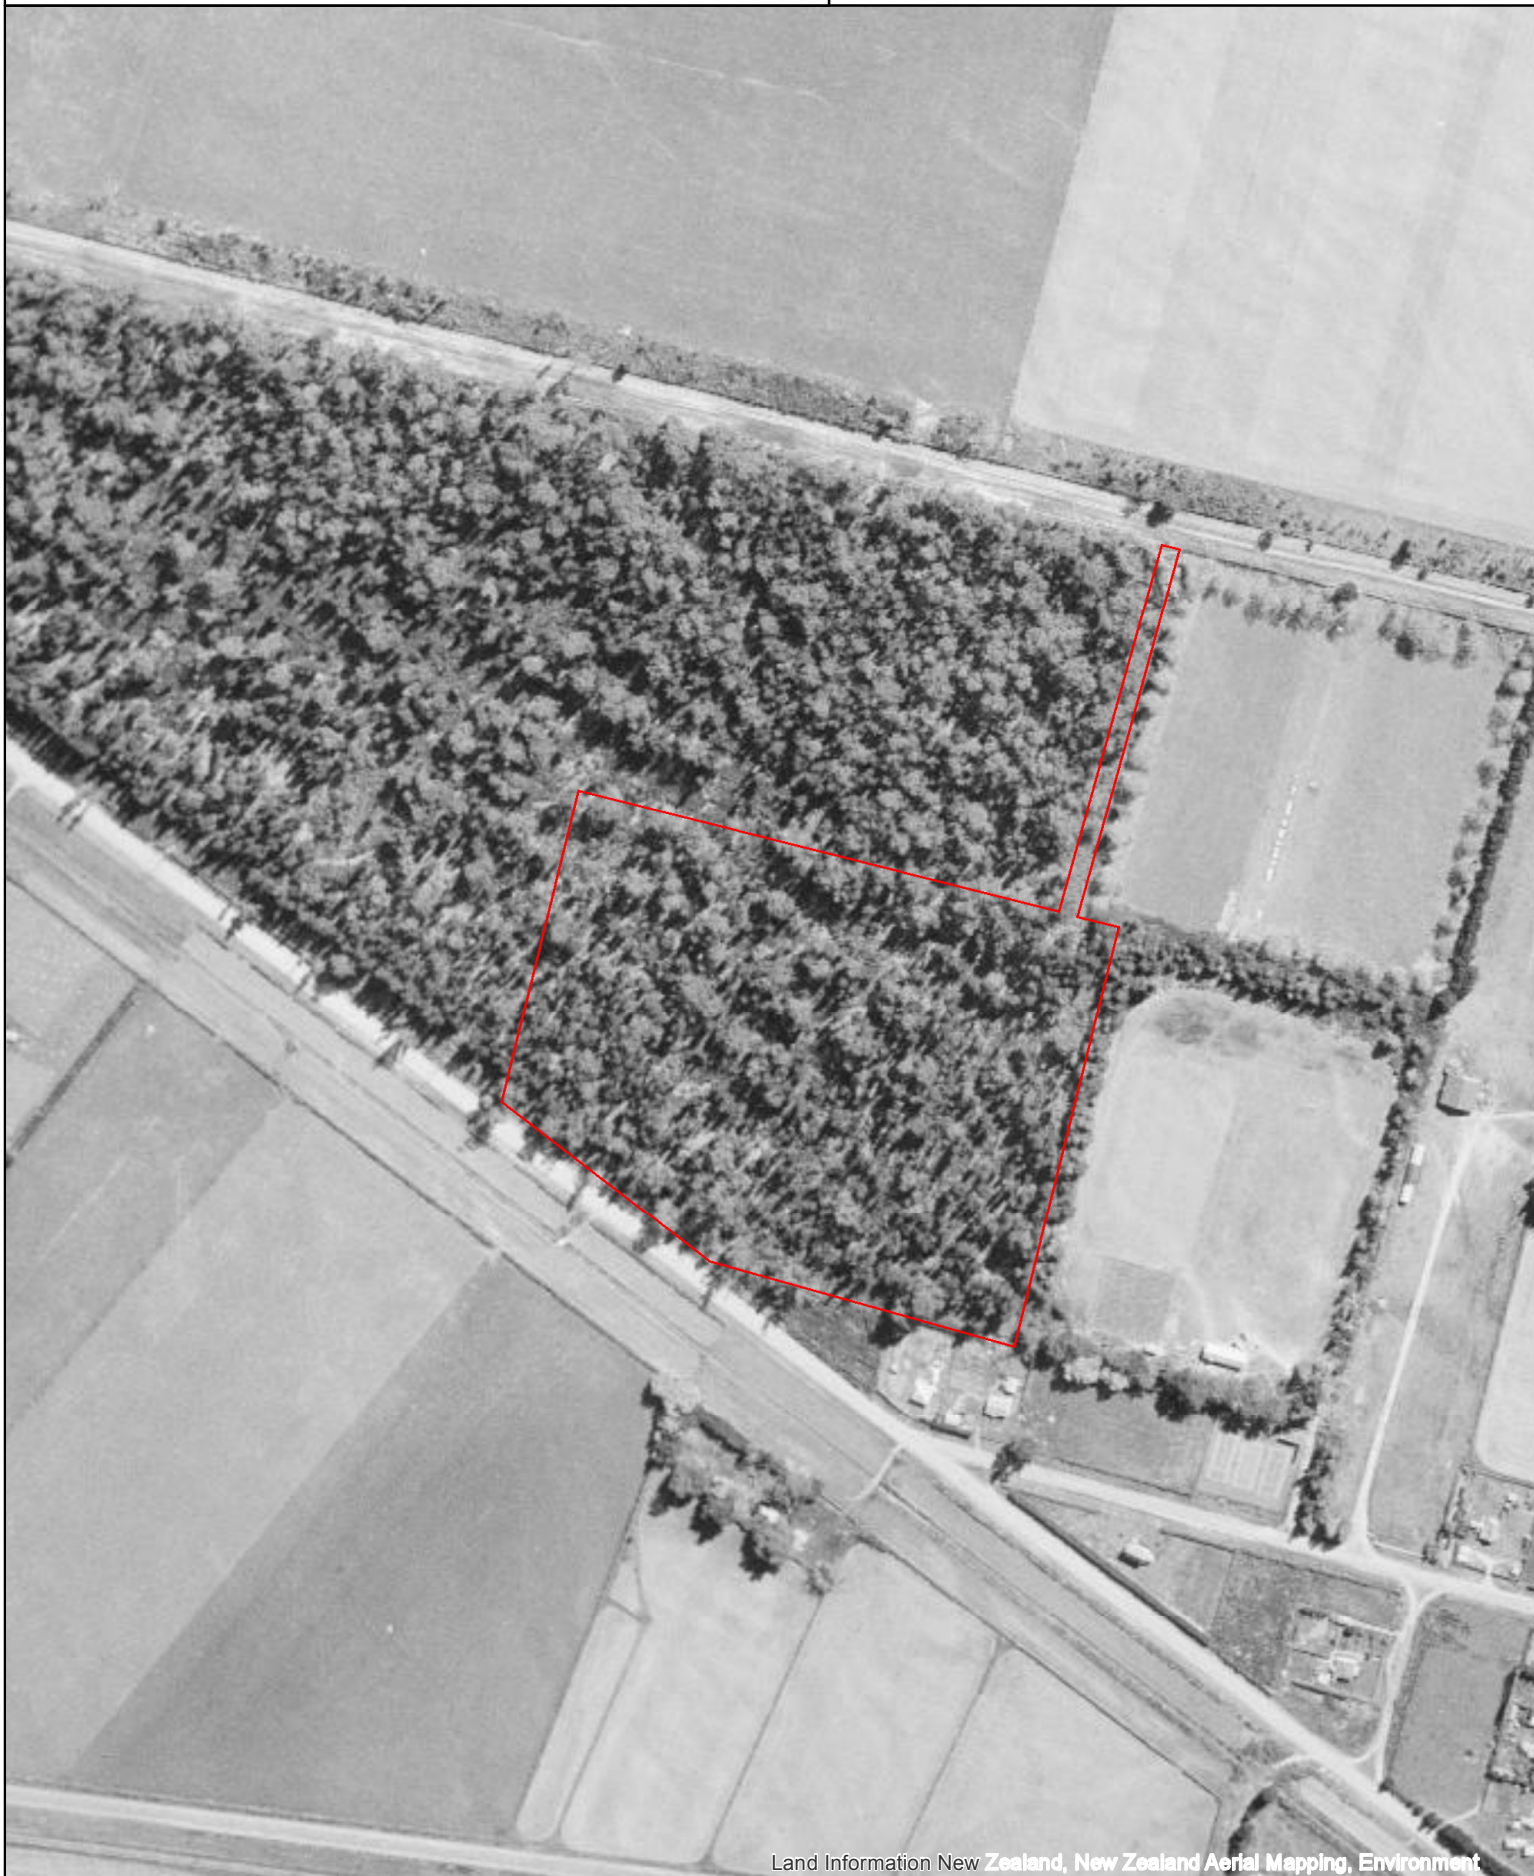
- A photo from **1955** is also sourced from ECan's GIS. There are no significant changes to the subject site. A building has been added on the adjacent land to the east. Two dwellings have been built to the south of the subject site. Tennis courts have been constructed beyond the subject site to the south-east.

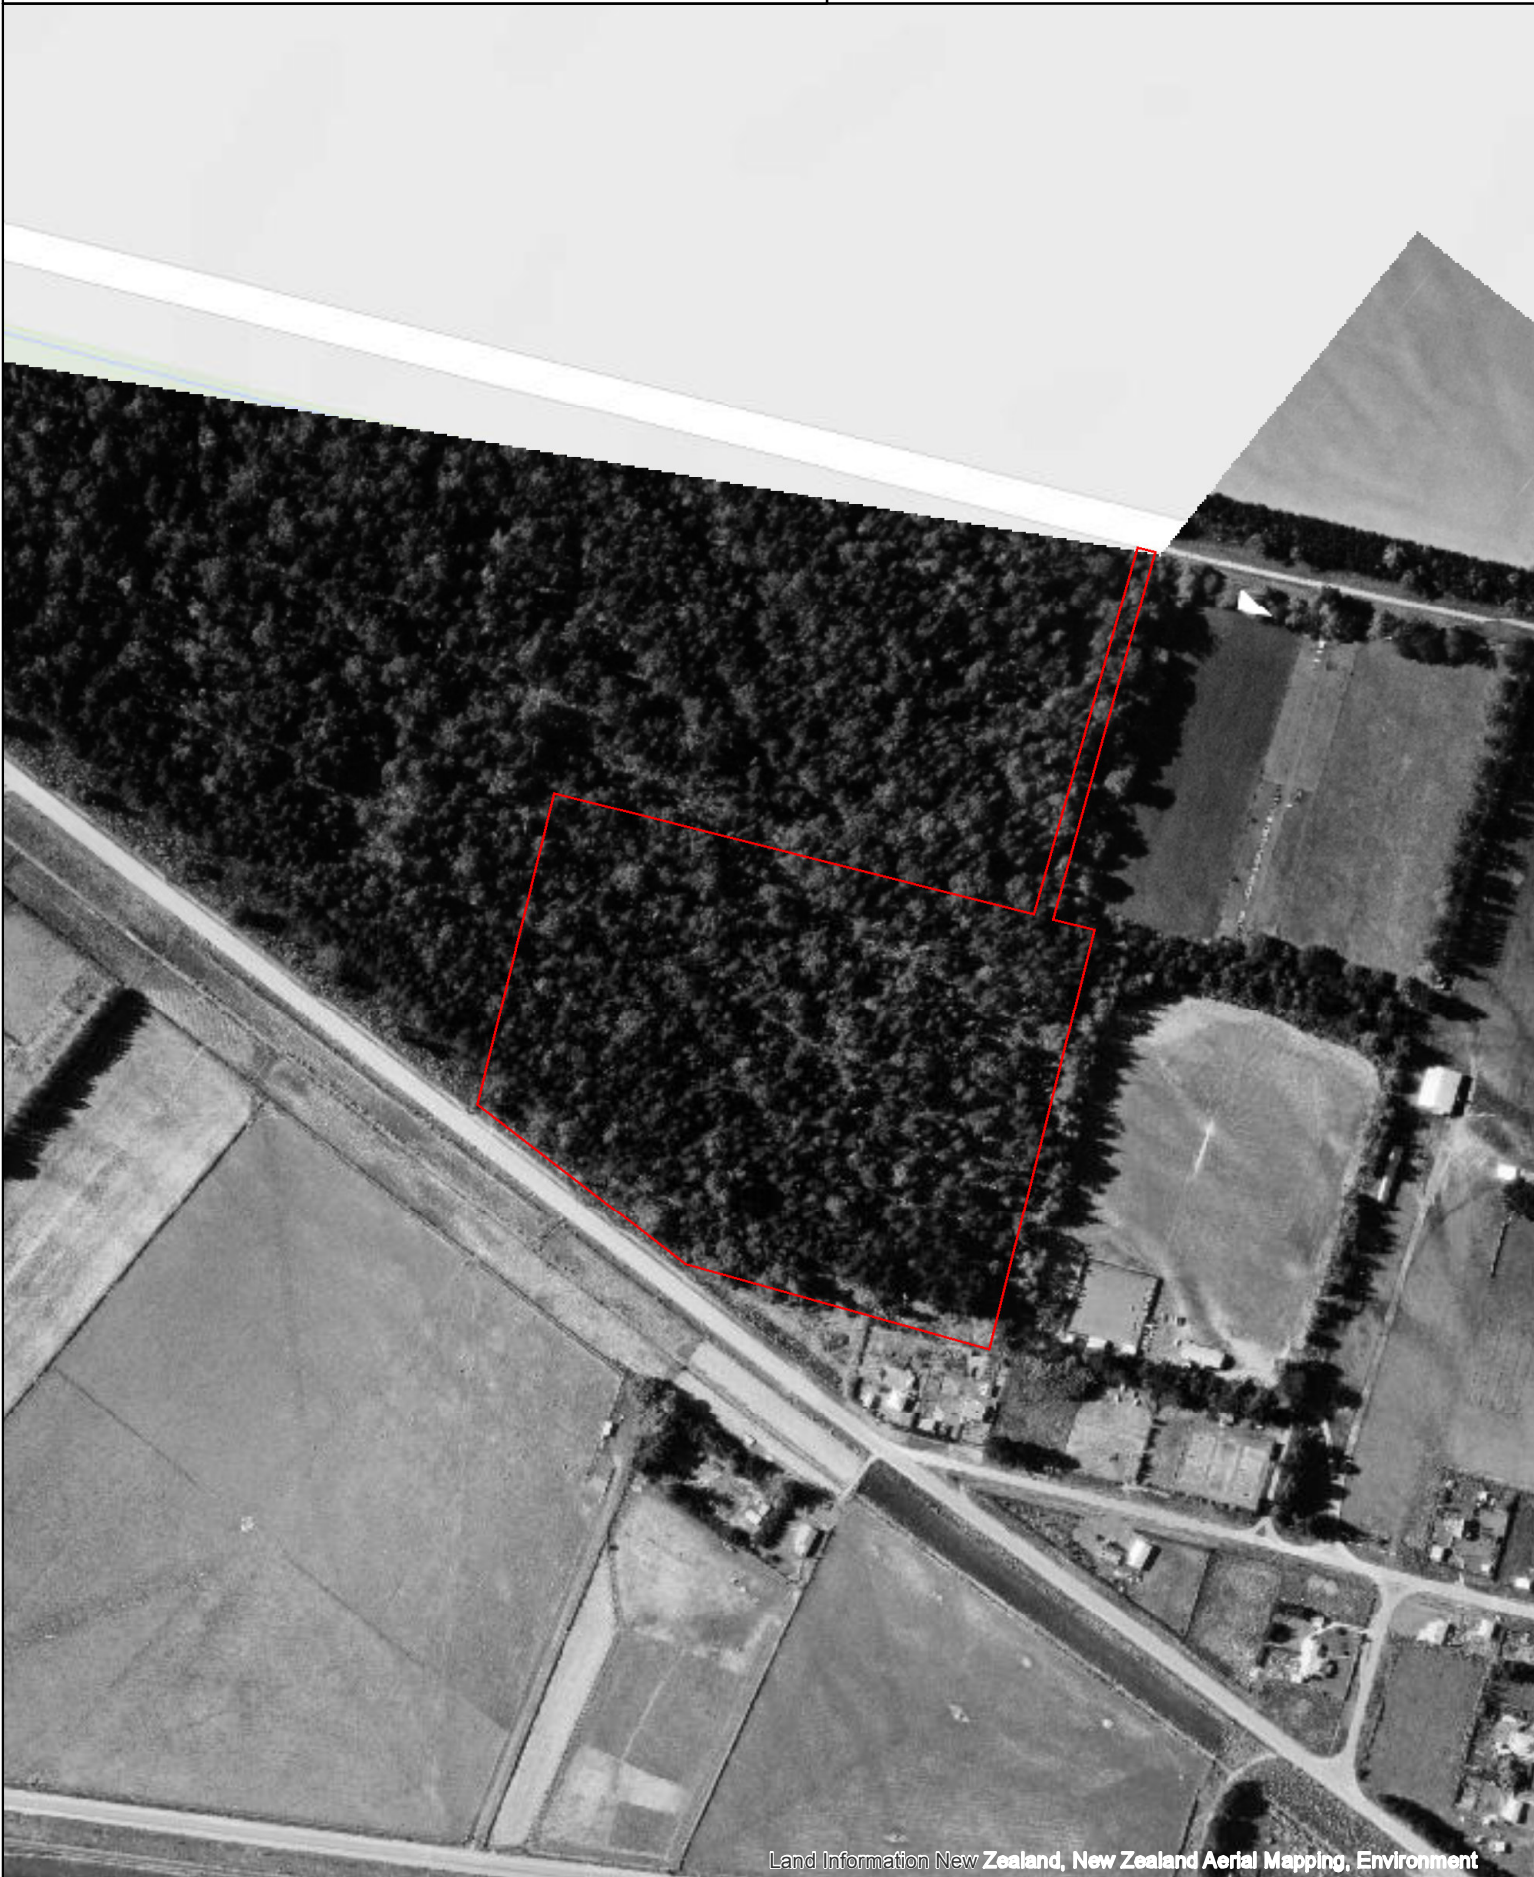
- A photo from **1965** is sourced from ECan's GIS and shows no significant changes to the subject site. The adjacent land to the east appears to have a recreational use with a sports field and a bowling green. Three buildings have been constructed on this land adjacent to the bowling green.

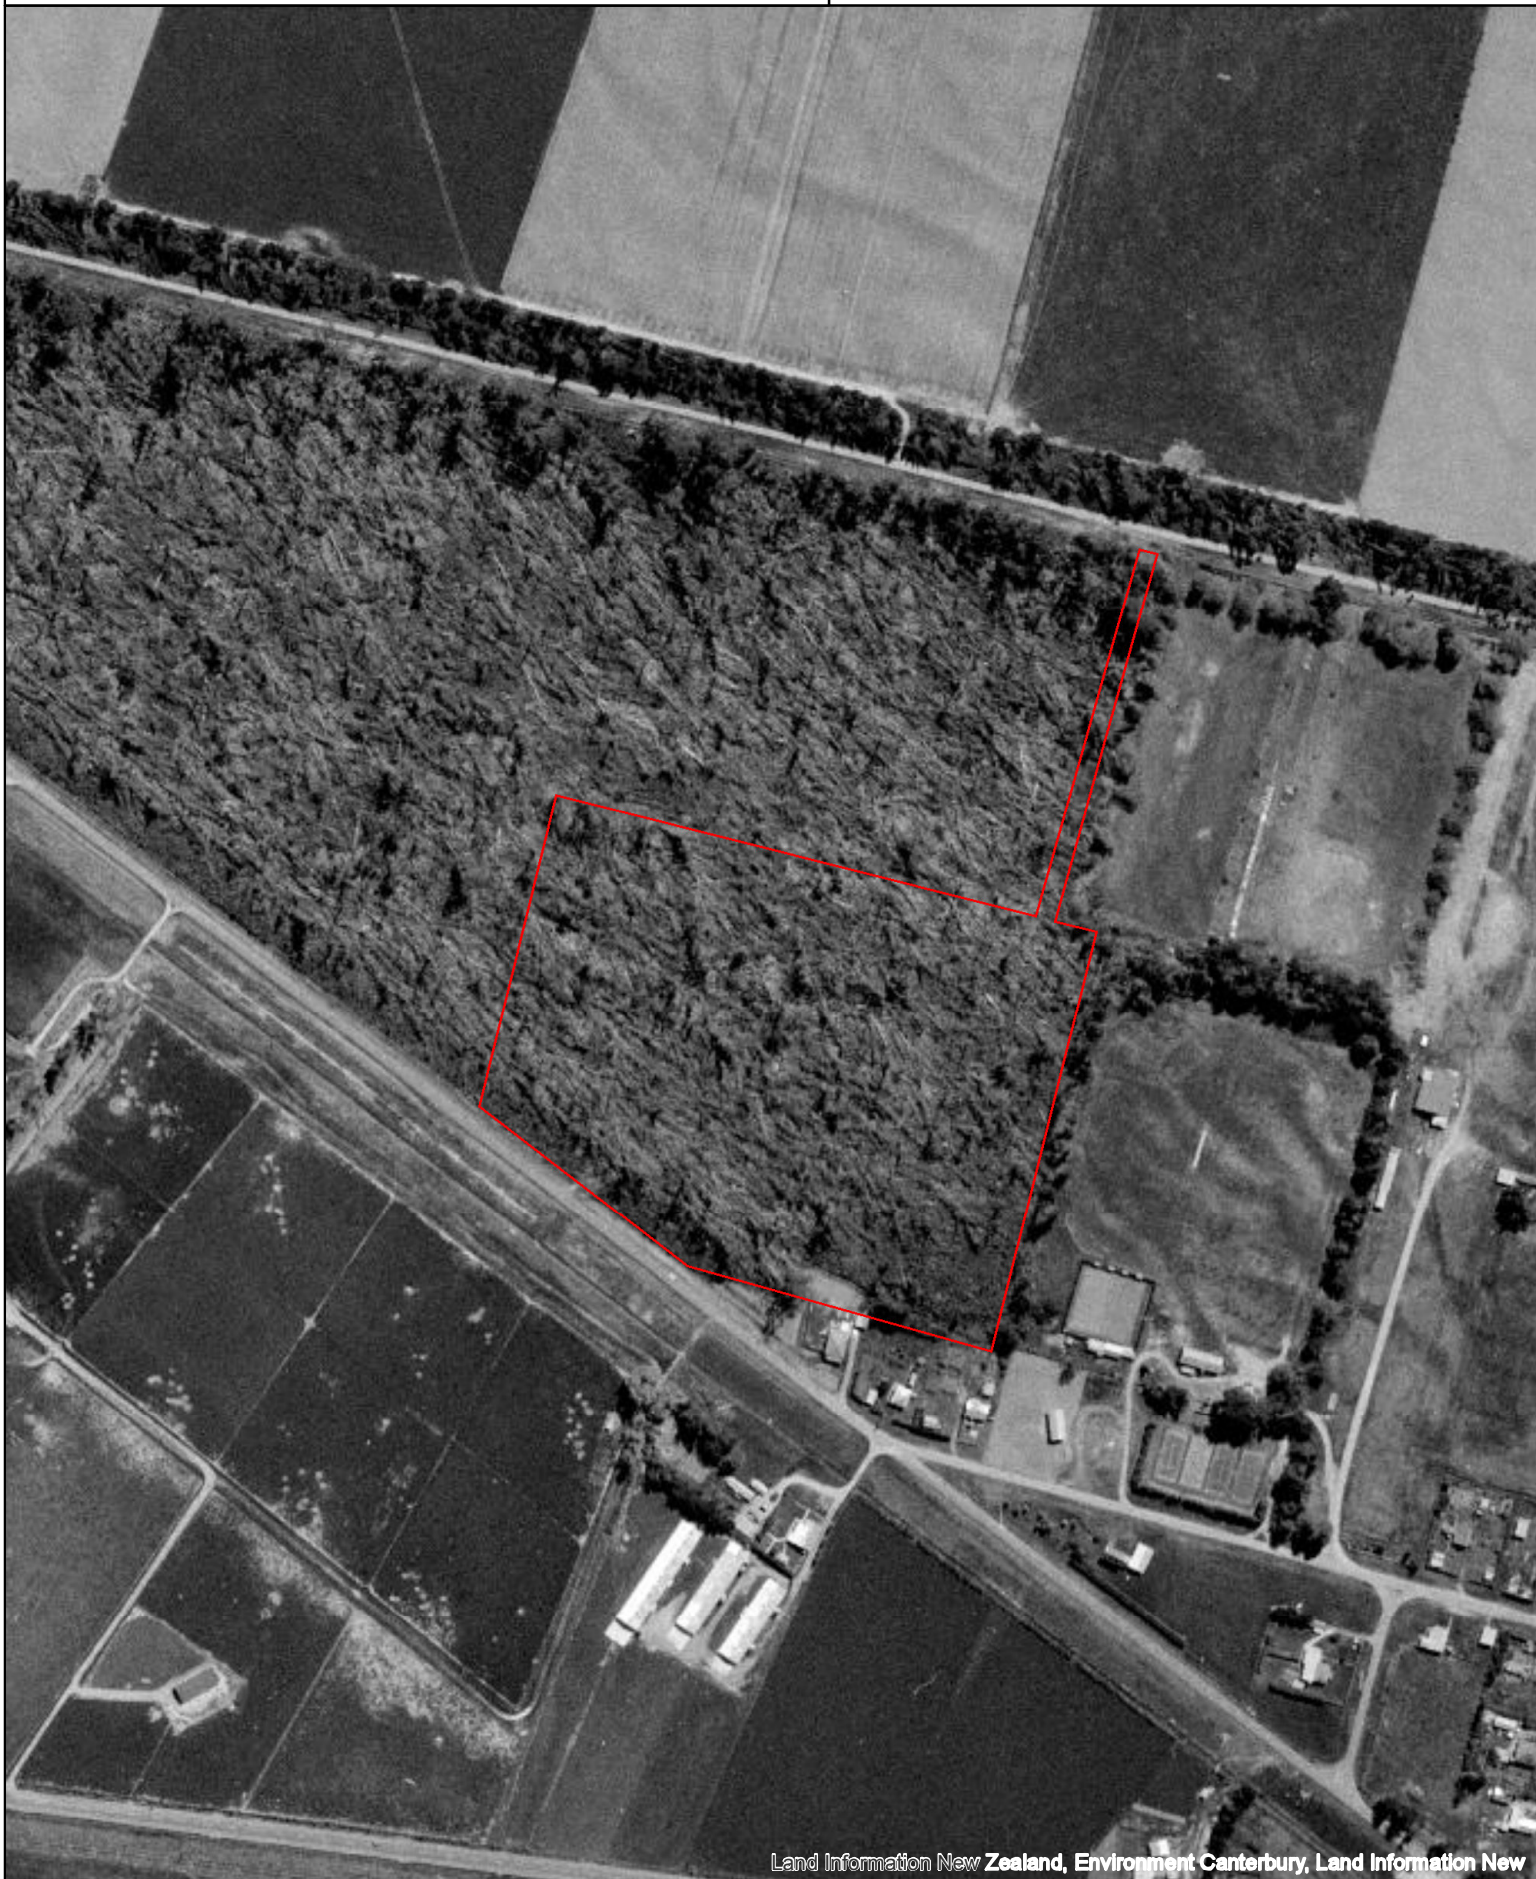
- A photo from **1975** is sourced from ECan's GIS and shows no significant changes to the subject site. A third dwelling has been built to the south of the subject site. Three poultry houses have been constructed beyond the subject site to the south, across Tramway Road.

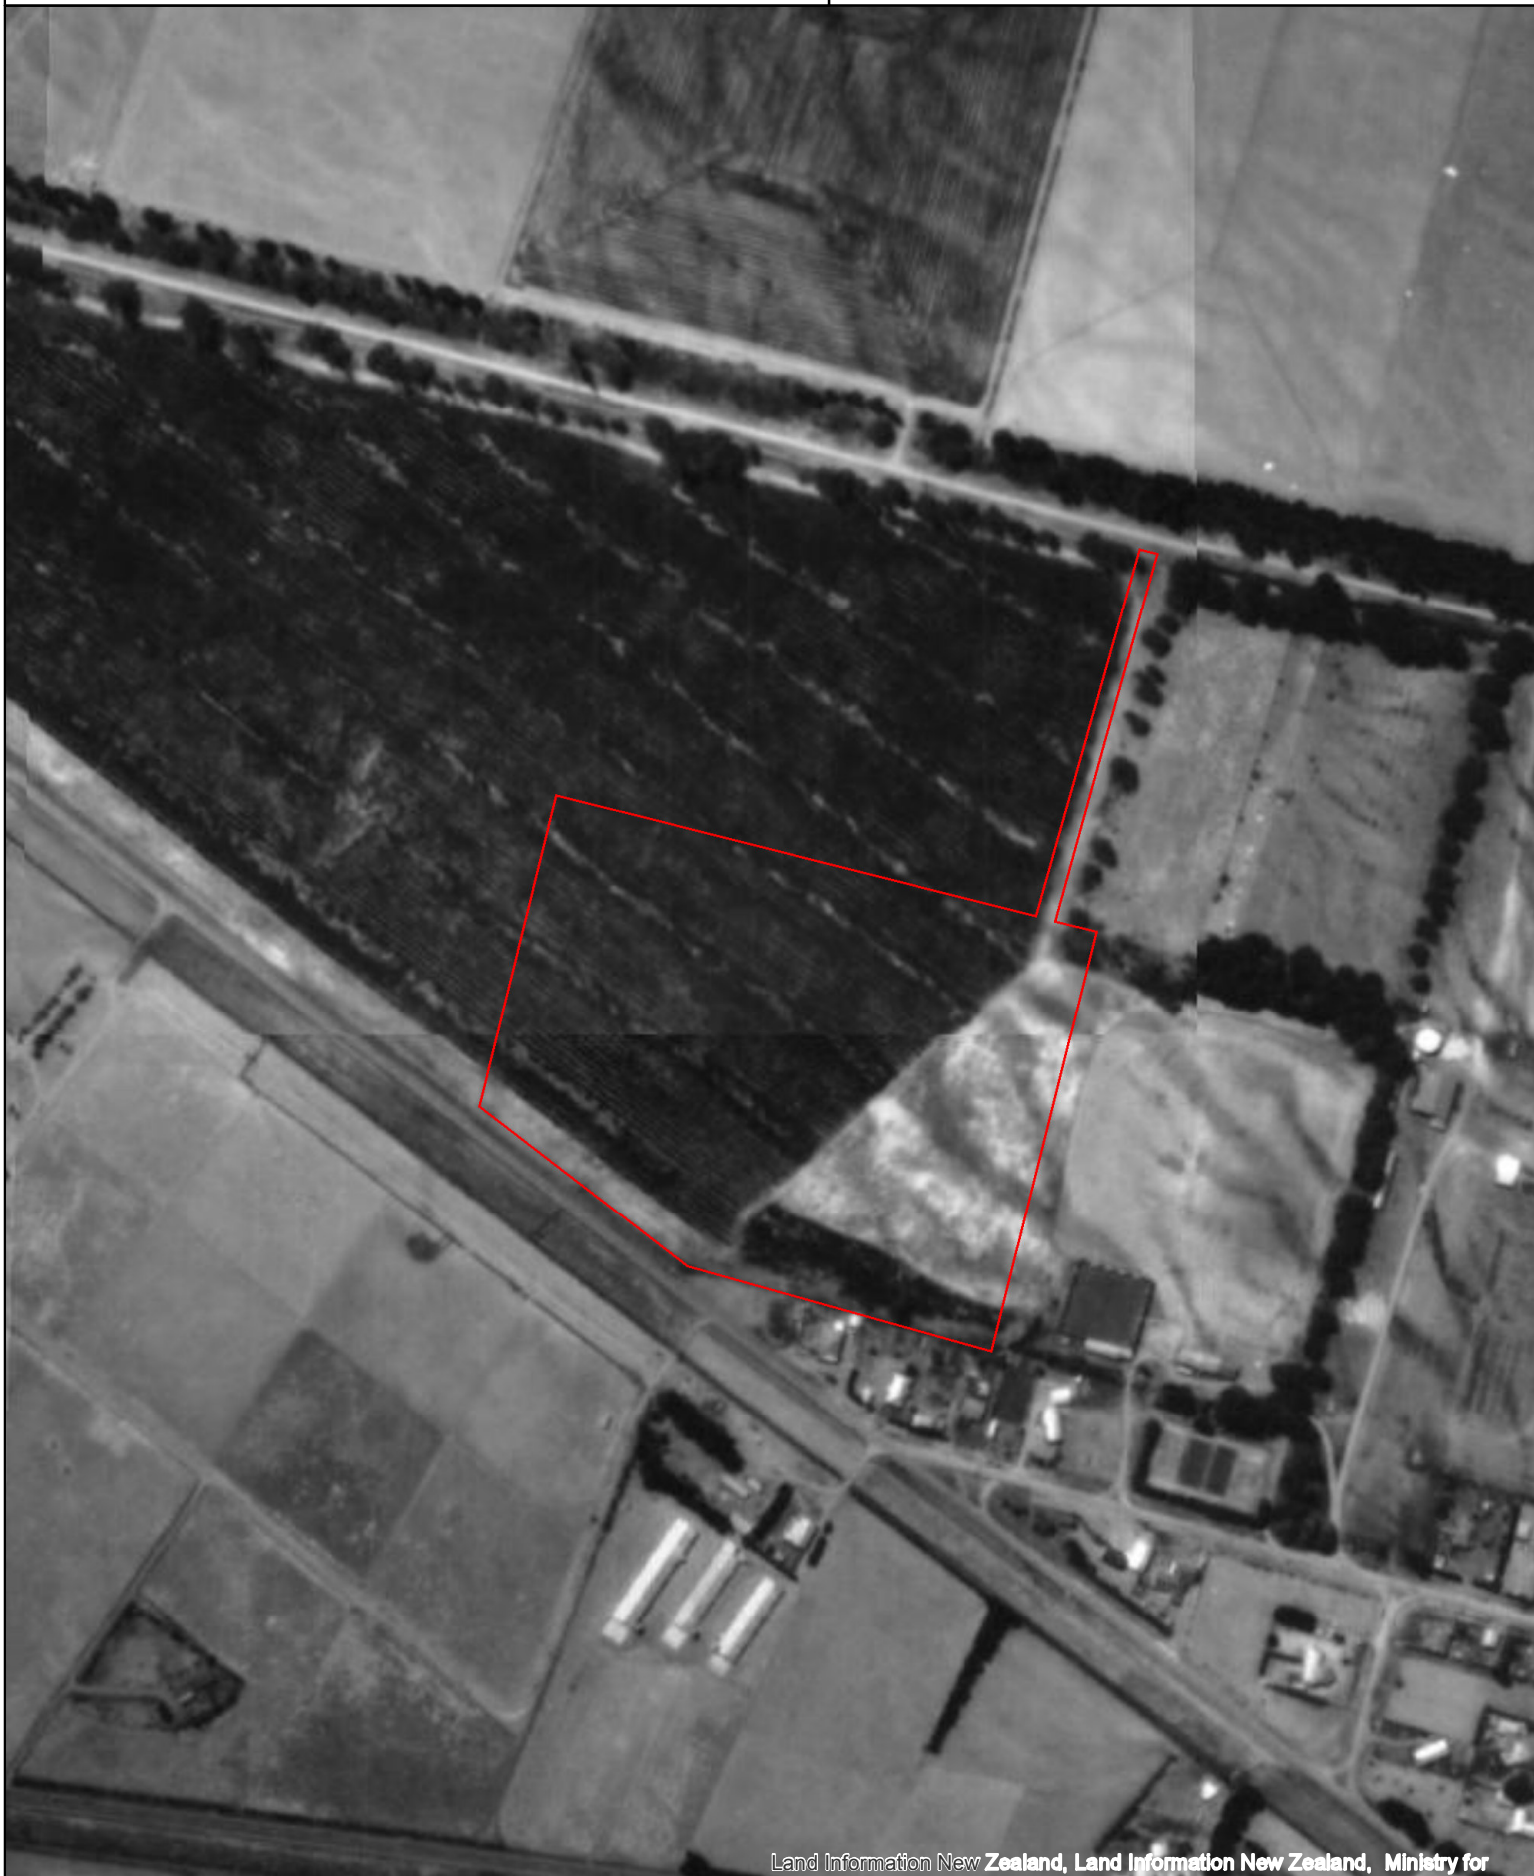
- A photo from **1982** is sourced from ECan's GIS and shows the trees have been removed on the south-eastern corner of the site. This corner is now grassed. There are no significant changes to the surrounding area.

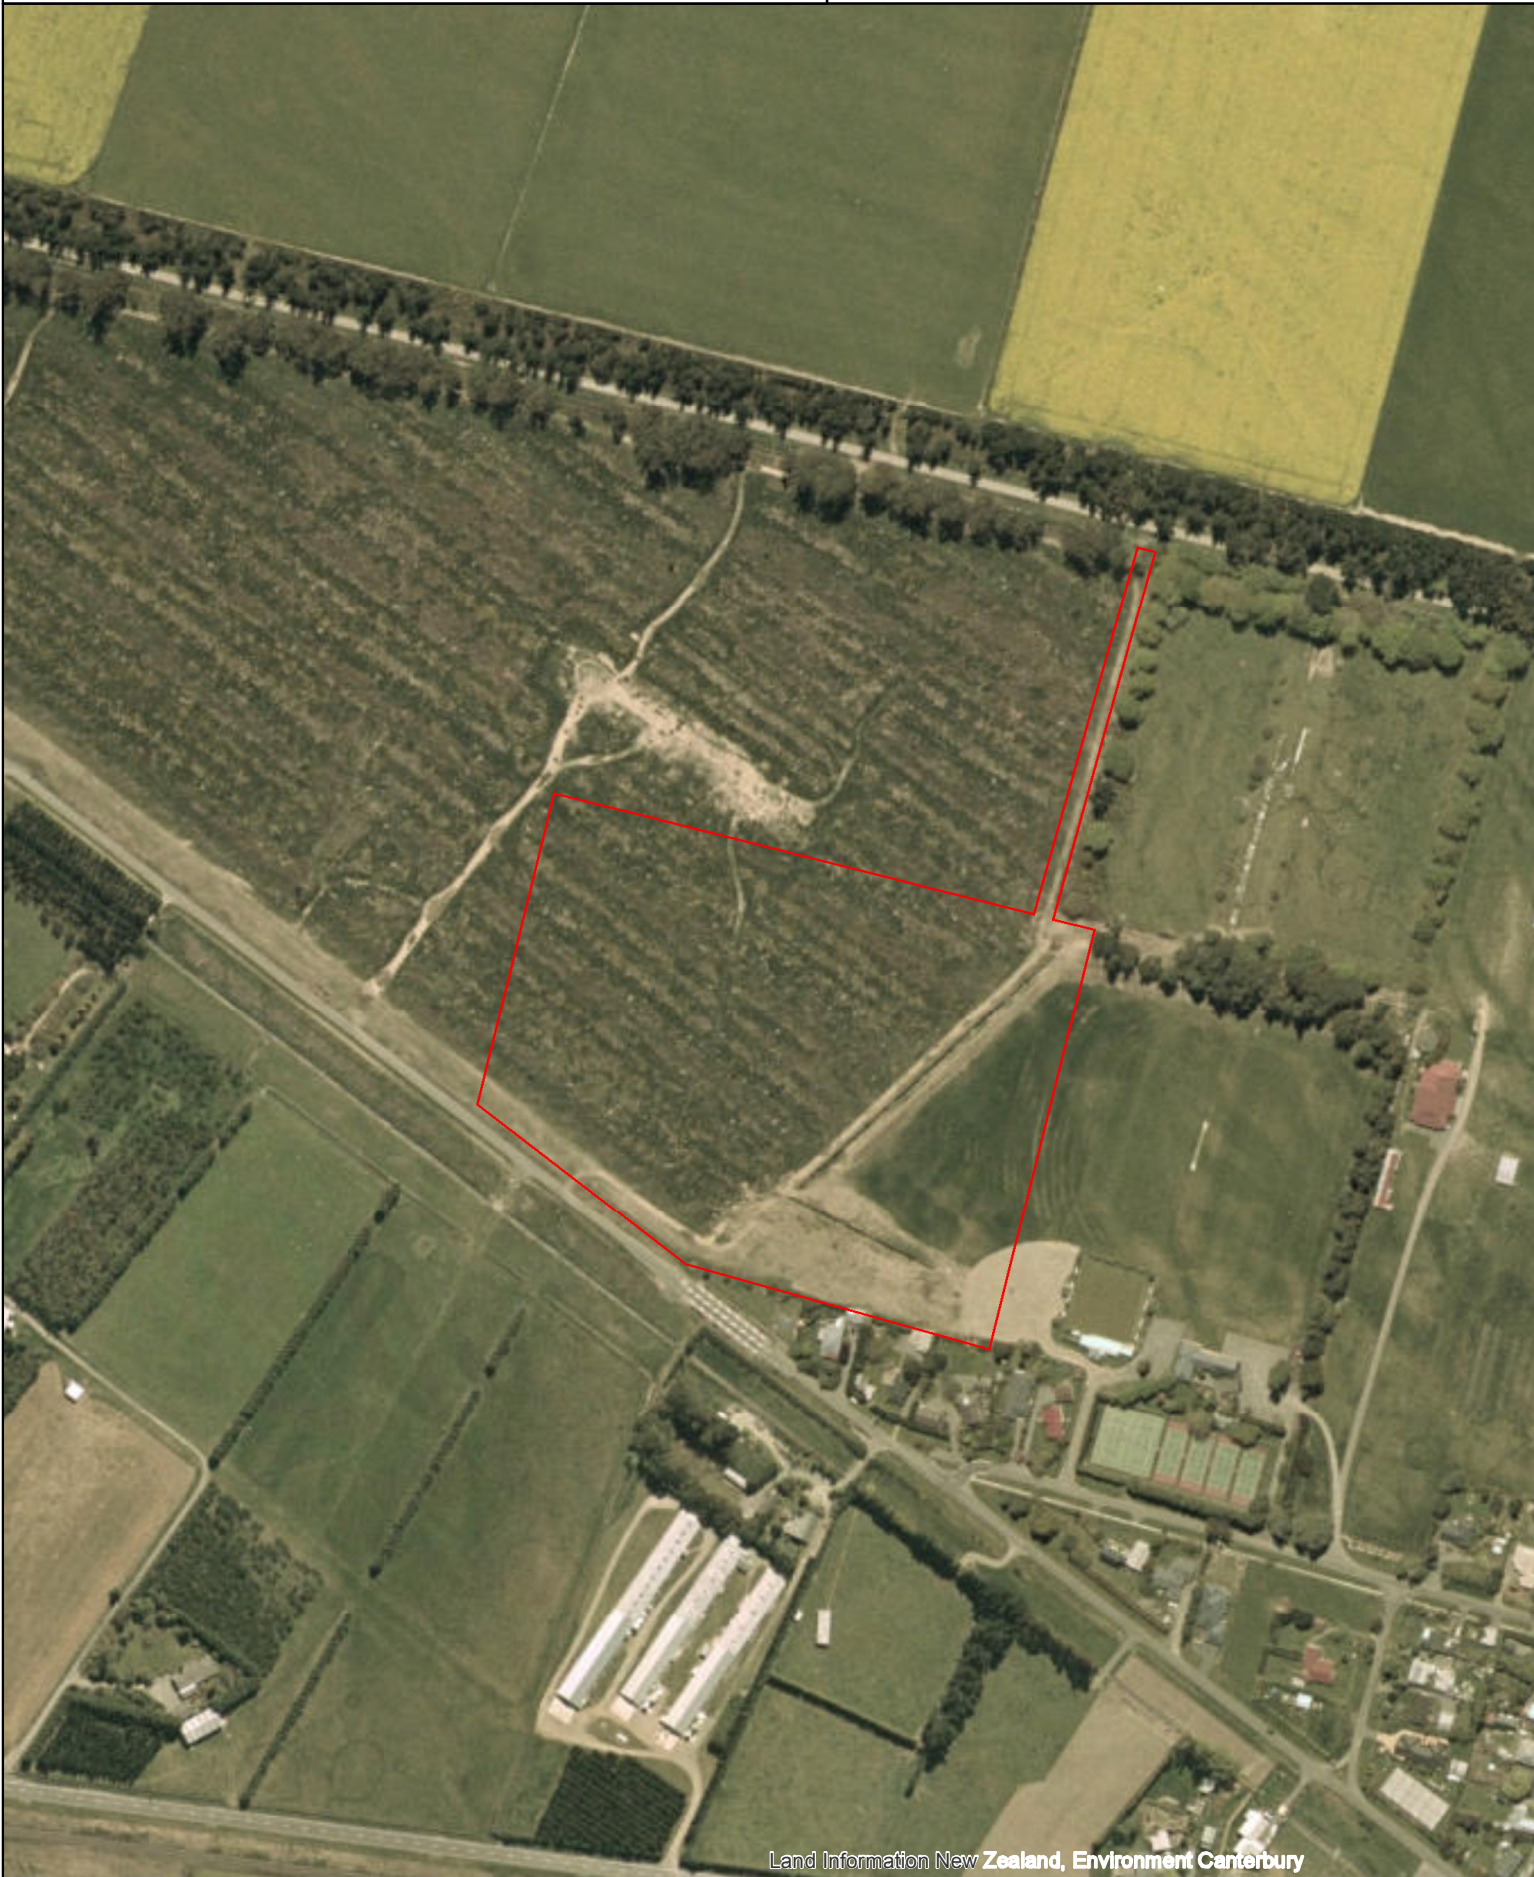
- A photo from **2004** is sourced from ECan's GIS and shows the south-eastern corner of the subject site is being developed as an extension of the reserve and has a recreational use. The trees on the rest of the subject site appear to have been harvested. Beyond the subject site to the south the third poultry house has been extended.

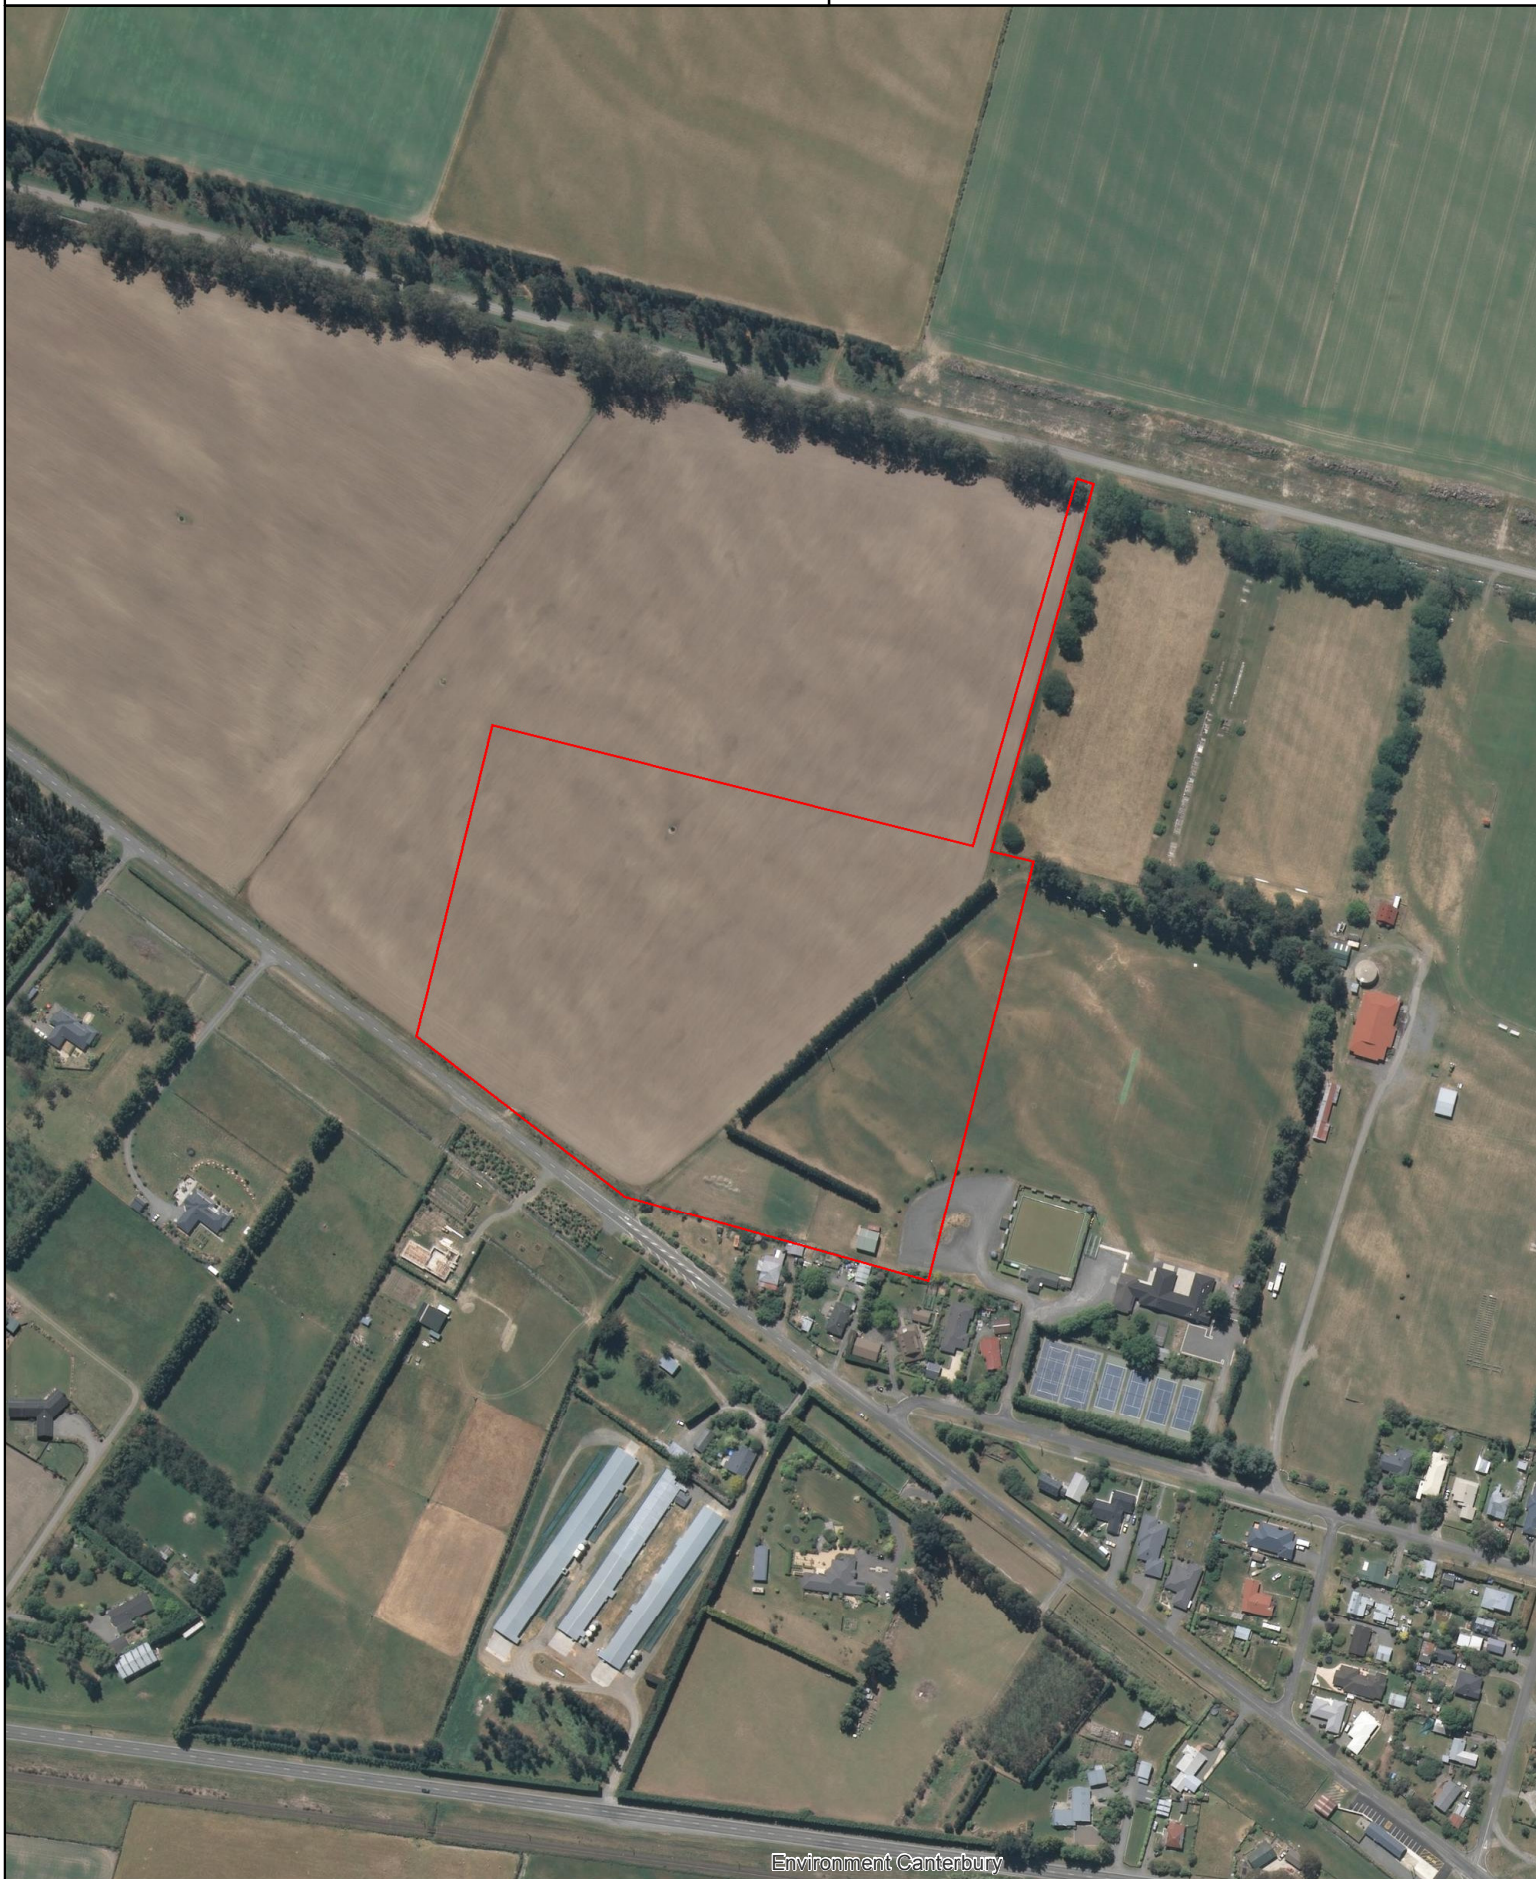
- The most recent aerial photo reviewed, dated **2015**, is sourced from ECan's GIS. The area of the subject site not yet developed as reserve is now pasture. A shed has been built on the reserve area of the subject site. Rural residential development has occurred to the

south of the subject site. The tennis club building to the east of the subject site has been extended.
