Soil Contamination Risk Detailed Site Investigation Report

***27 Hamptons Road,
Prebbleton***

November 2018

Client: Selwyn District Council

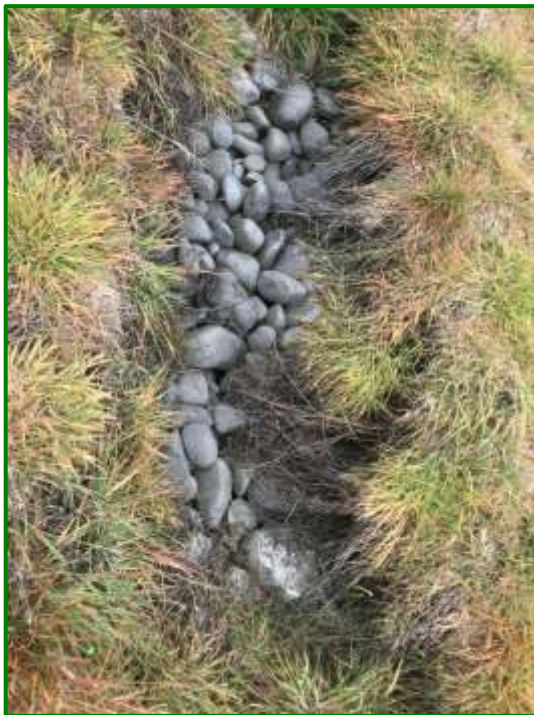
Photo 1: Soak pit filled with boulders

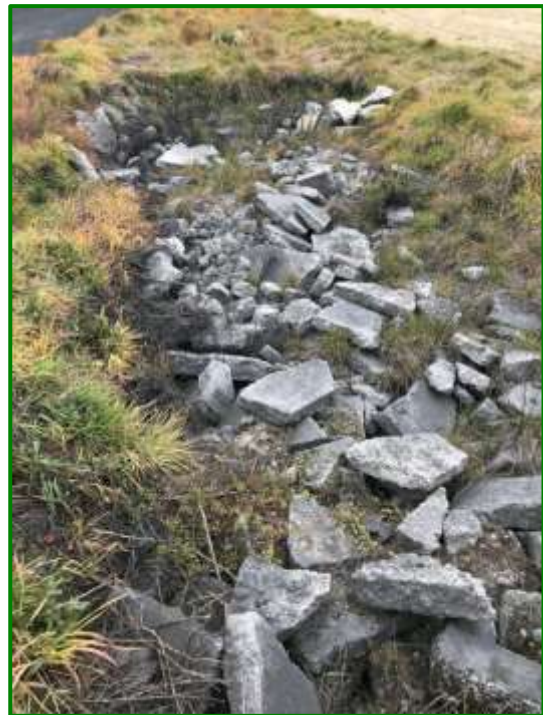
Photo 2: Soak pit filled with concrete

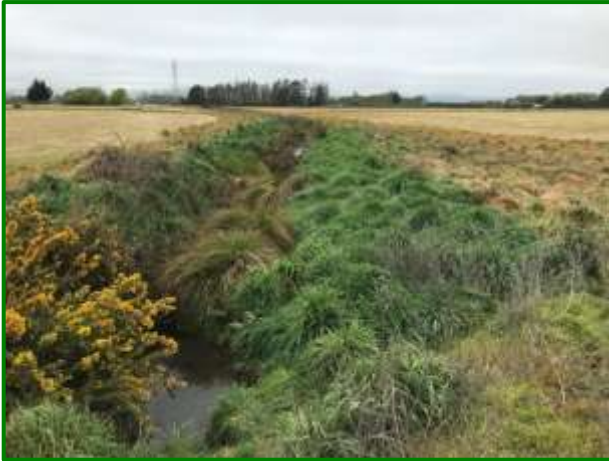
During sampling Knights Creek was inspected. The water appeared clean and no rubbish items were seen.

Photo 3: Knights Creek

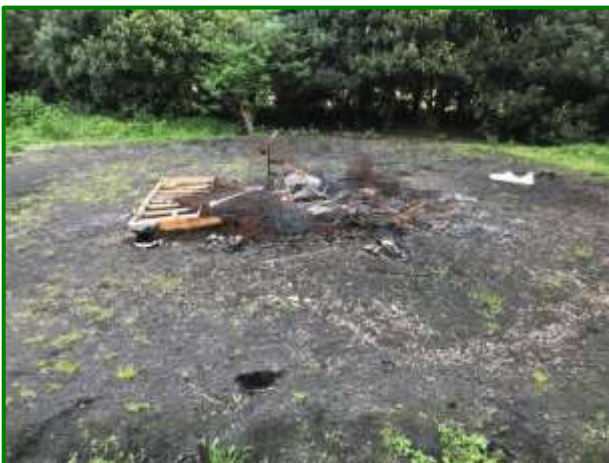
Three burn piles were identified within the farm working area. Each pile was XRF tested and sampled at the surface. At BP1 the burn pile was on top of the concrete floor of the demolished stables, therefore the soils below were protected. BP2 was a very small circle with no obvious rubbish items. At BP3 the burn pile was on a training circle with underlying track ash. The partially burnt items included a bed frame and mattress. The sample from BP3 was submitted to Hill Laboratories and analysed for heavy metals including mercury and PAHs.

Photo 4: Burn pile within the training circle

The PAH analysis of BP3, from one of the burn piles, detected only traces of 1-Methylnaphthalene, 2-Methylnaphthalene and Phenanthrene.

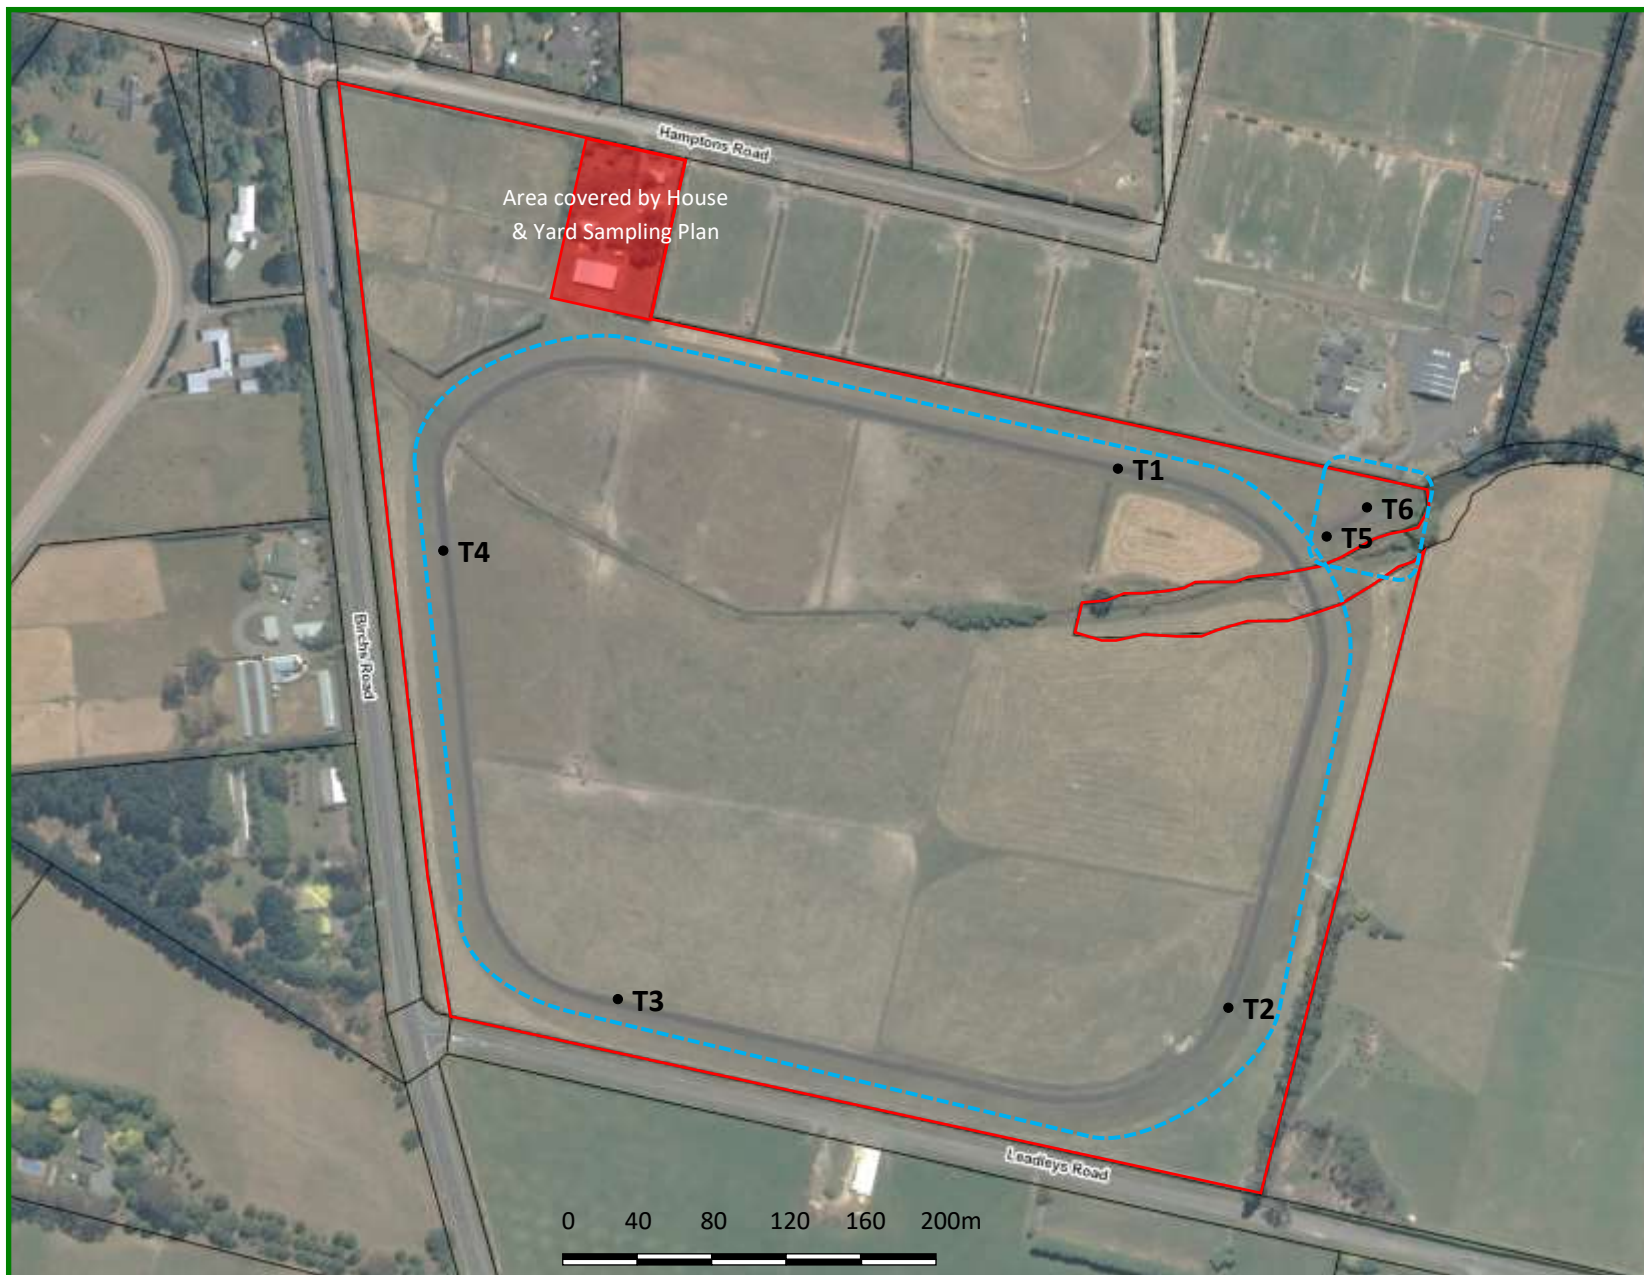
Drawing No: 01058/1

Four samples, T1 to T4, were taken from the surface of the horse training track. Two samples, T5 and T6, were taken from the track ash stockpile to the north-east of the training track. A section of the track through the yard area also appeared to consist of track ash so this was sampled as T7. Two composite samples were analysed by Hill Laboratory for heavy metals including mercury, and PAHs (polycyclic aromatic hydrocarbons). Two soak pits were noted beside the track in the south-east corner. One was filled with broken clean concrete, the other river boulders. Neither pit appeared to contain rubbish items or any suspected asbestos containing materials. No sampling was carried out.

Sample Location Plan 27 Hamptons Rd - Horse Track Area

The laboratory results from the coal ash in the horse training track area showed no evidence of soil contamination above the recreational SGV, and indeed most results were close to expected background concentrations. It is considered highly unlikely that there will be a risk to human health if this area of the site is used for recreational activities and is suitable for recreational use with no further investigations required.

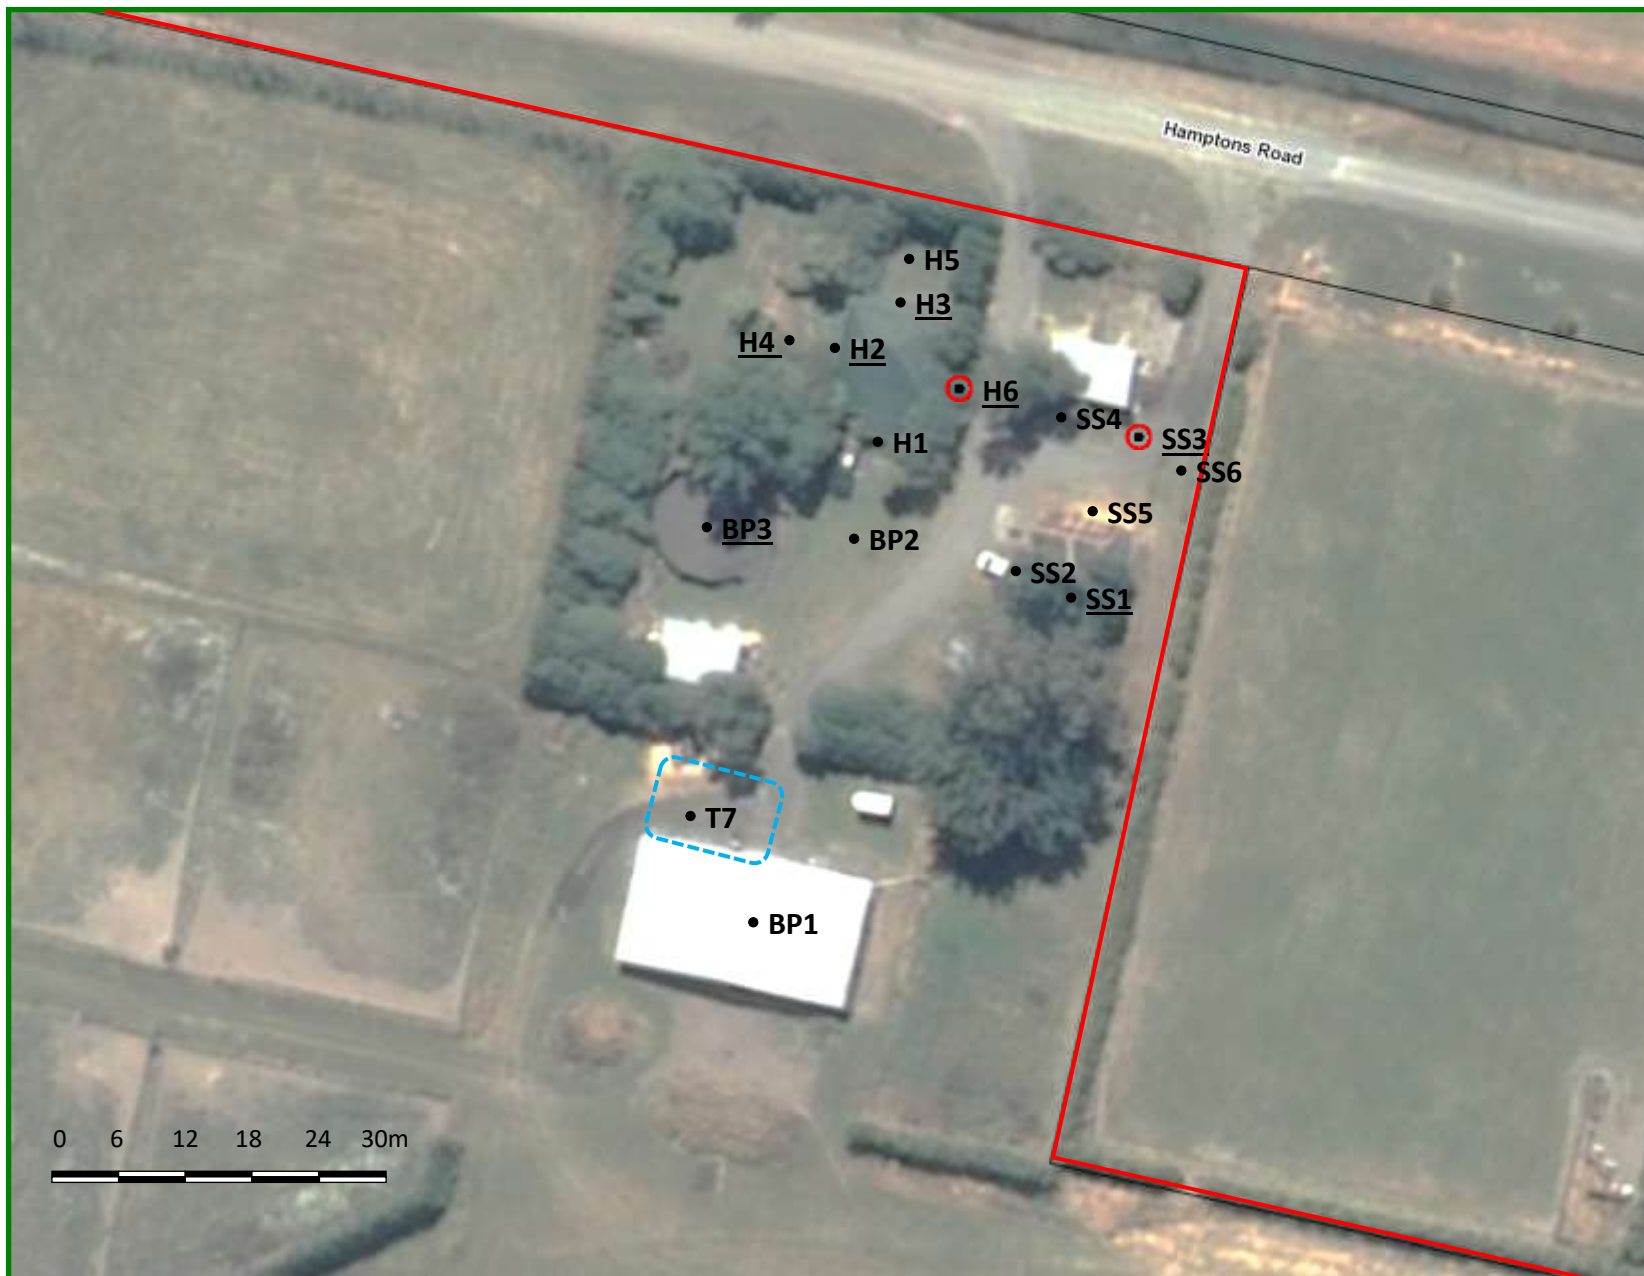
Drawing No: 01058/2

The XRF and laboratory results showed lead concentrations above the recreational soil guideline values (SGV) at two sample locations. The highest reading was from SS3.1 with a lead concentration of 1,500 mg/kg.

Two samples from the dwelling and farm working area exceeded the recreational SGV for lead. This could pose a risk to human health if this area of the site is used for recreational activities. The results from the rest of the dwelling and farm working area were all below the relevant recreational SGV. The following conceptual site models address the potential risks associated with the two small lead contaminated areas:

Sample Location Plan 27 Hamptons Rd - House and Working Area

Prior to using this area for any proposed recreational activities it is recommended that remediation of some form is carried out. Potential remedial options could include excavating and removing to an authorised disposal facility or to an onsite managed bund or similar, soil mixing, or capping with the likes of car parking. Whilst only a small area has lead levels above the 'recreational' SGV, there is a larger area affected by contamination and care must be taken
