Ecology and proposed naturalisation of Upper Dawson Creek

Prepared for:
Selwyn District Council

AEL Report No. 178

October 2019

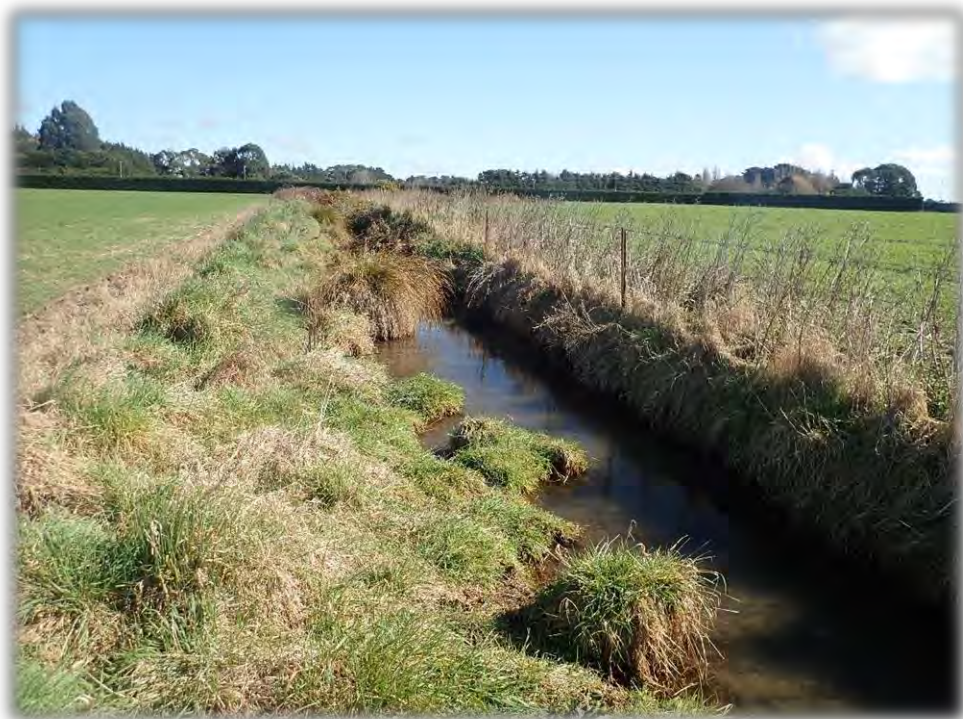
Looking upstream at a typical reach within the development area

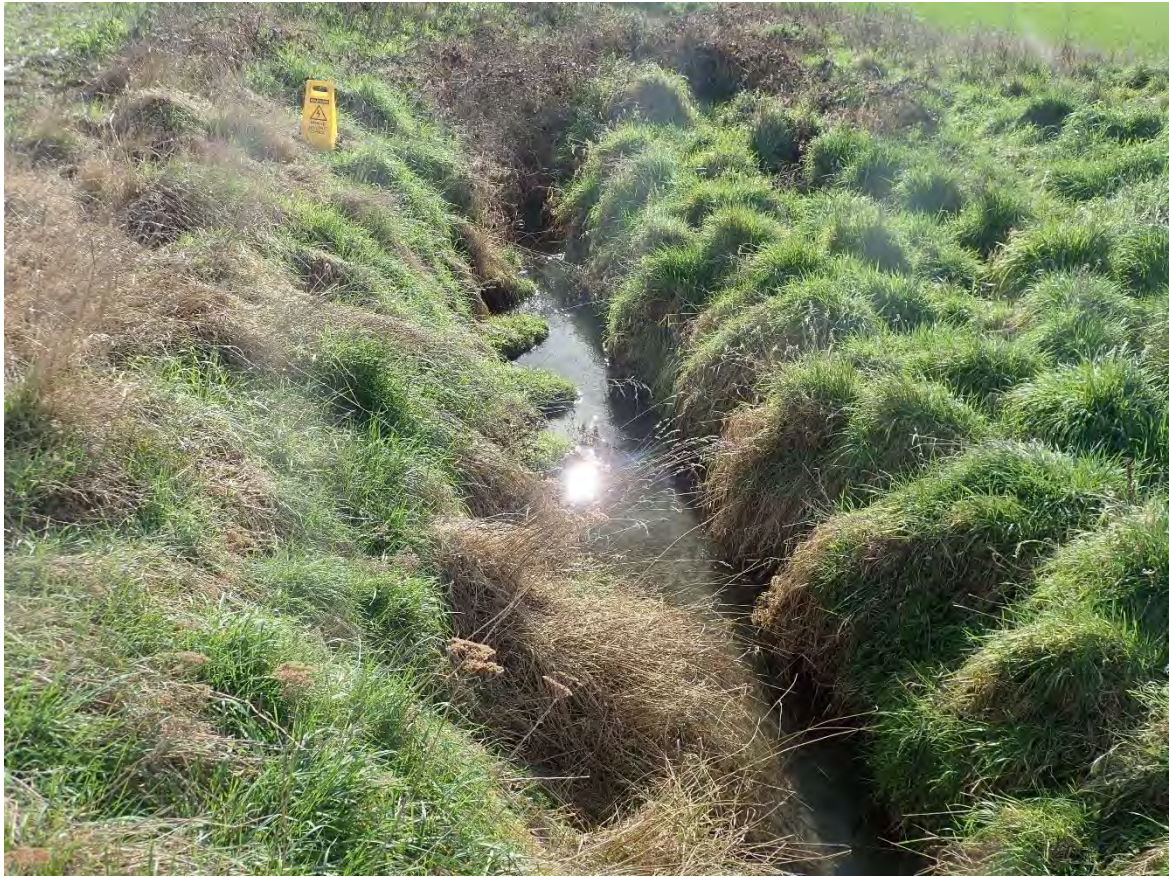
Figure 4. Looking upstream at Site 1.

Overall, the habitat assessment showed that Sites 1, 2 and 4 were of similarly poor quality, with total scores ranging from 28.5 – 30 (Figures 3 – 7). Site 3 was in slightly better health, but still poor, with a total score of 39.

All four sites were characterised by having high sediment cover, low active bank erosion and low invertebrate habitat diversity/abundance (Figure 3). Riparian vegetation typically consisted of long pasture grass, with occasional native vegetation, bracken, bramble and gorse (Figures 4 – 7).

At all sites, the long grass provided fish cover in the form of overhanging vegetation. Additional fish cover was provided by undercut banks (Sites 1 – 3), root mats (Site 2) and debris (Site 4). Despite Site 2 having a greater diversity of fish cover, Site 3 the most fish cover amongst the four sites (Figure 3). This was largely due to the extent of undercut banks at Site 3. Hydraulic heterogeneity was comparably low at all sites and ranged from slow to fast run (Figure 3). Riparian width was greater at Sites 1 and 4 (Figure 3). At Site 4 this was mostly likely due to the shallow, uneven bank creating an unsuitable base for sowing bankside grass. There was no clear reason for the larger area of unsown pasture on the north bank at Site 1. Riparian shade was substantially higher at Site 3, as both banks were deeply incised (Figures 3 – 6).
