## **RESULTS:**

A modified version of the Emerson Aggregate Test was carried out on two loess samples, taken from two different locations within the Porter Heights Village Area. The test results indicate that neither soil sample shows the characteristic properties that would normally be associated with a dispersive soil.

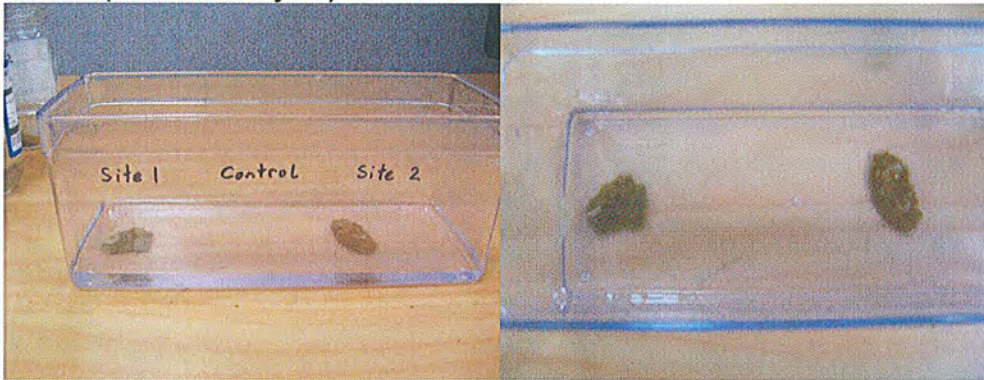
**Time 0 (start of analysis)**

The photographic images shown below indicate visually the level of dispersion at the start of the test and upon completion of the test, after 24 hours. It can be seen that no change was noted through the 24 hour testing phase and that no degree of dispersion was apparent.

### **SITES 1 & 2 COMPARISON (note no control was placed in the container)**

All the samples analysed, from Sites 1 and 2, showed no level of dispersion over the 24 hour testing phase.

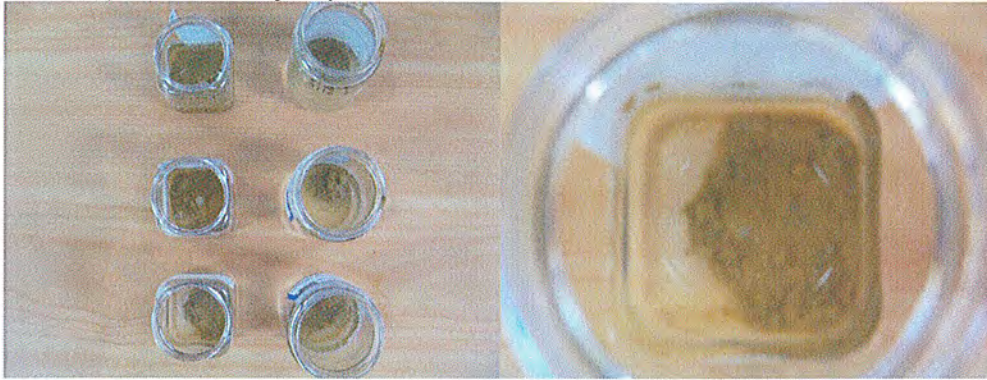
**Time 0 (start of analysis)**

**SITE 1 RESULT**

Three undisturbed soil aggregates and 3 reworked aggregates were analysed from each Site where a soil sample was collected. An aggregate from each Site was also placed in large container for comparative purposes. Each sample was visually analysed over a 24 hour period and, over this time frame, no sample was seen to display any measure of dispersion. It is therefore concluded that neither soil is dispersive by nature.

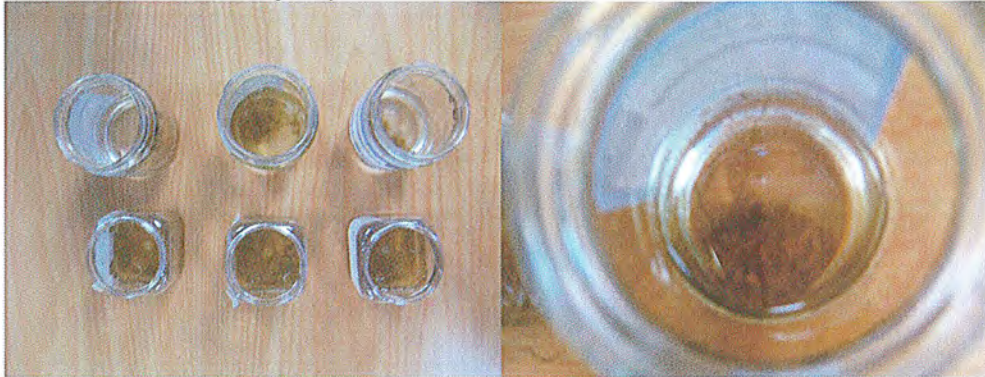
**Time 0 (start of analysis)**

## **SITE 2 RESULTS**
