# **Appendix 8: Contamination Report**

# **Preliminary Environmental Site Inspection**

# 100 BIRCHS ROAD, PREBBLETON, CANTERBURY

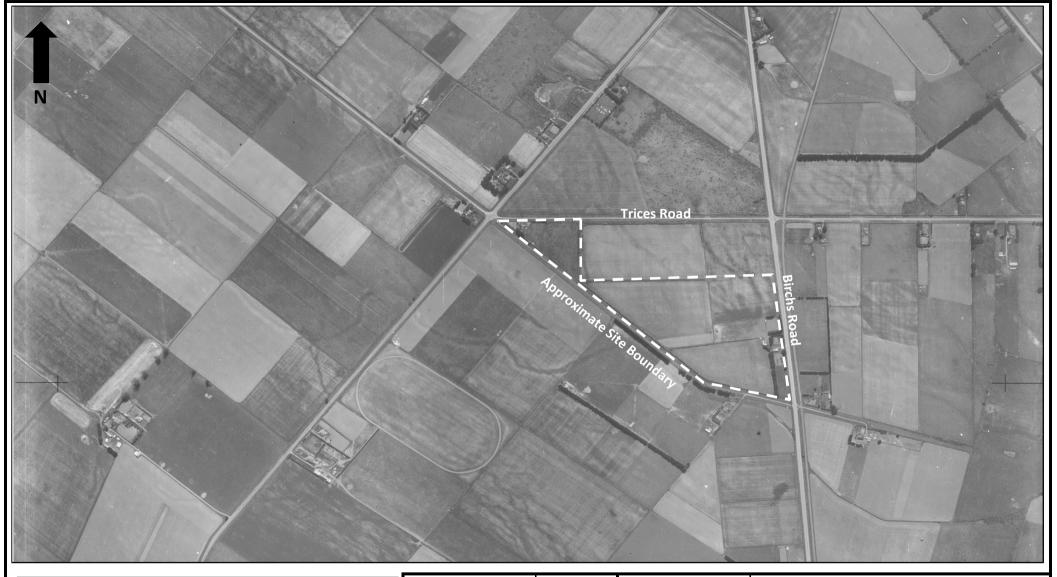
Date	Dec-12	Client	Conifer Grove Trustees Ltd c/- Baseline Planning		
Drawn by	НА	Project	100 Birchs Road, Prebbleton		leton
Approved by	DR	Description	1942 Aerial Photograph		
Scale	NTS	Figure Number	2	Project Number	9875

Date	Figure No.	Description
1942	The site is being used for both agricultural and residential land use site is predominantly agricultural land with buildings present in the western corner and lower eastern boundary. The buildings appear used for residential use but it is unclear. The surrounding land use predominantly agricultural with some associated residential dwelling	
1984	3	The central area of the site is being used a horse trotting track. The north-

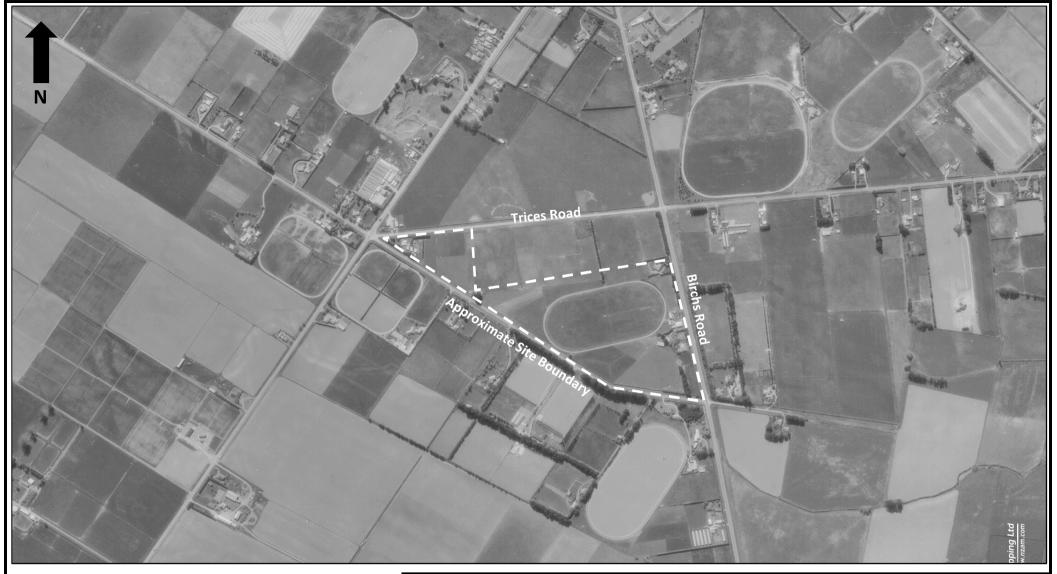
Date	Dec-12	Client	Conifer Grove Trustees Ltd c/- Baseline Planning		
Drawn by	НА	Project	100 Birchs Road, Prebbleton		
Approved by	DR	Description	1984 Aerial Photograph		
Scale	NTS	Figure Number	3	Project Number	9875

Date	Figure No.	Description		
		western corner of the site has numerous buildings present with their usage unknown. Other buildings are now present along the eastern boundary with their use appearing to be a mix of agricultural and residential. The surrounding area is predominantly agricultural with a number of horse trotting tracks in the surrounding area.		
2011	Google Earth	The site is a mix of residential and agricultural. The horse trotting track is no longer present. The north-western corner of the site is now being used for residential purposes. The buildings on the eastern boundary of the site are being used for residential purposes. The building in the south-eastern corner of the site is being used as an electricity substation which was built between March 2010 and February 2011.

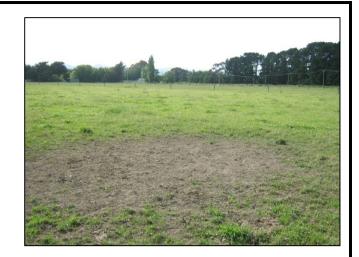
Photo 3: Area of grass damaged by cattle

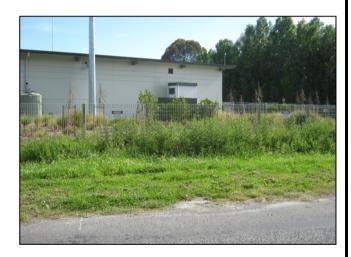
Activities included on the Hazardous Activities and Industries List (HAIL)<sup>4</sup> trigger the requirement for a contaminated land investigation prior to development. The electricity substation is considered a HAIL activity; B4 – Power stations, substations or switchyards. The substation was built in 2010and unlikely to pose a risk from contaminated land to future residents and site workers.

An electricity substation was built in the south-east corner of the site in 2010.

Photo 6: Electricity Substation
