REPORT ON

**PRELIMINARY CONTAMINATION ASSESSMENT
86A EDWARD STREET, LINCOLN
CANTERBURY**

R 077813078 / 02

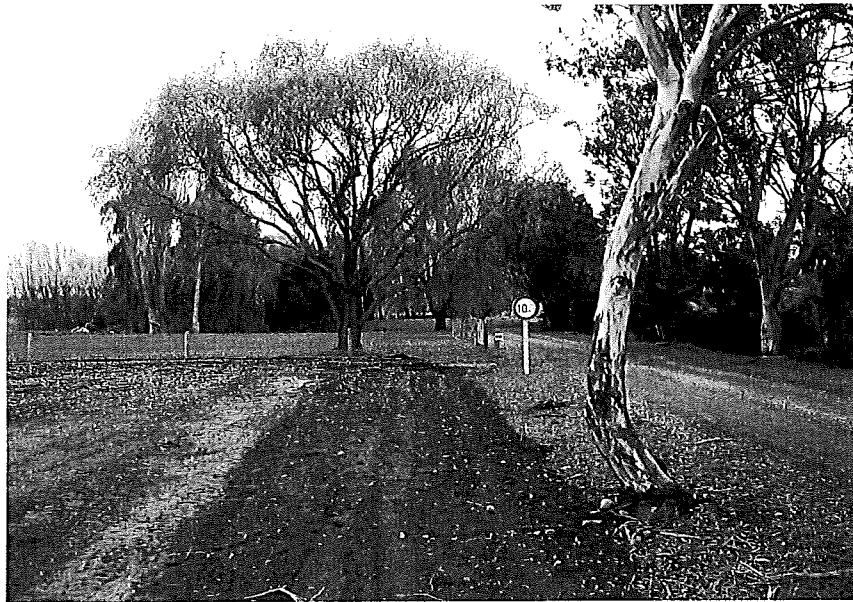
Photograph 1 - Site entrance track (to the right)

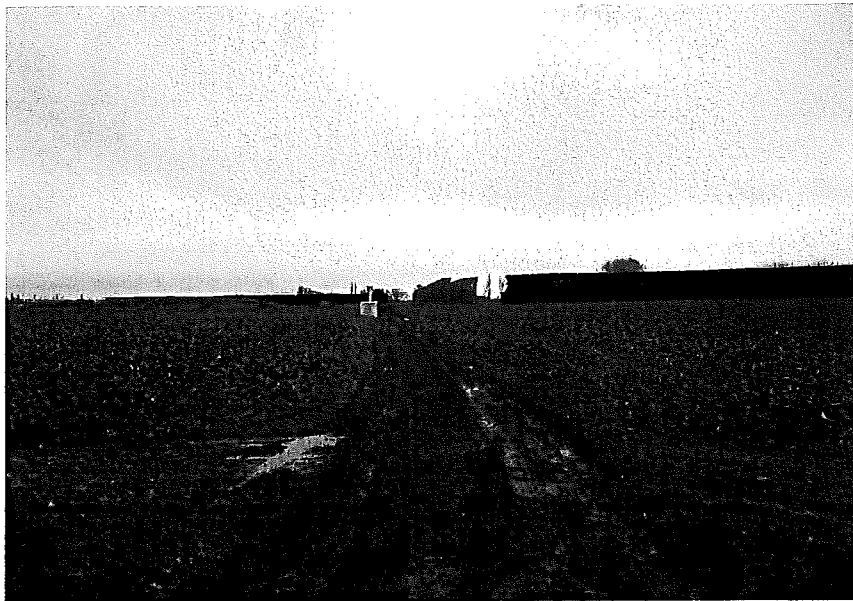
Photograph 2 - Central dirt track with Paddock 09 (R) and Paddock 10 (L)

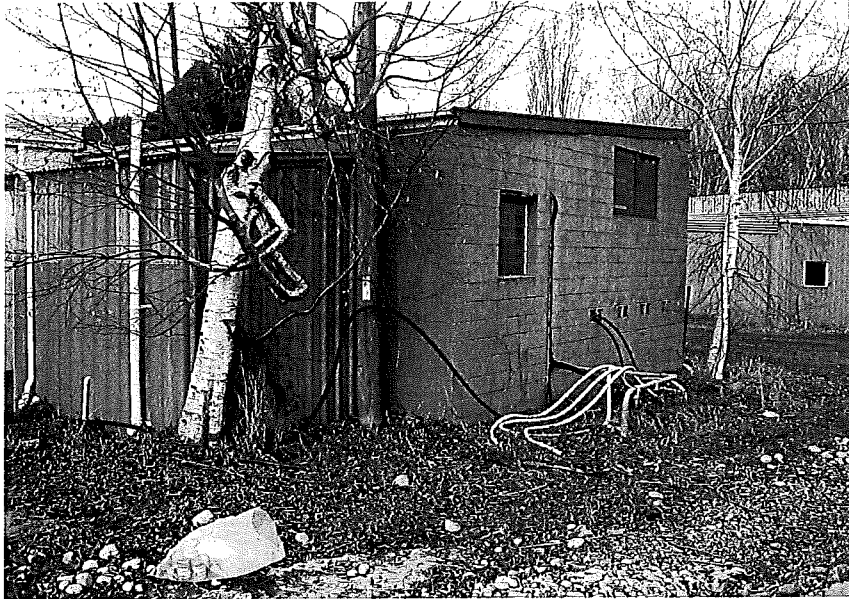
- A former diesel AST located in the east of the site;
- A former chemical storage shed also located in the east of the site (photograph 3 and 4);
- A former chemical dispensing point in the east of the site (photograph 5); and
- The direct application of pesticide sprays to orchard crops.

Photograph 3 - Former chemical store

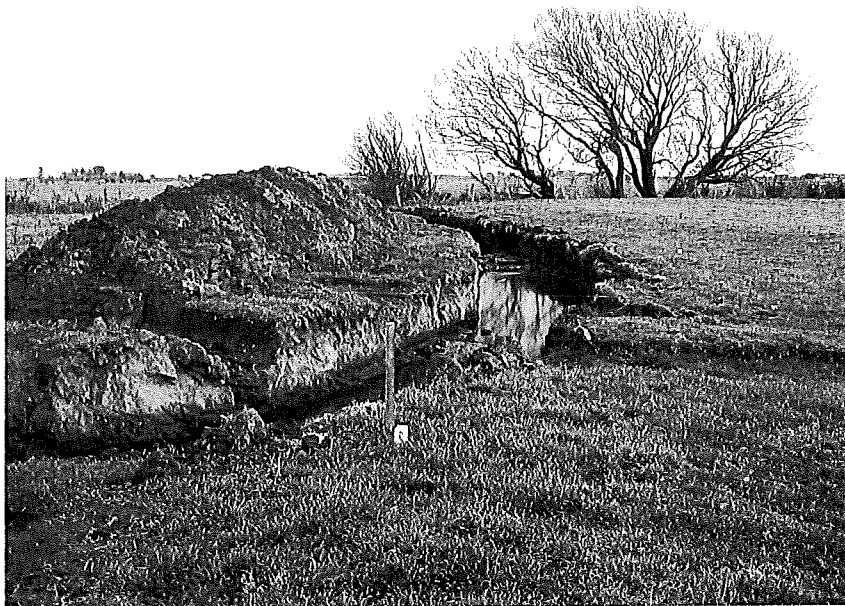
In addition, the southern boundary of the site is defined by a man-made culvert (photograph 8), although during the site inspection did not appear to be in hydraulic continuity with the aforementioned water course. As discussed in Section 2.2, anecdotal information suggests that the southern 5% of the site is susceptible to flooding events.

Photograph 8 - Man-made culvert in the south of the site
