Assessment of Ecological Values at Liffey Springs

Proposed Plan Change

September 2009

A report for:
Selwyn District Council

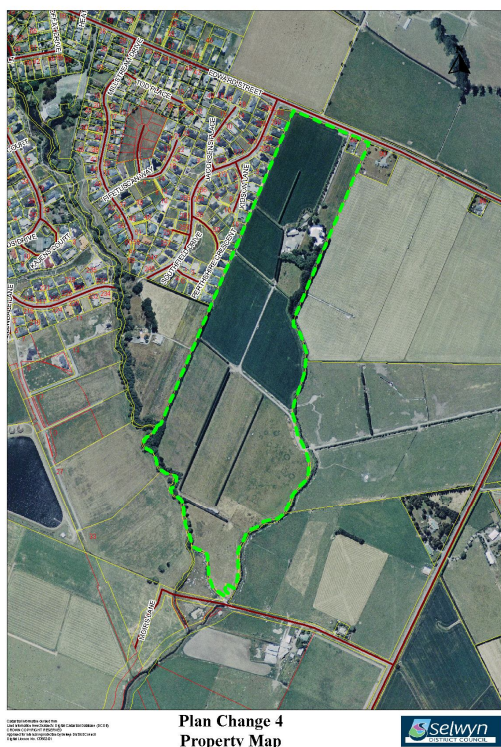
Fig.1 Aerial photo of site with property outlined with green dashed line. The site adjoins Lincoln village and is bounded by the LI River (on left) and the LII River (on right).

The site covers 28ha of mainly cultivated paddocks with shelterbelts. The slightly sloping land is bordered by two streams the LI (also known as Liffey Creek) and LII (*Fig.1*). Both streams are spring fed with the LI flowing through Lincoln before joining the LII just below the southern boundary of the site. The LII originates on the site at a large pond (*Fig.2*) near the house and more springs swell the stream as it flows south towards the junction with the LI. Soils are Wakanui yellow grey earth and Taitapu recent soils which are heavy and slow draining. Since European settlement and agricultural development the streams draining the site would have been deepened and regularly cleared so that now the banks of the LI are quite steep in places.

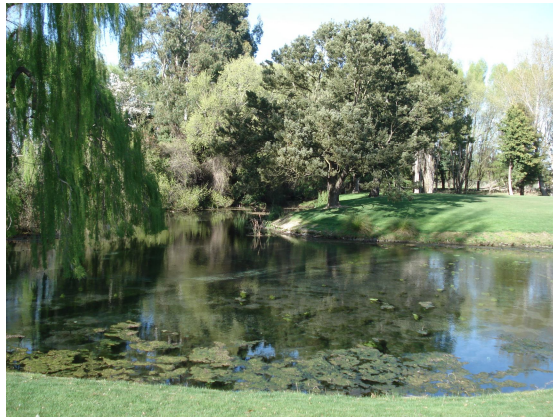
Fig. 2 The springs at the head of the LII River.

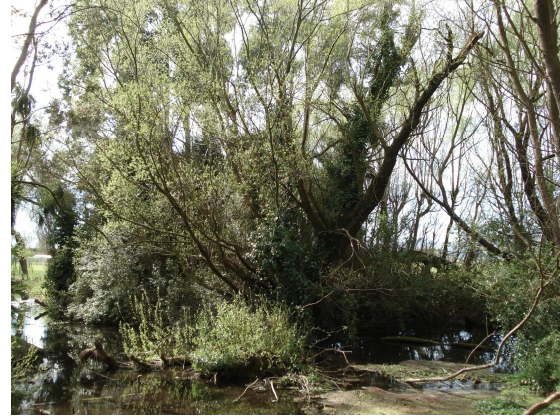
Fig. 3 Crack willow choking the LII River.

As most of the site is cultivated paddocks with shelterbelts little remains of the indigenous vegetation which once covered the site. The few indigenous plants that have survived here are on the river banks that have not been cultivated. The springs, ponds and waterways are also mainly exotic. The area around the spring ponds is manicured grass cover down to the pond on northern and western sides (*Fig.2*). Large exotic trees including weeping willows and wattles give some shade. On the eastern side of the springs are a jumble of tall crack willow and Eucalyptus with ivy climbing up trunks. An occasional cabbage tree and karamu survive amongst the tall trees. Below the pond on the eastern side of the LII crack willow, silver birch, pussy willow, hawthorn, elderberry and several rows of plum and walnut trees provide the main vegetation cover (*Fig.3*).

Crack willow (Fig.3), poplar, ivy (Fig.9), elderberry, pampas grass, cotoneaster, prunus, pines, blackberry, silver birch, hawthorn, silver poplar, gorse, walnut, are all considered to be conservation weeds (Howell, 2008). These plants have the potential to spread and compete with native plantings. They should be removed from the site before planting takes place.

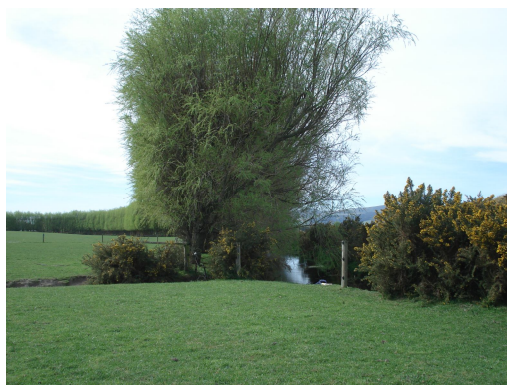
Fig. 4 Pasture and willows line the LII River looking upstream.

The western side of the LII is lined with Matsudama willows for almost a kilometre (*Fig.4*). The southern part of the LII is lined with gorse on both sides of the stream (*Fig.5*). The southern boundary is along a cut-through channel that diverts some of the LI water into the LII before the junction proper. Here grass goes right to the steep bank. The LI stream edge is lined with crack willow, elderberry and occasional gorse.

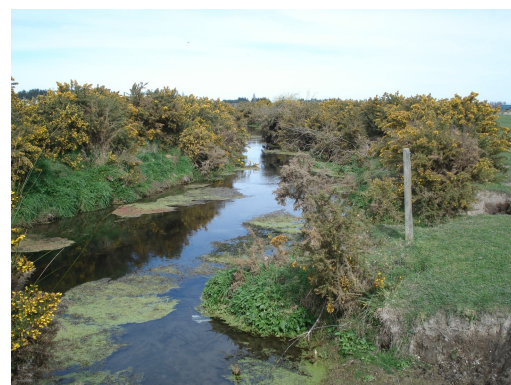
Fig. 5 Gorse lines the LII River downstream

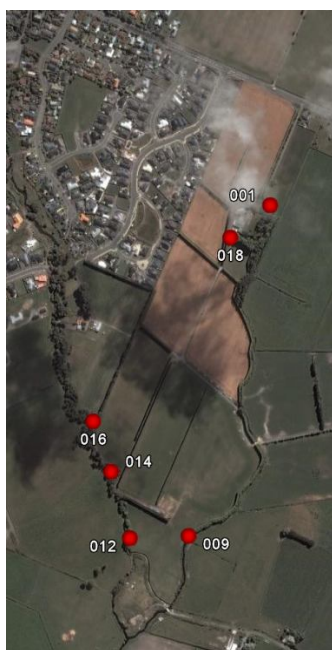
Fig. 6 Location of the occasional naturally occurring indigenous plants on the banks of the LI and LII rivers. Point 014 marks the site of the swamp nettle. See Appendix 2 for other species locations.

There are a few indigenous plants on the waterway margins (Fig.6). Some have been planted and some are naturally occurring. Around the LII springs pond there are a few tall cabbage trees (*Cordyline australis*), several karamu (*Coprosma robusta*) and the occasional flax (*Phormium tenax*)(Fig. 6, Point 001). Near the waters edge several kahikatea (*Dacrydium dacrydioides*) have been planted and are doing well. Planted fuchsia (*Fuchsia excorticata*) has not done so well (possibly frosted). Also around the pond are some pukio (*Carex secta*), and in the pond a small clump of raupo (*Typha orientalis*). A cluster of pukio fills a depression near the house where there are more springs (Figs.2,10, point 018). Downstream in the LII are a few native rushes (*Juncus edgariae*) amongst the gorse covered banks (Point 009).

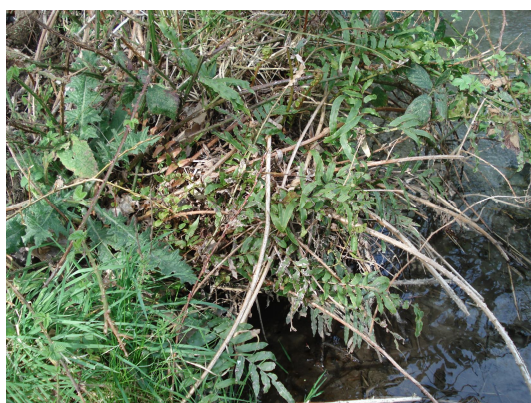
Fig. 7 Swamp kiokio at point 014 on the LI

fern swamp kiokio (*Blechnum minus*)(Fig.7). This cluster of swamp plants is an indication of the plant communities that would have once been common in this area. Also nearby is the climbing indigenous vine pohuehue (*Muehlenbeckia australis*) here climbing over a large crack willow.

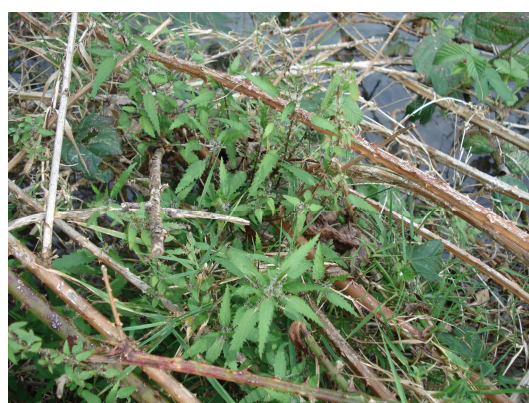
Fig. 8 Swamp nettle at point 014 on the LI

On the east bank of the LI are some naturally occurring indigenous plants not found elsewhere on the site. Of note are two very small clumps of the nationally endangered swamp nettle (*Urtica linearifolia*). This plant has a threat status of 'At risk - declining' (de Lange et al, 2009). The clumps of swamp nettle are near the waters edge and are under some blackberry that has been sprayed (Fig.8). It is likely that the live blackberry leaves protected the swamp nettle from spray damage. Close to the swamp nettle are some pukio and a single

The site is regarded as significant because of the presence of swamp nettle which is on the New Zealand threatened plant list (de Lange, 2009). The creation of an esplanade reserve along both the LI and LII rivers will provide legal protection for the swamp nettle and its associated cluster of plants. Physical protection can be achieved by identifying and marking the swamp nettle and restoration of the site during landscaping (Fig.8). Restoration would involve removing the blackberry vines by careful cutting and pasting the stems with herbicide, taking care to not damage the existing swamp nettle, pukio and the swamp kiokio. Planting along the stream edge with more of the swamp nettle, pukio and swamp kiokio would restore the site to a viable plant community.

1. Protect the swamp nettle as above.
2. Ensure that all species planted are locally sourced.
3. The trees and shrubs in the landscape plan are a good selection for establishment planting. Once established swamp kiokio and swamp nettle can be planted amongst the flaxes and sedges.
4. Add pokaka as a companion plant to kahikatea. Like kahikatea it can stand wet feet and therefore is a good tree to plant in wet areas. It also provides berries for birds.
5. Add more divaricating shrub species in drier areas eg *Coprosma virescens* for berries to encourage birds and lizards
6. Remove as many of the weedy species as possible. Remove most exotic trees as the native plants become established.
7. Don't plant willows as they will shade out the sedges and clog streams.

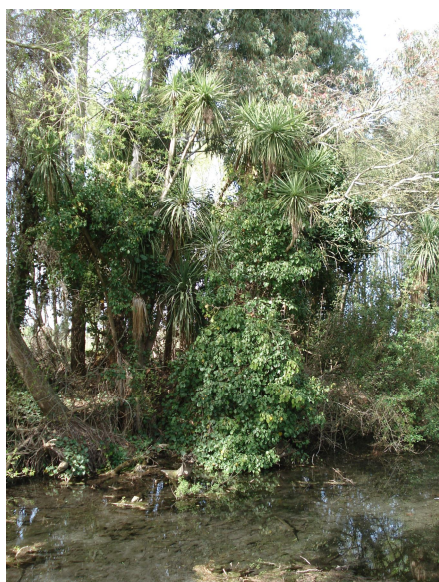
Fig. 9 Ivy growing up a cabbage tree.

Plant pests are a threat to the few remaining indigenous plants. The few pukio are being shaded out by willows and ivy is threatening to smother cabbage trees (Fig. 9). Because there are so few native plants their resilience to plant pests is low.

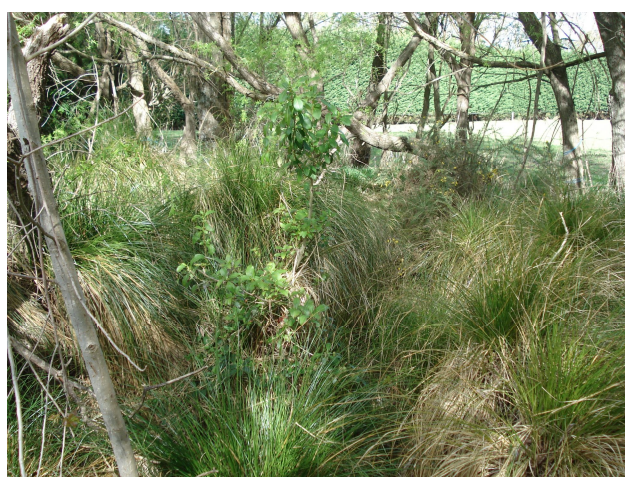
Fig. 10 Pukio in a depression around a spring (Point 018)
