Soil Contamination Risk

Stage 1 Preliminary Site Investigation Report

**311 Trents Road • Prebbleton
P16845**

June 2013

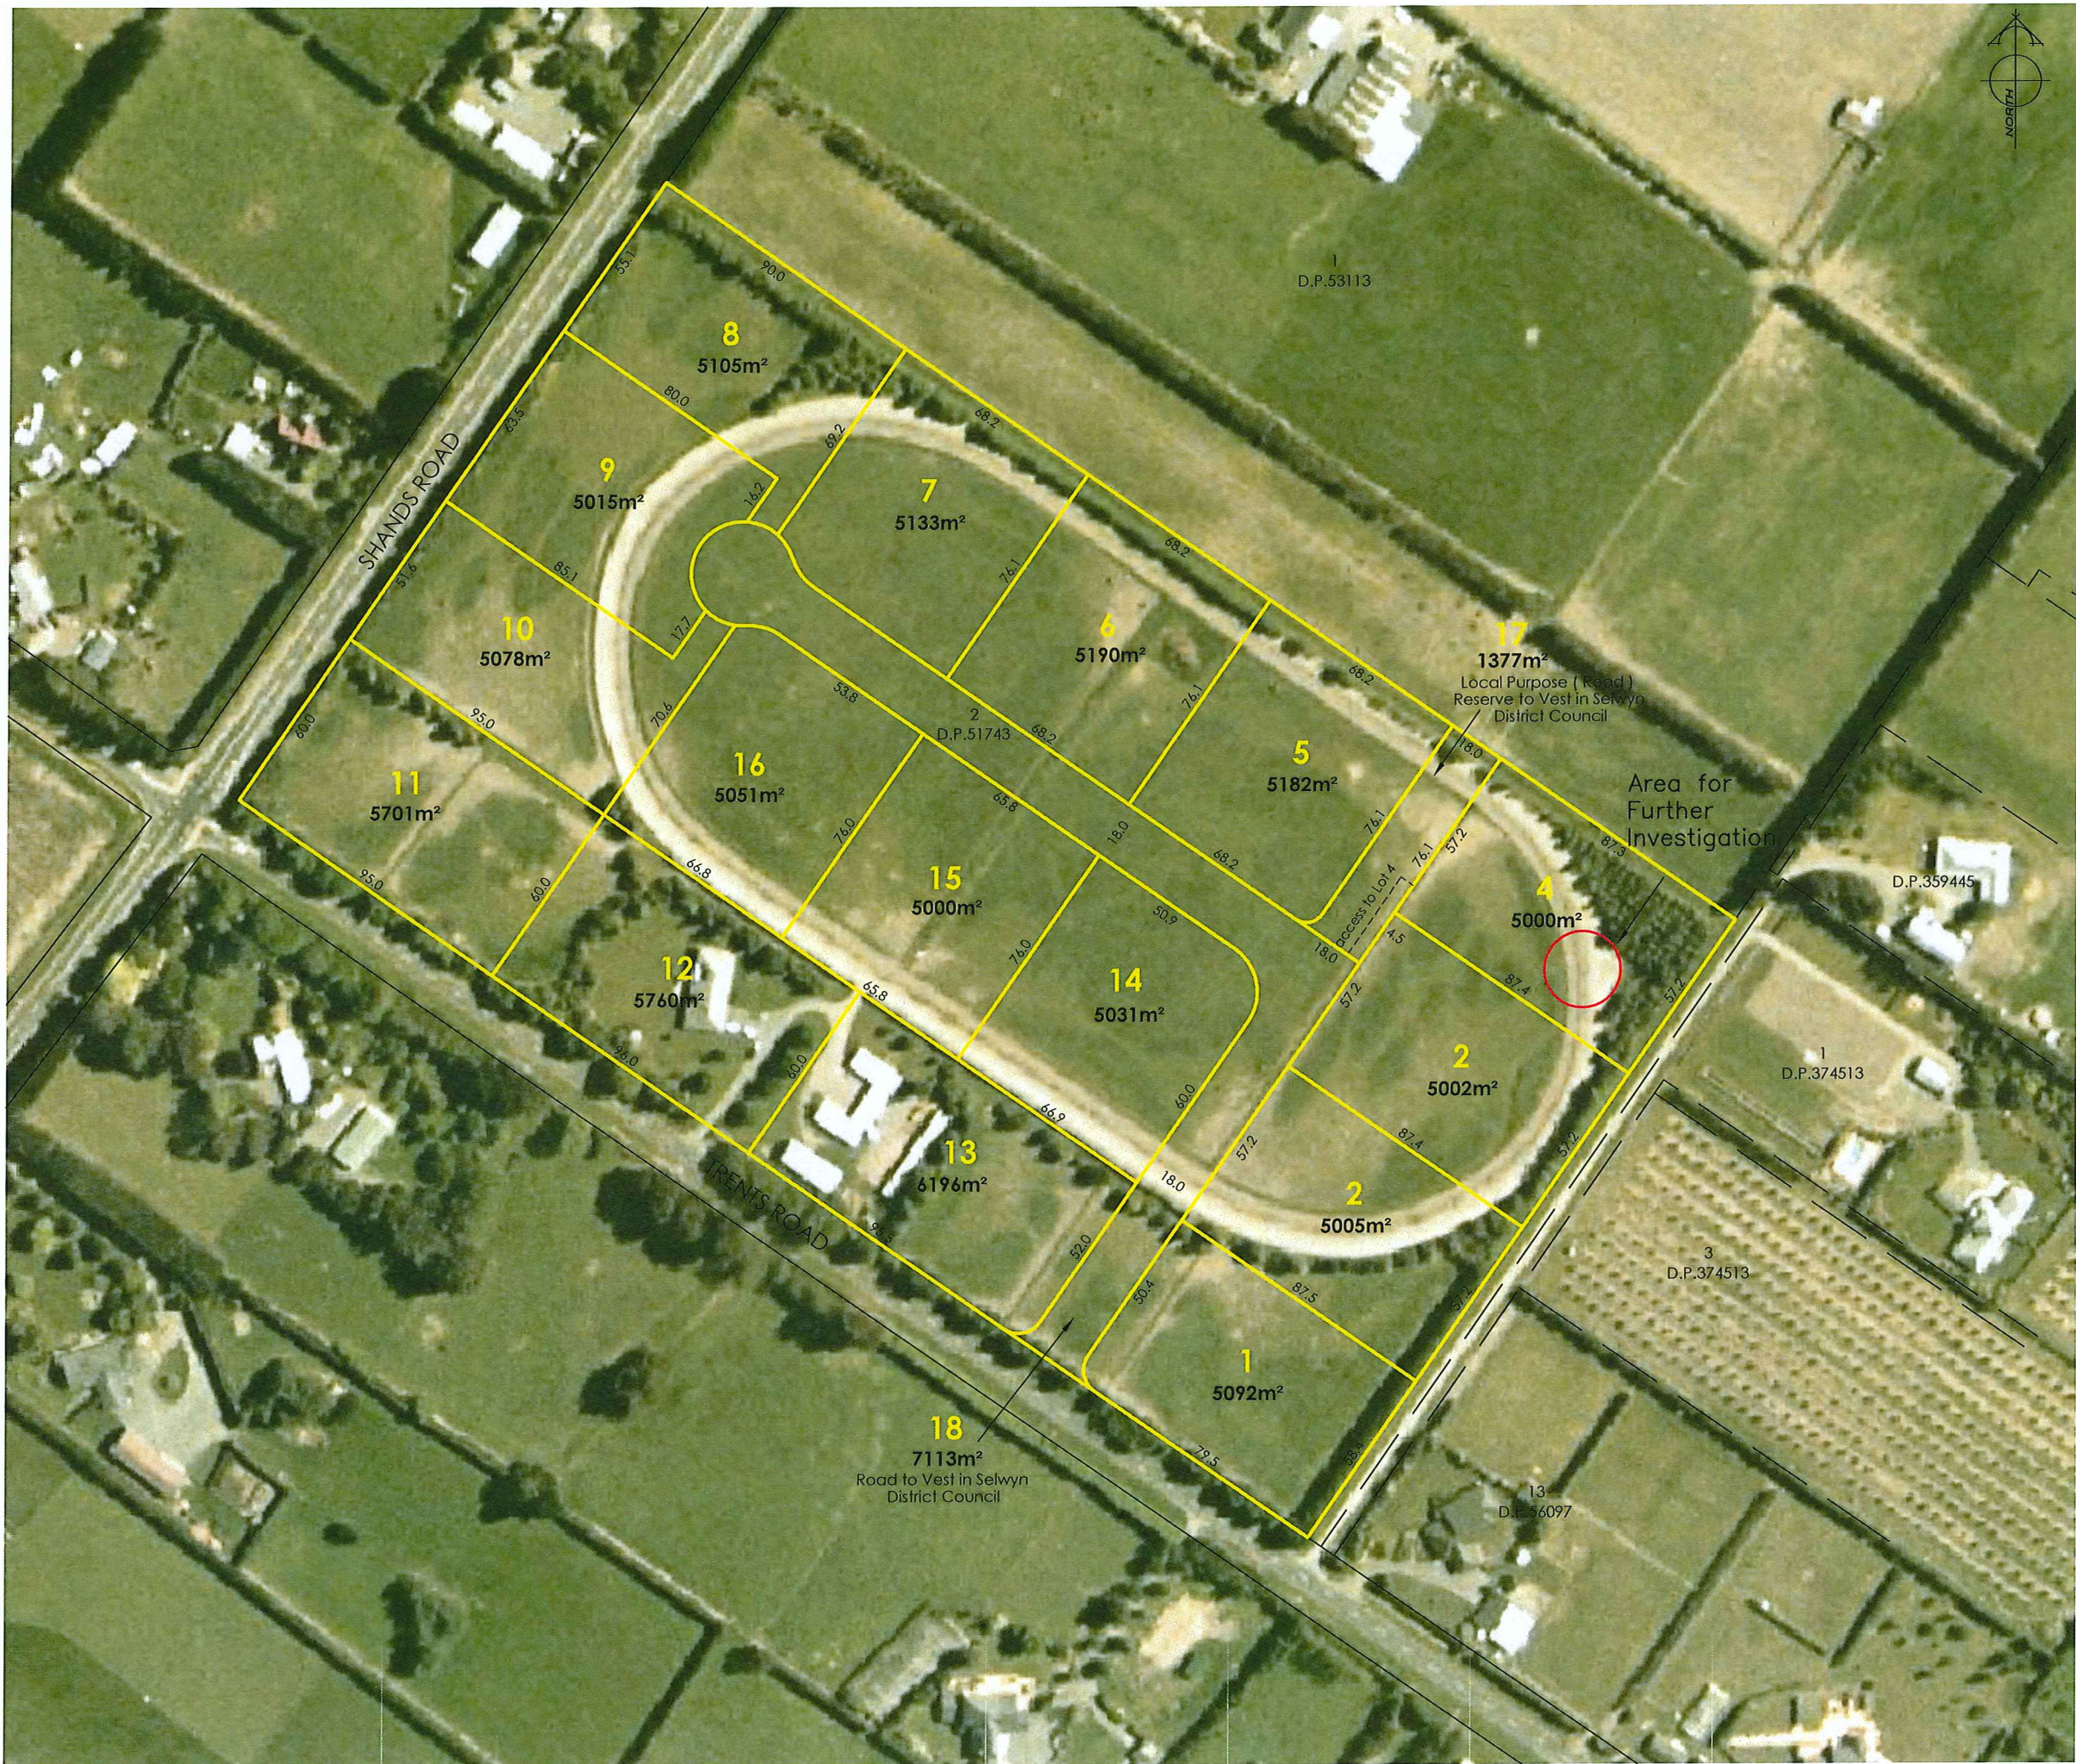
Appendix C – Proposed Subdivision Plan

SHEET TITLE:
**Possible Subdivision of
Lot 2 DP 51743**

The area below and around the above ground diesel tank should have further investigations carried out including soil sampling. The plan included in **Appendix C** identifies the area that should have further investigations carried out.

It is recommended that further detailed investigation, including soil testing, be carried out on the site in the identified risk area shown on the plan in **Appendix C.**

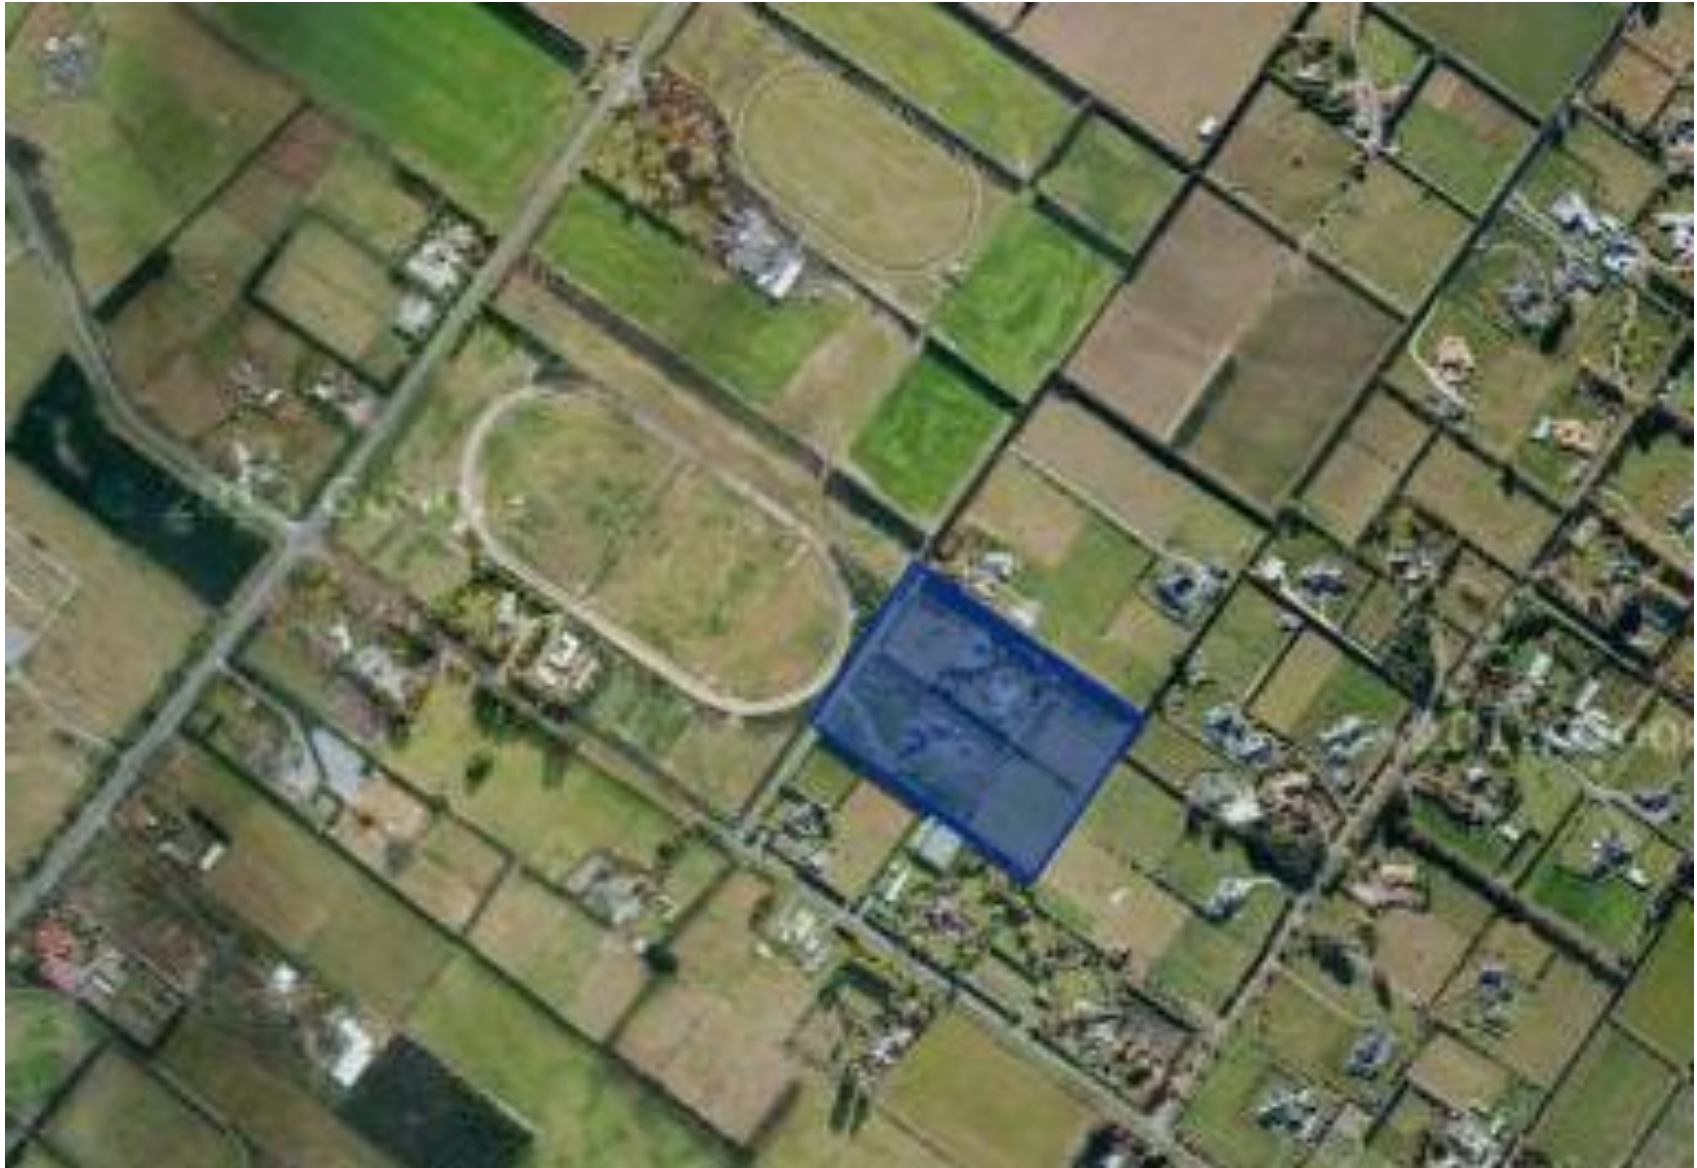
Appendix F – LINZ Mapping Layers – Orchard Layer

A small block adjacent to the eastern boundary has been identified on the LINZ orchard layer (Copy in **Appendix F**) as having been used in the past as an orchard. The site has been used as an olive orchard since the early 2000's. An established shelter belt of large, tall trees along the property and a driveway, approximately 8m wide, exists between the site boundary and the location of the olive orchard. A 2004 aerial indicates the edge of the tree crown at that time was approximately 20m from the boundary and that the shelter belt crown was approximately 8m wide.

A small block adjacent to the eastern boundary has been identified on the LINZ orchard layer as being used since the early 2000s as an orchard.

The adjacent land identified as an orchard in the LINZ orchard layer was used as an olive orchard since the early 2000's. (Copy in **Appendix F**) Olives are generally relatively resistant to pests and disease in New Zealand. If sprays were used on this orchard, they were likely to have been modern copper based sprays which do not persist in the environment. The shelter belt on the site boundary will have provided a barrier to any spray drift. Due to the orchard being established many years after the last permitted use of the types of chemical sprays that persist in the environment, the recent use as an olive orchard, and the significant shelter belt and
