**COLES PROPERTY PARK  
LANE: ROLLESTON**

**GEOTECHNICAL  
ASSESSMENT FOR  
SUBDIVISION PLAN CHANGE  
AND RESOURCE CONSENT**

**Report Reference:** 12891-A

**Date:** 18 December 2012

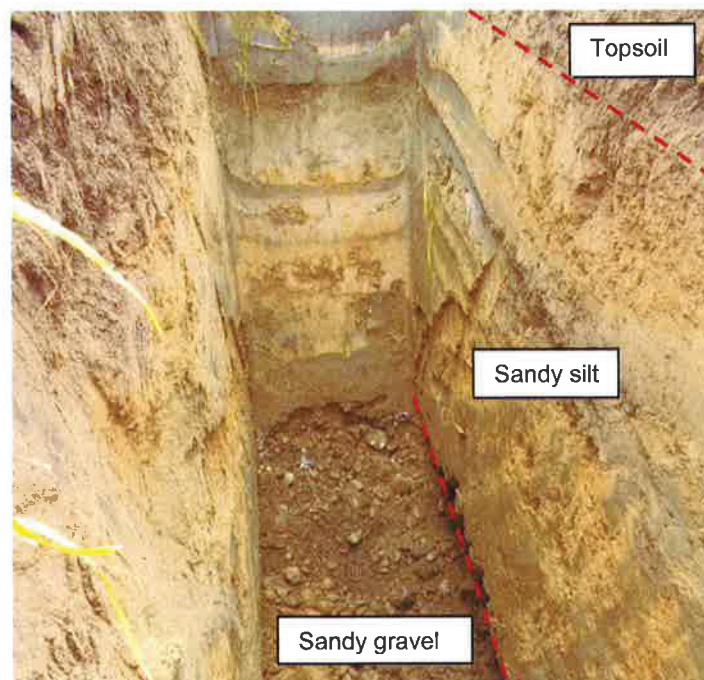
**Photo 1: Sandy silt underlain by sandy gravel with cobbles and boulders to 2.0 m depth (TP3)**

The material encountered in the test pit investigations comprised between 200 and 600 mm organic sands (topsoil) underlain by sandy silts and silty sands to a depth of between 0.75 to 2.2 m. Gravels were located below the sand and silt layers to the extent of testing (a maximum of 5.2 m in TP5).

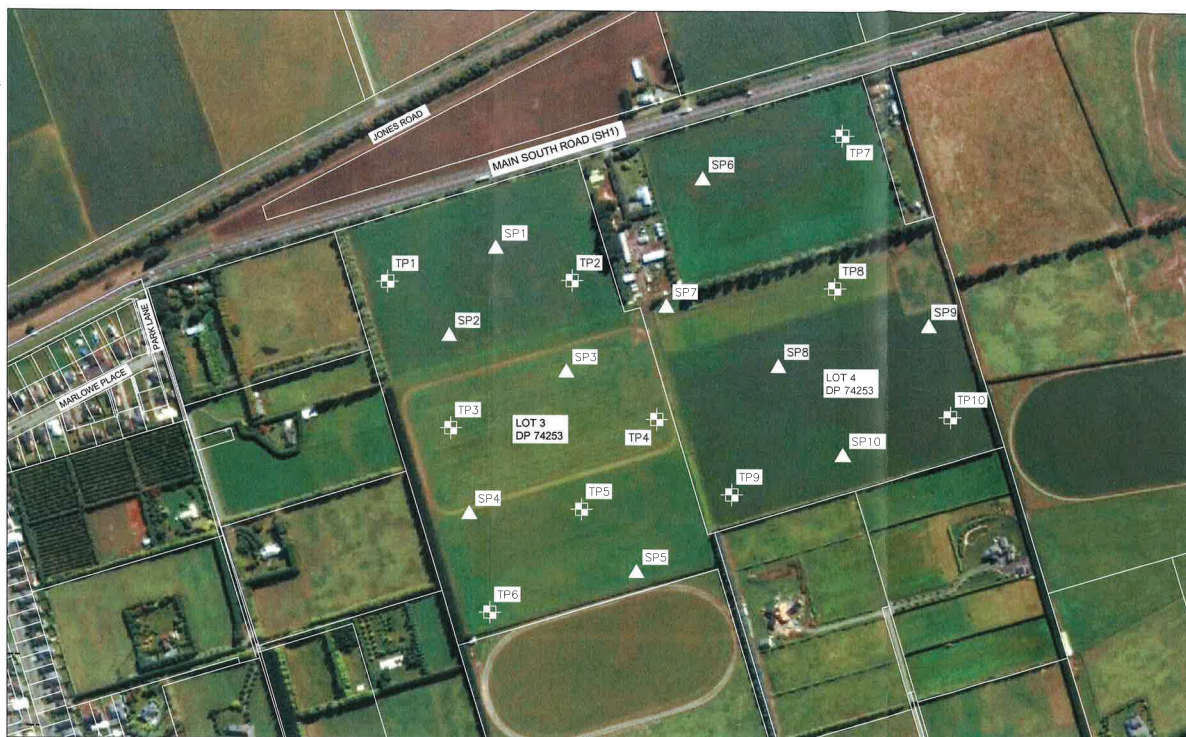
<b>RILEY</b> CONSULTANTS	P.O. BOX 4355 CHRISTCHURCH TEL. 03-3794402 FAX. 03-3794403	TITLE  <b>NIMBUS GROUP</b> <b>COLES PROPERTY, PARK LANE</b> <b>GEOTECHNICAL INVESTIGATION SITE LOCATION PLAN</b>	CAD FILE 12891-01

The testpits were logged in accordance with the NZGS guidelines (December 2005) and the location of the geotechnical investigations is shown in Appendix A.
