**RE: GEOTECHNICAL LETTER  
RESPONSE TO PEER REVIEW  
PLAN CHANGE REPORT, 631 SHANDS ROAD, CHRISTCHURCH**

Soil & Rock Consultants have been asked to respond to a peer review by Ian McCahon of Geotech Consulting Limited who have peer reviewed a Soil & Rock Consultants plan change geotechnical report titled "*Geotechnical Investigation, proposed Rural Residential Subdivision, 631 Shands Road, Prebbleton; Rev A, Ref C15449, dated 16 October 2015*". Attached to this letter is the geotechnical peer review letter.

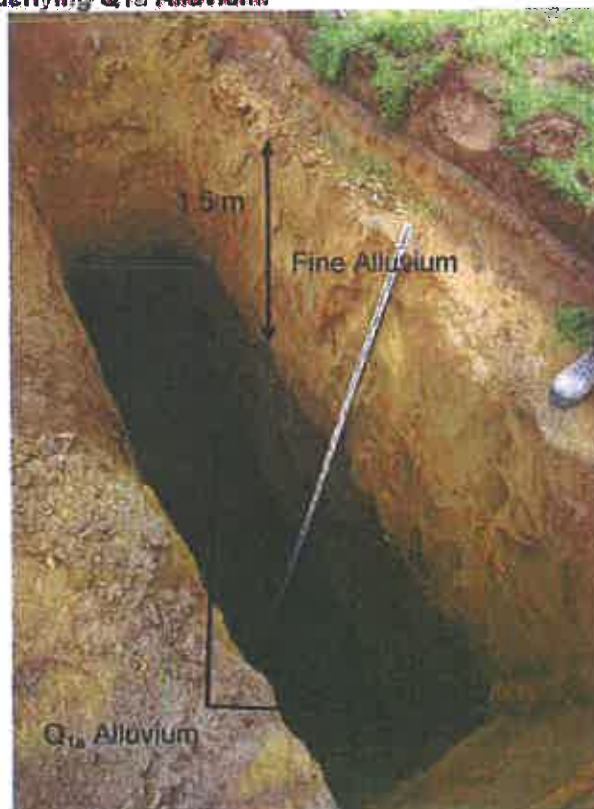
**Figure 2. Photograph of inspection pit TP2 showing the contact between the Fine Alluvium and underlying Q1a Alluvium.**

This unit typically consists of silty SAND and underlies Topsoil. Its thickness ranges between 0.35m (TP8) and 1.6m (TP1) (Figure 2). The variable thickness reflects undulations in the ground surface, and an irregular/channelled surface in the underlying Q1a Alluvium.

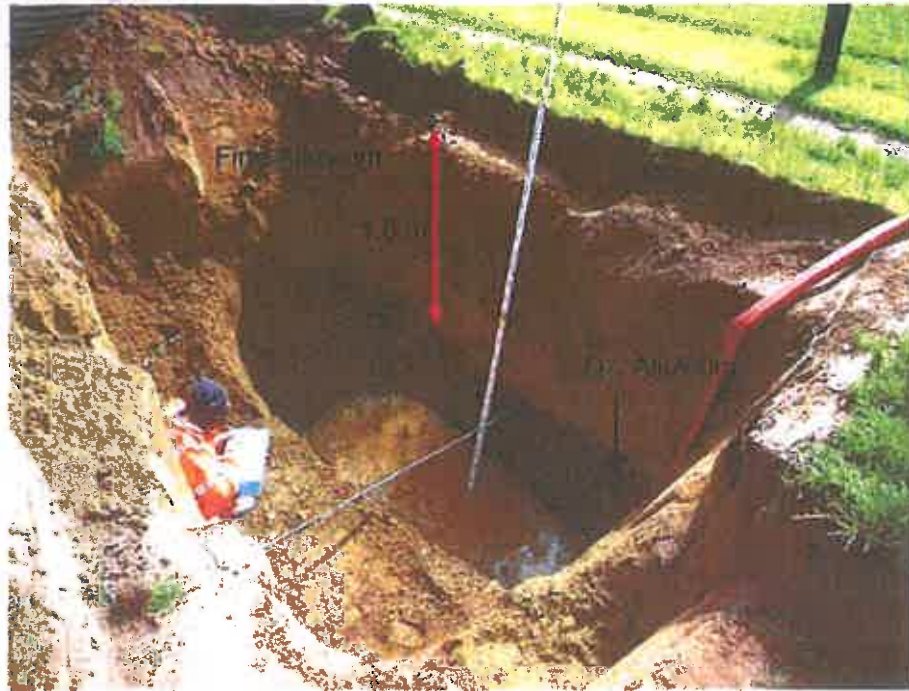
**Figure 3. Photograph of Infiltration test of gravelly Q1a Alluvium in inspection pit TP3**

We understand that on-site disposal of clean stormwater will be via soakage pits. To assist the preliminary design (by others) of the soakage pits two infiltration tests were completed in TP3 and TP6. The tests were undertaken in general accordance with the Auckland City Soakage Design Manual.

- Each pit was pre-soaked twice prior to the commencement of a falling head percolation test. After pre-soaking, each pit was then re-filled with water to the top of the gravel alluvium and the drop in water recorded at regular intervals.
- The two tests were carried out at different depths below the fine alluvium to assess any change in geological conditions resulting in variability in the permeability rates, and as such the percolation rates calculated range in value. (refer Table 2 and Figure 3, with further calculation details in Appendix D).
- The results were calculated using a formula from Digest 365 of the British Research Establishment, and are limited by the fact that the inspection pits excavated were assumed to be perfectly rectangular and the precision of the measuring devices used (stopwatch and survey staff).

From the soil infiltration tests undertaken in the (Q1a Alluvium) gravel we the infiltration rates calculated differ by a factor of 10, and that this is most likely due to differences in the geology between the pit locations. Further testing is advised when during detailed design (by others) of the stormwater system for the subdivision.
