Appendix 8: Preliminary Site Investigation Report

Preliminary Site Investigation – 193 and 223 Creyke Road, and 1878 Telegraph Road, Darfield

✦ March 2016

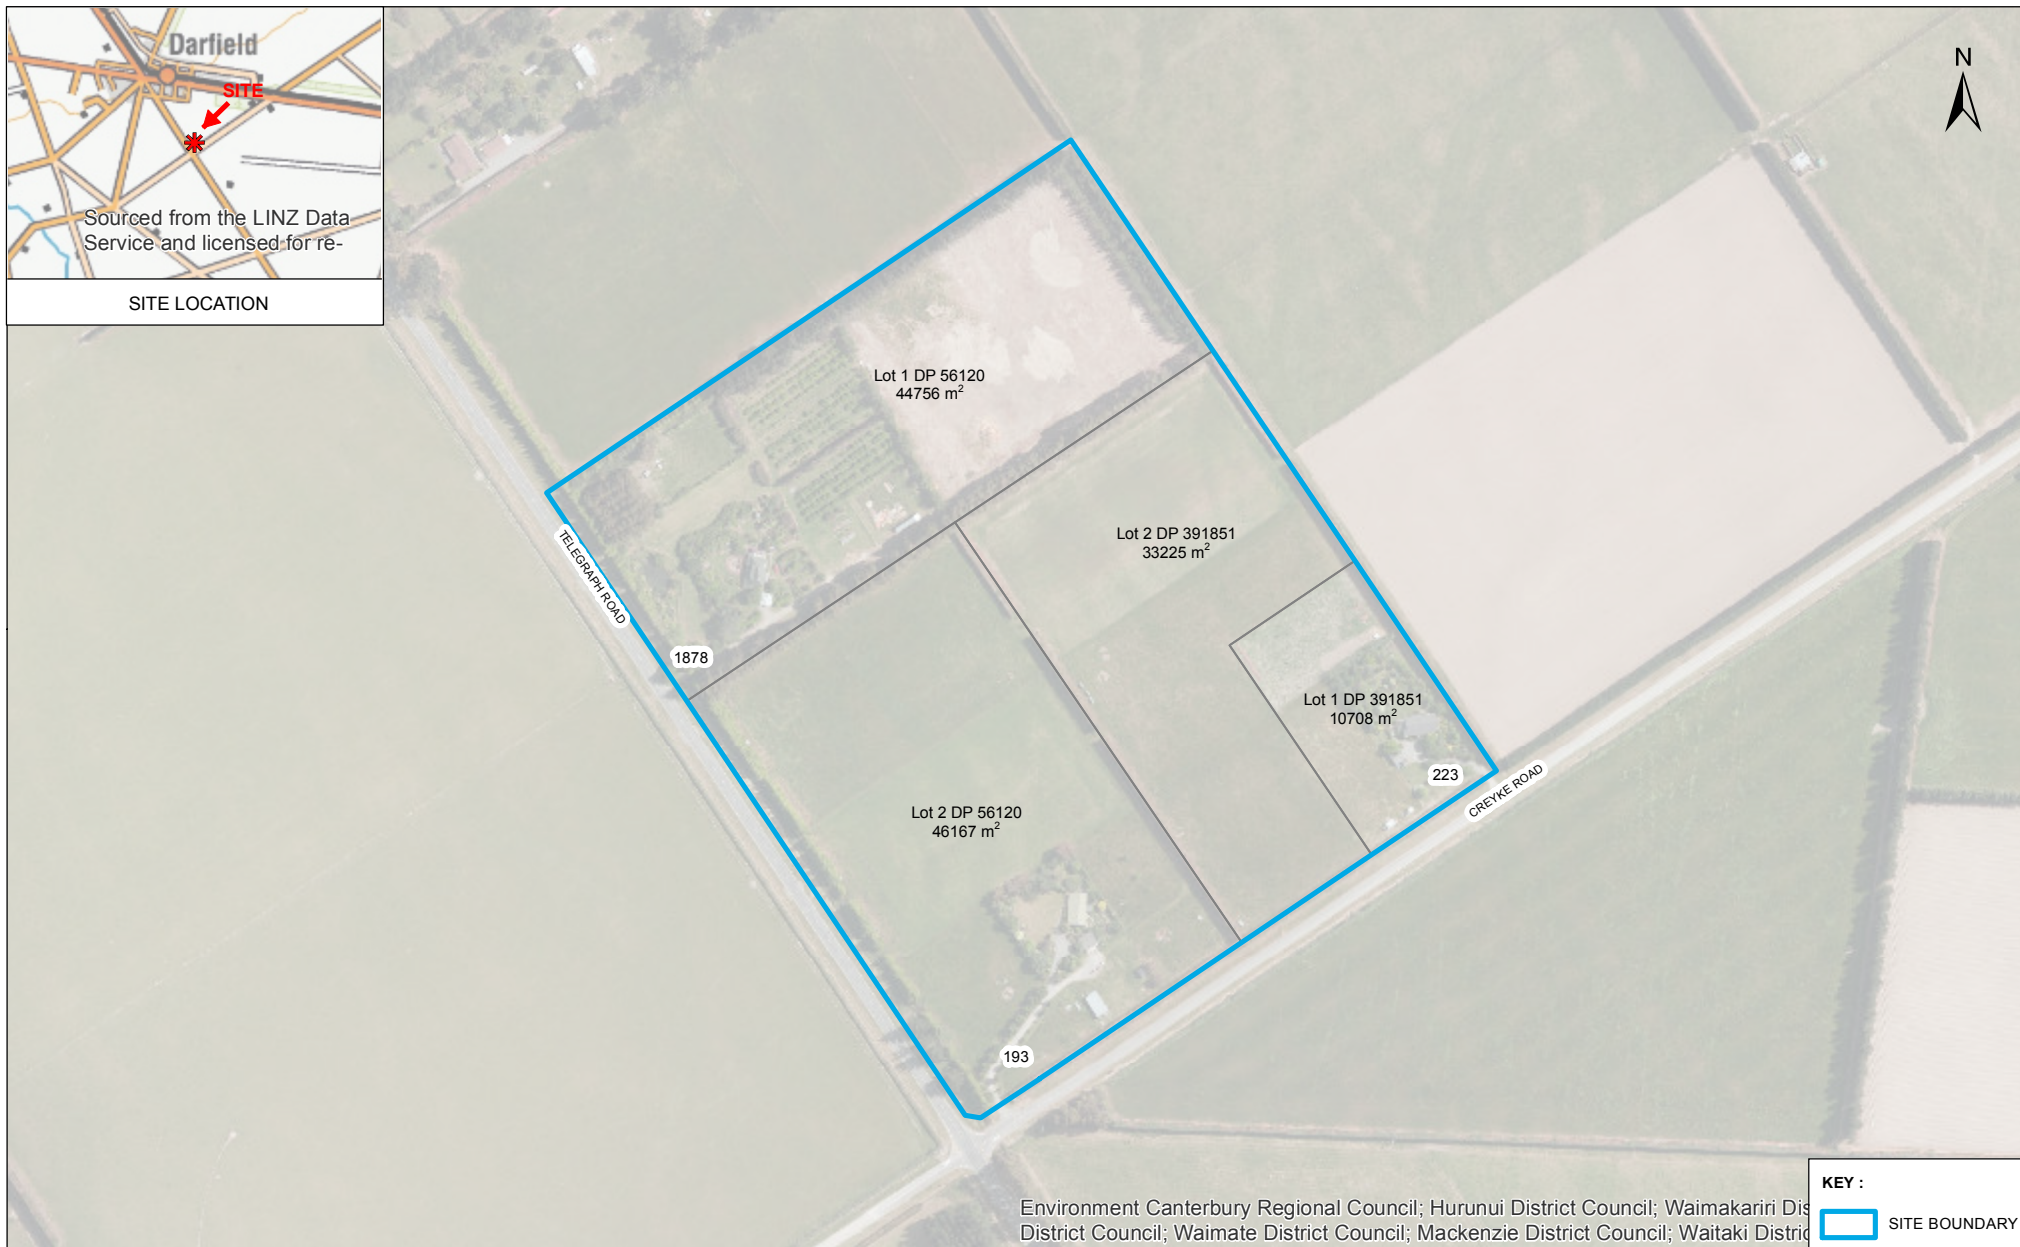
FIGURE 2 : LAND PARCELS

The details of the site are provided below, while a site location map is presented as Figure 1, Appendix A and a land parcel layout plan is presented as Figure 2, Appendix A. Photographs of the site are presented in Appendix B.

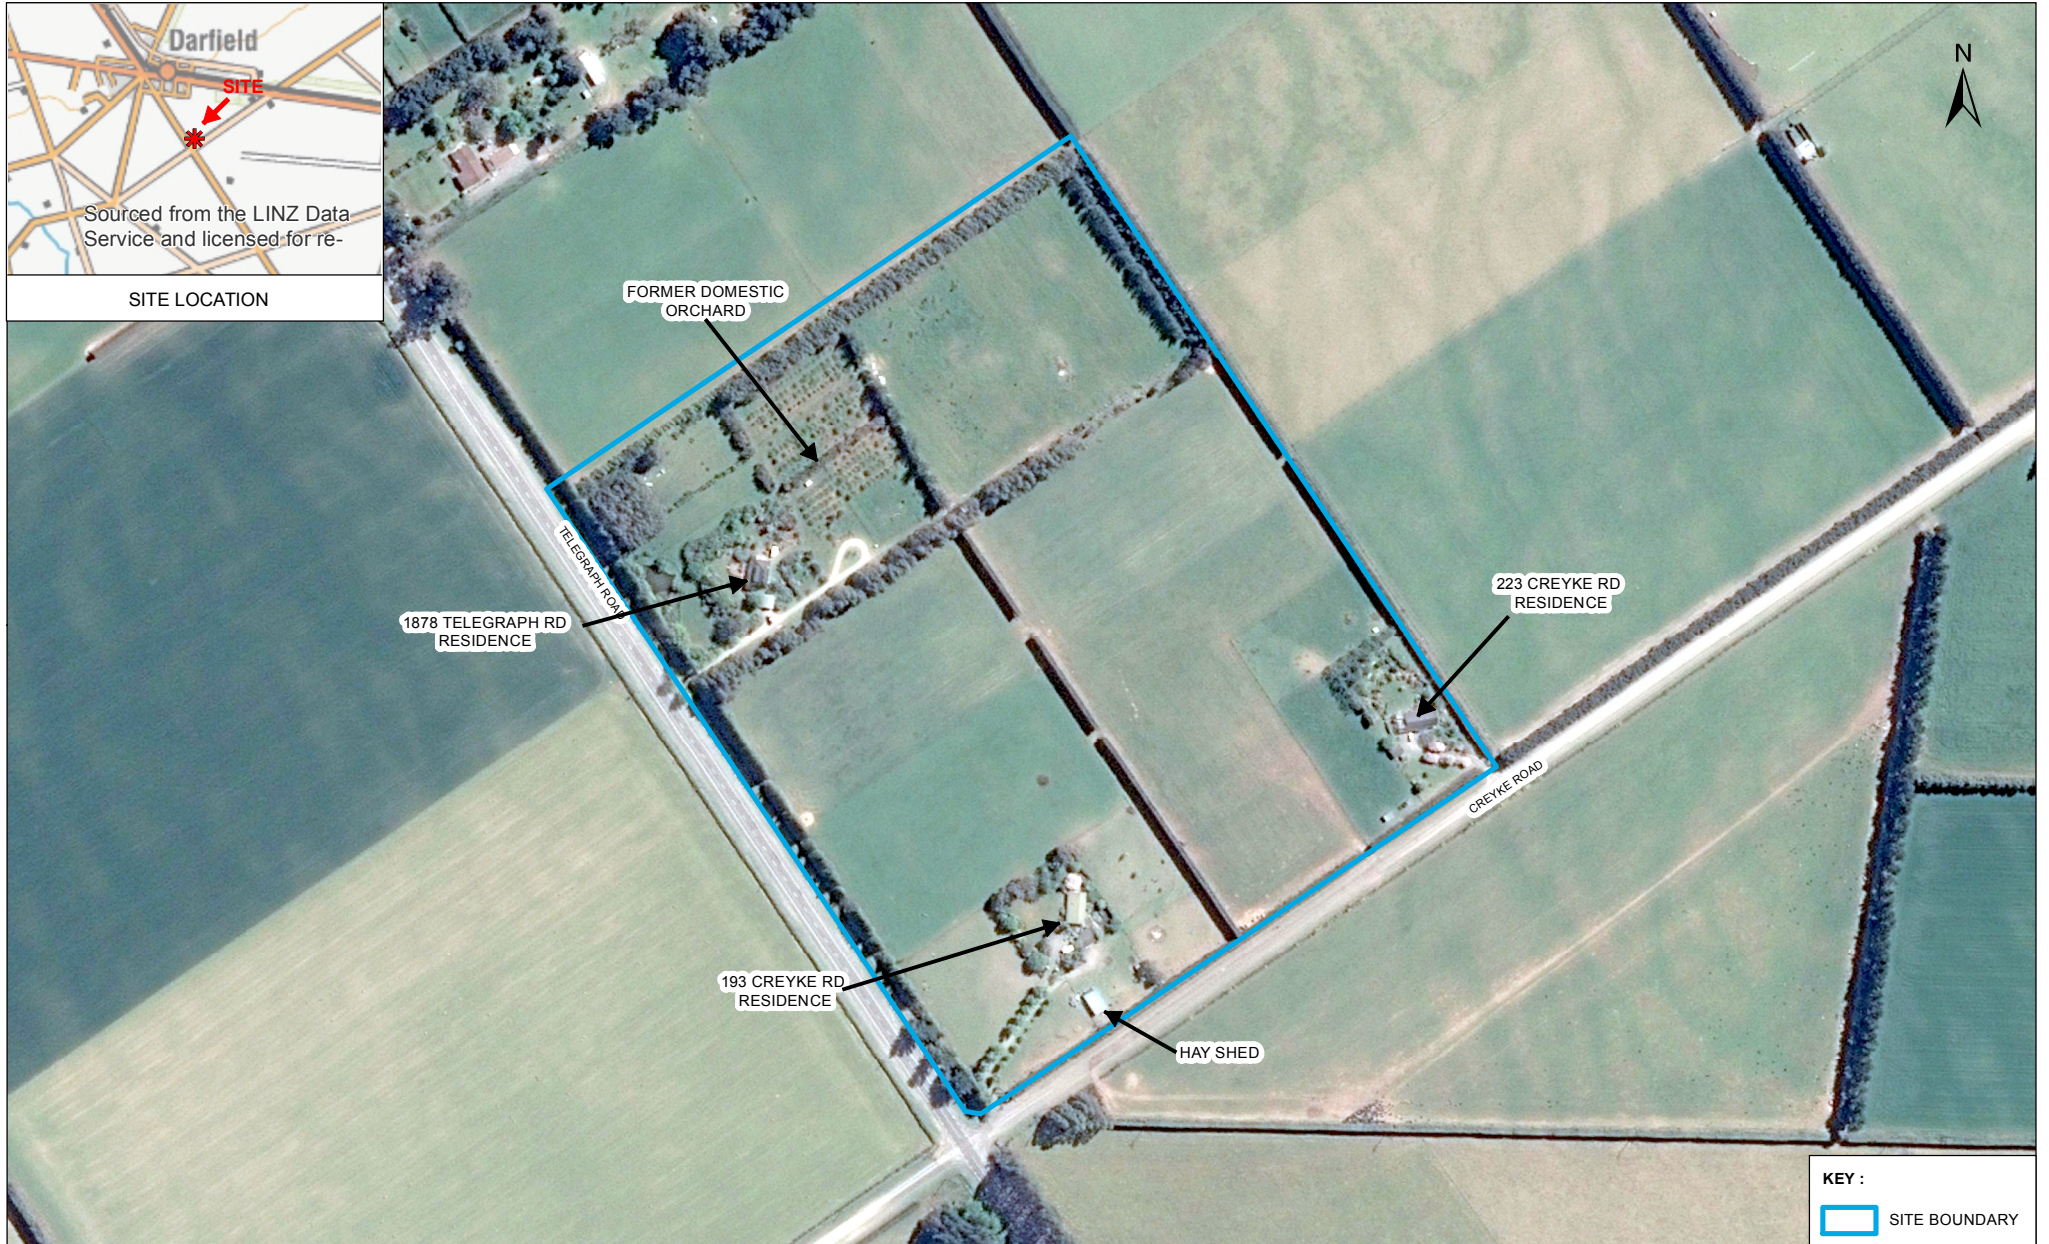
A site inspection was undertaken by a PDP environmental scientist on 9 March 2016. Details of the site are presented on Figure 3, Appendix A, and noted below. Photographs of the site are presented in Appendix B:

- ✧ 193 Creyke Road is a rural-residential property with a house, garage and two hay barn sheds. Sheep, horses and ponies are grazed at the site. A small burn pile of predominantly greenwaste is located in one paddock;
- ✧ 223 Creyke Road is a small rural-residential property with a house and garage. Two sheep and a pony are grazed at the site; and
- ✧ 1878 Telegraph Road is a rural-residential property with a house and garage. The property was largely overgrown and the remnants of a small scale domestic orchard were visible to the rear (east) of the house.

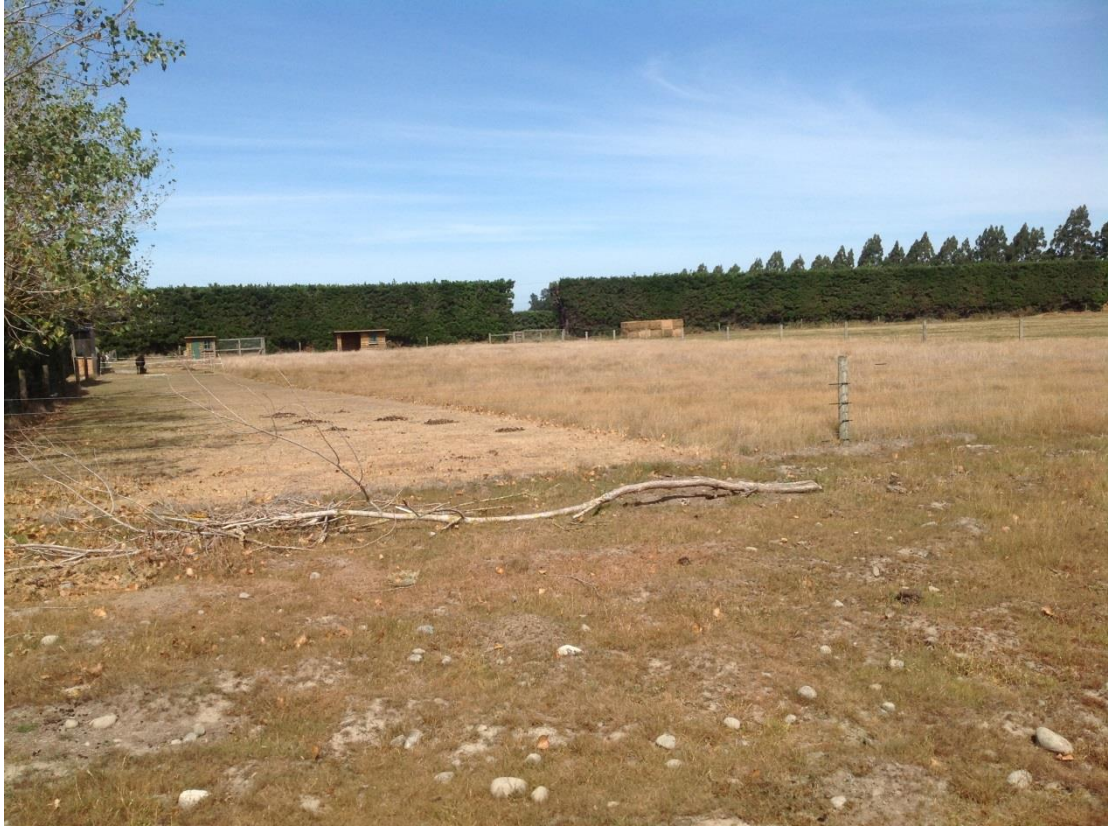
Photograph 1: View looking south-east towards Creyke Road within the 223 Creyke Road property.

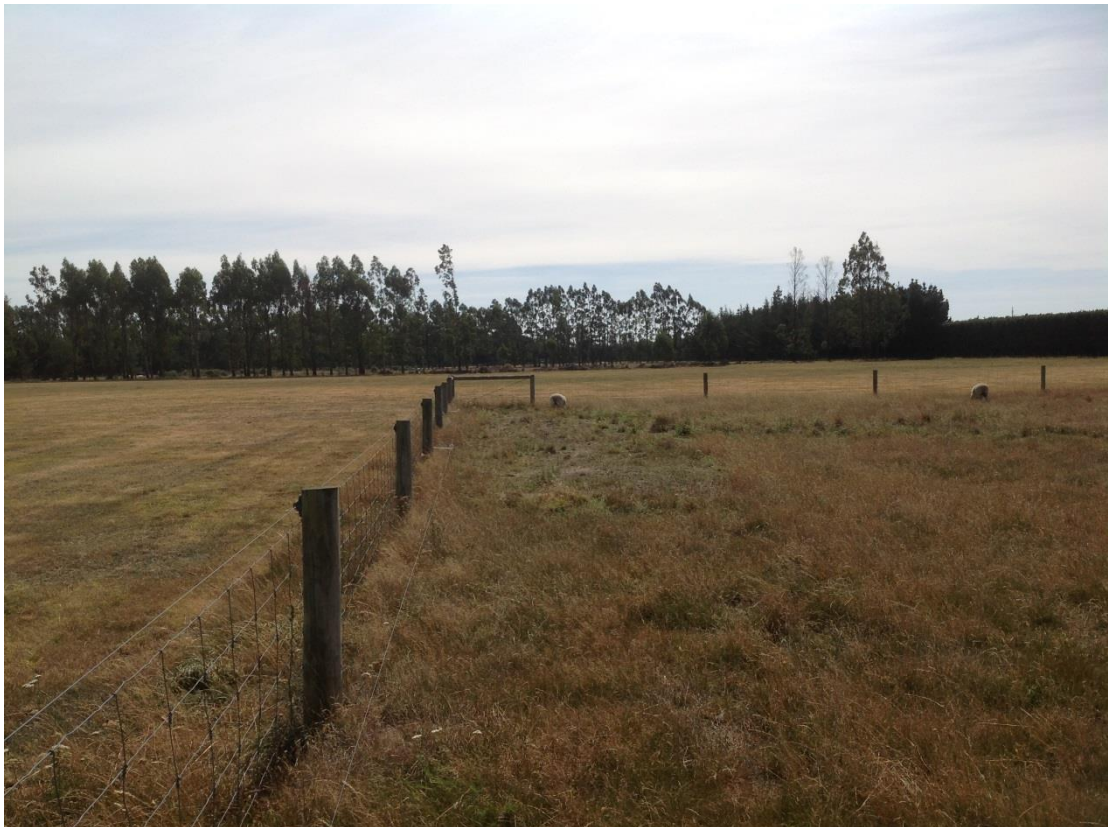
Photograph 2: View looking north-west from within the 223 Creyke Road property.

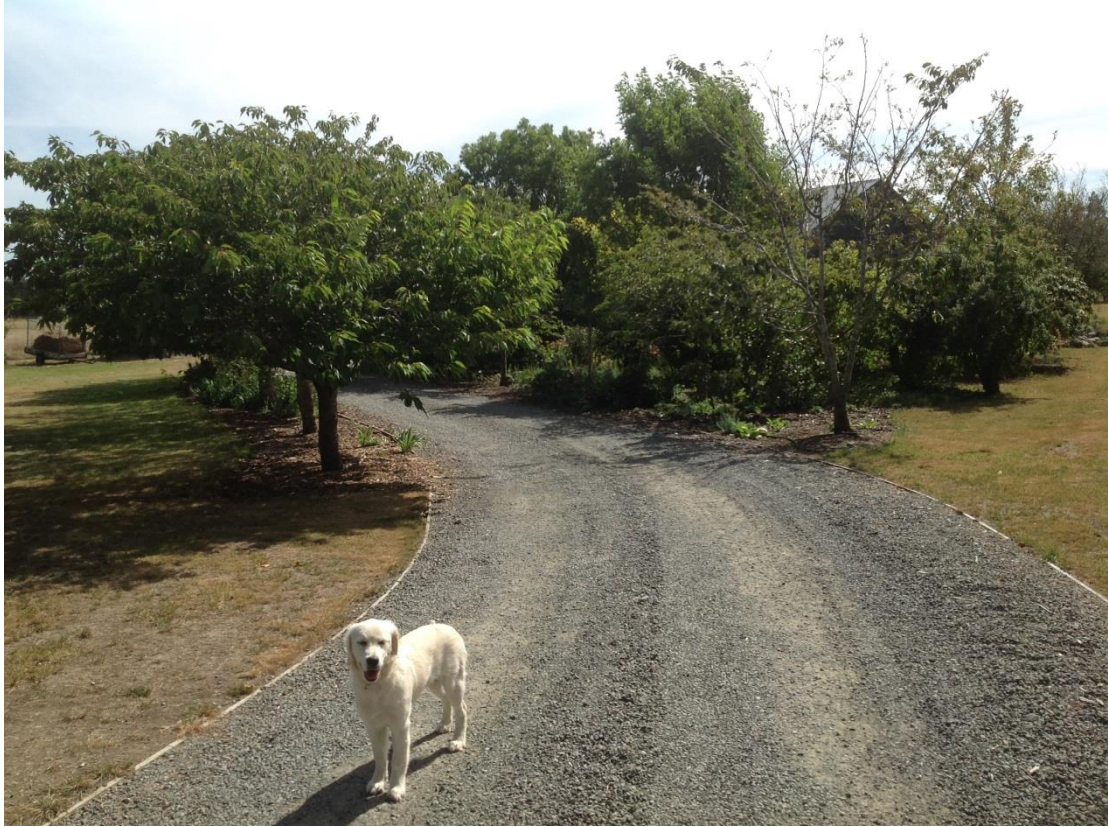
Photograph 3: View of the residential property at 223 Creyke Road.

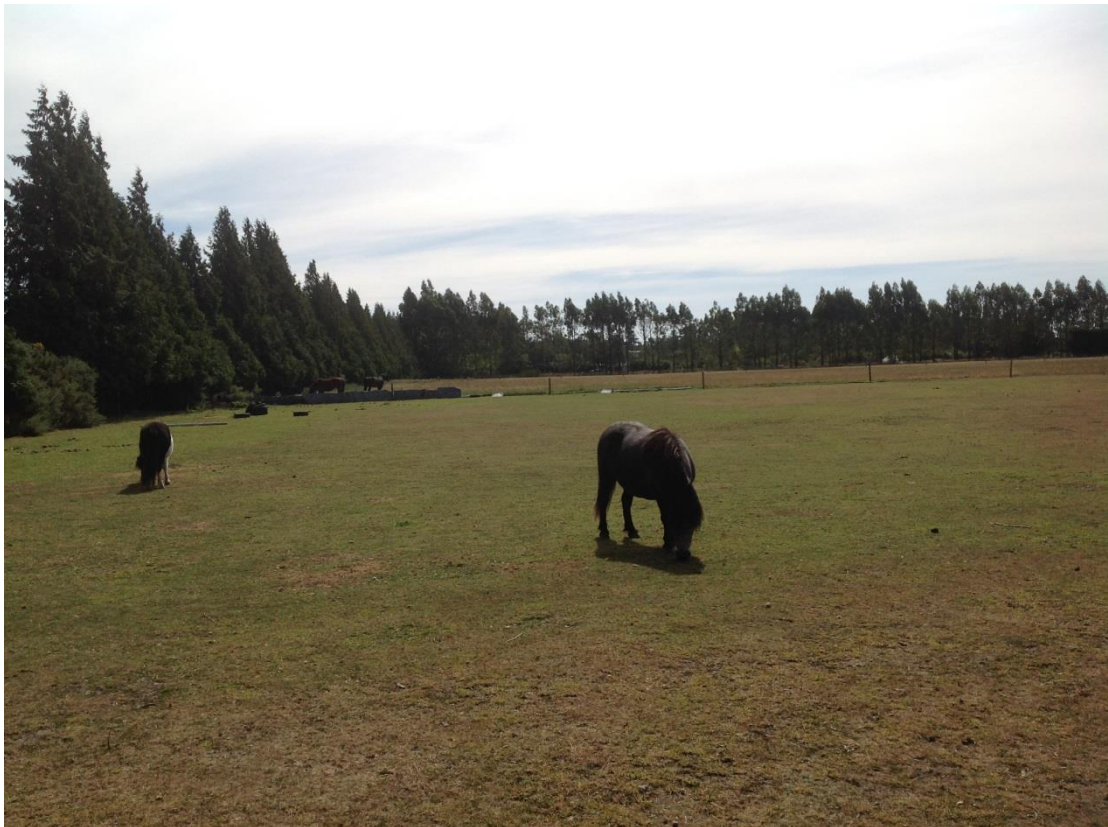
Photograph 4: View looking north-west from the driveway of the 193 Creyke Road property.

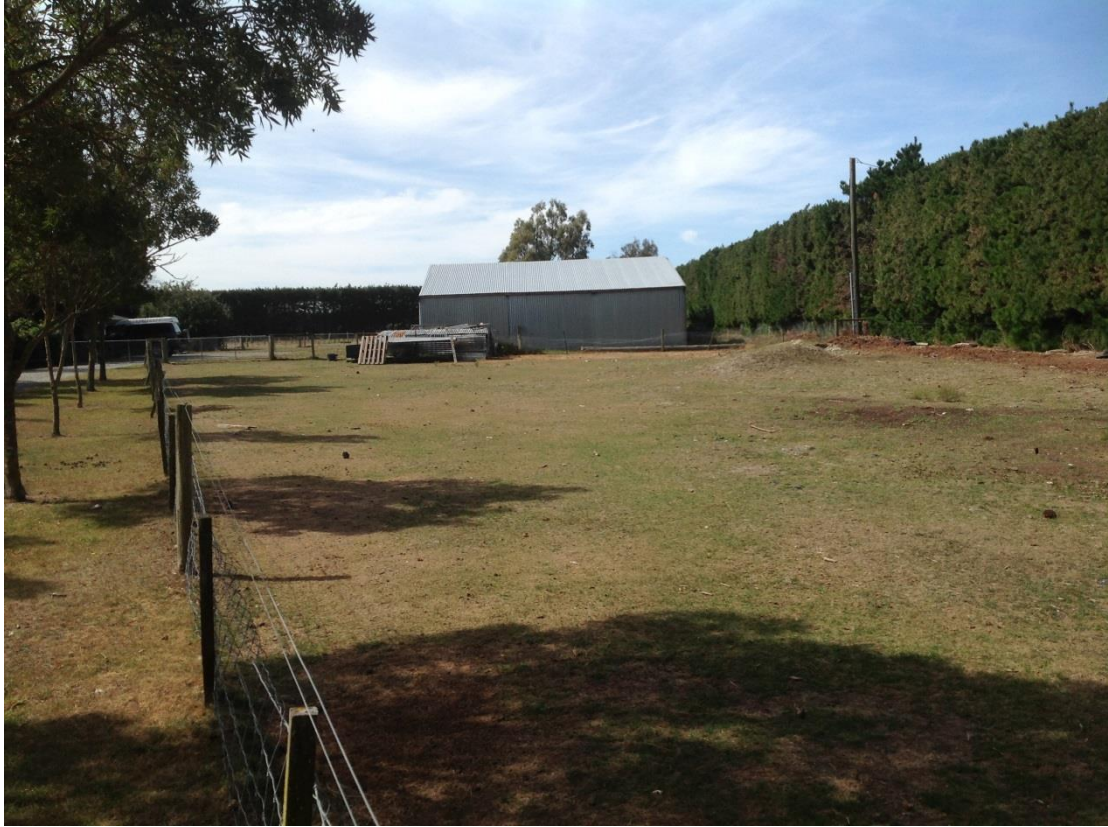
Photograph 5: View looking north-east towards the hay shed at 193 Creyke Road.

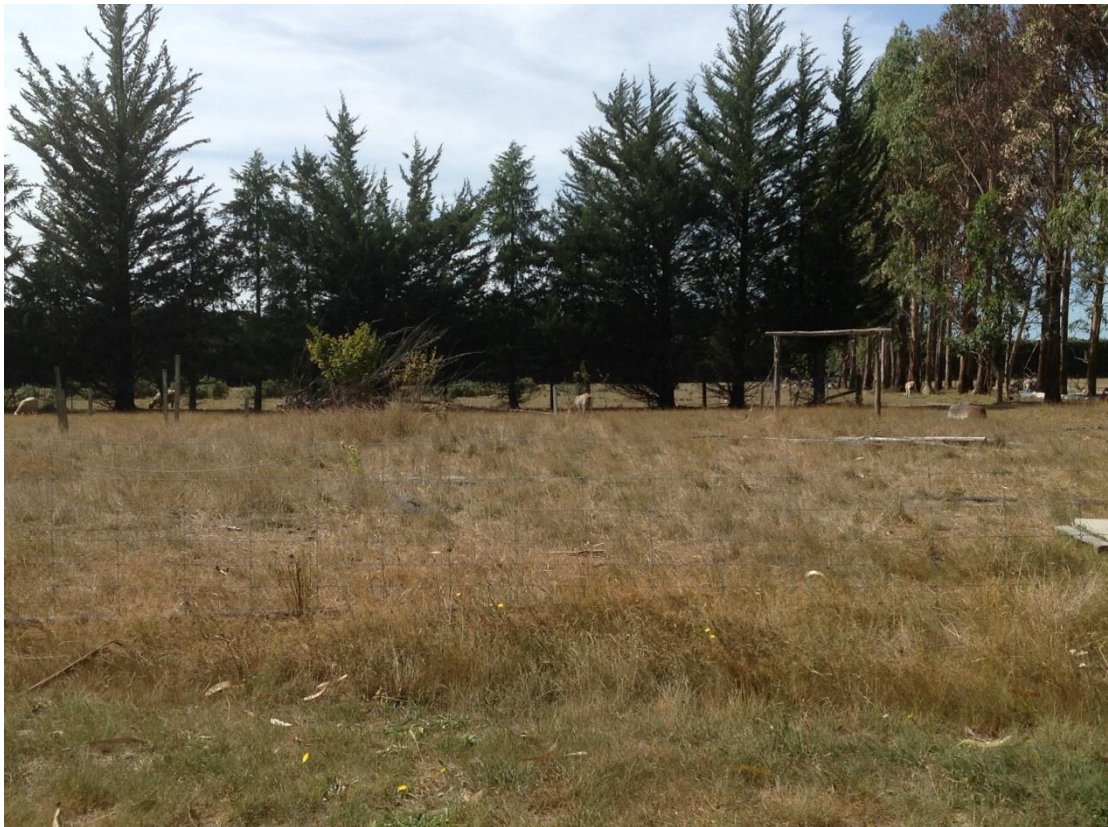
Photograph 6: View looking north-east towards the former orchard and area of trees at 1878 Telegraph Road.

- ✧ Mrs Lisa Reily owned the 1878 Telegraph Road property between 2005 and 2008. The trees were planted approximately five years before they purchased the land (i.e. around 2000). No chemicals/sprays were ever used on the orchard; and
- ✧ Mrs Carolyn Mead owned the property between 2009 and 2011. Only water was used on the hazelnut trees rather than any chemicals/sprays.

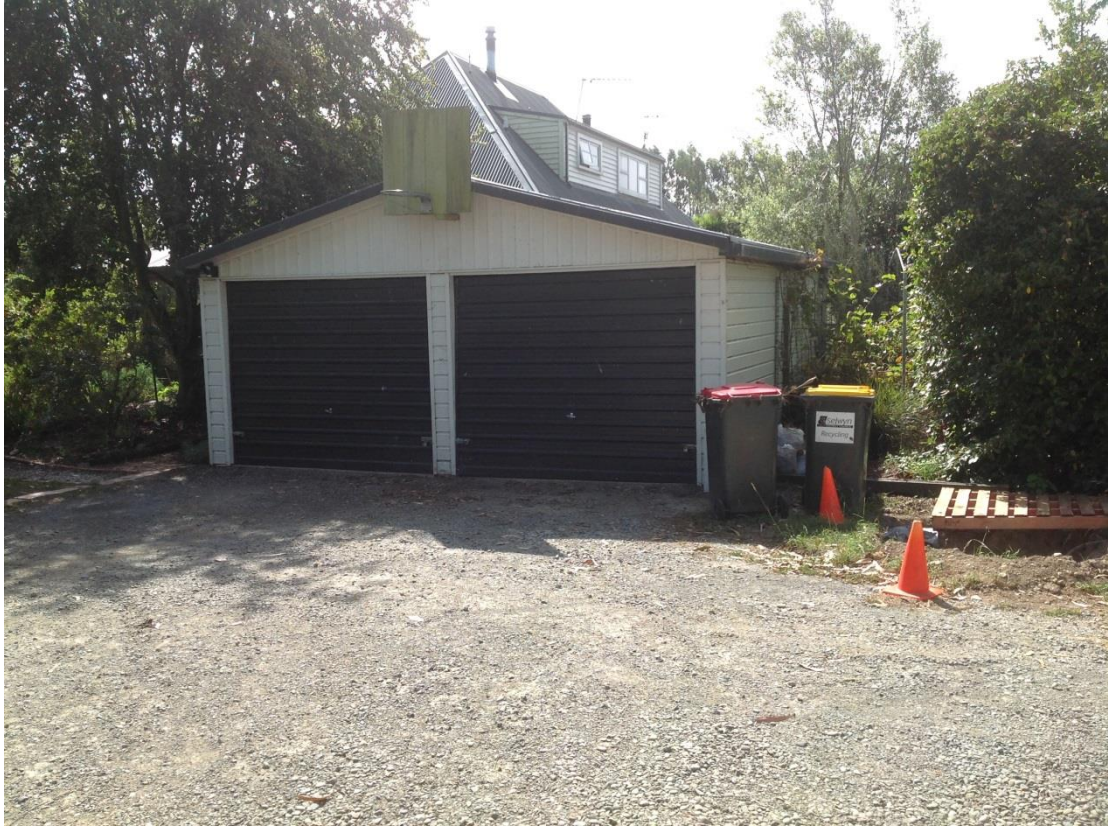
Photograph 7: View of the residential property at 1878 Telegraph Road.

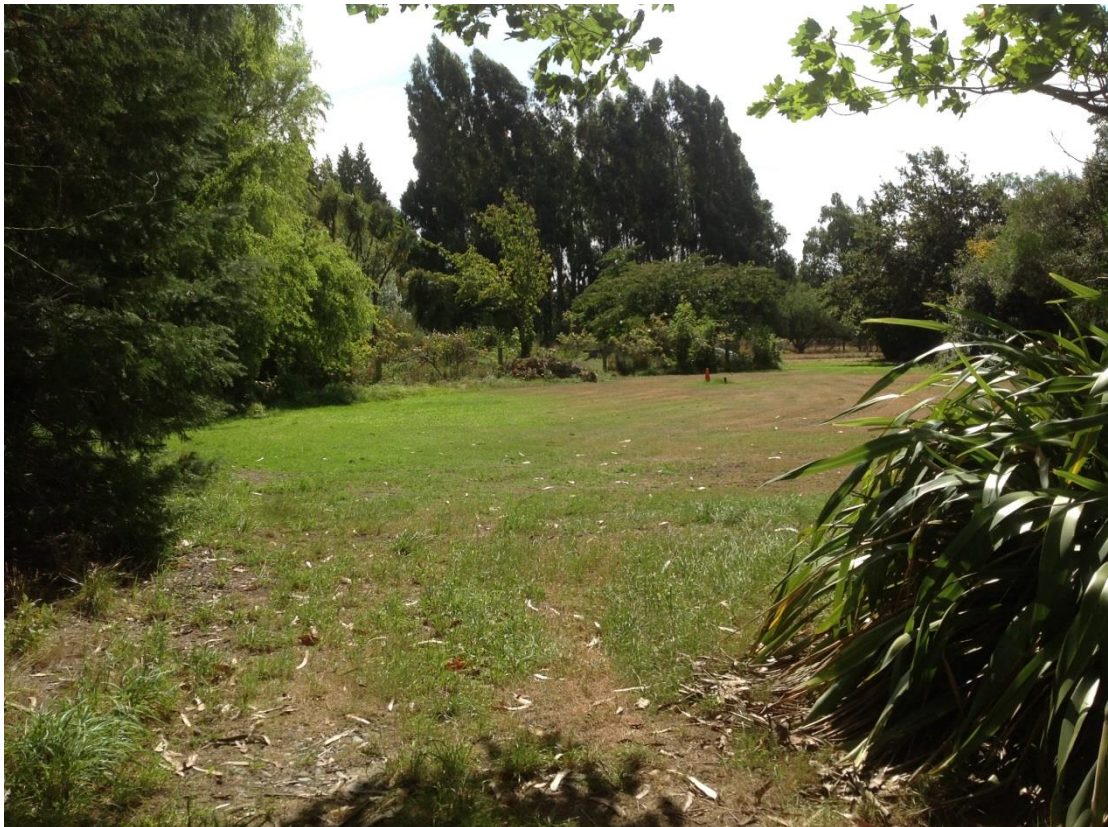
Photograph 8: View looking north-west across the front lawn area of 1878 Telegraph Road.

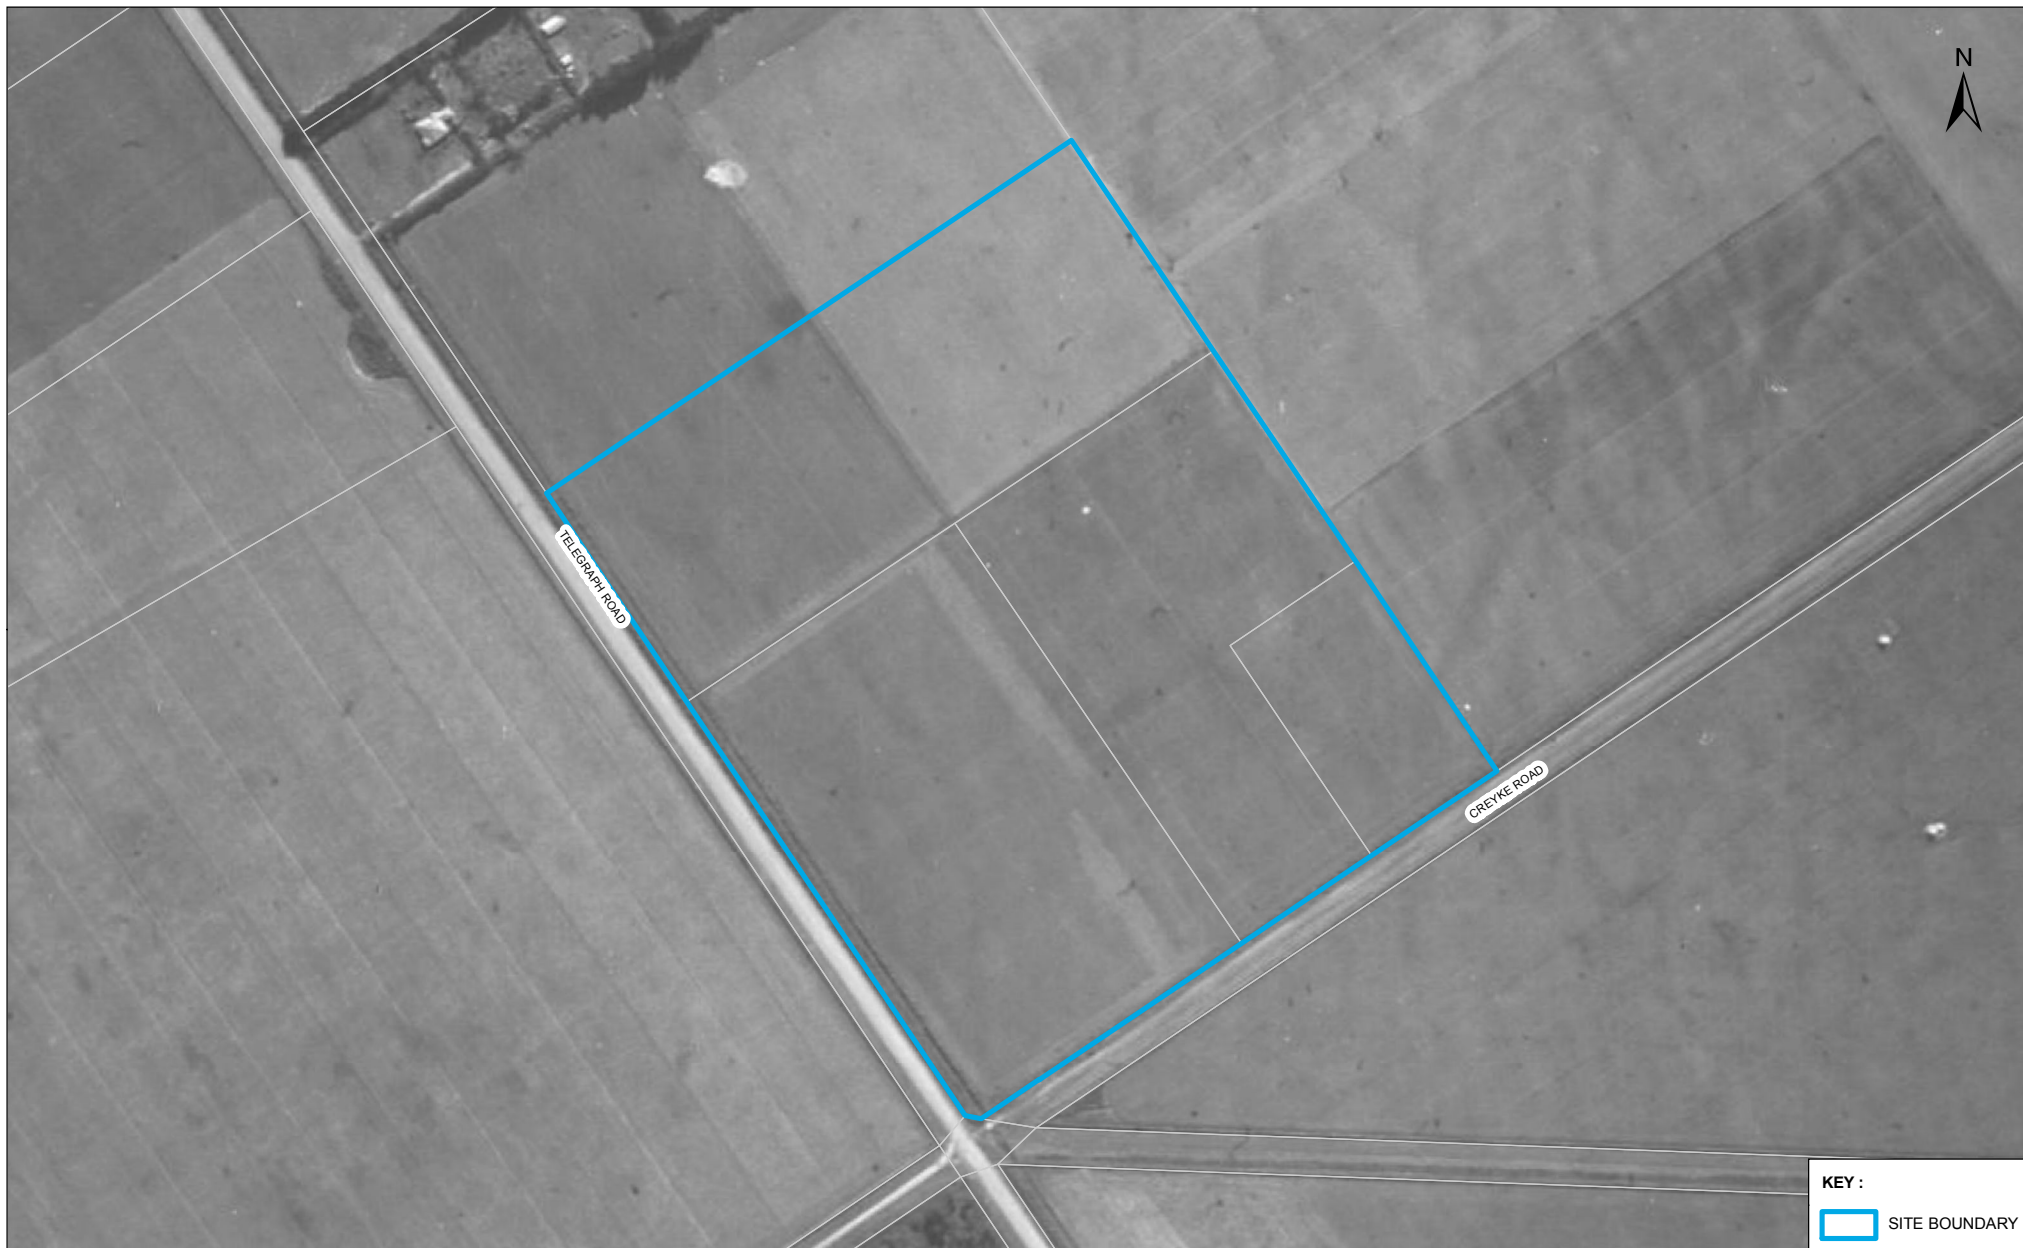
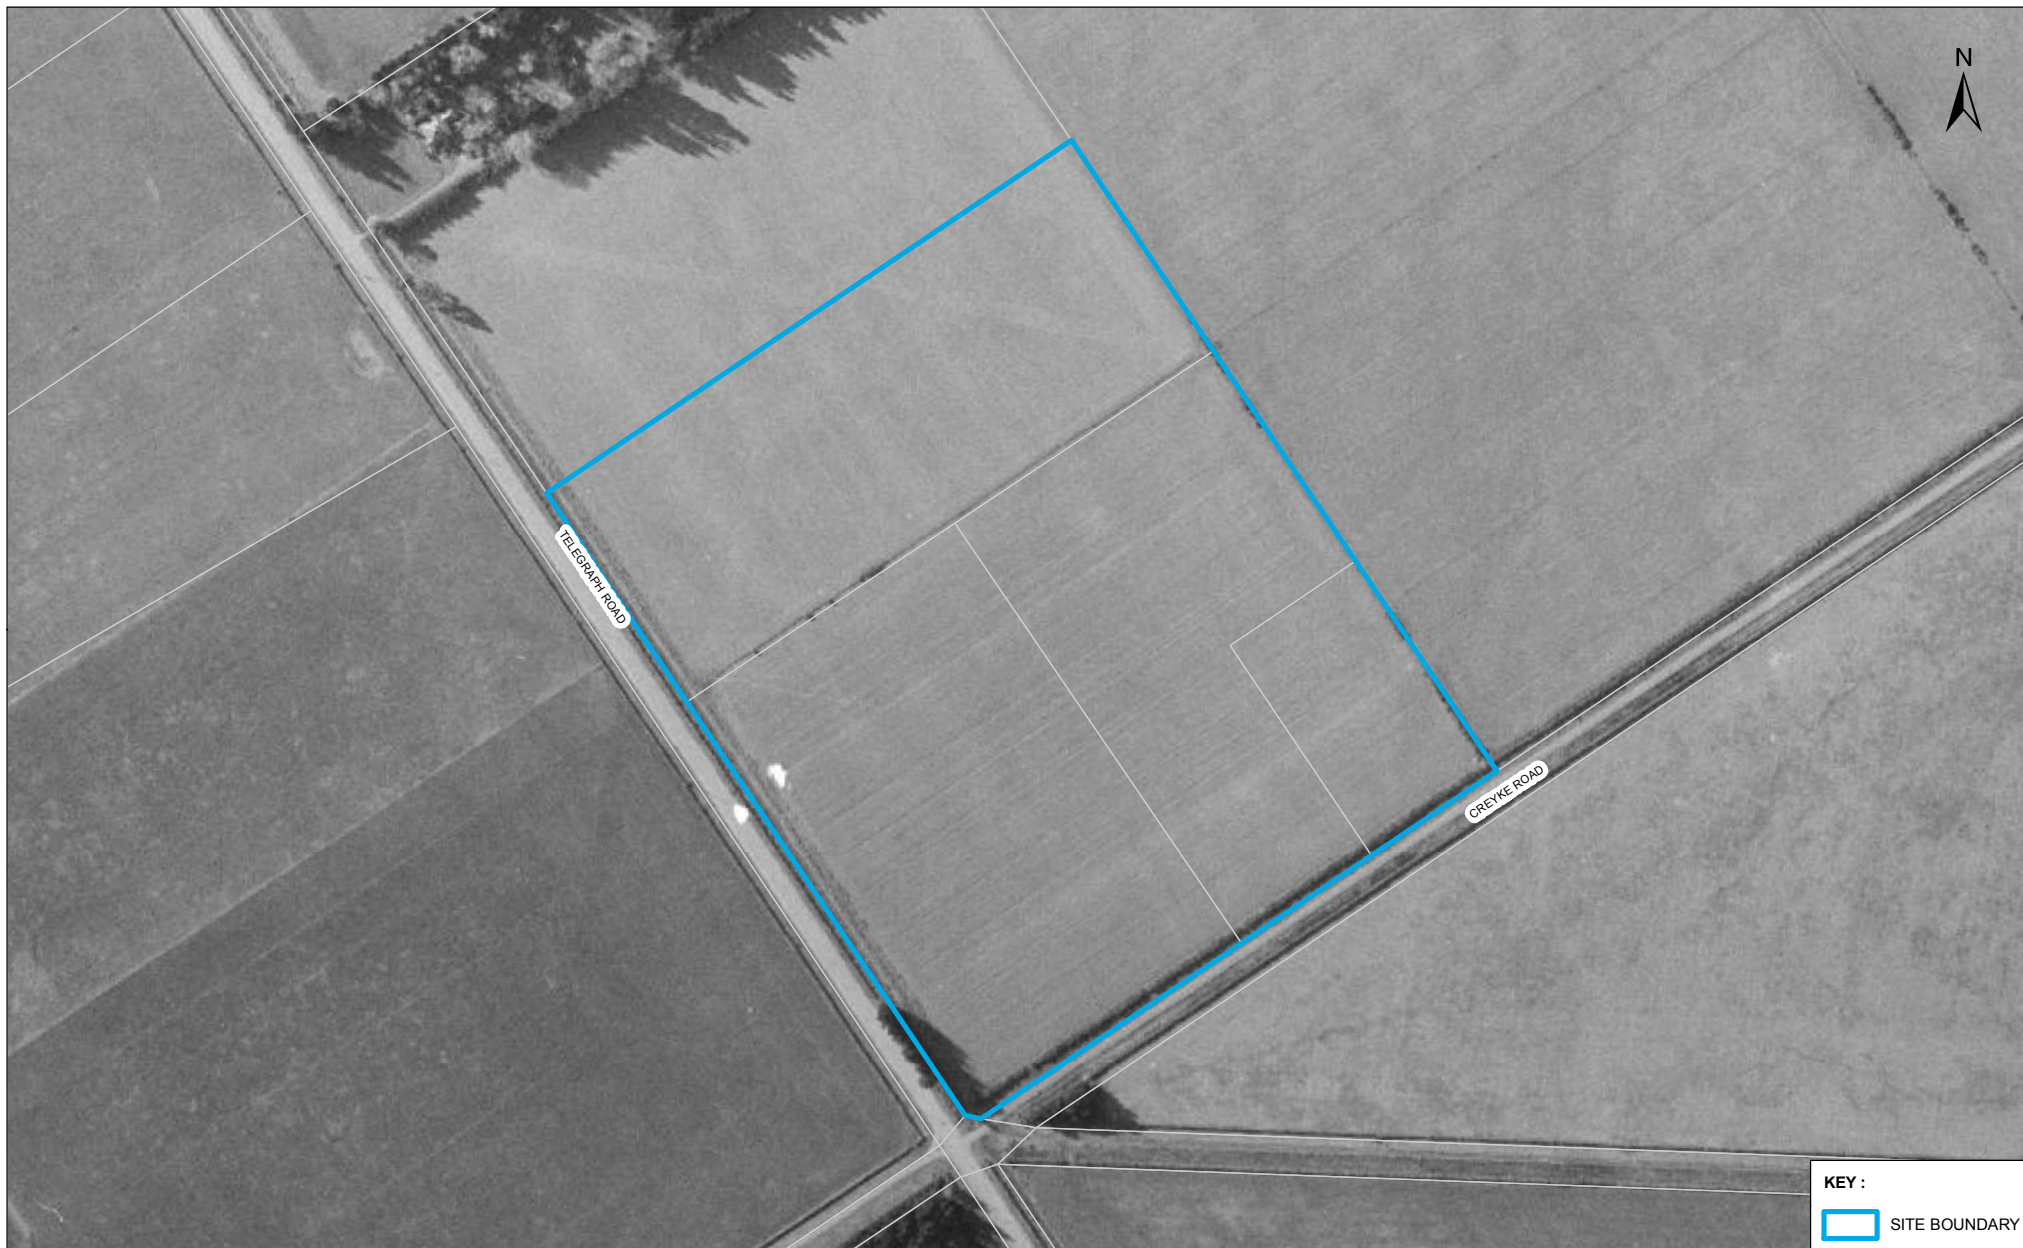
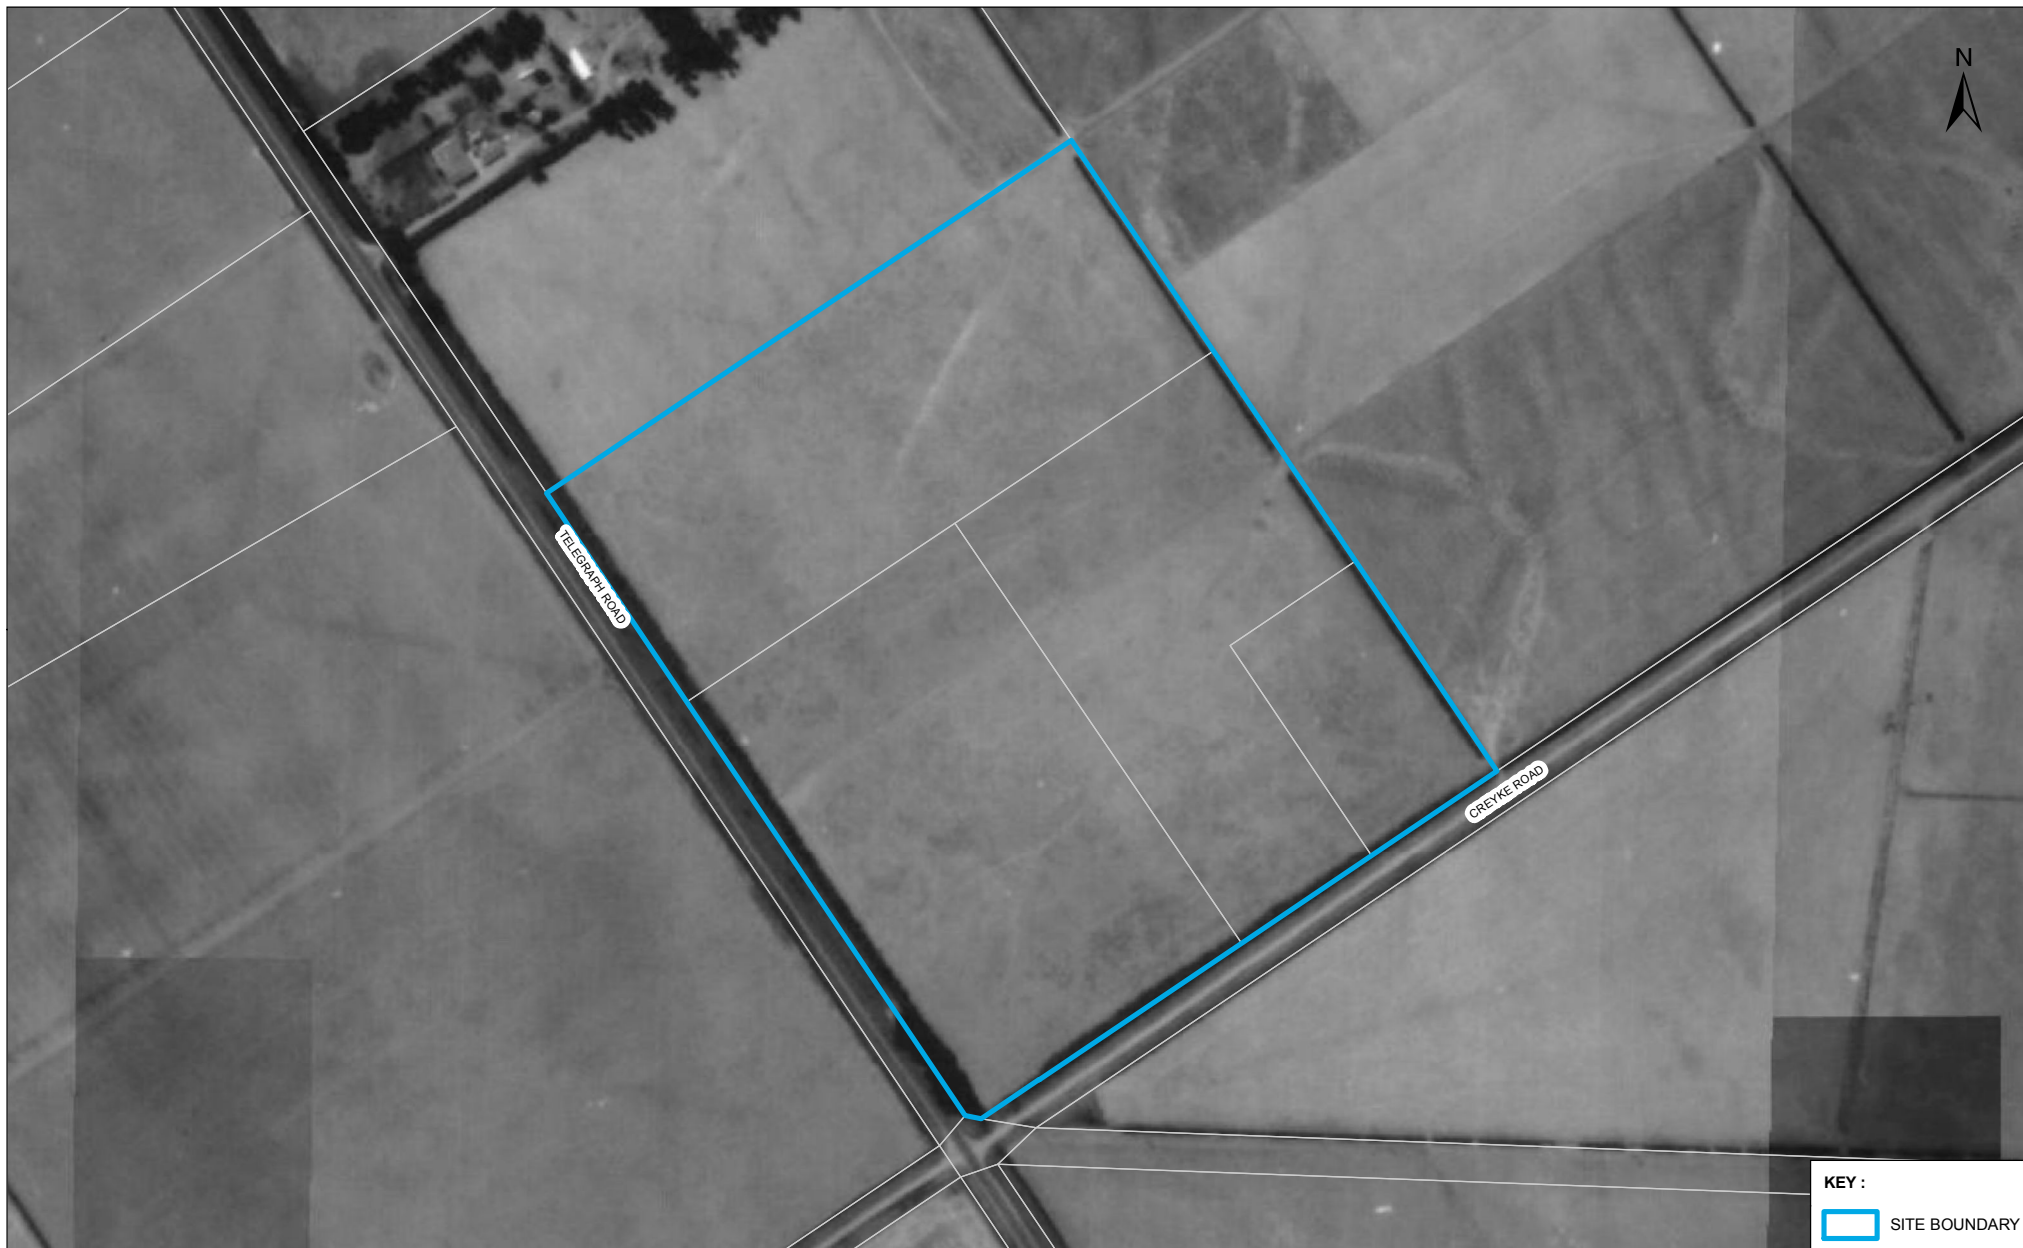
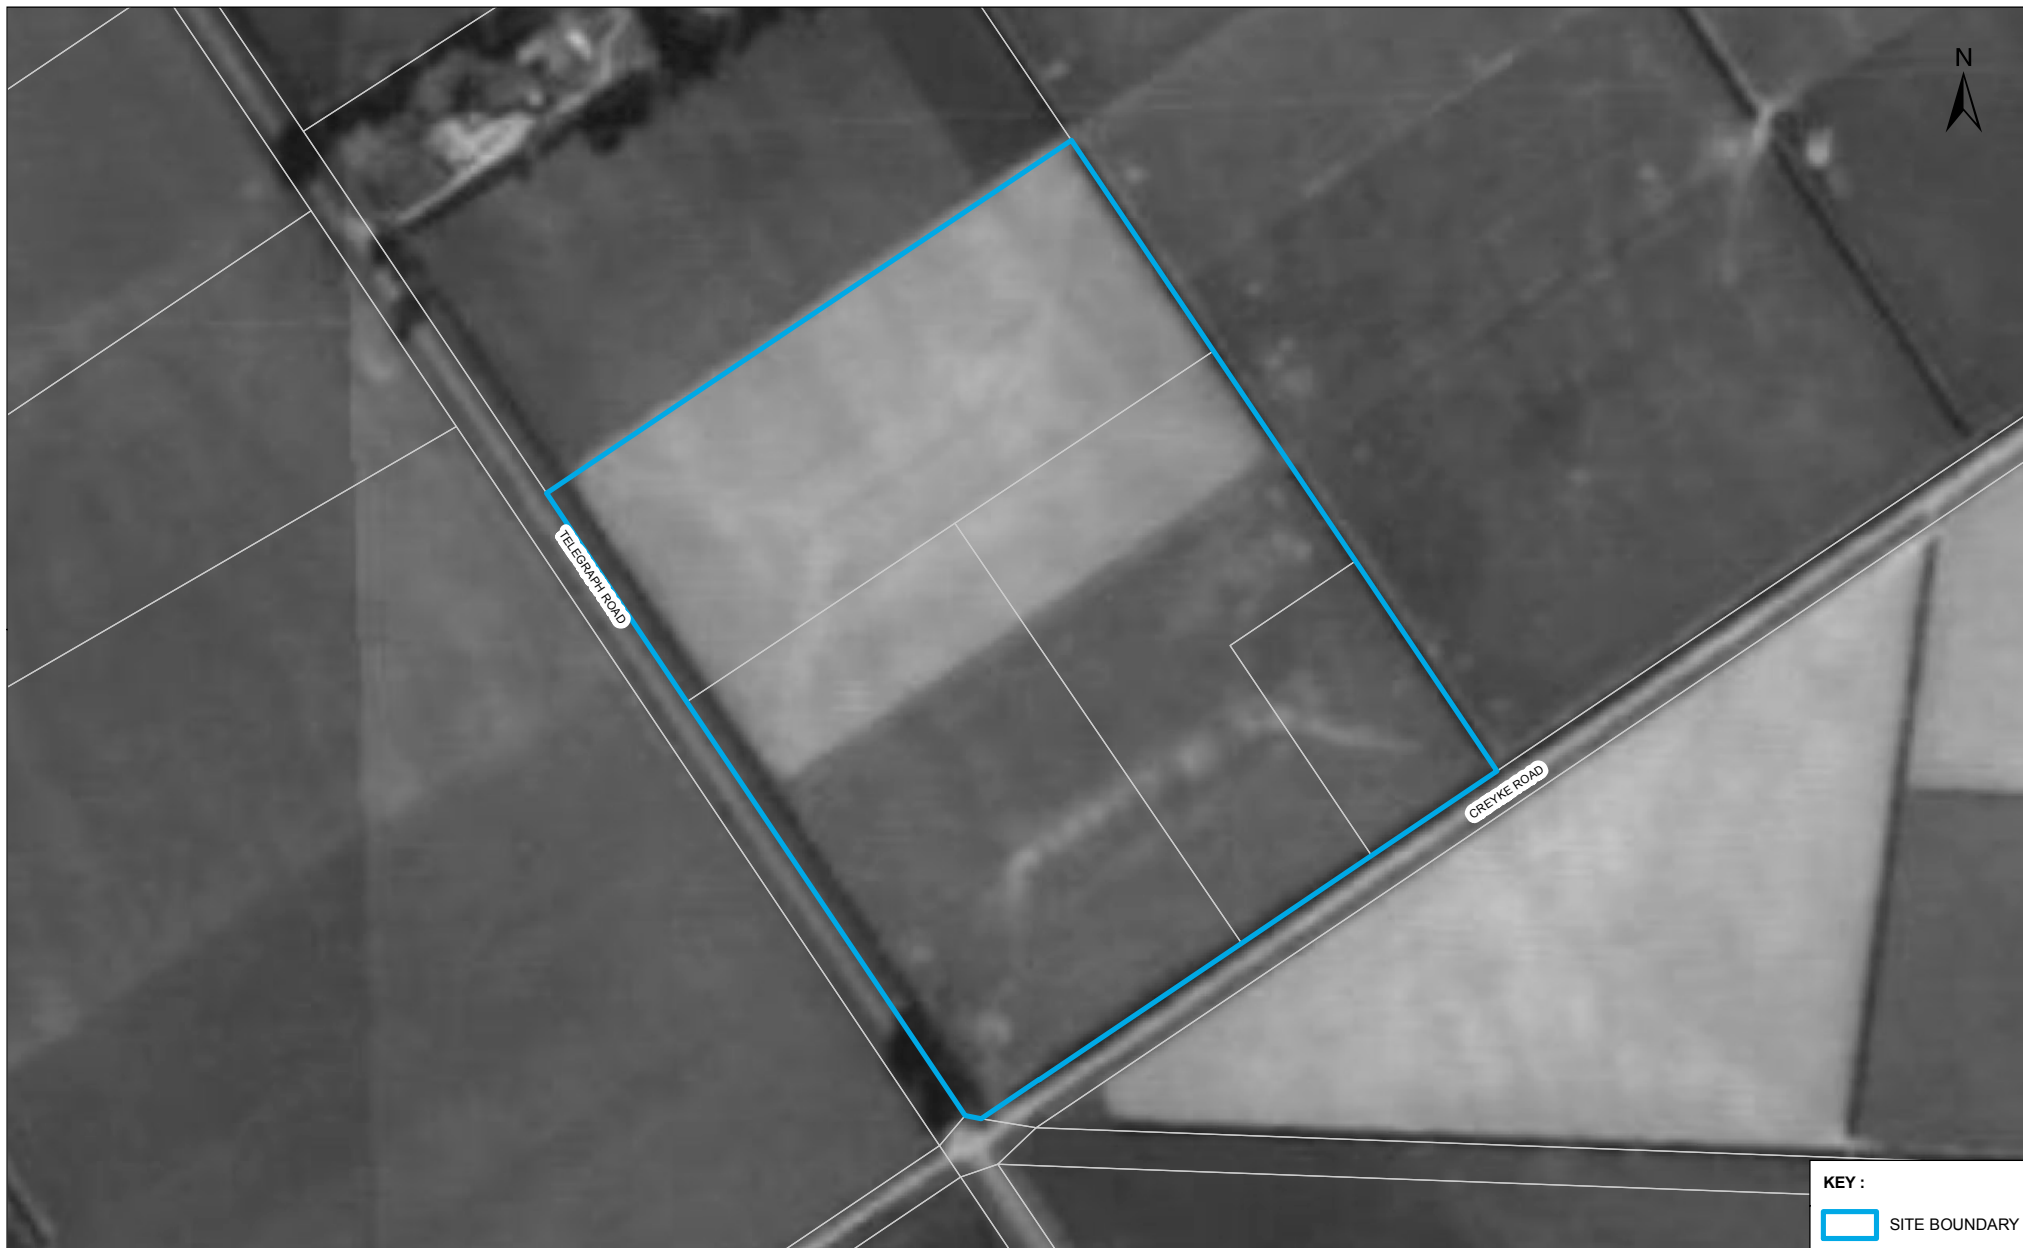
Table 2: Historical Aerial Photograph Review	
1941, 1958, 1982, 1985	The site is farmland with no notable features.
1998	Houses have been constructed in the present day locations. Rows of trees are located within the northern portion of the site (i.e. 1878 Telegraph Road), with farmland across most of the rest of the site.
2004	Little change from 1998 with the exception of cropping/orchard activities to the south-west of the trees in the northern portion of the site at 1878 Telegraph Road.
2012, 2015	Trees in the northern portion of the site have been cleared and the area grassed in 2015. The hazelnut orchard still remains.
Notes: <ol style="list-style-type: none"> 1. Historical aerial photographs sourced from Canterbury Map Partners, administered by Environment Canterbury and Google Earth Pro (2015). 2. It should be noted that some aerial images are at a large scale and therefore of relatively low quality.
