Appendix 8: Preliminary Site Investigation Report

Preliminary Site Investigation – 193 and 223 Creyke Road, and 1878 Telegraph Road, Darfield

✦ March 2016

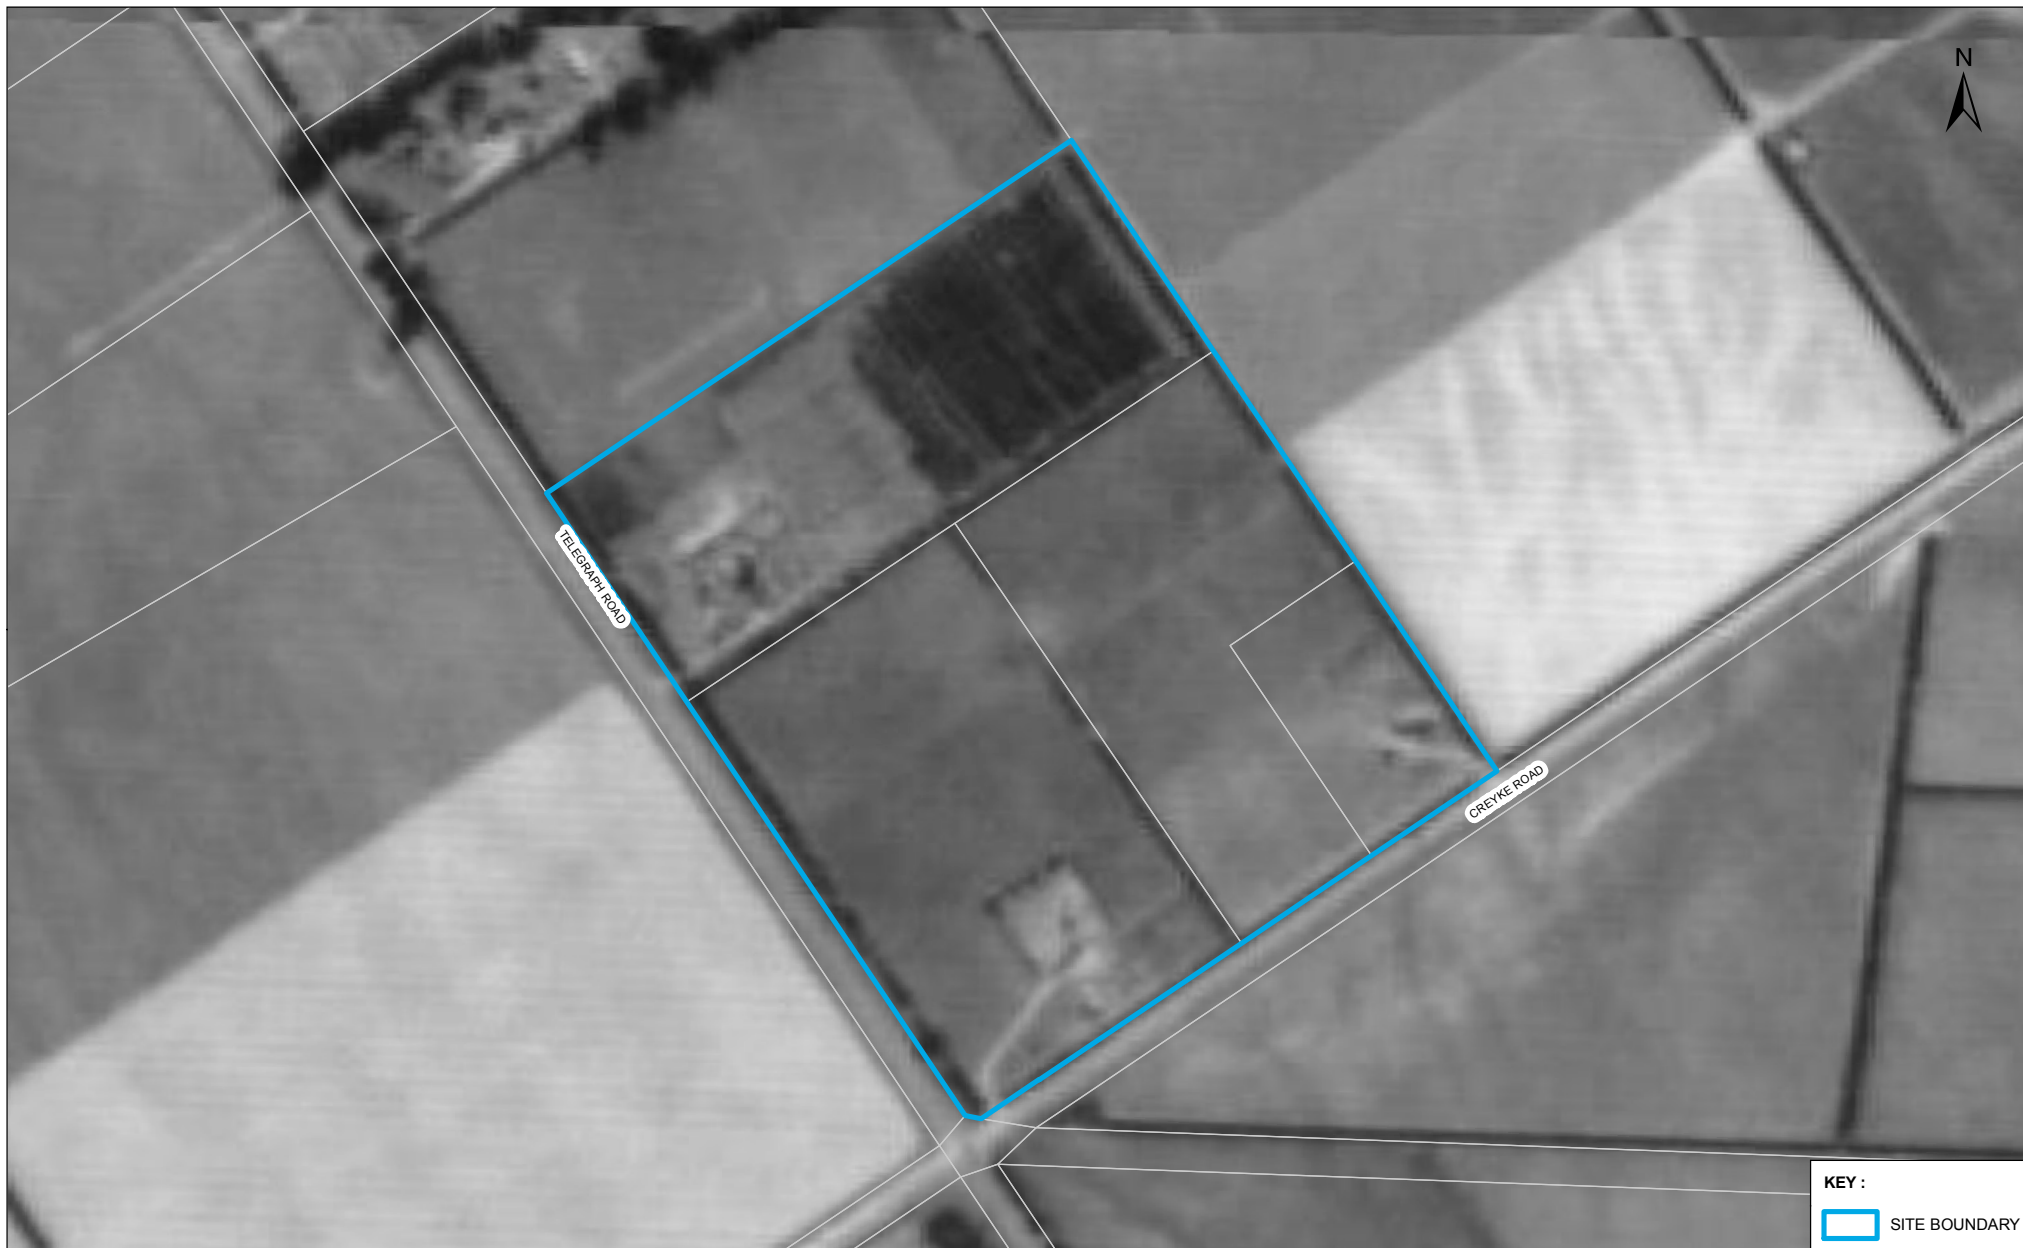
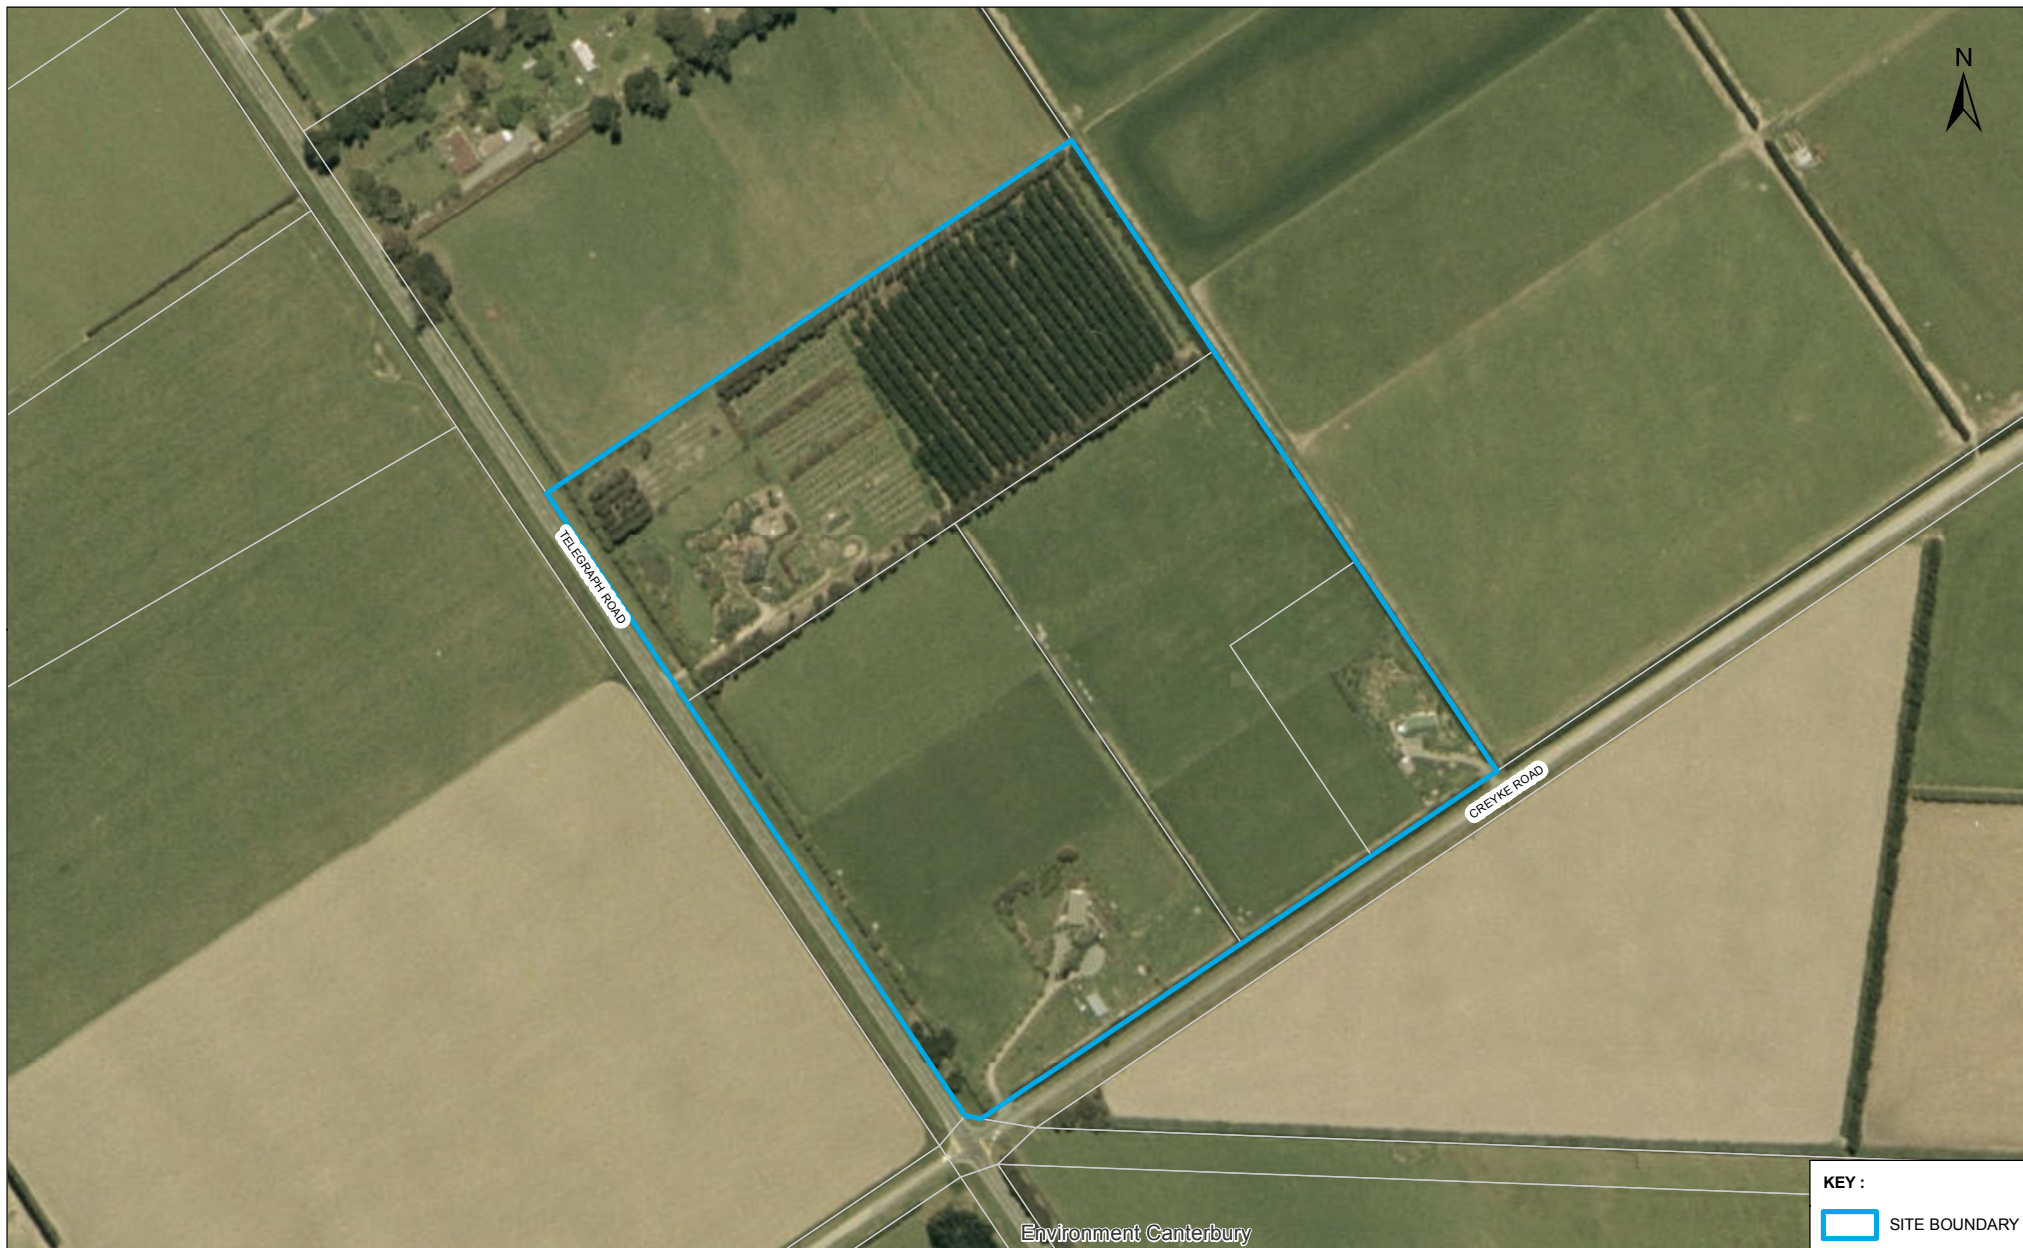
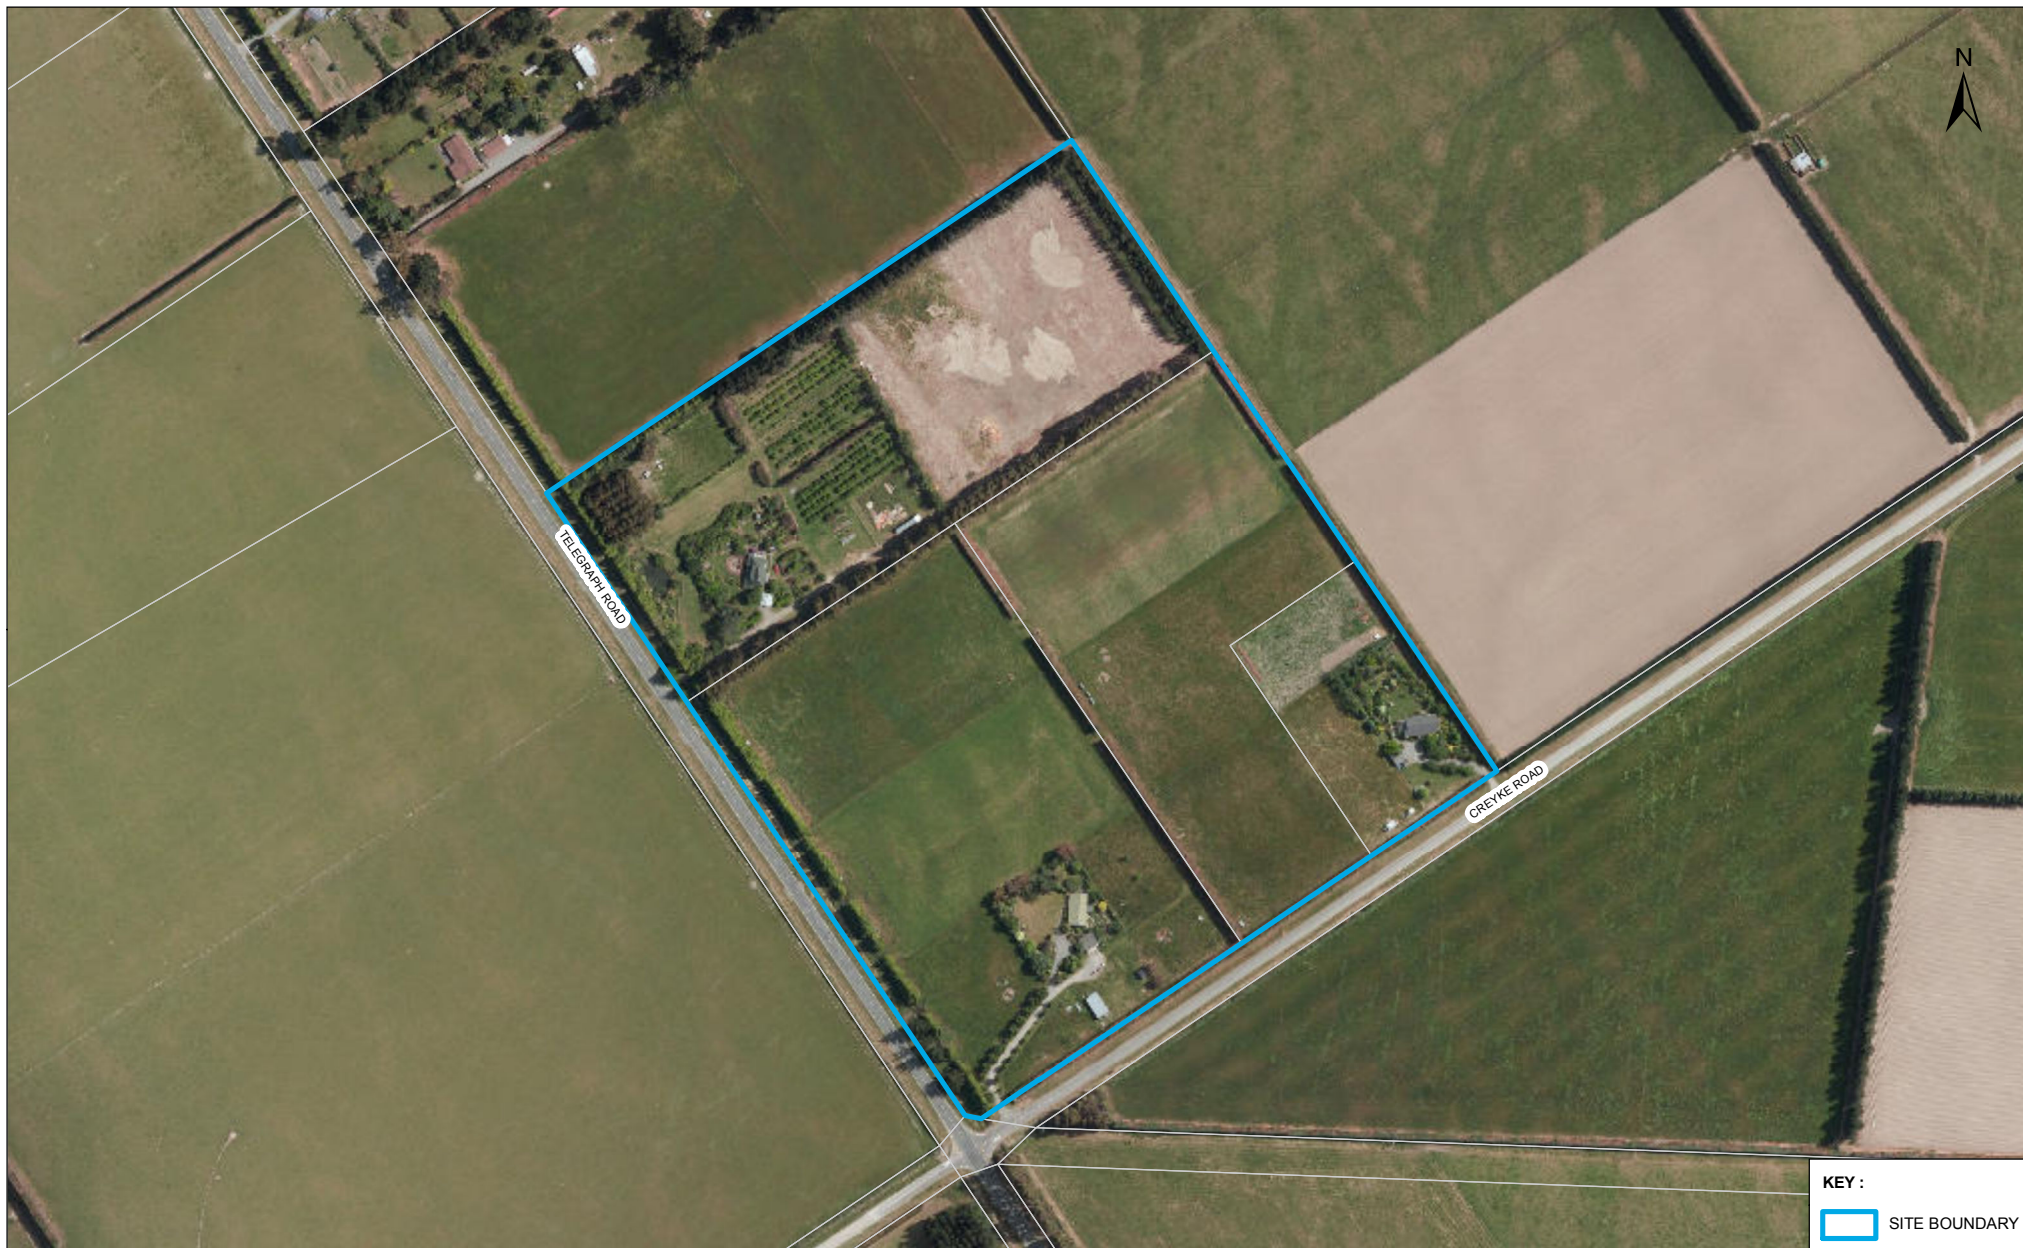
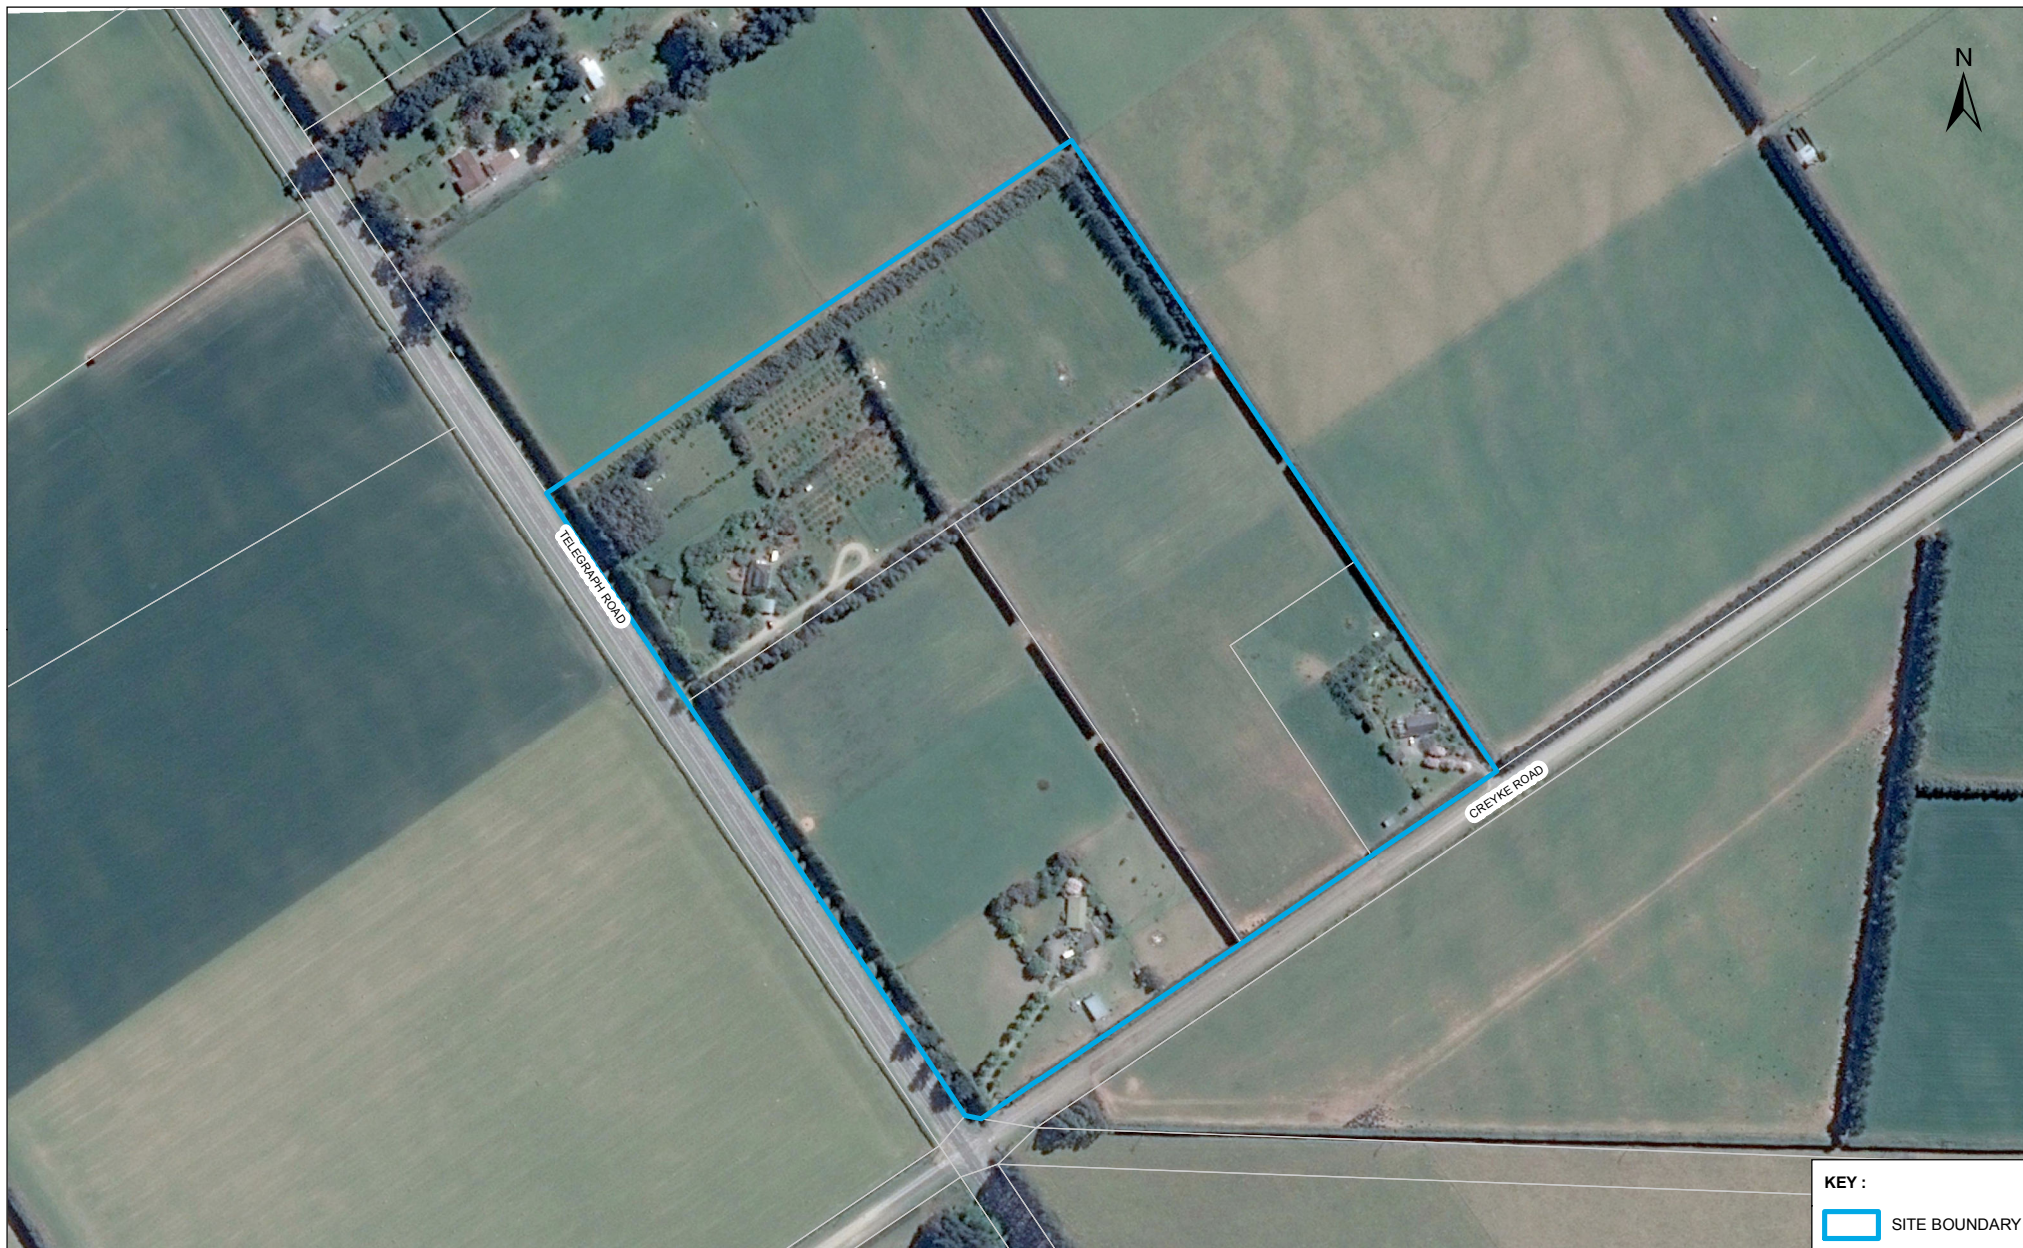
Table 2: Historical Aerial Photograph Review	
1941, 1958, 1982, 1985	The site is farmland with no notable features.
1998	Houses have been constructed in the present day locations. Rows of trees are located within the northern portion of the site (i.e. 1878 Telegraph Road), with farmland across most of the rest of the site.
2004	Little change from 1998 with the exception of cropping/orchard activities to the south-west of the trees in the northern portion of the site at 1878 Telegraph Road.
2012, 2015	Trees in the northern portion of the site have been cleared and the area grassed in 2015. The hazelnut orchard still remains.
Notes: <ol style="list-style-type: none"> 1. Historical aerial photographs sourced from Canterbury Map Partners, administered by Environment Canterbury and Google Earth Pro (2015). 2. It should be noted that some aerial images are at a large scale and therefore of relatively low quality.

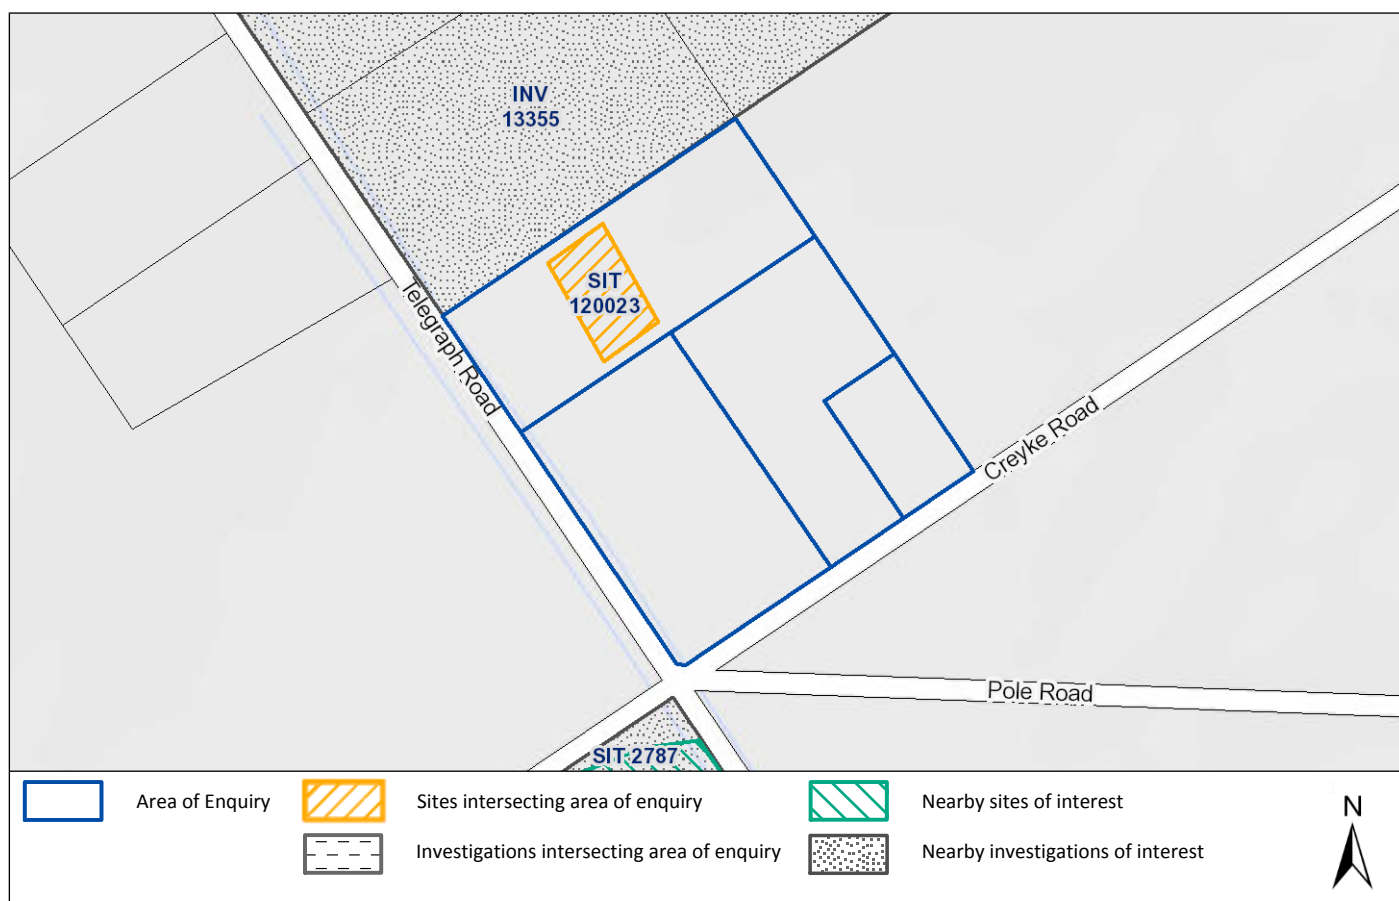
The information presented in this map is specific to the area within a 100m radius of property you have selected. Information on properties outside the search radius may not be shown on this map, even if the property is visible.

7 Dec 2015	This record was created as part of the Selwyn District Council 2015 HAIL identification project.
7 Dec 2015	Area defined from 1998 to Present aerial photographs. Horticultural activities (persistent pesticides) were noted in aerial photographs reviewed.

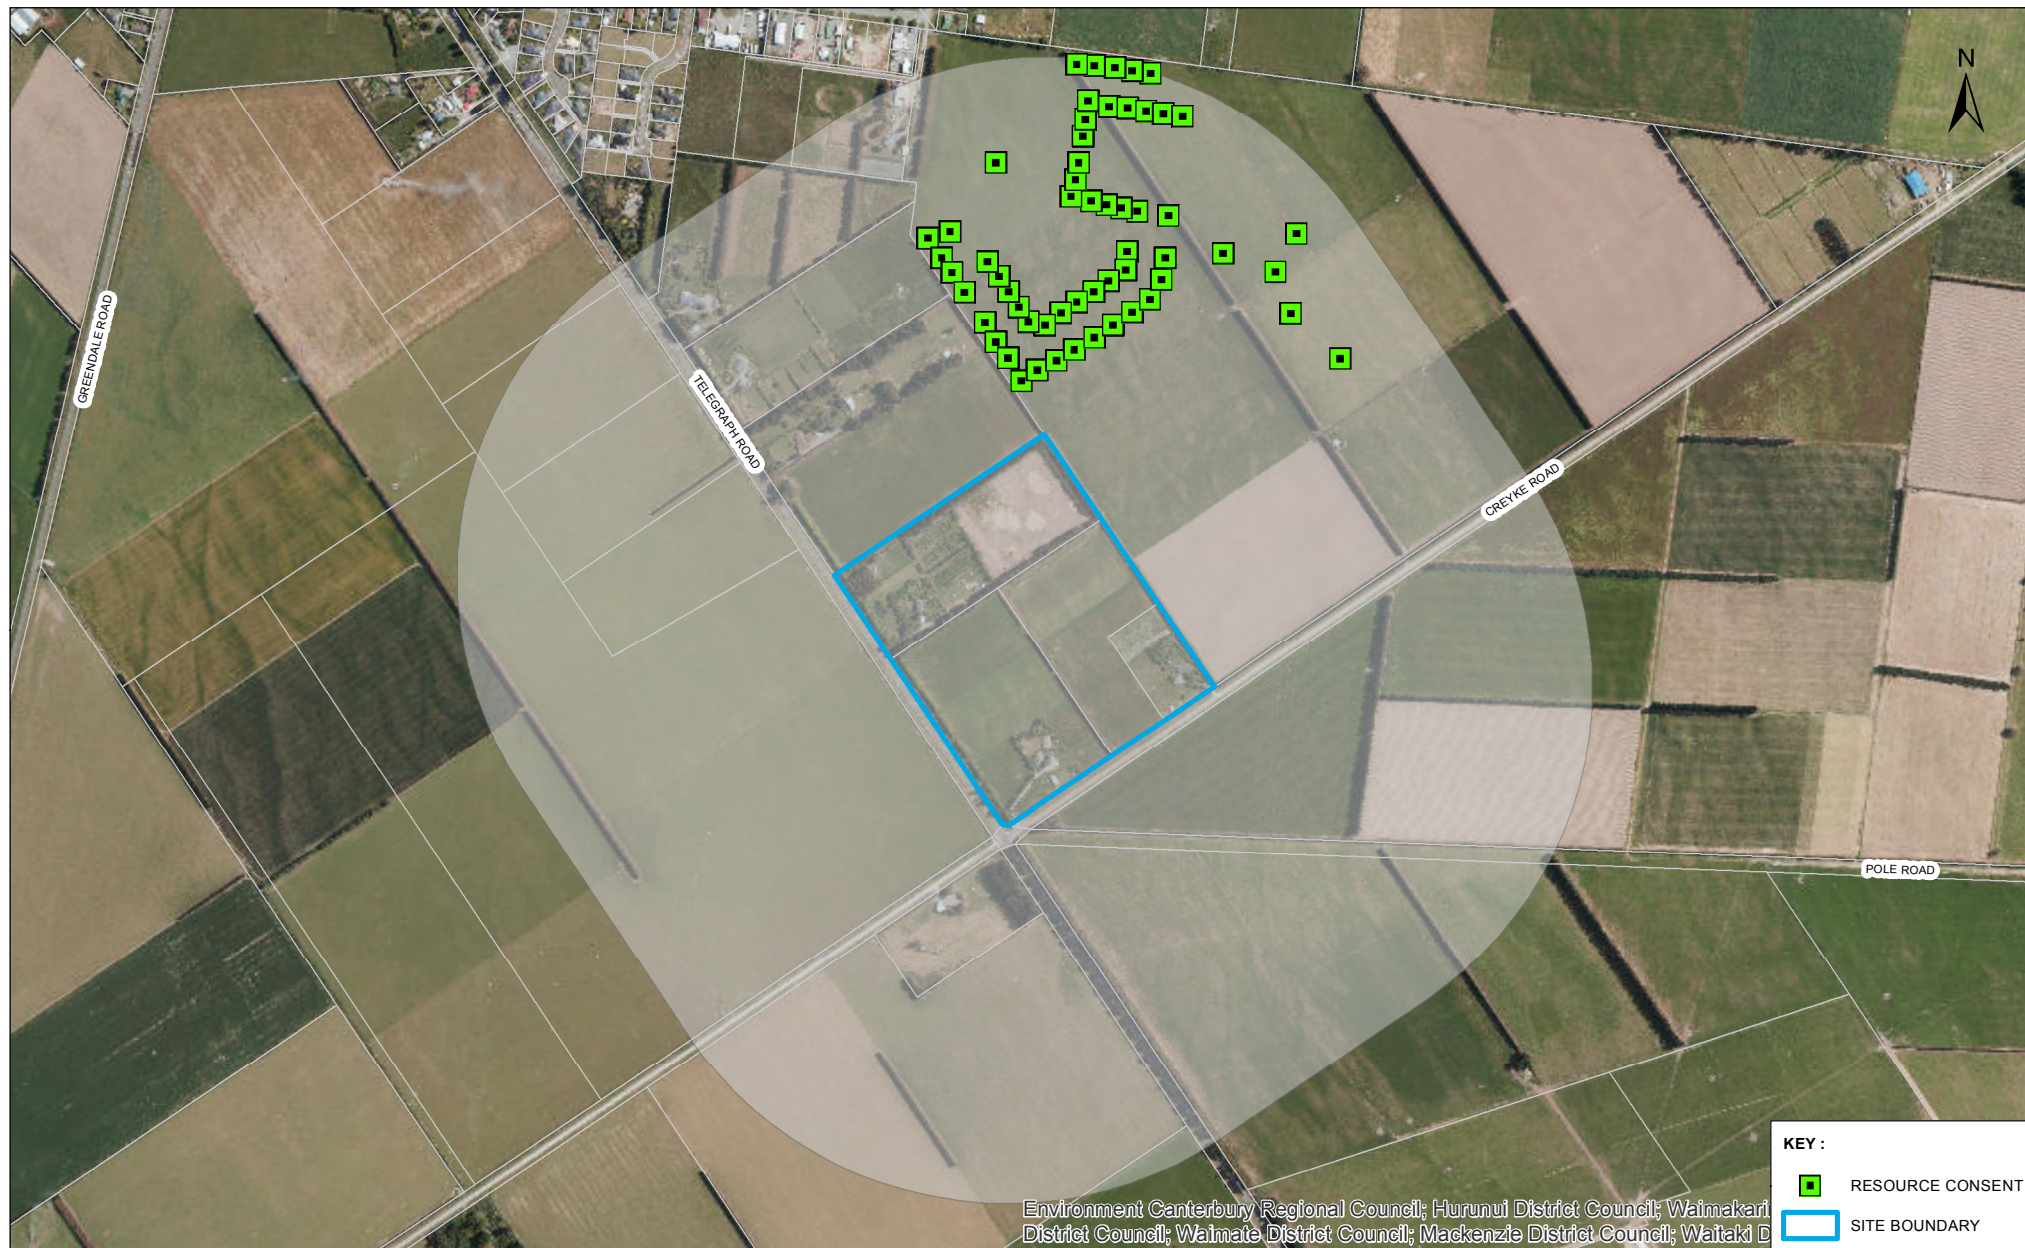
RESOURCE CONSENTS WITHIN A 500 M RADIUS OF THE SITE

The ECan online GIS database was searched for resource consents located within a 500 m radius of the site. There were no resource consents recorded for the site. While a total of 111 resource consents were located within a 500 m radius

of the site boundary, none of these were reported to be ‘active’. Inactive consents located to the north of the site are for the collection and discharge of residential stormwater and the disposal of effluent. A table and plot of resource consents within a 500 m radius of the site are attached in Appendix E.
