19 June 2012

FLOOD RISK - LOT 2 DP 436571 - HAUSCHILDS ROAD, TAI TAPU

Our Ref: HAZA/FLD/ASS/CHC/12480

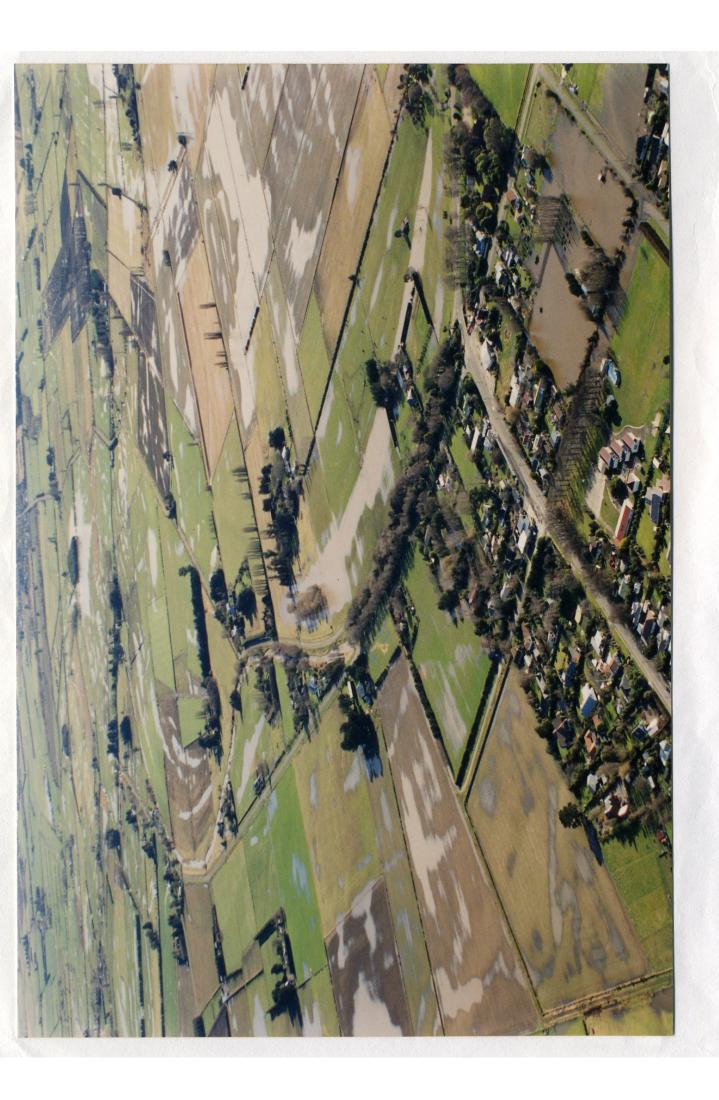
603. Leatham Swamp centre left. Tai Tapu centre right. (North)

Photograph No. **603** was taken on 24 August 1986 following a rainfall event where 77 mm was recorded at Greenpark and 81 mm at Lincoln over 72 hours. Photo No. **216** was taken on 28 July 1994 following a similar sized event with 76 mm recorded at Greenpark over 72 hours. Both events are estimated to have a return period of 2 - 5 years. For the 1986 event, the return period of the flooding is considered to be slightly greater than the return period of the rainfall due to rainfall earlier in the month.

Note that the photographs may not show flooding at its peak, as there is often a delay between the cessation of rainfall and the taking of photographs.
