Preliminary Site Investigation Report

Preliminary Site Investigation
Hauschilds Rd
Tai Tapu

Prepared for Jonathon Williams
Sharon & Zane Croft

August 2015

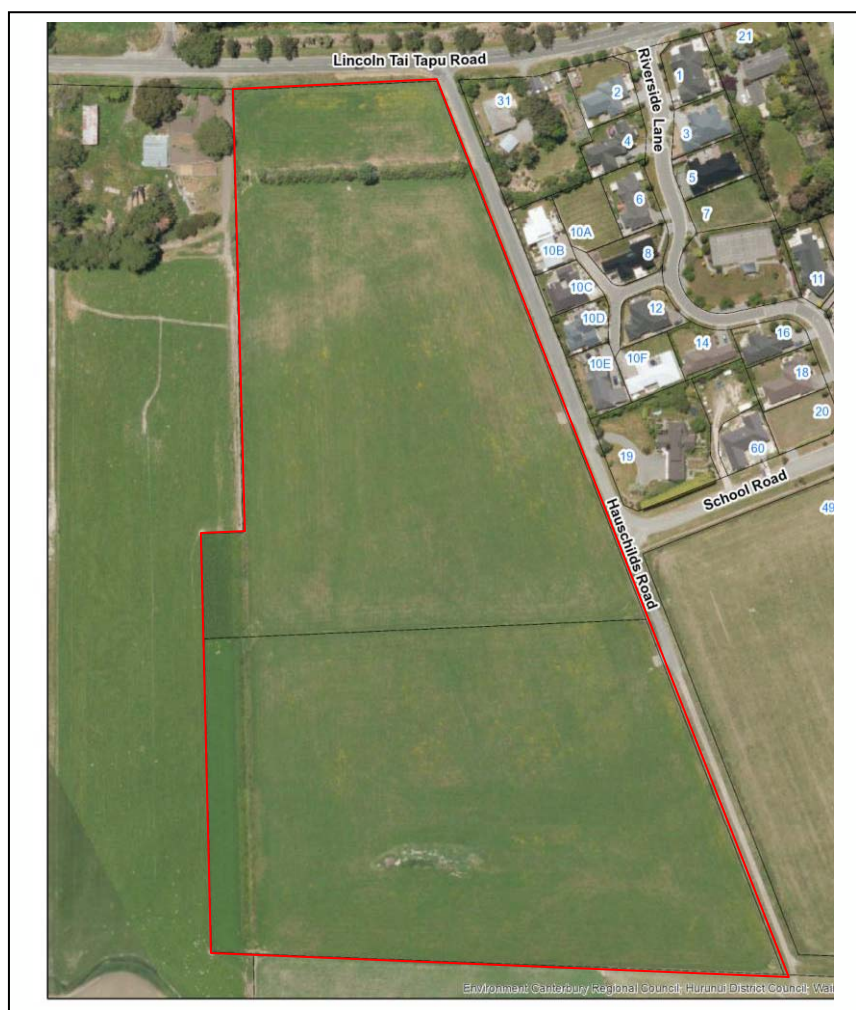
Figure 3 – Aerial photograph of the property

The property is currently being used for pastoral farming. There were no structures on the property at the time of the investigation. Recent aerial photographs show an anomalous area at the southern end of the property. At the time of the investigation this area was not vegetated and appeared to have been recently worked. The current owner of the property, Mrs S Croft, explained that this was a natural low point in the land that is part of a swale that runs west east across the paddock. They have imported natural topsoils from adjacent residential land to fill this area. The stockpiles of fill are evident in the 2012 aerial photograph shown in Section 5 below. A shallow test pit (0.5 m) showed topsoil material with some organics and some gravel confirming the comments from Mrs Croft.

Figure 3 shows an aerial photograph of the site while Figure 4 shows the former sheep spray on the adjacent property.

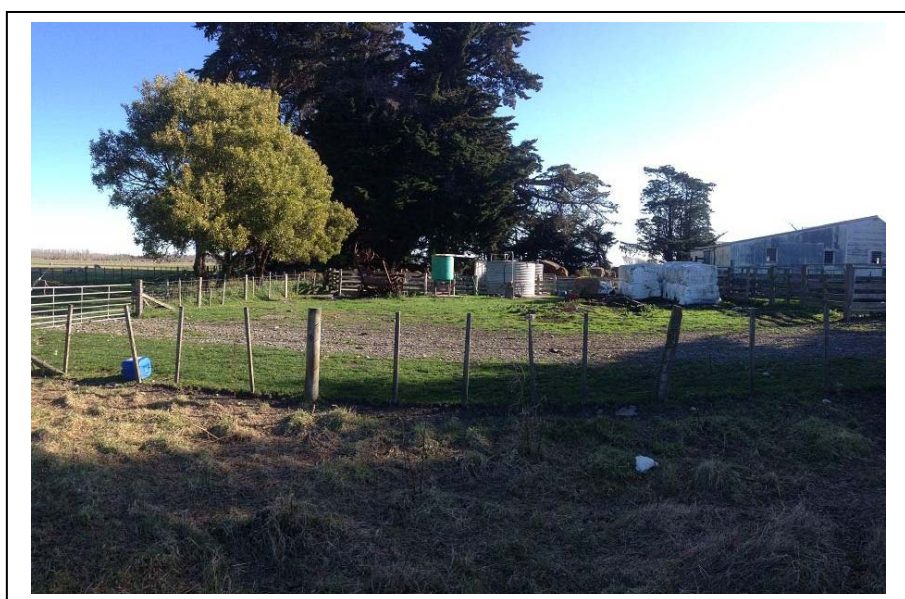
Figure 4 – the sheep spray located on the adjacent property

The site is predominantly surrounded by rural land uses however adjacent to the eastern boundary is a residential subdivision which is part of the Tai Tapu township. As discussed earlier there are no structures or buildings on the investigation area however immediately adjacent to the western boundary and at the northern end is the original farm yard area from when the surrounding land was being run as one farm. The yard includes sheds, stock yards and a former sheep spray.

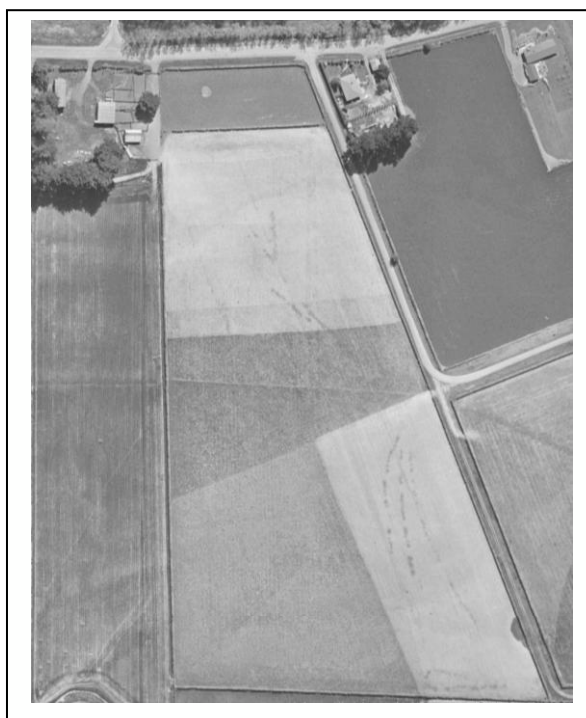
Figure 5 – Hauschids Rd 1973

The historical aerial photographs show that the area being proposed for development has primarily been used for pastoral grazing purposes. It is unlikely that the property was used for anything other than grazing before 1973. It is evident in Figure 5 that the surrounding land, including the adjacent farm yard area was all part of the same farm property. The sheep spray located within the yard area is clearly visible and appears to be operational in 1973. There is a small anomaly shown in the northern paddock in 1973 however a hand dug test pit in this area showed no indication of any introduced or uncontrolled fill.

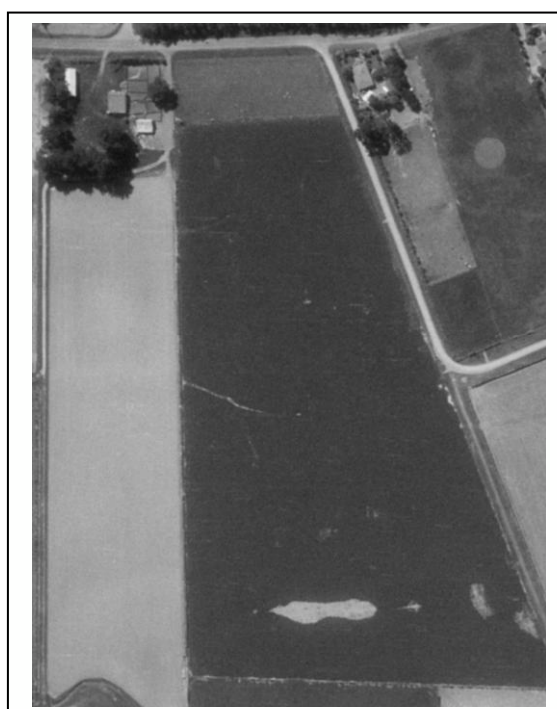
Figure 6 – Hauschids Rd 1984

Figure 6 shows the site in 1984. Very little has changed with regard to the general use of the property however at the southern end of the property is an anomalous feature that requires further investigation.

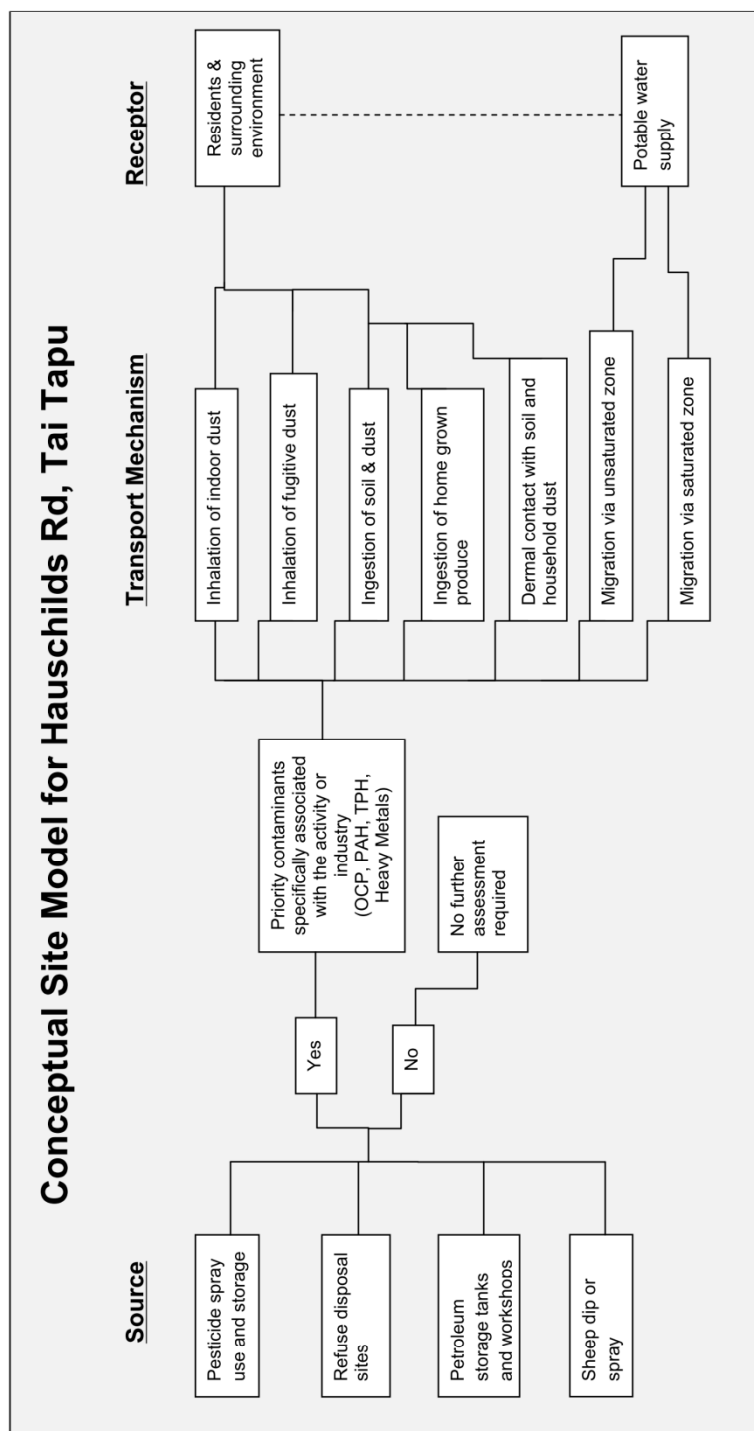
Figure 9 – Conceptual site model

A conceptual site model helps to identify whether or not a complete exposure pathway exists. An exposure pathway must include a contaminant source, a transport mechanism and a receptor. If one of these components does not exist or can be removed then the exposure pathway is incomplete. If the exposure pathway is incomplete then there is little risk to human health at this location. For an agricultural site the possible HAIL activities associated with this land use type is bulk storage, use and disposal of persistent pesticides, refuse pits, fuel storage, commercial work shops and former sheep dip or spray sites. A conceptual site model has been prepared for the site and is included as Figure 9. An assessment of the exposure pathway will be discussed below in Section 8 – Site Characterisation.

The conceptual site model identifies sheep dips / sprays, refuse pits, fuel storage, pesticide use and storage and workshops as possible HAIL activities that may cause contaminant concentrations in the soil to be elevated. The property being investigated has primarily been used for pastoral grazing purposes. No structures have been associated with the site therefore the storage of fuel and pesticides is unlikely to have occurred while pastoral grazing is not considered as a land use that was exposed to the extensive application of persistent pesticides.

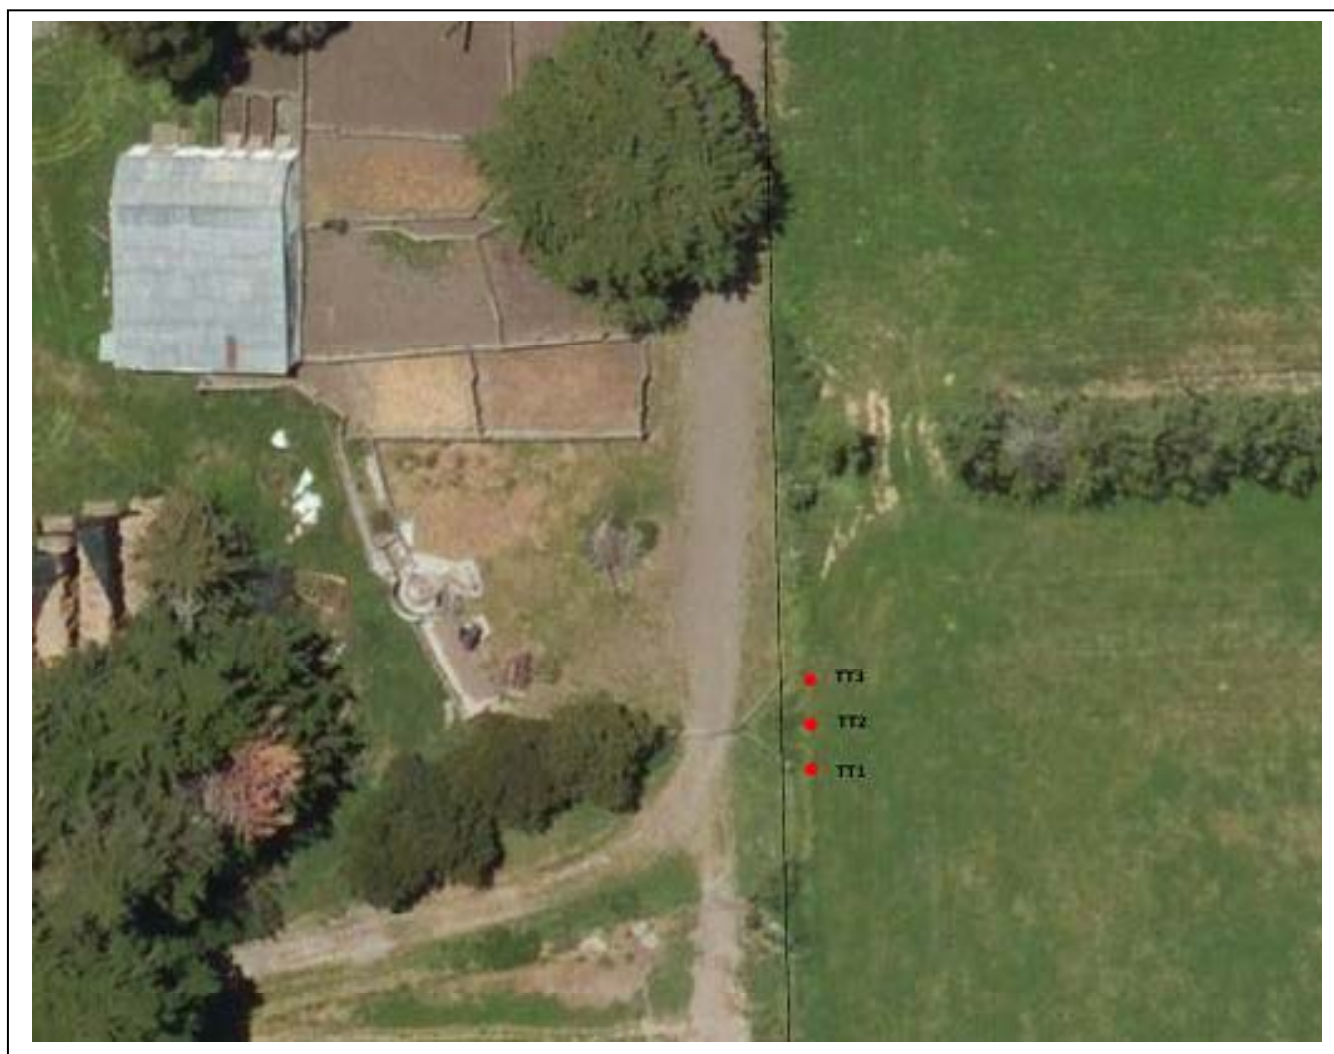
Figure 10 – soil sample locations

As discussed earlier, a former sheep spray has been identified on the adjacent property. That property and the property under investigation once operated as one farm. It is therefore possible that sheep may have been released from the sheep spray and directed on to the property being investigated via a set of adjoining gates. To identify whether or not spray contaminants were carried into the adjacent paddocks, three surface soil samples were collected from the area immediately adjacent to the gate entrance. The soil sample locations are shown in Figure 10.

A former sheep spray has been identified on the adjacent property. Given the location and layout of the facility, three soil samples were collected from a location where treated sheep were likely to have entered the investigation property. The analytical results showed elevated arsenic concentrations that are above the NESCS trigger value for a rural residential land use therefore a complete exposure pathway may exist if the development is to go ahead. It is anticipated that contamination is most likely highest at this point and decreases in concentration with distance away from the entry point onto the property, however this will need to be shown through further investigation.

- Prior to the property being subdivided, further investigation is required to ascertain the depth and extent of the arsenic contamination that has been identified along the western boundary and shown in Figure 10;
- A site remedial action plan will be required following the additional investigation and prior to any earthworks being undertaken;
- No other HAIL activities associated with agricultural land use practices have been identified;
- While the information that has been sought as part of this investigation indicates that some soil contaminant concentrations have been identified that may pose a risk to human health, it would be prudent to highlight to contractors undertaking earthworks on any part of the property, that if by discovery odorous, discoloured or uncontrolled fill is observed (including buried refuse) then the appropriate authorities should be contacted.

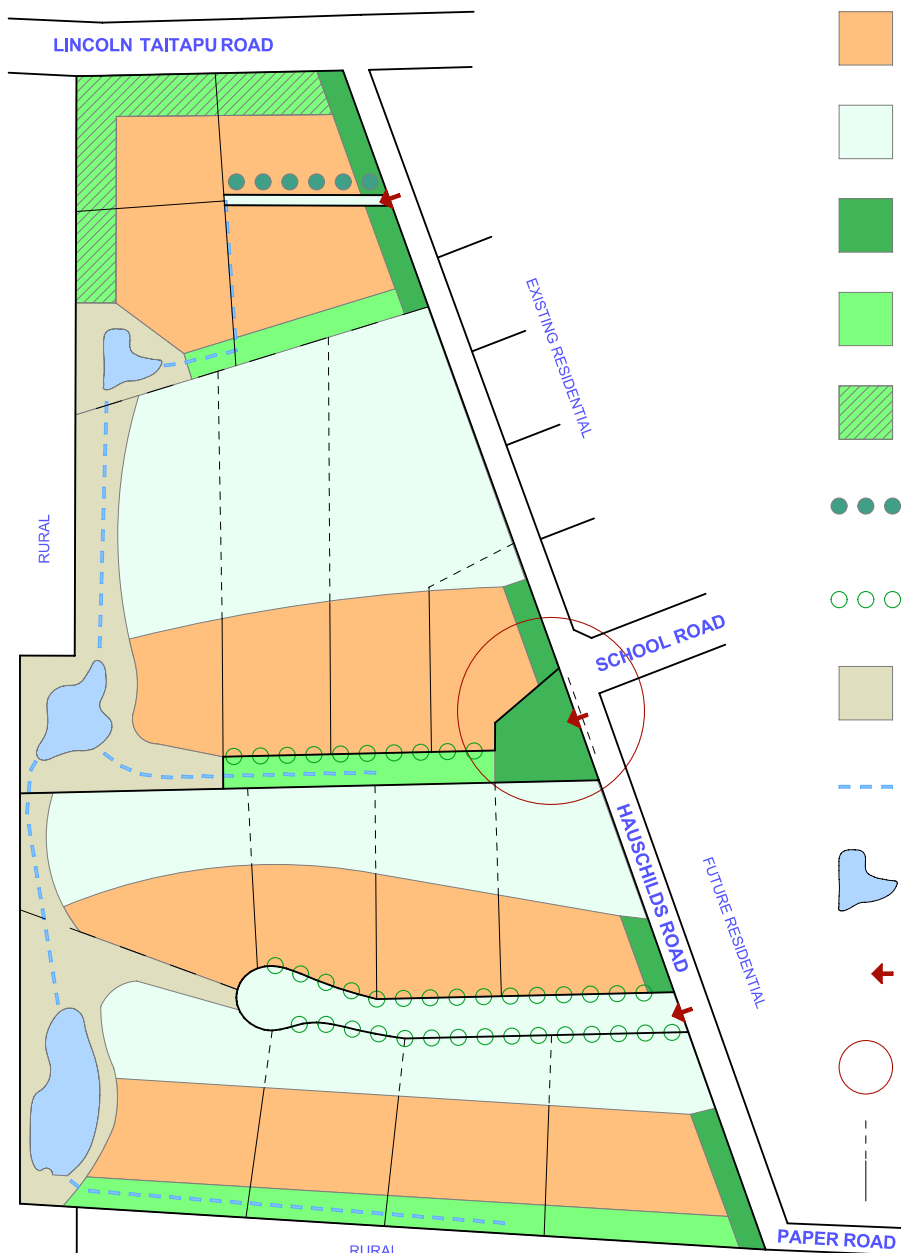
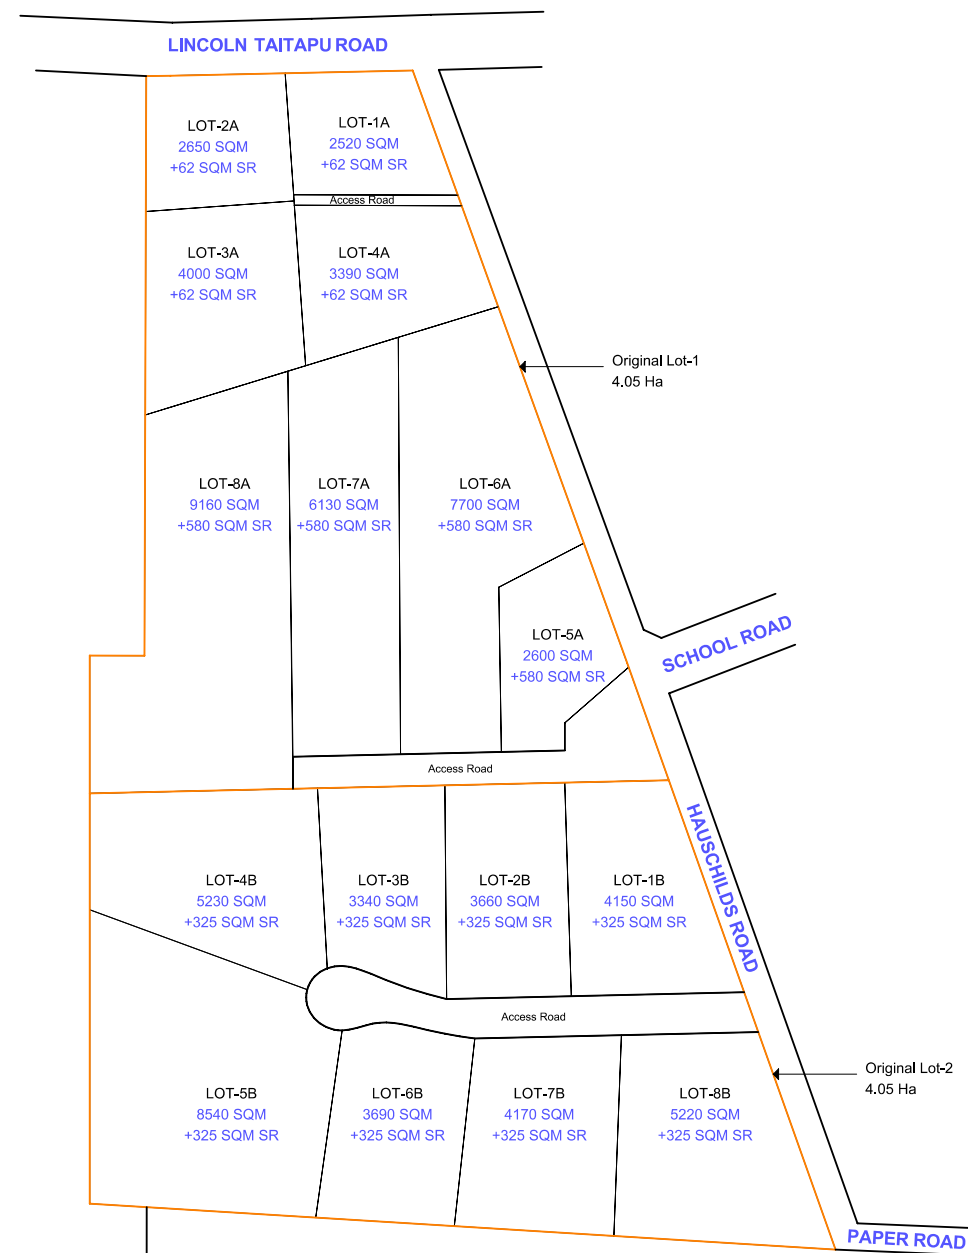
SCHEME PLAN

A proposed scheme plan showing the likely new lots and building areas is attached as Appendix 1. Please note that the attached scheme plan is only a draft proposal and may be subject to change.

- Building Areas
- No built areas to secure viewshafts for existing residential development (rural outlook)
- Cohesive buffer planting of rural scale to screen houses
- Strategic planting to provide shelter
- Landscaped setback from Road
- Existing vegetation to be retained if suitable
- Landscape treatment to access Road
- Storm water Management Area
- Naturalized swale
- Storm water detention pond
- Access point off Hauschids Road
- Specific Gateway Entry Design
- Fencing controls to protect "open views" + provides privacy between lots
