GEOTECHNICAL REPORT FOR PLAN CHANGE
Corner of Annanvale & Pocock Roads, Springfield
For **Ballymena Holdings Limited**

23 August 2013

GEOTECHNICAL REPORT FOR PLAN CHANGE

Corner of Annanvale & Pocock Roads, Springfield

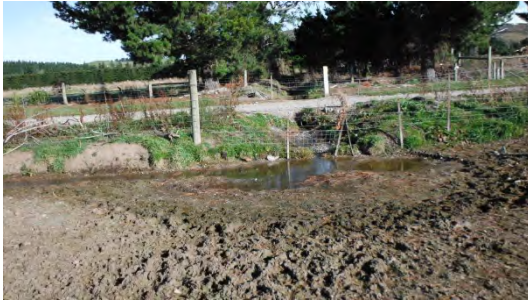
Figure 4: The water race at the western part of the site, adjacent to Annanvale Road (photo taken 1 July 2013).

A shallow water race runs across the site and is approximately 0.5m deep by 1m wide. Refer to Figures 2, 4 and 5. In addition, Kowai River is located approximately 600m north of the site.

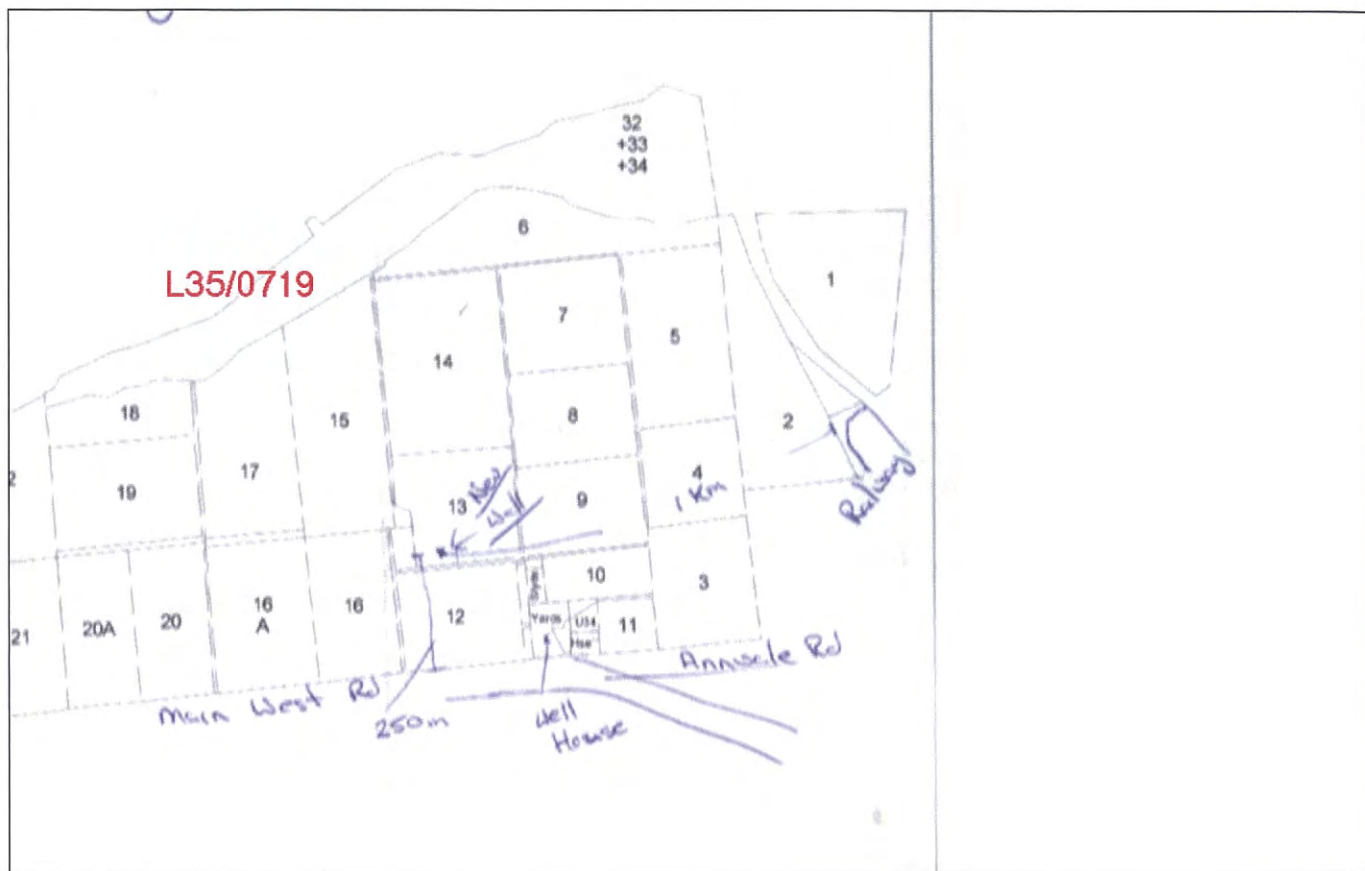
Borelog for well L35/0719

Nearby well logs L35/1161, L35/1159, L35/1160, L35/0719, L35/0287, and L35/0674 typically encountered deep clayey/silty gravels to at least 15m below ground level, with some minor lenses of clay or silt between 2 to 4m depth. Refer to Appendix C.
