Geotechnical Report

Hoskyns Road, Kirwee

Proposed Subdivision

May 2013

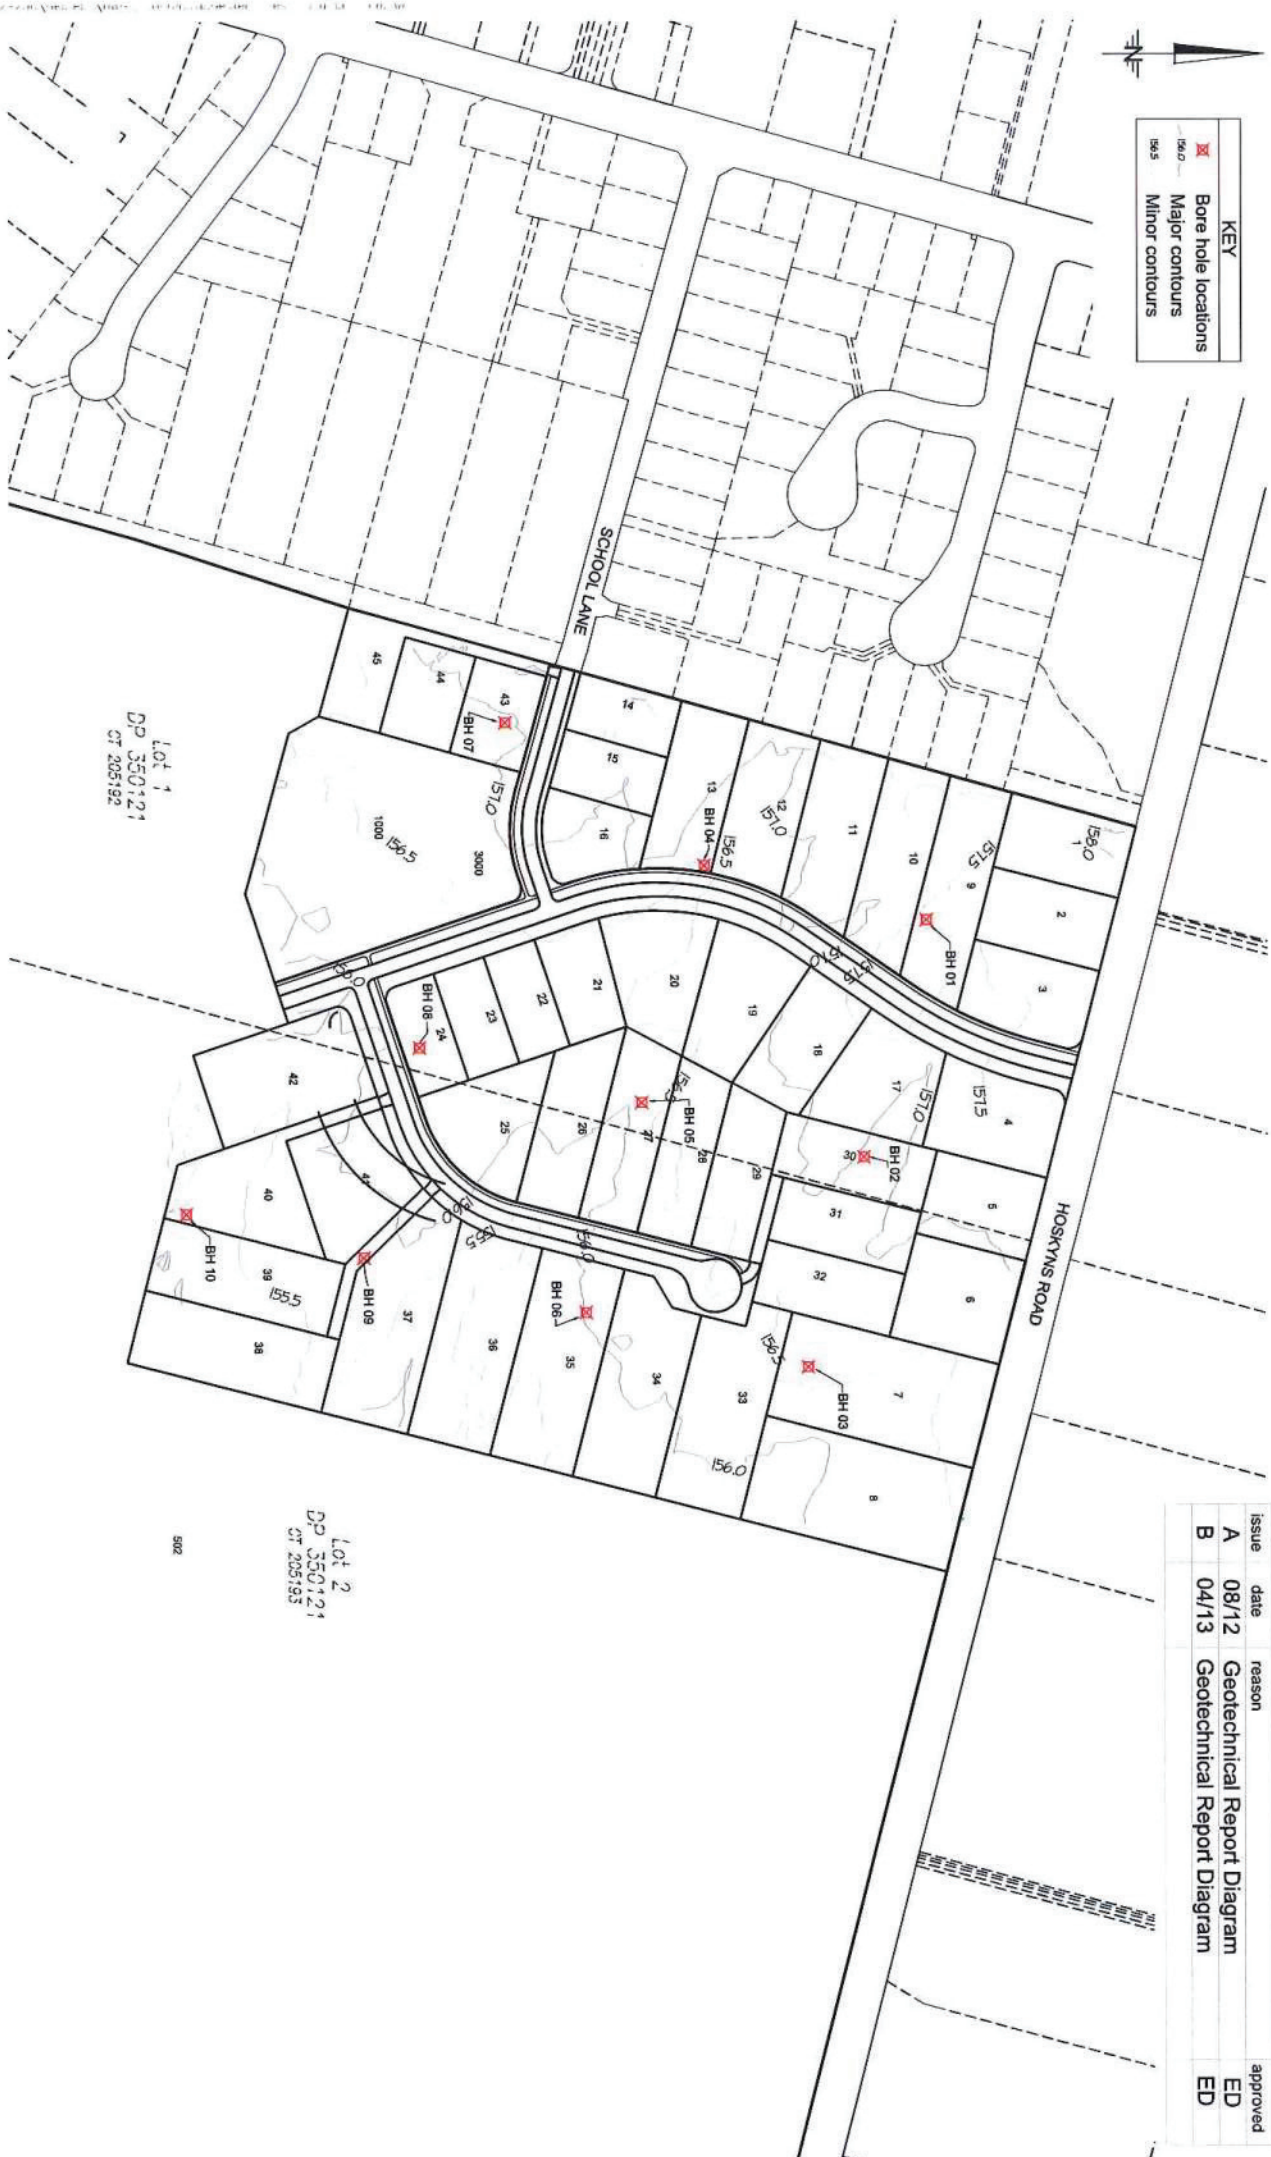
Layout Plan

KEY

- ✗ Bore hole locations
- Major contours
- Minor contours

The site investigation comprised a site walkover and ten boreholes with Standard Penetration Testing (SPT) carried out at 1.5 m depth intervals. A Geotechnical Site layout plan is presented in Appendix A of this report.

Ashburton Contracting Limited (ACL) were contracted to advance ten Boreholes (BH) across the site at locations presented in appended geotechnical site location plan presented in Appendix A of this report. The boreholes were advanced using a sonic drill rig, with continuous sampling capabilities. Standard penetration testing (SPT) was carried out 1.5 m centres during the drilling process to provide relative density of the underlying soils.

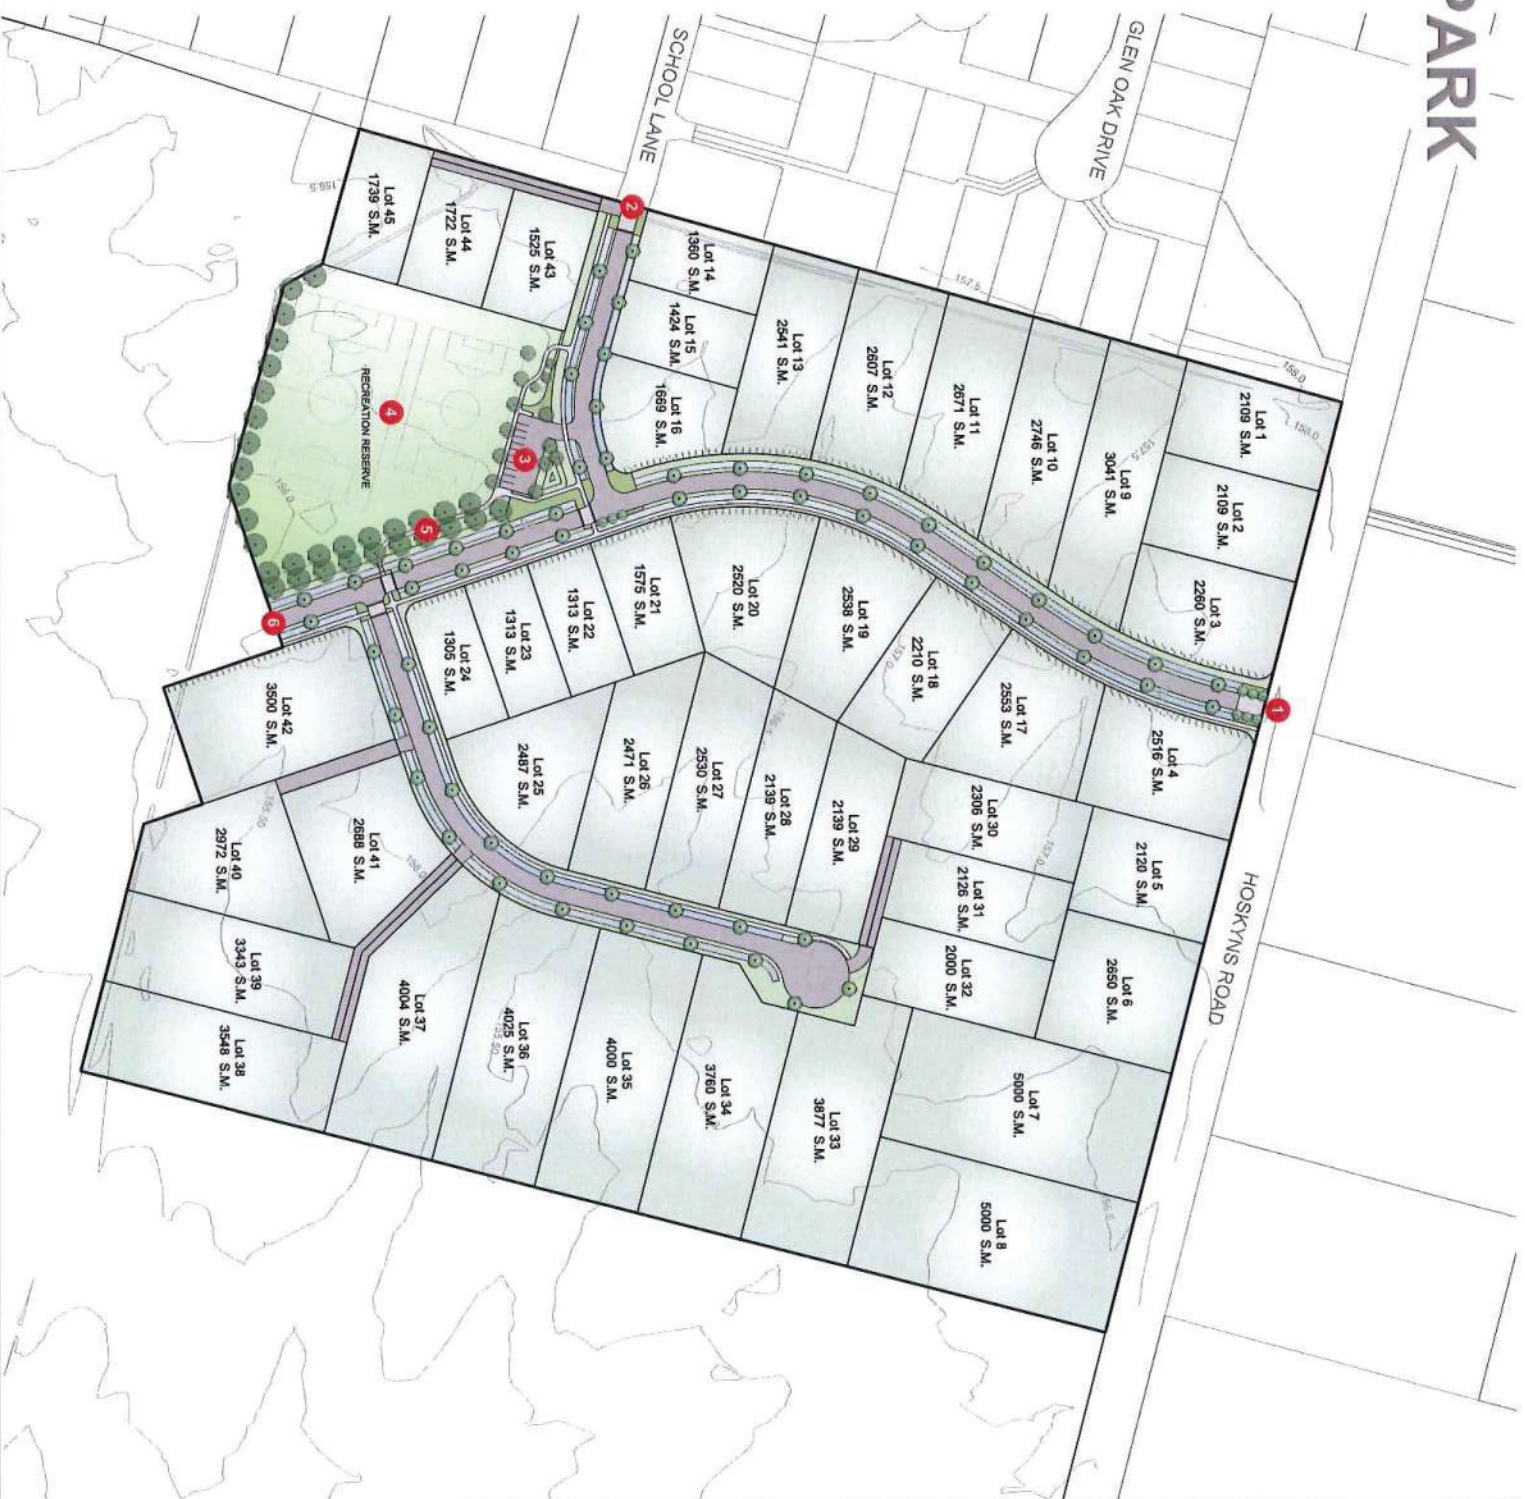
McDougal Park Subdivision Plan (Morgan and Pollard 28/05/2013 001A Preliminary)

1. HOSKYN'S ROAD ENTRANCE FEATURE (PRIMARY)
2. SCHOOL LANE ENTRANCE FEATURE (SECONDARY)
3. CAR PARK
4. SPORTS FIELDS
5. OFF ROAD CYCLE/PEDESTRIAN LINK
6. LINK TO FUTURE STAGES
