8. Leeston

8.1 Description of existing environment and stormwater discharge

8.1.1 Leeston township description, stormwater network and discharge location

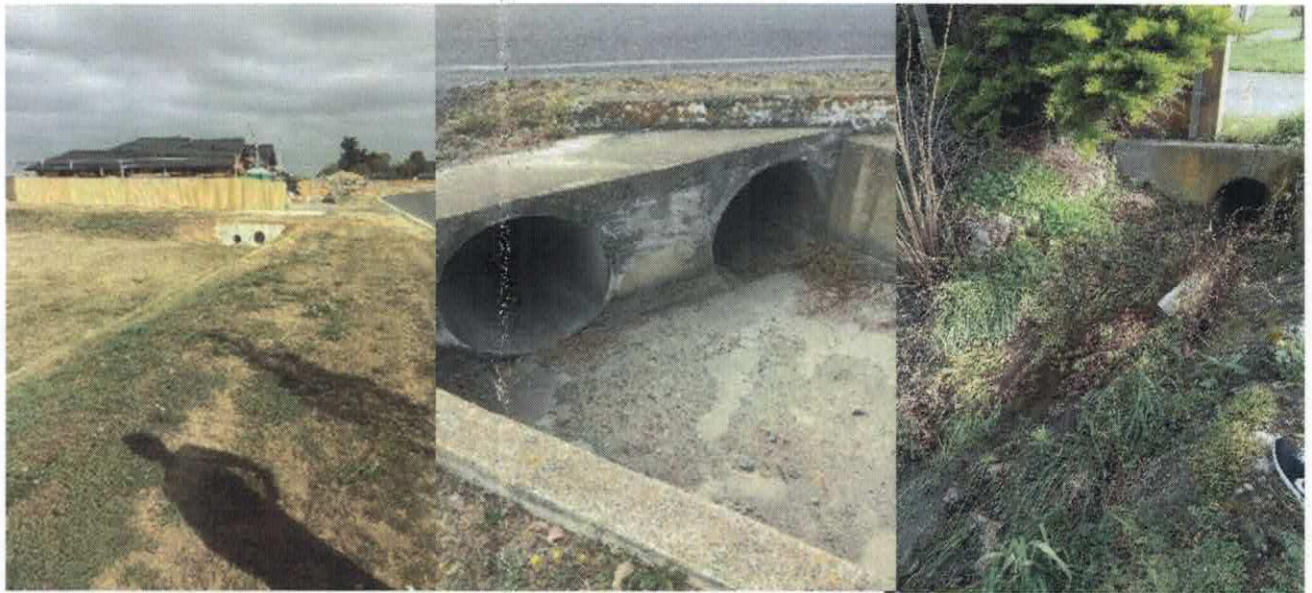
Figure 16 : Discharge points at Leeston. Left is the Birdling Brook stormwater basin, middle is Leeston Creek discharge and the right is Leeston Lake Drain discharge. All photos were taken on the 28 February 2017.

The receiving site for the Leeston Lake Drain subcatchment is the Leeston Lake Drain that runs alongside Leeston and Lake Road. This is a grassed straightened drain that is intermittently flowing. Figure 16 shows a picture of the drain on the 26th July 2017 following heavy rain where a small clear baseflow could be seen in the narrow grassed channel.

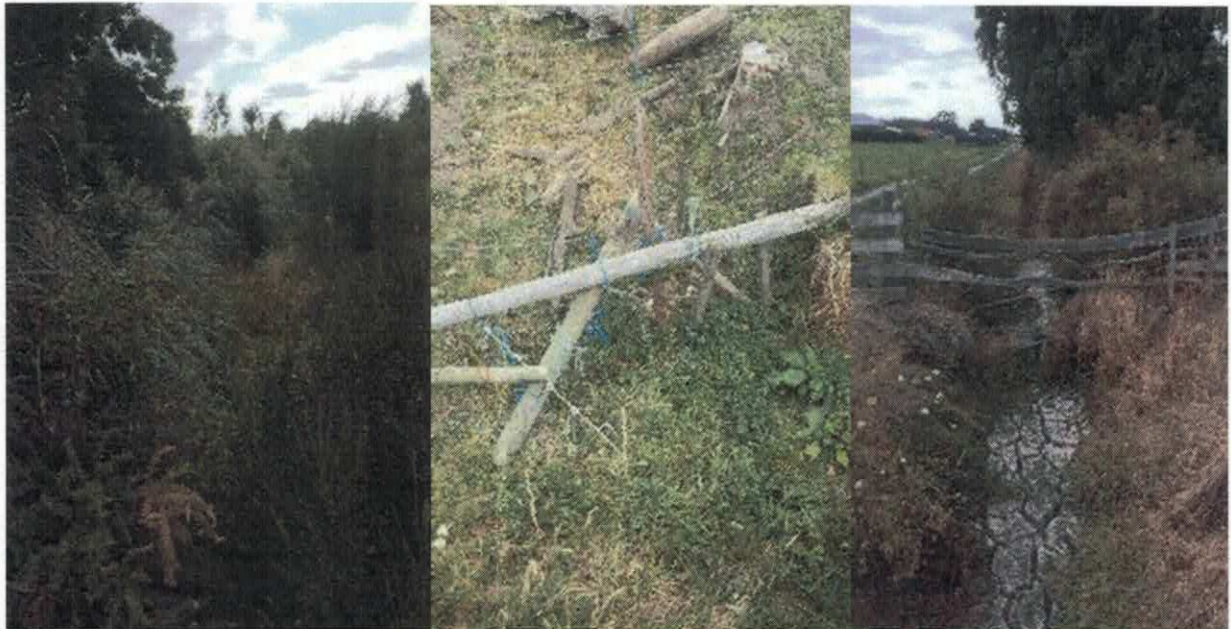
Figure 17 : Reference sites for Birdling Brooks (Left and middle) and Leeston Creek (Right). Photos taken 28 February 2017

The reference site for Birdling Brook and Leeston Lake Drain was located just above the High Street and Hermans Road intersection. The site is characterised by starkly different land use from one side of the road to the other (Figure 17). There is high vegetation growth on the township side of Birdling Brooks in comparison to the grassed farmland on the opposite side. The site was dry during the dry weather site visit. This reference site is not directly upstream of Leeston Lake drain as the township drainage network forms all of the lake Drain catchment. This site is therefore the closest most relevant upstream point on an adjacent waterbody that can be monitored.

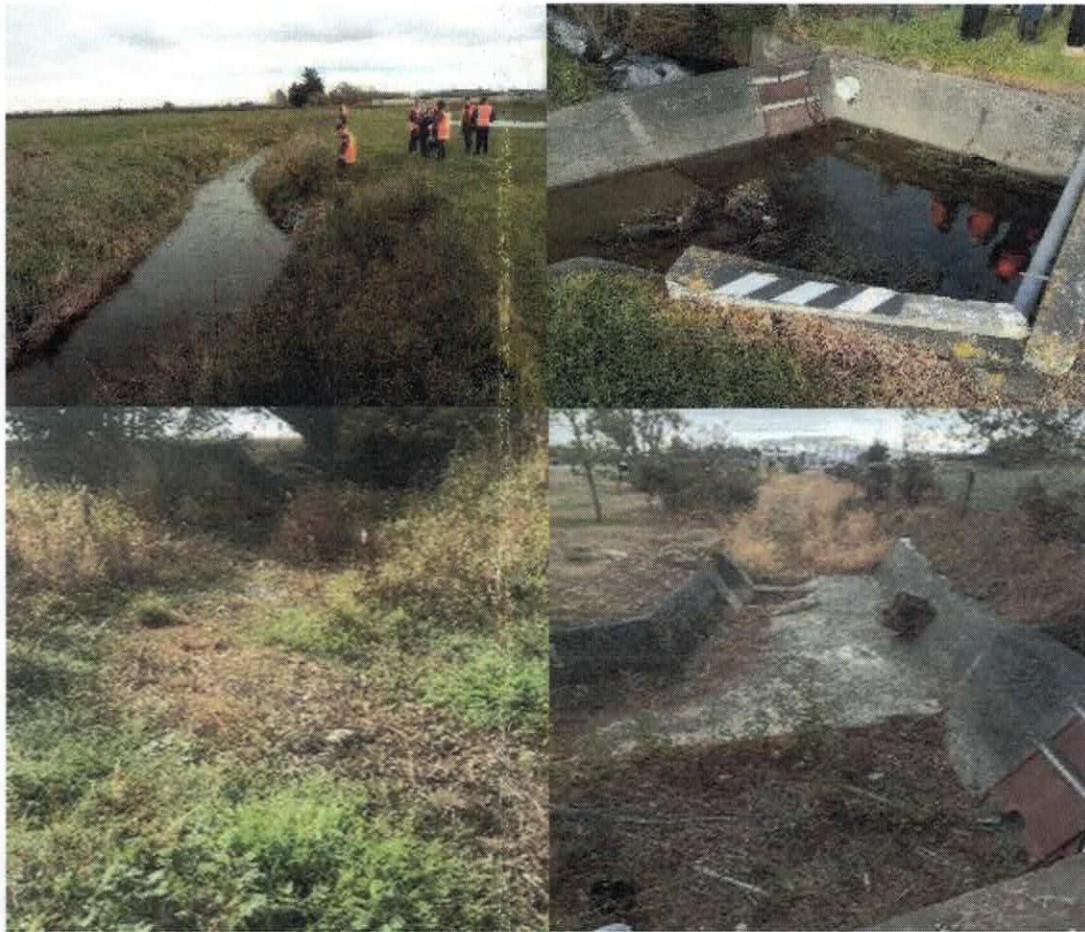
Figure 18 : Receiving sites for Birdling Brooks wet weather (top left) and dry weather (bottom left) and Leeston Creek wet weather (top right) and dry weather (bottom right). Photos taken on 28 February and 26 July 2017

The receiving site for Leeston Creek was based at the junction between Leeston Road, Volckman Road and Station Street (Figure 18). The drain at the time of surveying 28th February 2017 was dry. The drain splits into two at this location with flows governed by manual control structures. The main flow follows Volckman Road. Leeston Creek Drain was observed to be flowing during a site visit on the 26th July 2017. This was following a large rain event that caused localised flooding across the district. Figure 18 contains images of the discharge point in both wet and dry weather. Leeston Creek is therefore an intermittently flowing waterbody.

The receiving site for the Birdling Brook stormwater basin discharge was located downstream of the township past the stormwater basin at the end of Clausen Avenue (Figure 18). The surrounding environment included farm land and new housing development. Birdling Brooks stream was dry at the time of surveying 28th February 2017, however was flowing during a wet weather survey on 26th July and therefore the stream is considered to be intermittent.

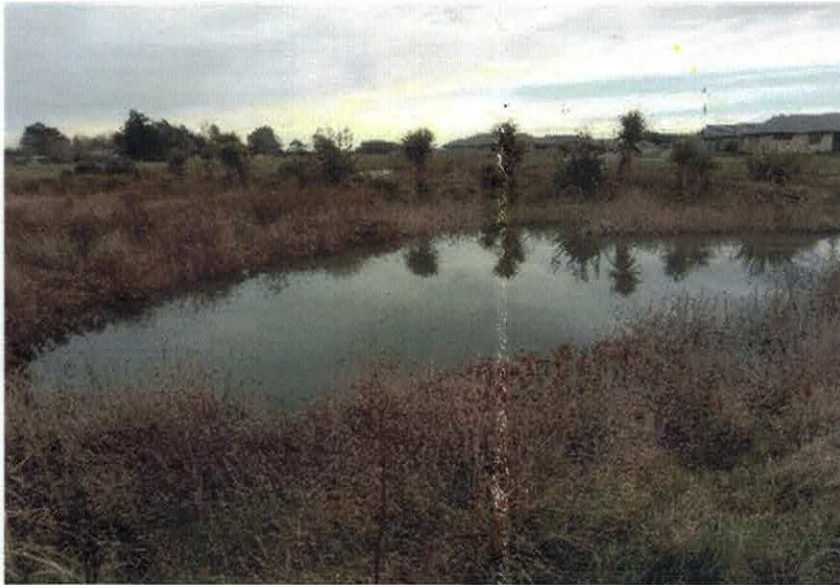
Figure 19 : Wetland providing treatment of stormwater discharge from the northern subdivision of Leeston. Photo taken on the 26th July 2017

The wetland servicing the Leeston North subdivision and the dry pond to the south are both expected to treat the hydrocarbon inputs such that no impact on the water quality and ecology below these sections of Leeston would be expected. The remaining areas of Leeston have less treatment and some hydrocarbons would be expected to enter the receiving waters.
