Appendix 6: Flood Hazard Assessment

LOT 1, 2, 3, & 4 DP 82846, LOT 1 DP 9138, LOT 2 DP 319397, LOT 2 DP 365379, PART RS 5482 & 5483, SECTION 7 LEESTON SETT – HIGH STREET, LEESTON

Flood Risk

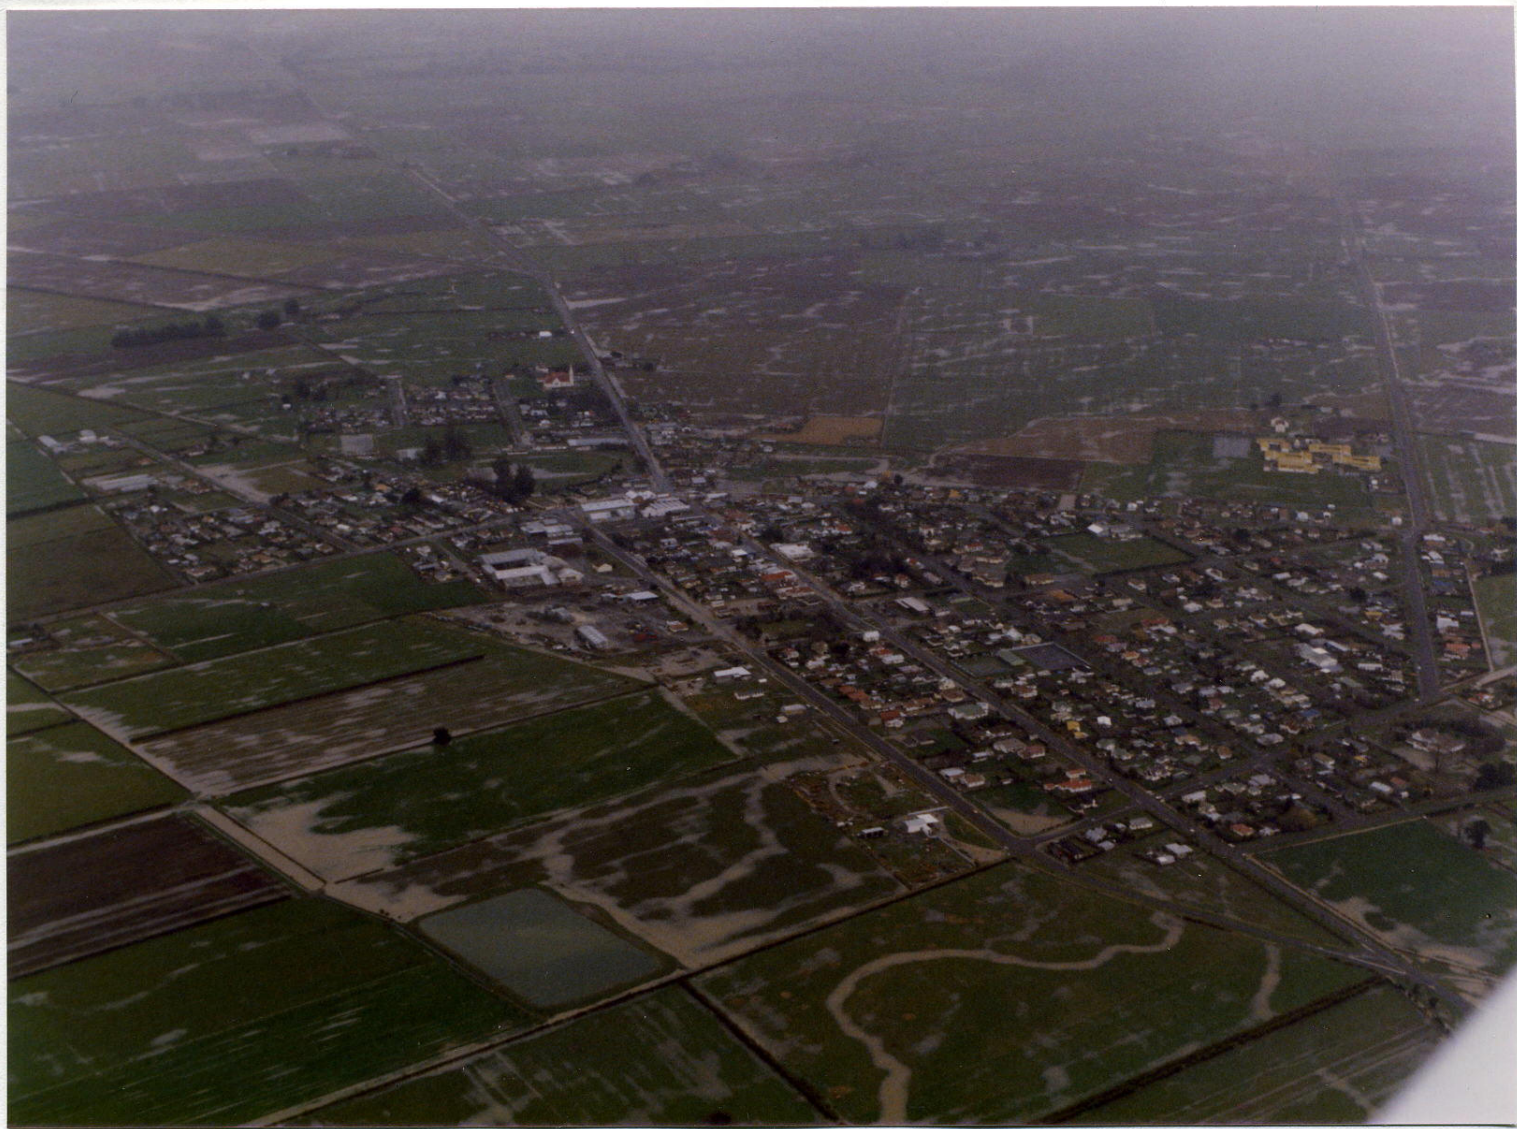
621. Leeston. (West)

Photograph No. **621** was taken on 24/08/1986 following a rainfall event where 72.7 mm was recorded at Greenpark, 81.3 mm at Lincoln, 96.8 mm at Burnham and 105.1 mm at Dunsandel in the 72 hours to 9 am on 23/08/1986. The return period of the rainfall at Greenpark and Lincoln is estimated at 2 - 5 years, with the slightly heavier rainfall at Burnham and Dunsandel having an estimated return period of 5 - 10 years. Antecedent conditions at the time were relatively wet due to rainfall earlier in the month.

The photographs show rainfall runoff flowing across the property and ponding behind barriers to flow and in natural depressions. Note that in both cases the photographs were taken 24 hours or more after the bulk of the rain had fallen, and therefore will not show flooding at its peak. In larger flood events it is likely that more extensive areas than those shown as flooded in the photographs will be affected.

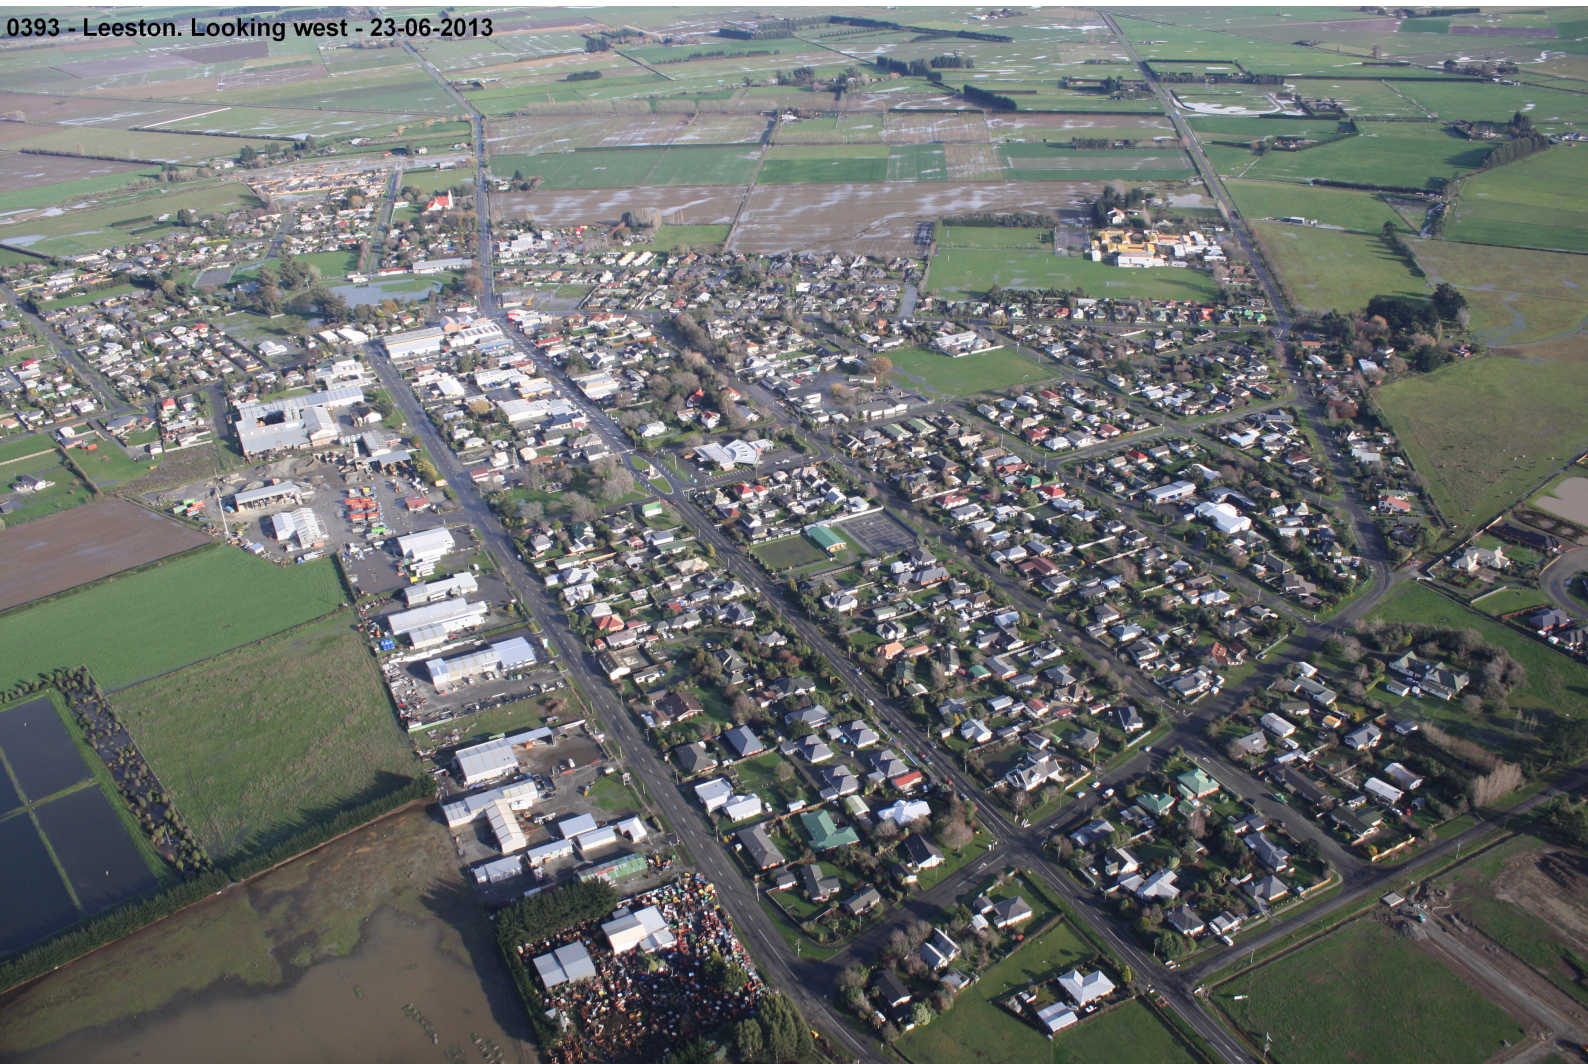
0393 - Leeston. Looking west - 23-06-2013

Photographs No. **0393, 0408, 0421, 0788, and 0802** were taken on 23/06/2013 following a rainfall event where 117.6 mm was recorded at Leeston in the 72 hours to 9 am on 22 June 2013. This rainfall had a return period of approximately 10 years, however this was following a rainfall of more than 60 mm earlier in the week.

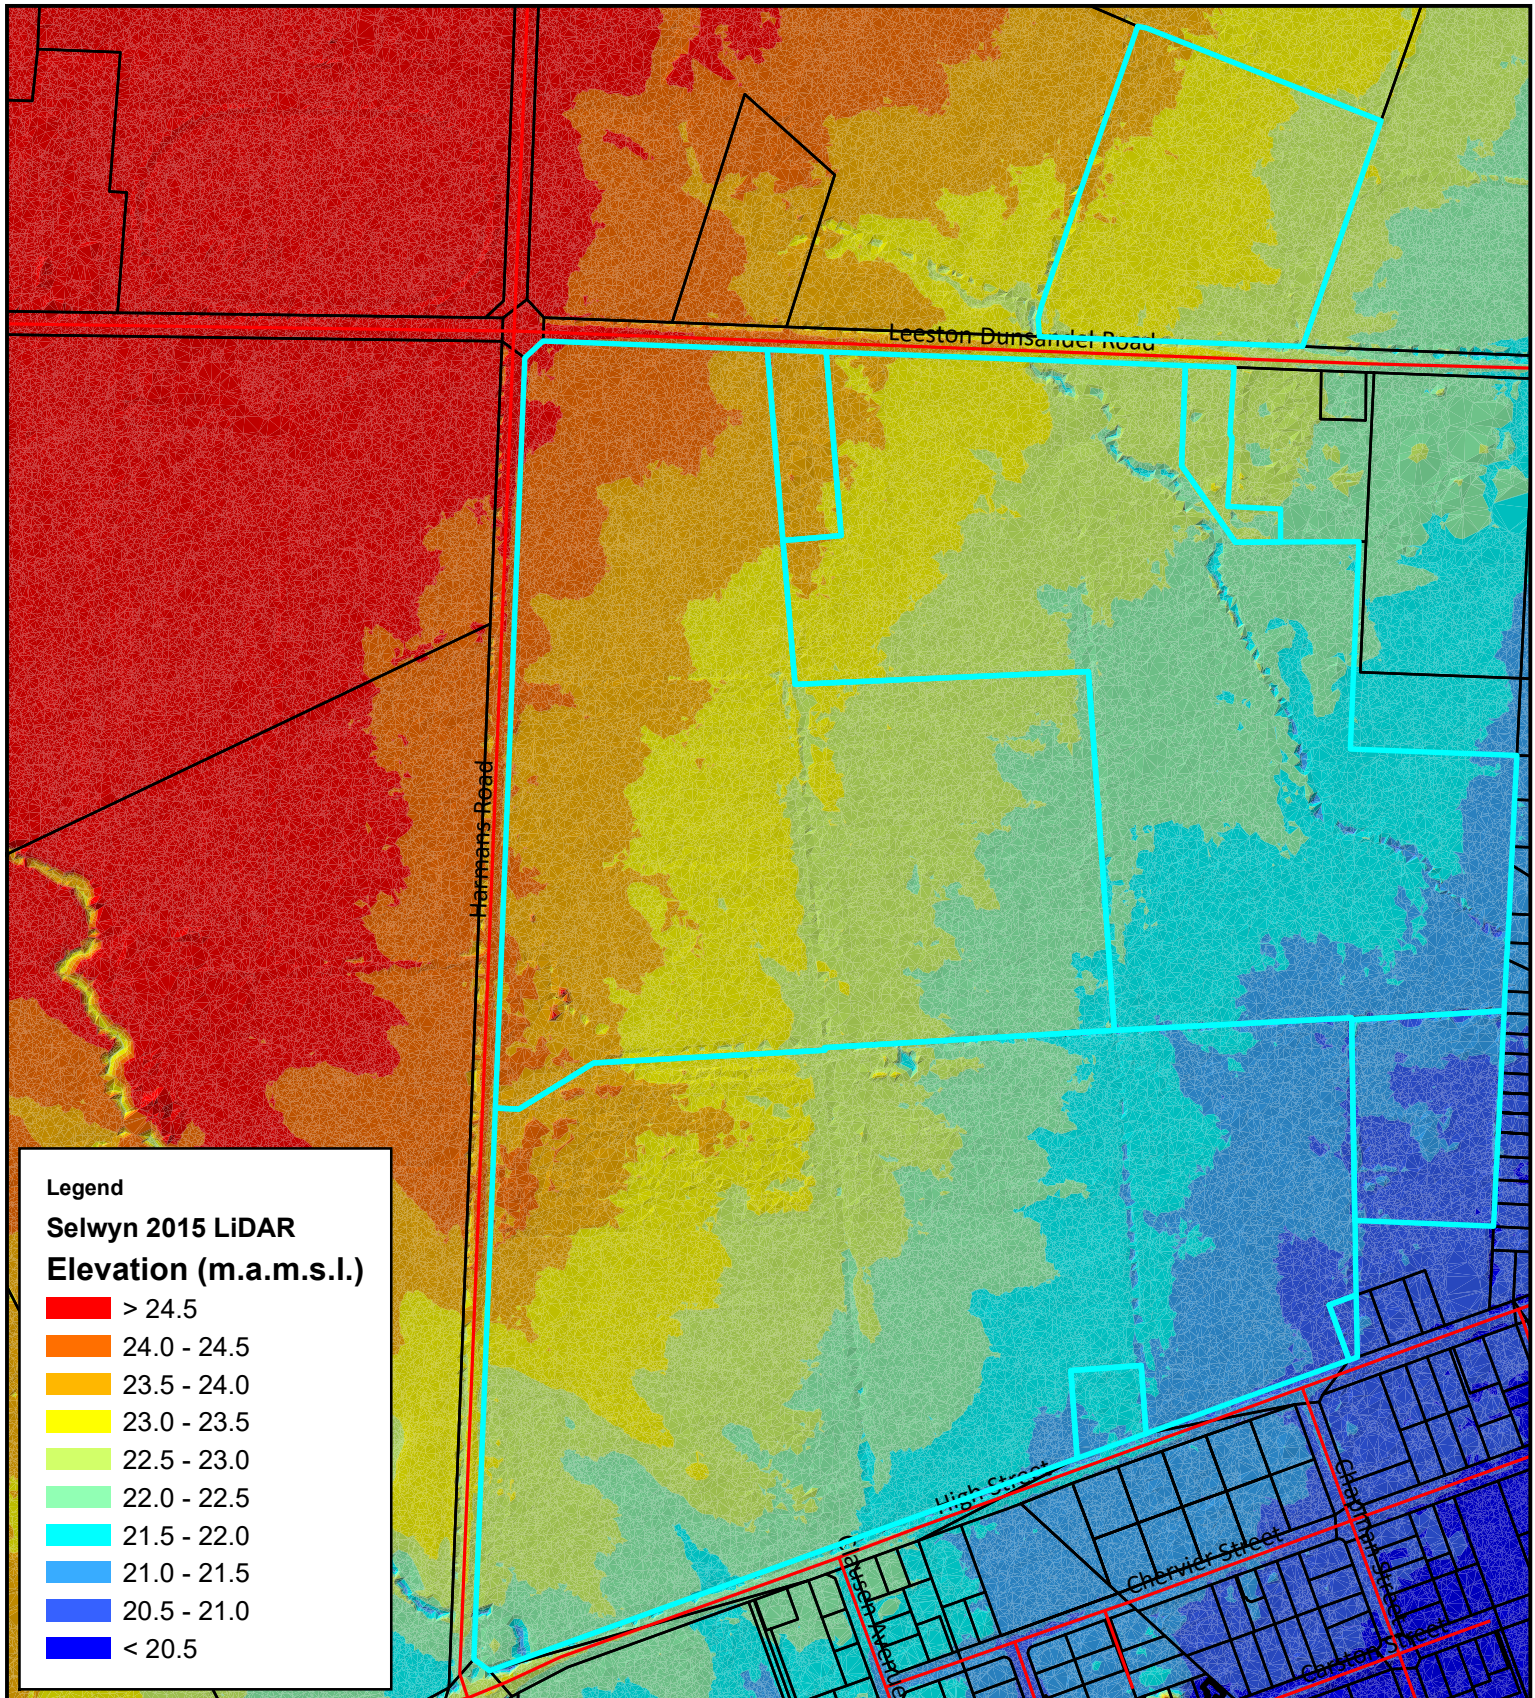
High Street, Leeston - 2015 LiDAR Map

The property is within part of the Selwyn District that has been flown by LiDAR; an airborne laser system that maps the ground topography. The accuracy of this topographical survey is considered to be in the order of ± 150 mm or better. Enclosed for your information is a **map showing ground level variations** at the property derived from LiDAR data obtained in 2015. These levels are presented in meters above mean sea level (m.a.m.s.l.) – Lyttelton 1937 Datum.
