SERVICING REPORT

KIMBERLEY ROAD AND BROADMEADOWS
DRIVE, DARFIELD

CLIENT
MERF AGRICULTURAL SERVICES LTD

PROPOSED PLAN CHANGE-
DARFIELD PREFERRED
DEVELOPMENT AREA 7
(MALVERN AREA PLAN)

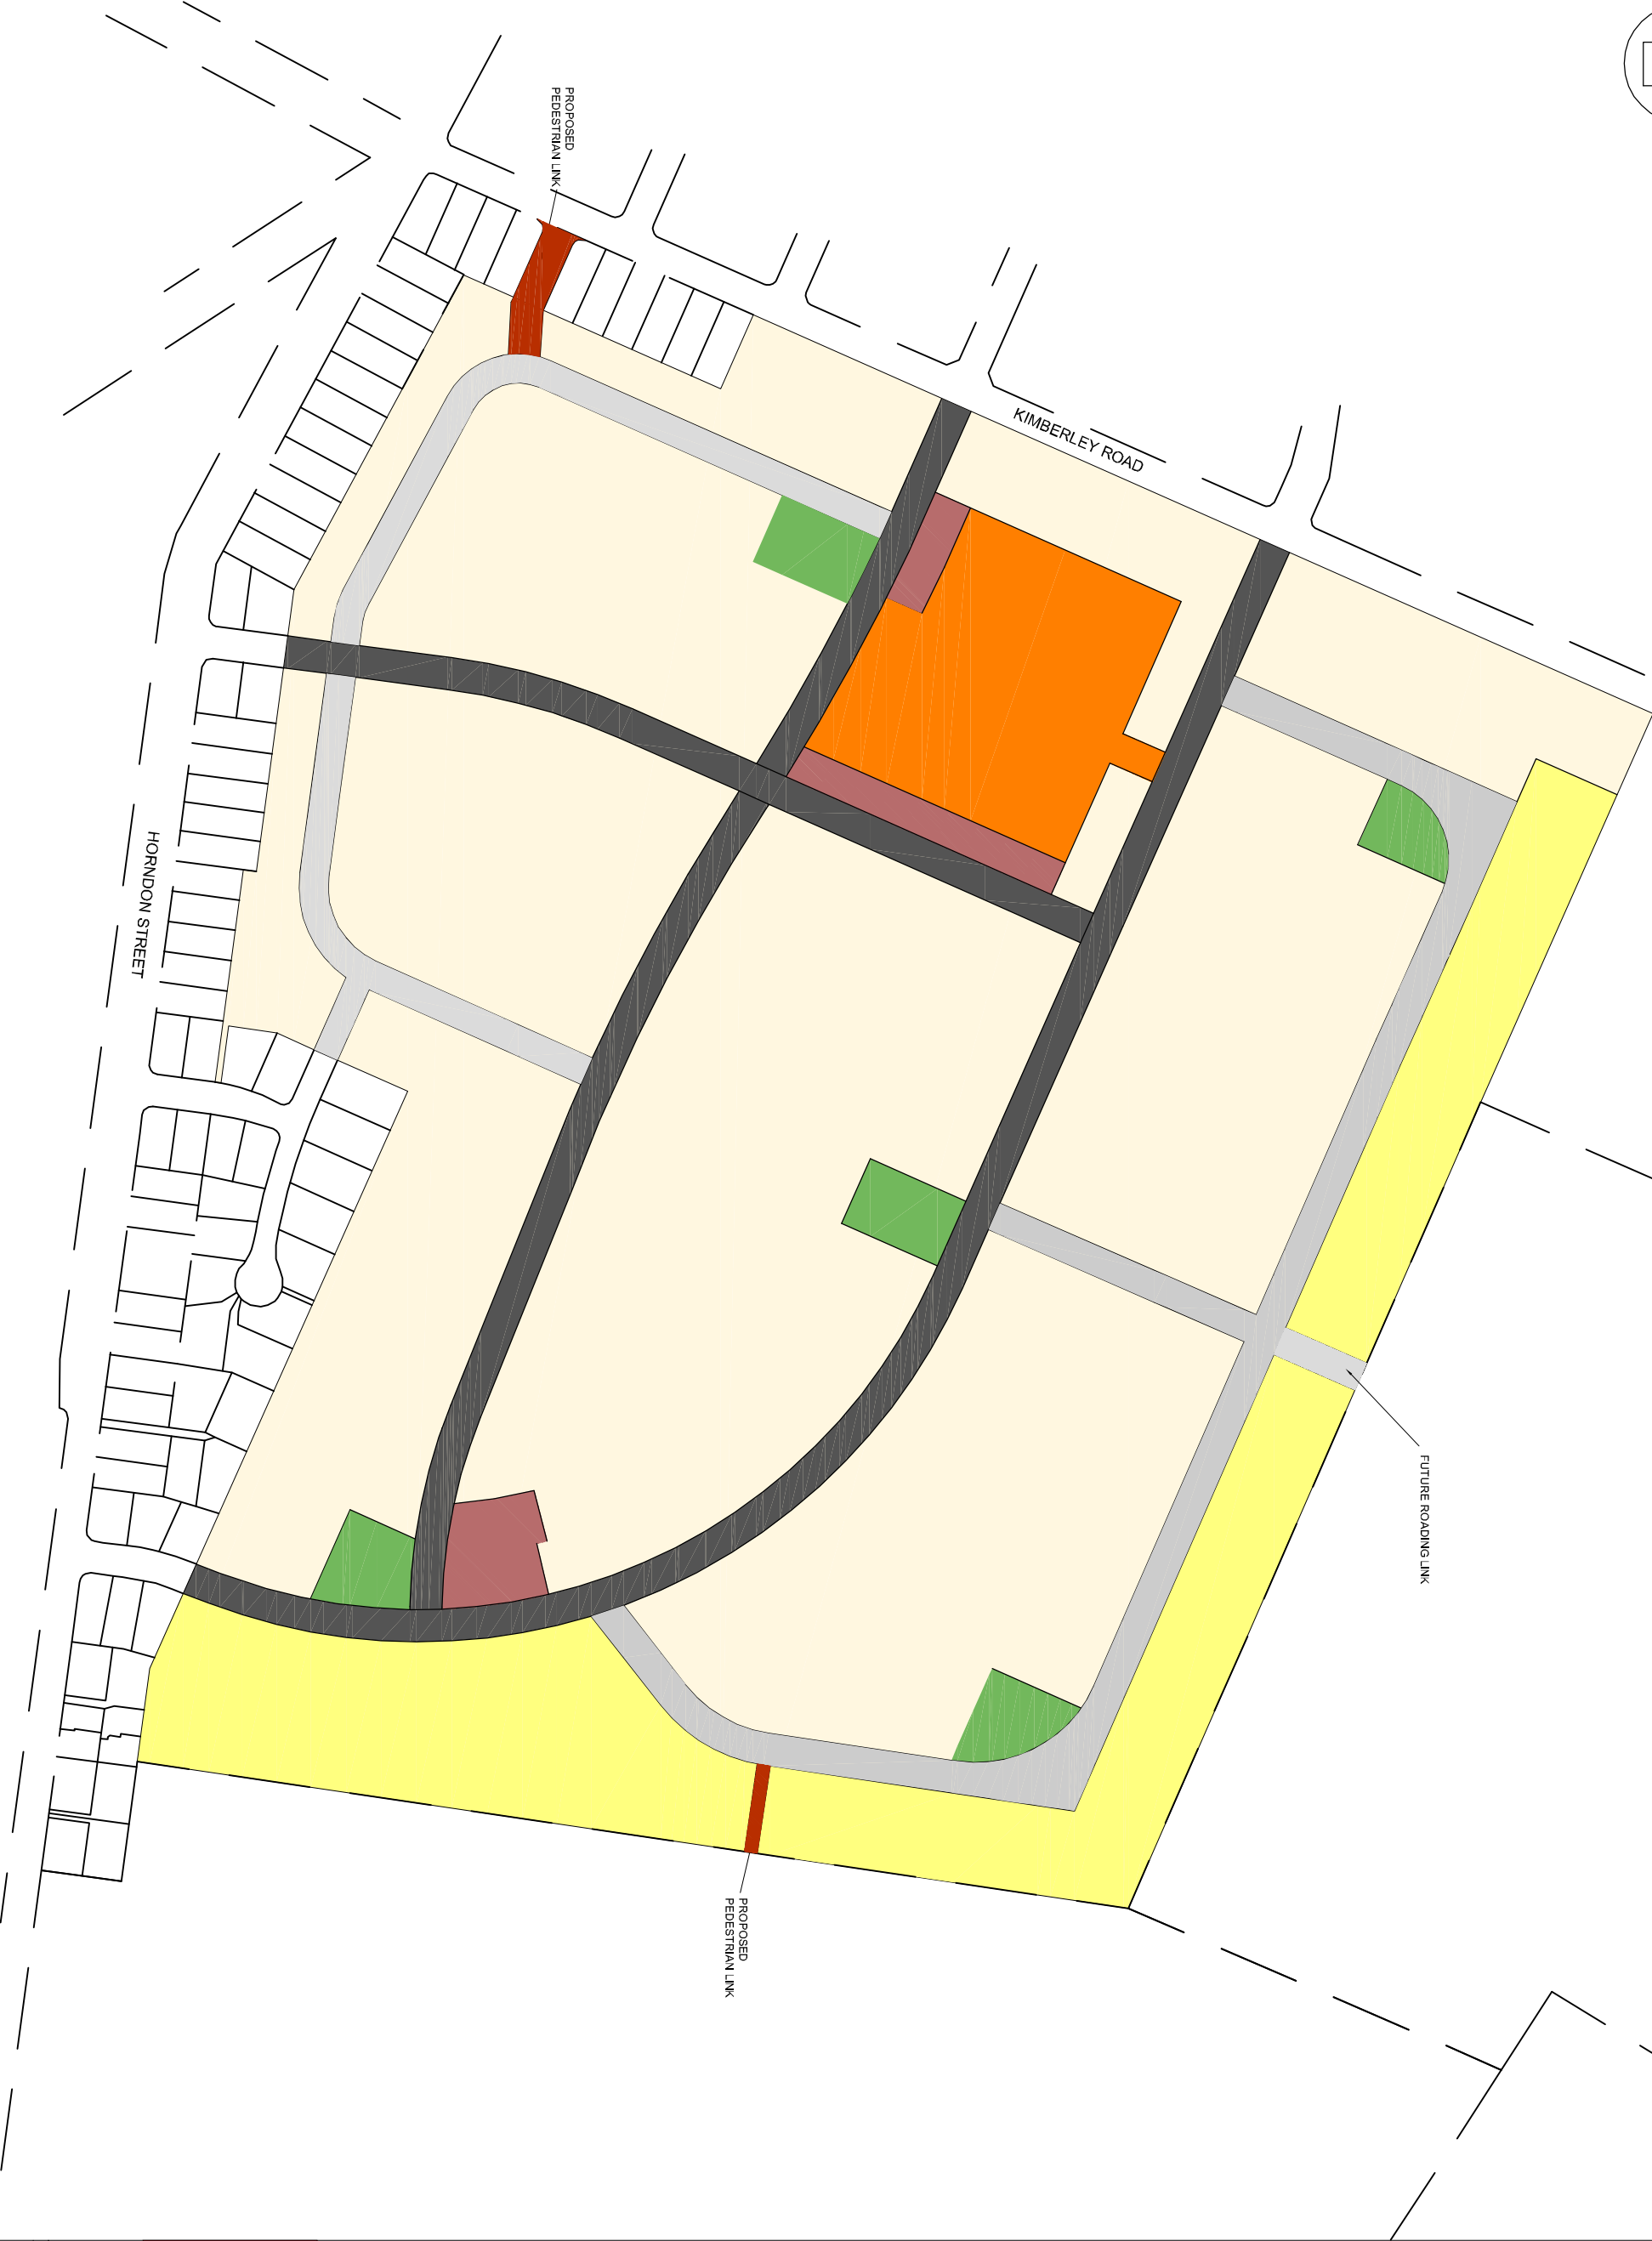
ODP and Scheme Plan

- PRIMARY ROAD
- SECONDARY ROAD
- RESERVE
- PEDESTRIAN LINK
- AGED CARE FACILITY
- MEDIUM DENSITY AREA (min 430m²)
- LIVING DENSITY AREA (min 1350)

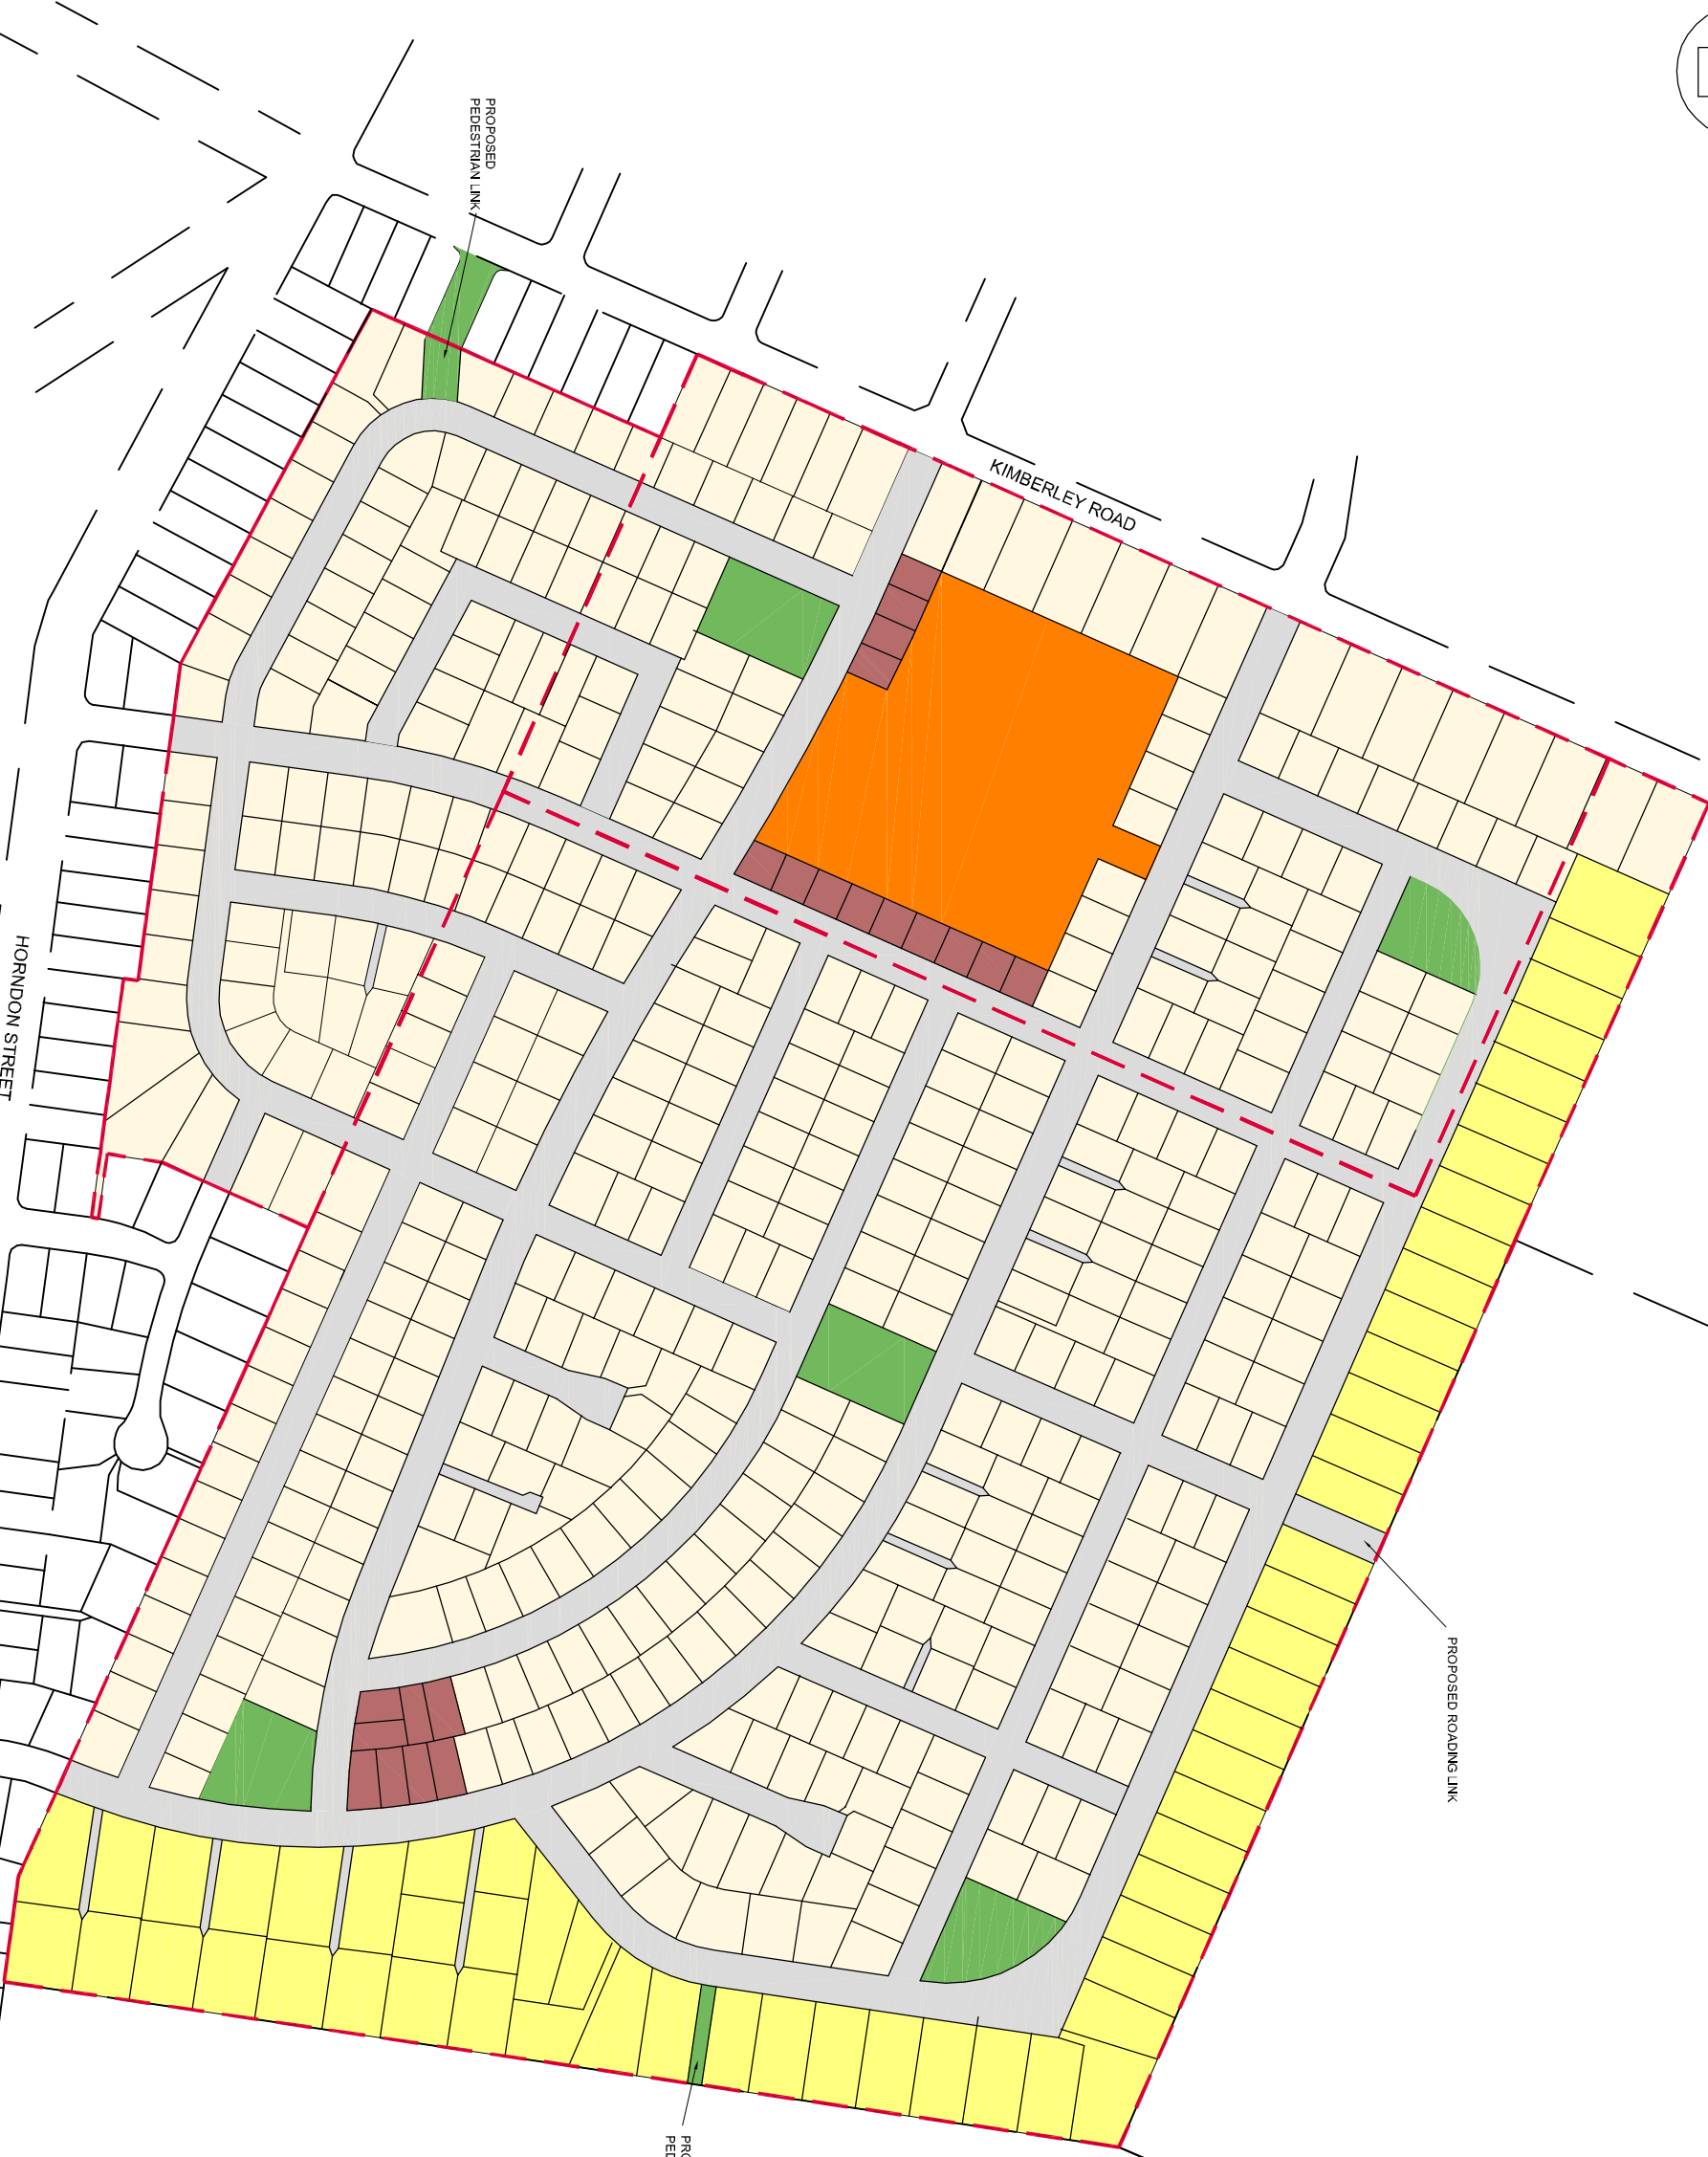
- MEDIUM DENSITY AREA (min 450m²)
- ROAD TO WEST
- REC RESERVE TO WEST
- AGED CARE FACILITY
- LIVING DENSITY AREA (min 1500m²)

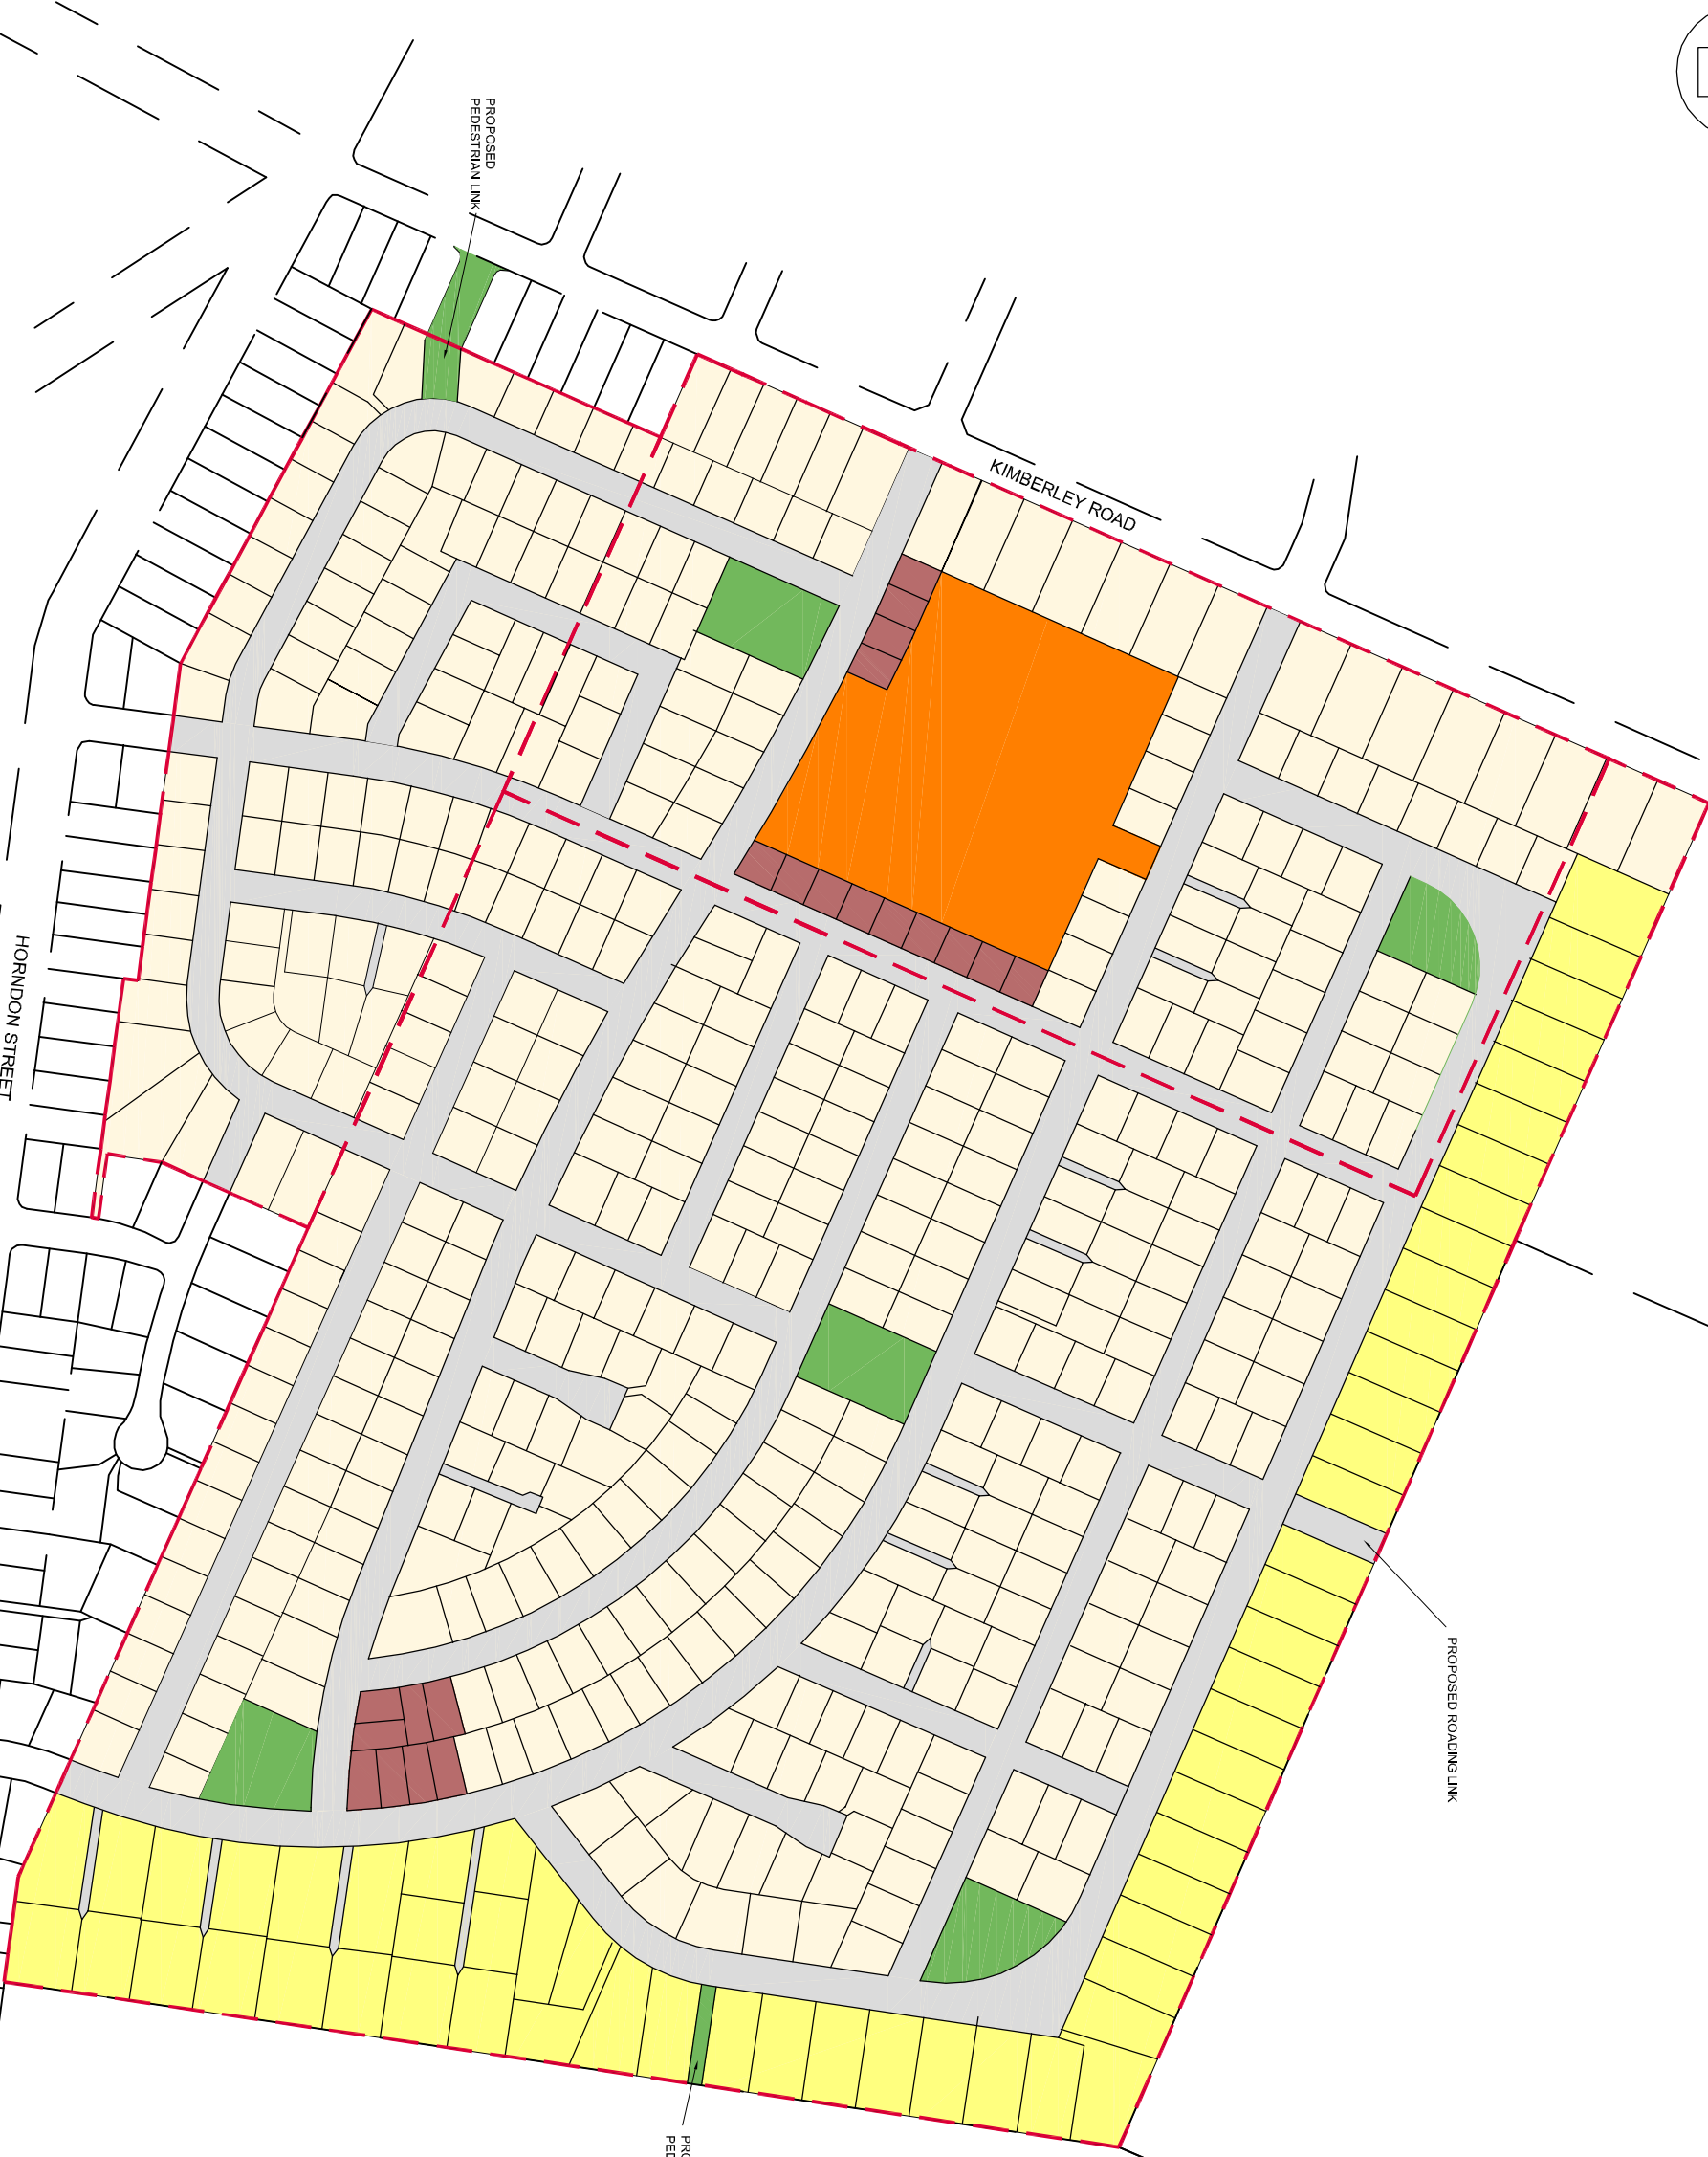
- MEDIUM DENSITY AREA (min 450m²)
- ROAD TO WEST
- REC RESERVE TO WEST
- AGED CARE FACILITY
- LIVING DENSITY AREA (min 1500m²)
