Geotechnical Investigation

174 - 250 Hamptons Road and 735 Shands Road

Prebbleton

17637.000.000_01

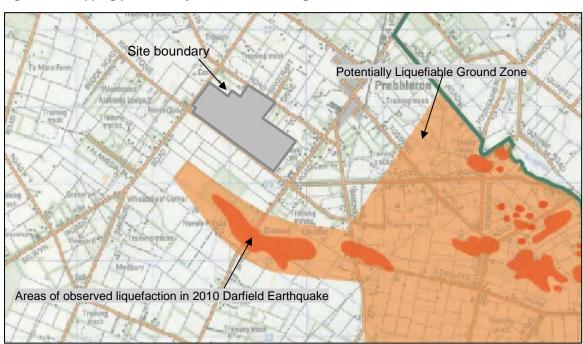
Figure 2: Mapping produced by Geotech Consulting 2010

We have reviewed the mapping undertaken by Geotech Consulting in their 2010 Canterbury Earthquake Liquefaction Report, dated 8 February 2011. The mapping shows areas of observed liquefaction following the 2010 Darfield Earthquake and areas assessed as likely to be underlain by potentially liquefiable ground (Figure 2). The mapping shows the site is located approximately 600 m north of an area of observed liquefaction, and approximately 500 m north of the Potentially Liquefiable Ground Zone.

Image from Geotech Consulting (2011). Not to scale.

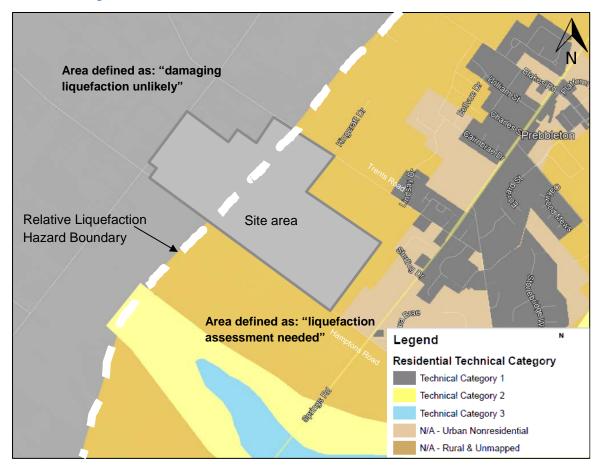
Figure 3: Canterbury Liquefaction Susceptibility Mapping by GNS Science/ECan and MBIE Residential Technical Categories

We have also reviewed the mapping undertaken by GNS Science in their report titled "Review of liquefaction hazard information in eastern Canterbury, including Christchurch City and parts of Selwyn, Waimakariri and Hurunui Districts", dated 2012. The site is mapped on the boundary between two zones delineating relative liquefaction risk. The northwest side of the site is mapped within an area where "liquefaction damage unlikely" and the southeast side of the site is mapped as "liquefaction assessment needed".

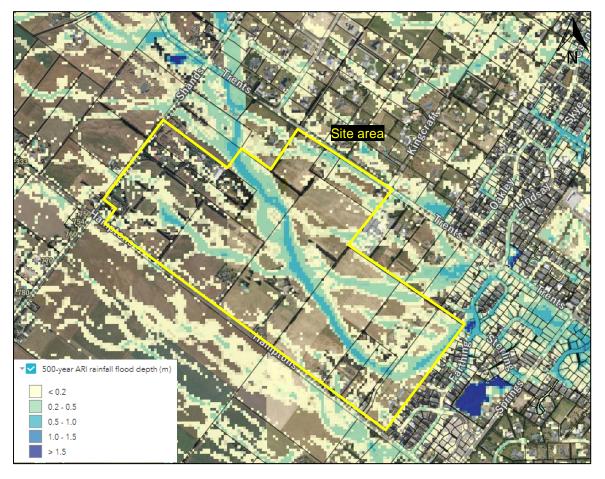
Figure 4: SDC Flooding map

The Selwyn District Council have carried out computer-based flood modelling to predict the extent and depth of flooding that could happen during a one-in-200-year and a one-in-500-year flood. Based on this modelling, the water depth through the site may be up to 1 m deep in the existing channel feature (Figure 4) during the 500 year flood.

Based on our observations and the nature of the site, and the site's distance from the nearest significant watercourse, we consider it unlikely for the site to be subject to any of the above hazards and, as such, the site is considered suitable for a plan change from a geotechnical perspective. As discussed in Section 3.3 of this report, we recommend that flooding hazard is considered during subdivision design.

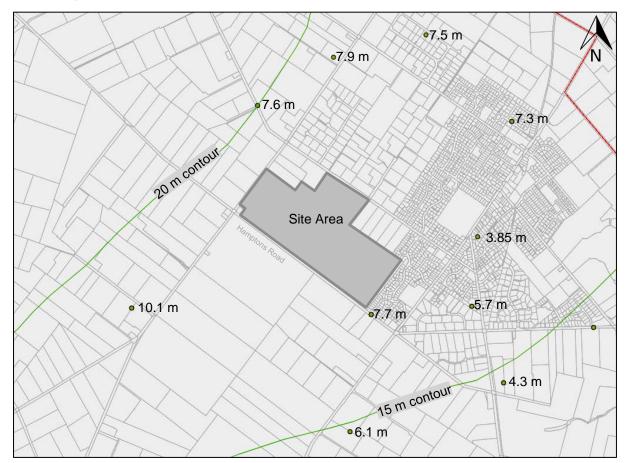
Figure 5: ECan Regional Piezometric Elevation Contours and Piezometric Wells used in various published groundwater studies.

We have reviewed the well information from ECan used in various published groundwater models and groundwater contour maps available on Canterbury Maps. Published regional mapping of groundwater shows the site is located approximately halfway between the 15 m and 20 m groundwater elevation contours. The site itself is located at an elevation of approximately 22 m (south-eastern end) to 27 m (north-western end), which suggests the depth of the groundwater surface below the site is approximately 4 m to 9 m depth (Figure 5). Various other published groundwater studies available on Canterbury Maps show the site located between contour lines ranging from 5 m to 10 m (Figure 6), indicating the groundwater beneath the site is at least 5 m deep and may be up to 10 m deep. Nearby piezometric wells summarised on Canterbury Maps (shown in Figure 5) generally corroborate with mapped groundwater contours and with the groundwater information from wells described in Section 3.4.

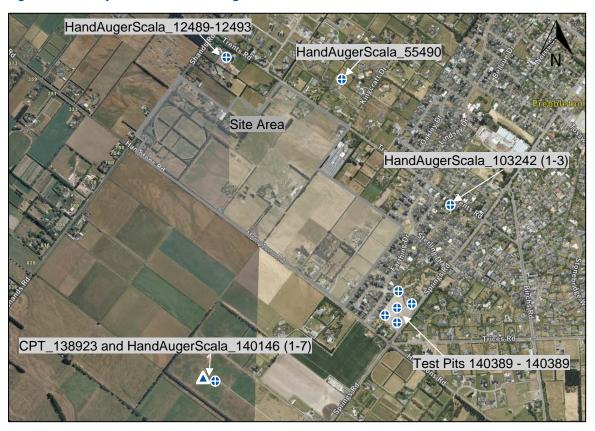
Figure 7: Nearby Geotechnical Investigations

The ground conditions in nearby testing locations are generally consistent and comprise shallow sand and silt overlying gravel.

Testing within an area located 800 m south of the site shows a deeper profile of sand and silt overlying gravel – liquefaction was observed in this area following the 2010 Darfield Earthquake and the land has been categorized as TC3 (see Figures 2 and 3). The area of observed liquefaction appears to be constrained to a linear area that is likely related to a deeper channel of silts and sands. We do not consider this area represents the ground conditions beneath the site.

Investigation Identifier	Position Relative to Site	Depth of Exploration (m)	Material Summary
HandAugerScala_12489- 12493	Approximately 300 m to the northwest	0.7 – 1.0	Silt to between 0.7 m and 1 m underlain by gravel
HandAugerScala_103242 (BH1-3)	Approximately 500 m to the east	0.7-1.2	Silt to between 0.7 m and 1.2 m underlain by (inferred) gravel.
HandAugerScala_55490	Approximately 500 m to the northeast	2.2	Silt and sand to 2.2 m underlain by gravel.
Test Pits_140389-140393	Approximately 800 m to the east	3.2 - 3.6	Silt to between 0.6 m and 1.0 m, underlain by gravels.
CPT_138923 and HandAugerScala_140146 (1-7)	Approximately 800 m to the south	CPT: 7.77 Hand Augers: 3.0	Silt and sand to 7.7 m underlain by gravel (inferred based on tip refusal)

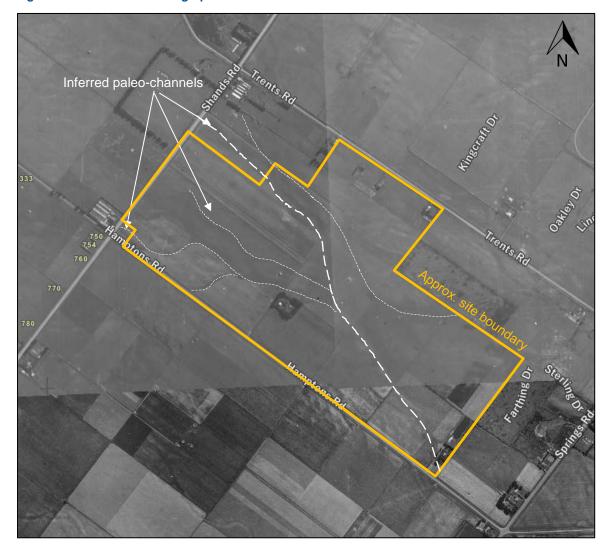
Figure 8: 1940 Aerial Photograph

We have reviewed historic aerial photographs dating back to 1940. It appears that land use at the site has included general rural farming activities with no significant ground modifications identified in the available photographs. Linear features trending northwest-southeast were identified in several historic and recent aerial photographs and are interpreted to be related to paleo-channels (presumably from large flood events), these features are shown in Figure 8 below.

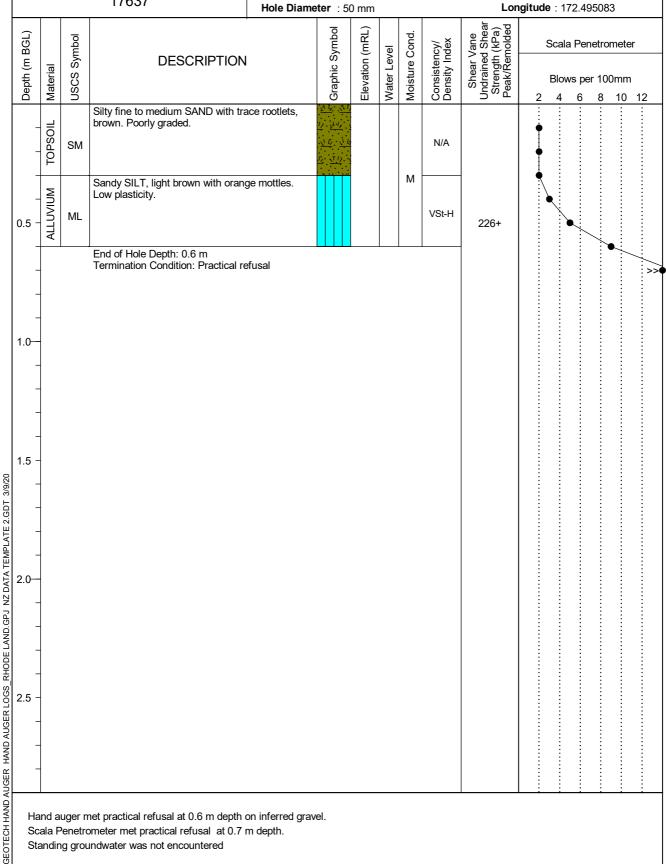
Hand auger met practical refusal at 0.6 m depth on inferred gravel.

Scala Penetrometer met practical refusal at 0.7 m depth.
