Preliminary Site Investigation

1491 Springs Road, Lincoln

21 December 2020

Preliminary Site Investigation - 1491 Springs Road, Lincoln

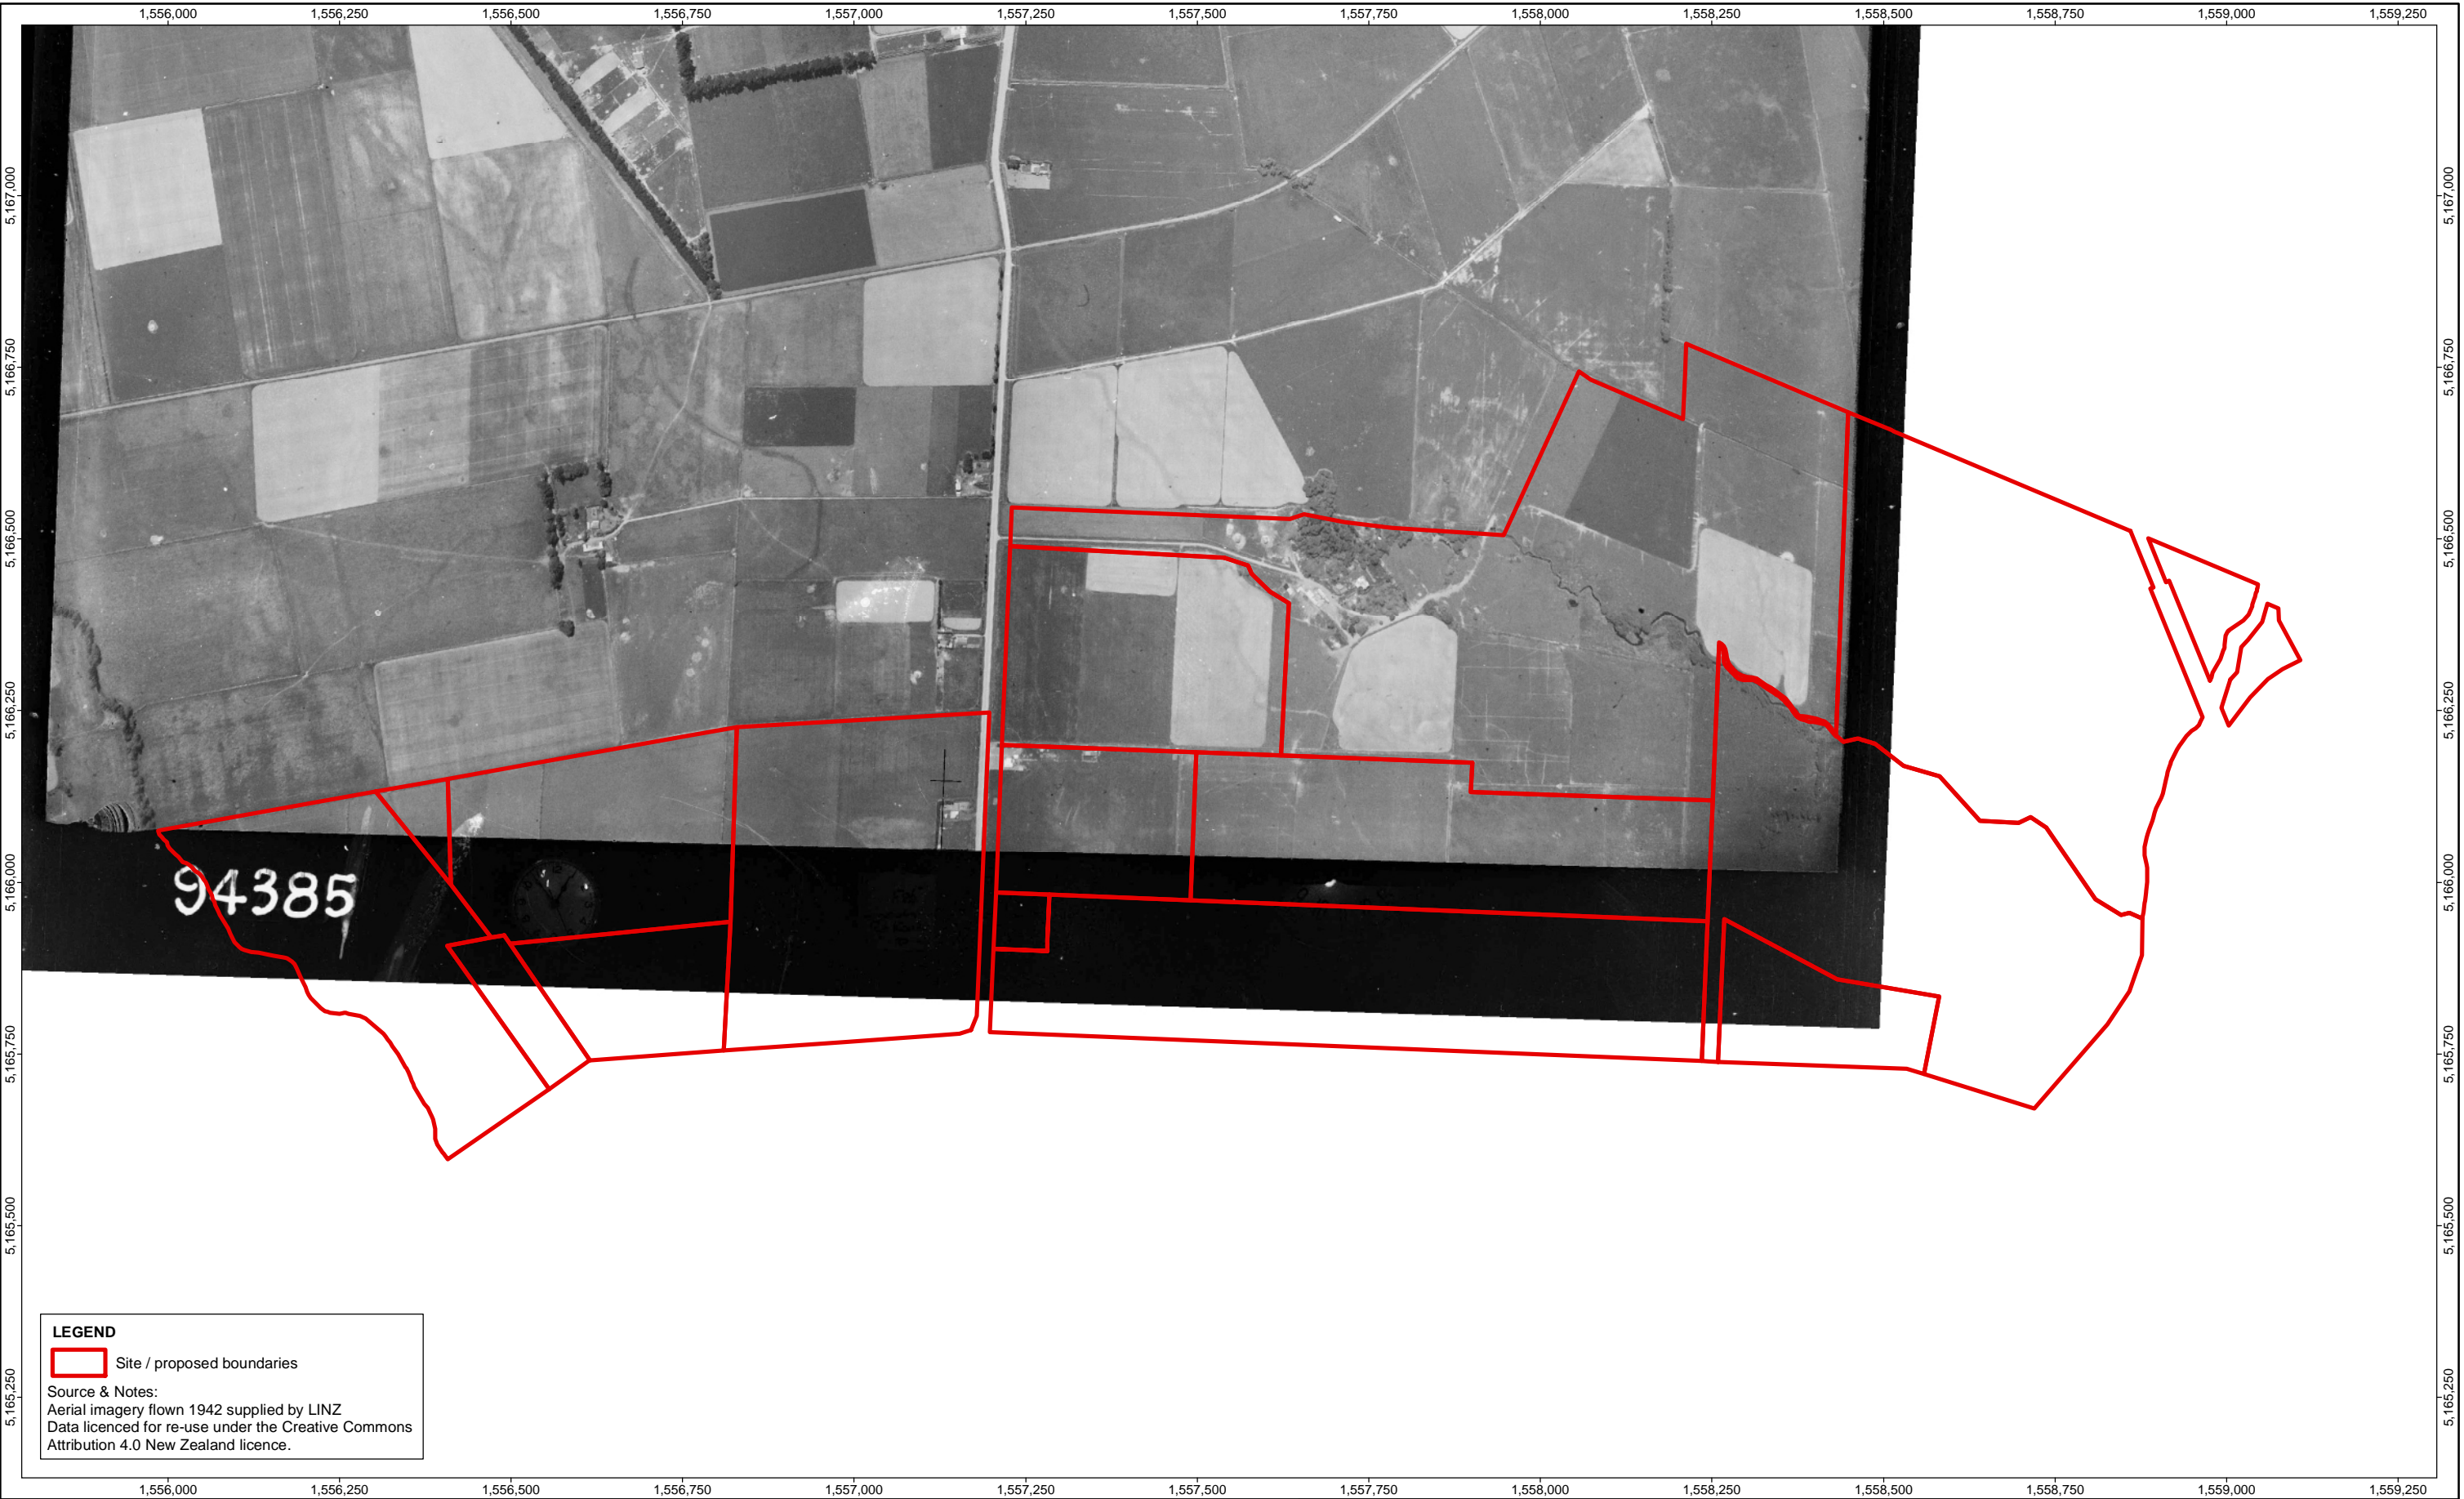
client:		CARTER GROUP LTD.		
project:		1491 SPRINGS ROAD, LINCOLN, CHRISTCHURCH		
title:		HISTORICAL AERIAL - 1942		
project no:	773-CHCGE280252	figure no:	01	rev: A

The site was in use as potential grazing or agricultural land from the initial 1942 historical aerial image with a single residential structure in the northern section of the site. The site has remained in use as agricultural land through all of the historical aerial images reviewed to present day.

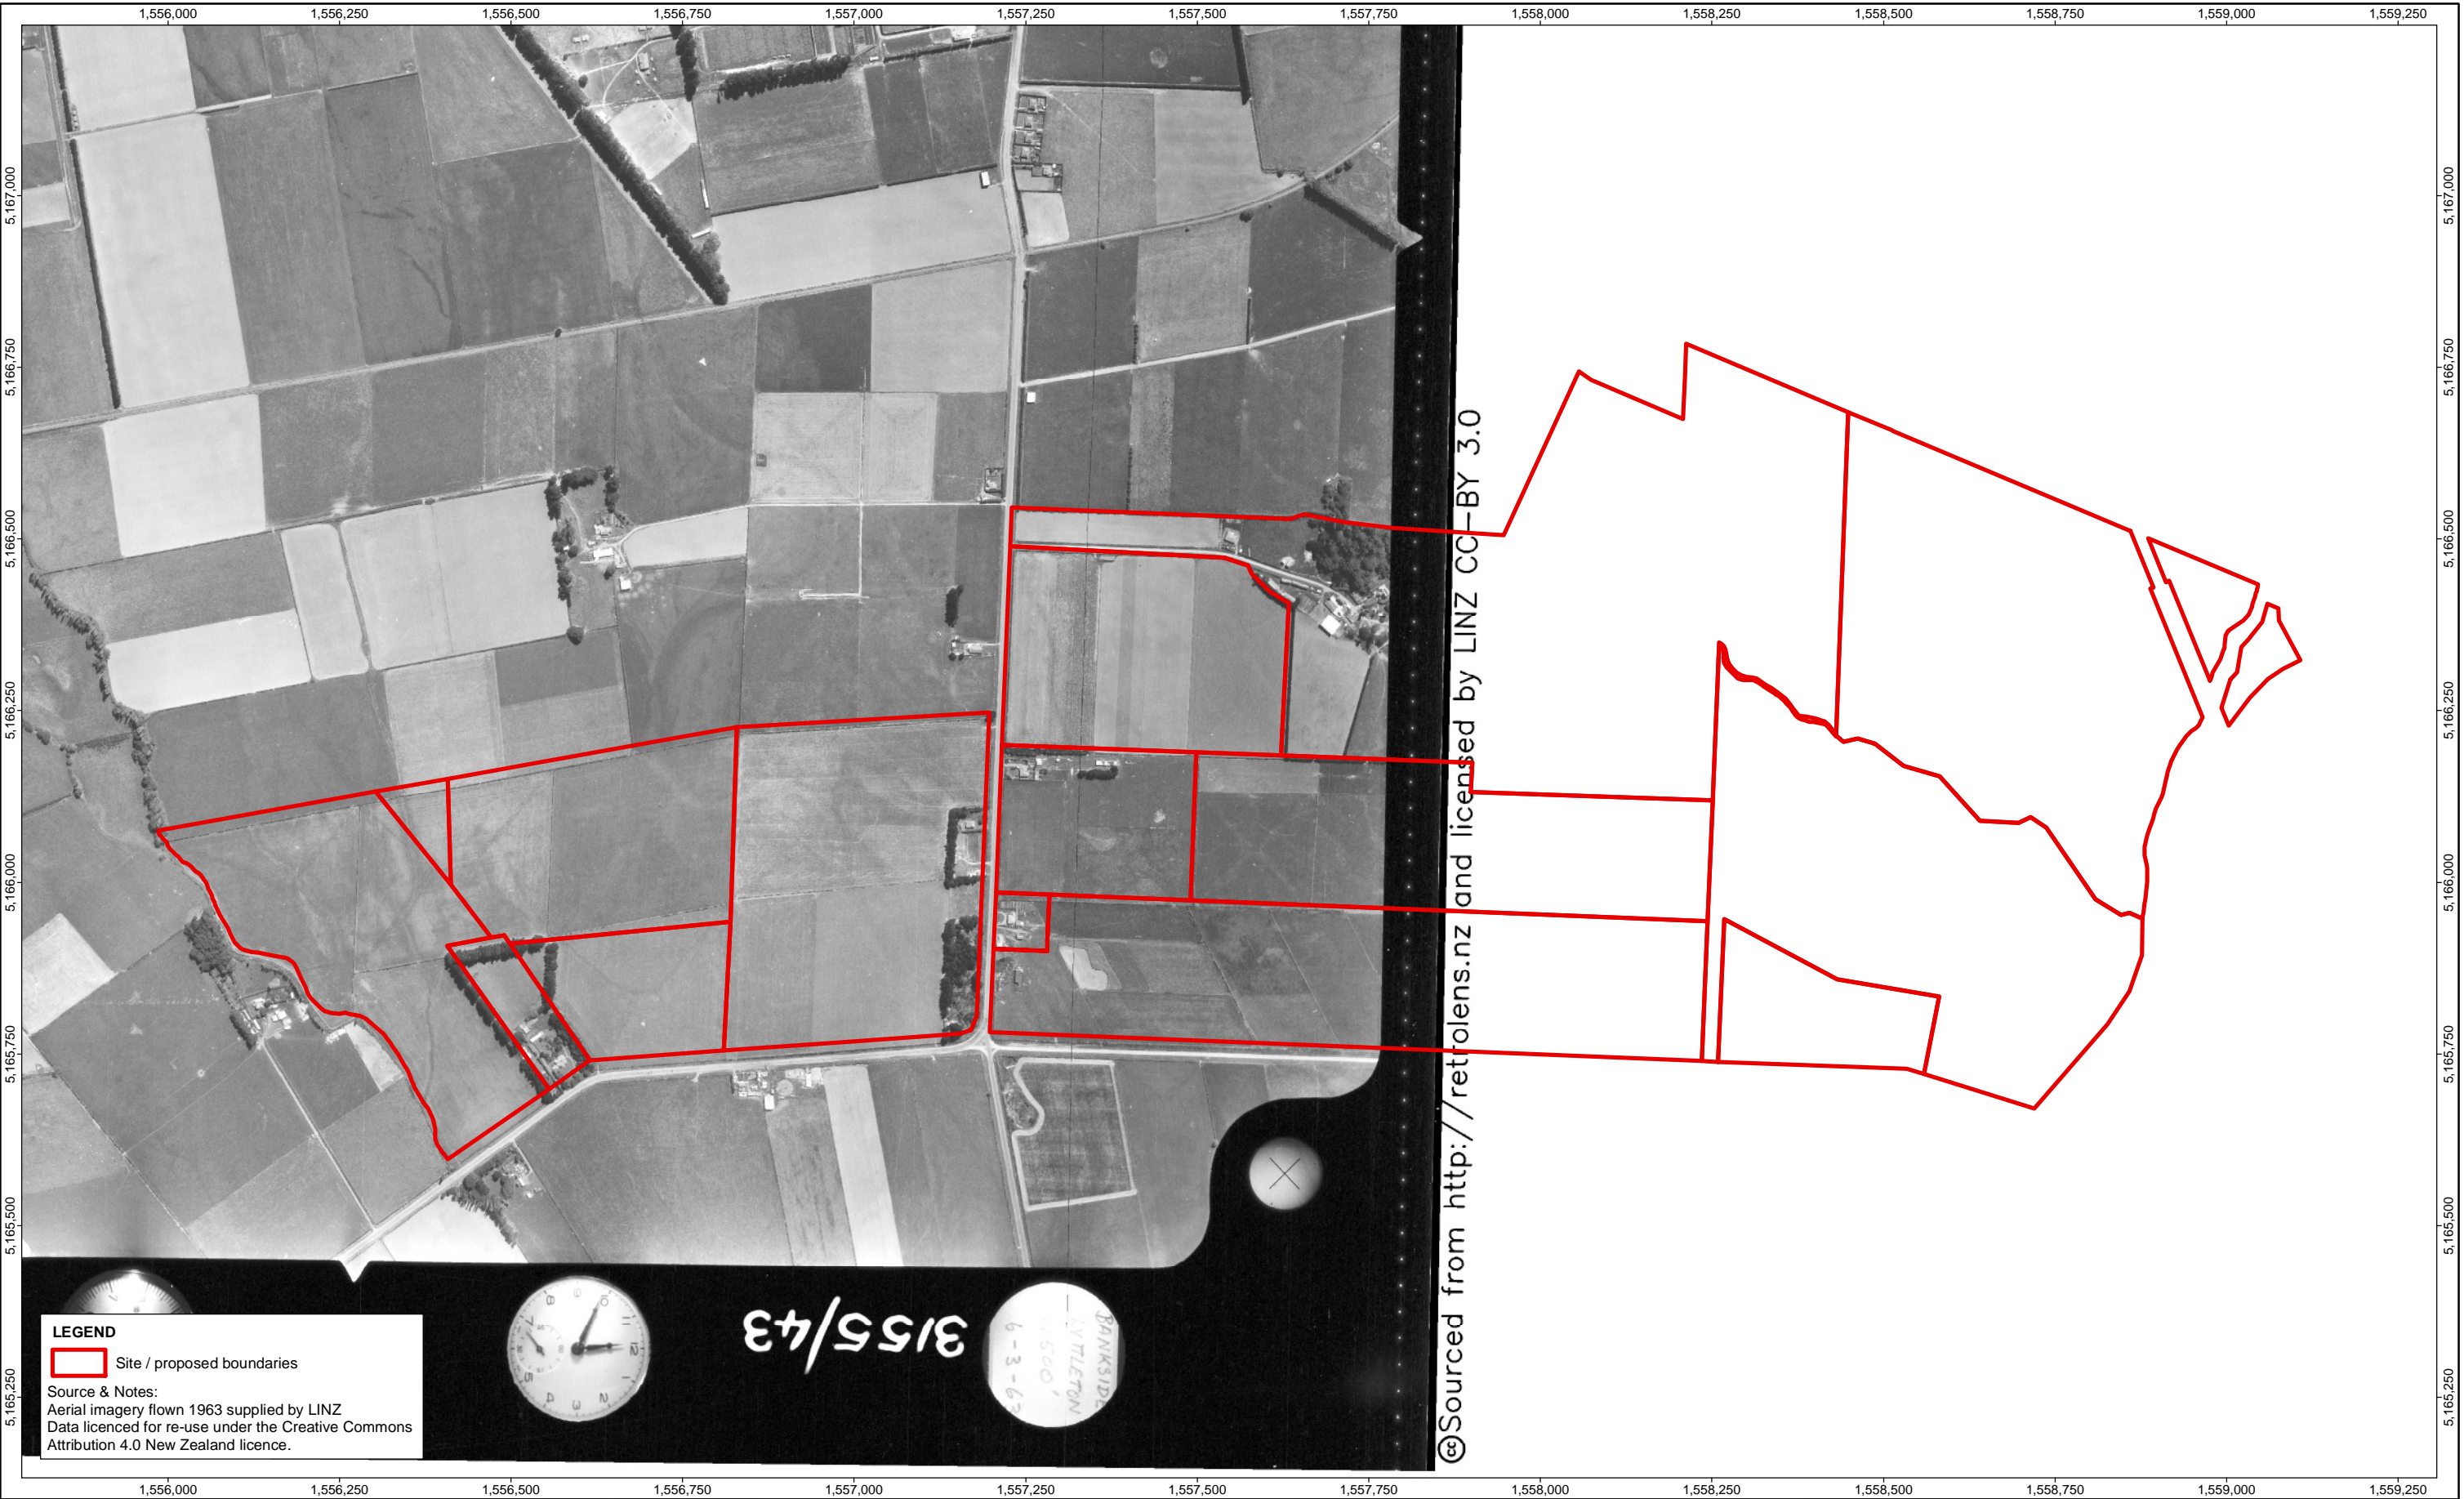
client:		CARTER GROUP LTD.		
project:		1491 SPRINGS ROAD, LINCOLN, CHRISTCHURCH		
title:		HISTORICAL AERIAL - 1963		
project no:	773-CHCGE280252	figure no:	02	rev: A

A section of land on the north-western corner of Springs Road and Collins Road can be seen to be covered in trees and shrub in the initial 1963 historical aerial image. These trees appear to have been removed in the 1980-84 image and potential excavation works can be seen from the 1994 historical image up to 2010 where the site appears to be gradually re-covered by grass.

Structures can be seen to have been constructed within 36 Collins Road, 1521 Springs Road, 1543 Springs Road and 208 Collins Road by the 1963 historical aerial image. Structures within all of these properties remain largely unchanged until present day.

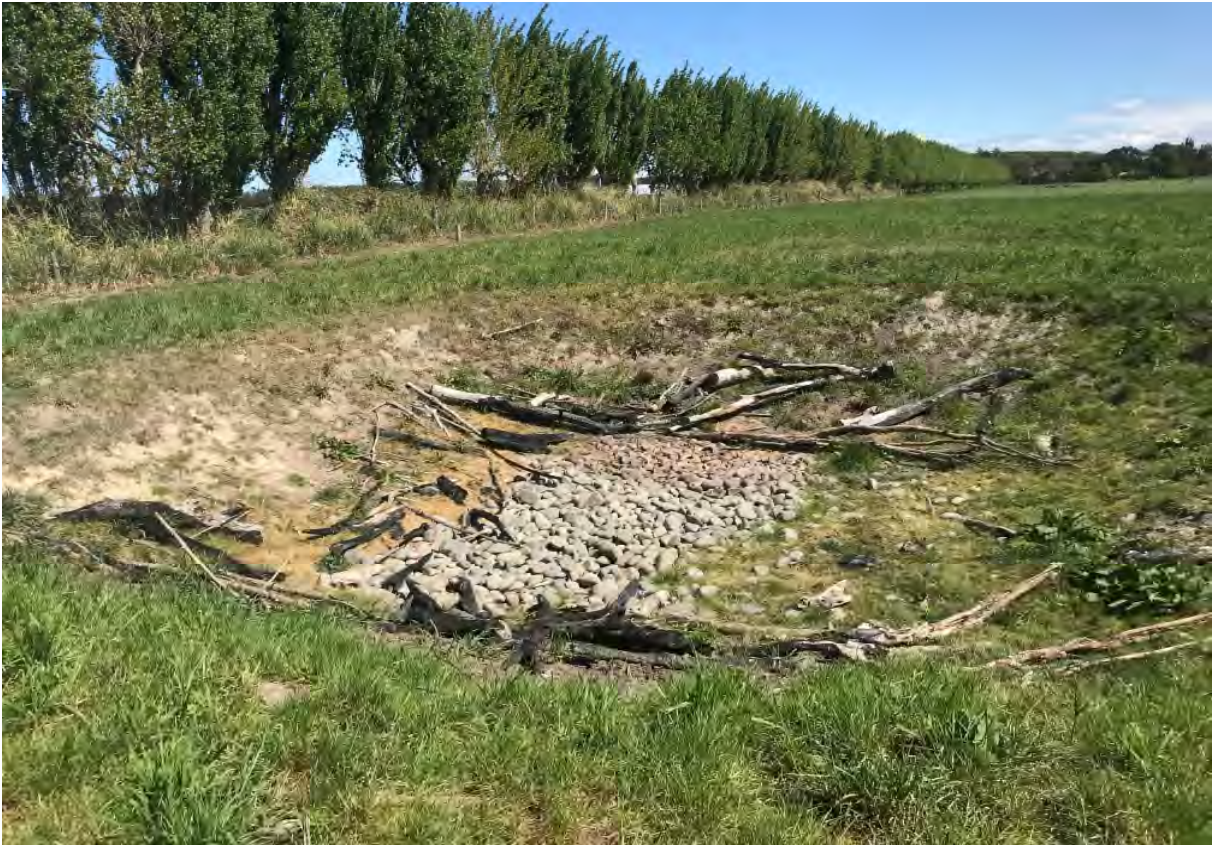
was not available at the time of this investigation, as such, further investigation into in-situ contaminant levels within this area is recommended during any further investigation. The site owner also noted an offal pit / farm dump in the centre of the western area of the site. On-site observations confirmed the location of the offal pit / farm dump.

Photograph 1: Potential farm dump / offal pit location showing general material and site cover.

excessive use of fertilisers are not present. It is also recommended that all waste material and soils impacted by the presence of the offal pit / farm dump (and any other identified impacted soils) be removed during any redevelopment works within the site. Due to the age of the structures within the properties comprising the proposed redevelopment, if demolition or these structures is required, that a full asbestos survey be completed on these structures prior to demolition and any asbestos materials removed by a suitably qualified and experienced asbestos removal specialist.

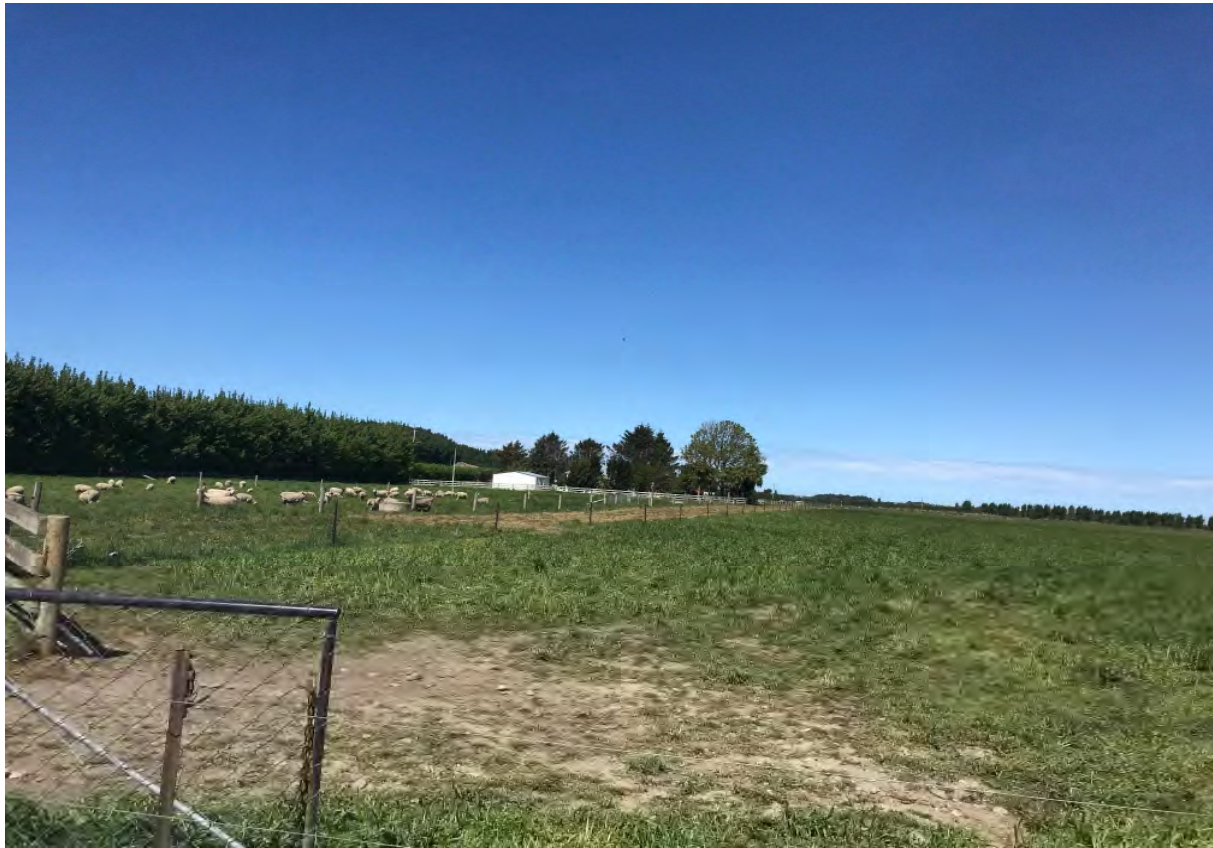
Photograph 2: General site cover and land-use.

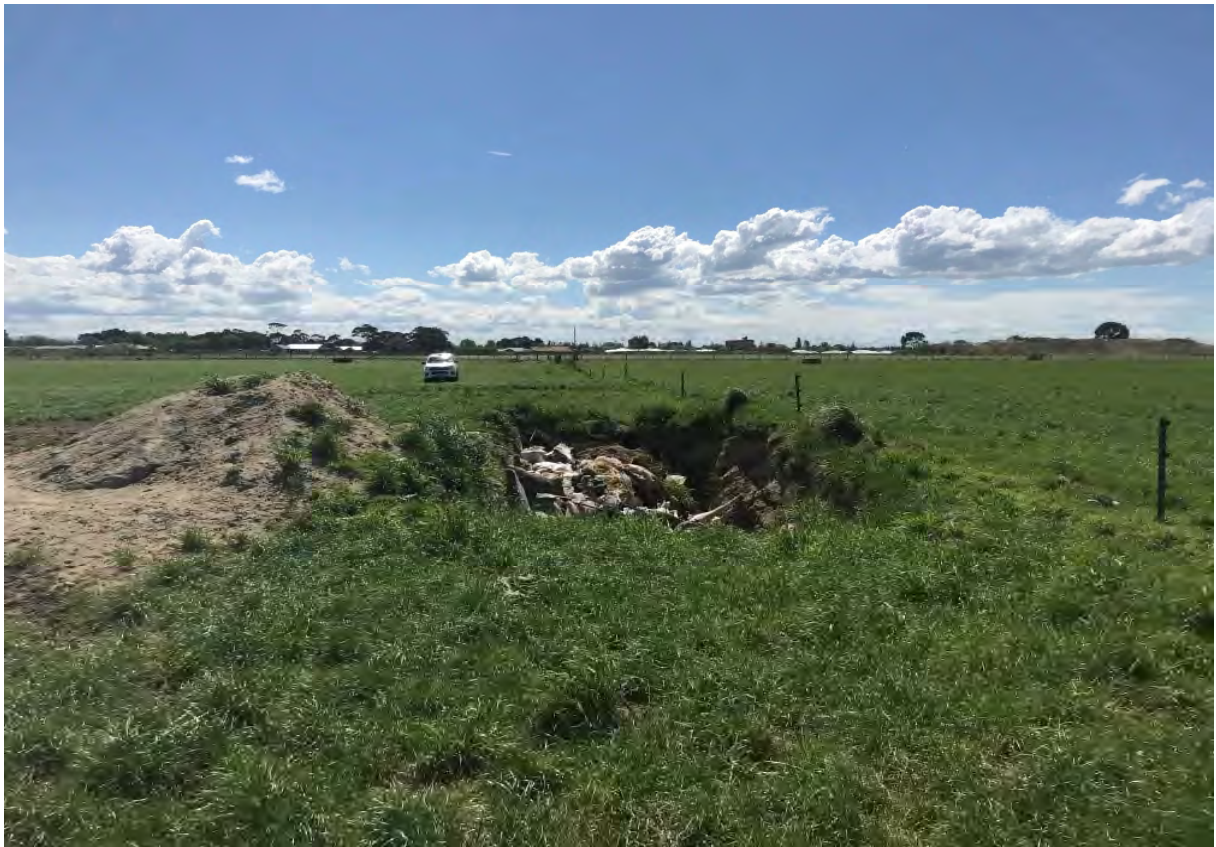
A conversation held with the previous site owner noted a borrow pit within the western section of the site, which it is understood has already had environmental reporting completed for it. This reporting

Landfill sites (HAIL Category G3)	Land filling activities	Environment Canterbury's LLUR	<p>The risk potential to the underlying soil and groundwater is considered low-high due to:</p> <ul style="list-style-type: none"> Unknown source for fill material. Unknown remedial works completed on soils.
Waste disposal to land (HAIL Category G5)	Farm dump / offal pit	Environment Canterbury's LLUR, site walkover observations	<p>The risk potential to the underlying soil and groundwater is considered high due to:</p> <ul style="list-style-type: none"> Known offal pit / farm dump. Contents of the pit are unknown.

Photograph 3: Known offal pit / farm dump within western section of the site.

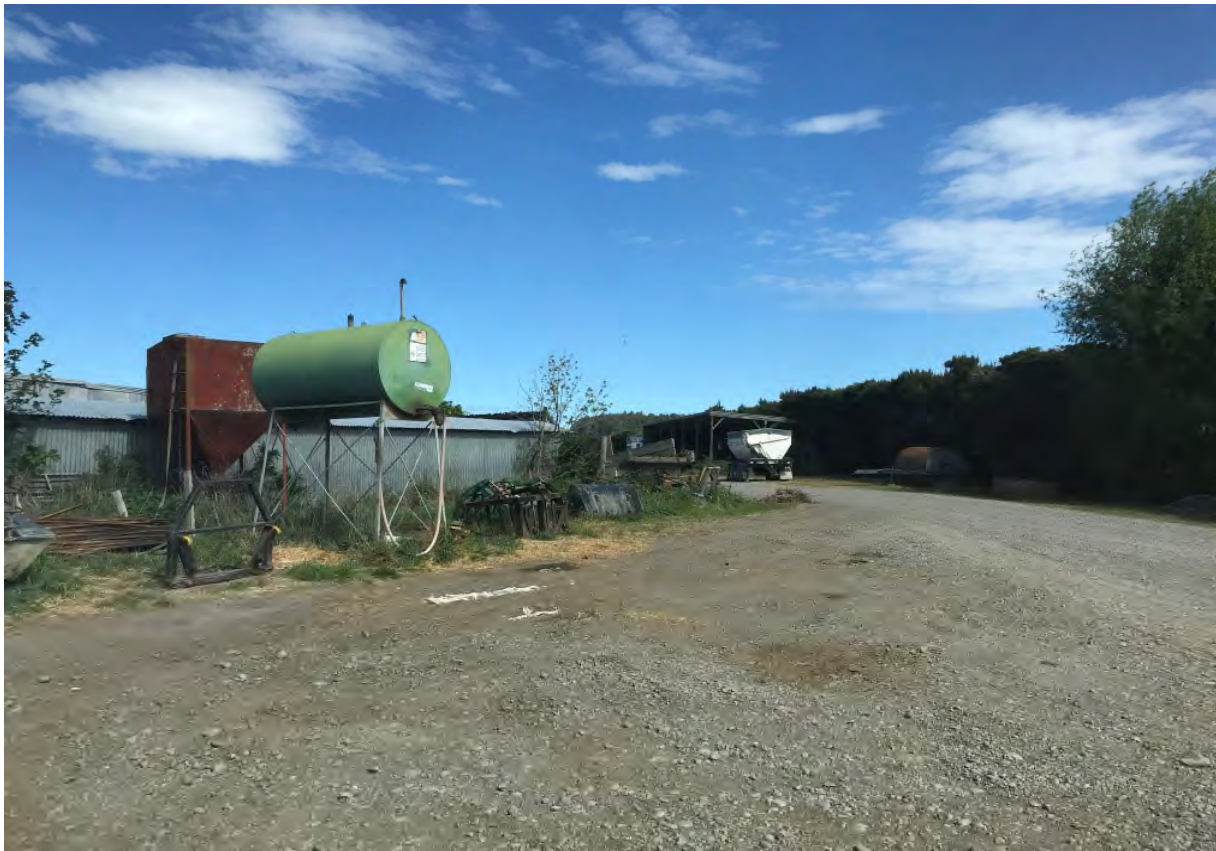
Storage tanks or drums for fuel, chemicals or liquid waste (HAIL Category A17)	Bulk petrol storage	Site walkover observations	The risk potential to the underlying soil and groundwater is considered moderate due to: <ul style="list-style-type: none"> Evidence of spills or staining on surrounding ground.

Photograph 4: Raised above ground petrol tank. Minor staining observed.

Coffey recommends sampling is undertaken in the vicinity of all identified sources of contamination in addition to soil characterisation samples taken from grazing areas to create a detailed site investigation (DSI) prior to earthworks consent being granted to ensure elevated heavy metals and

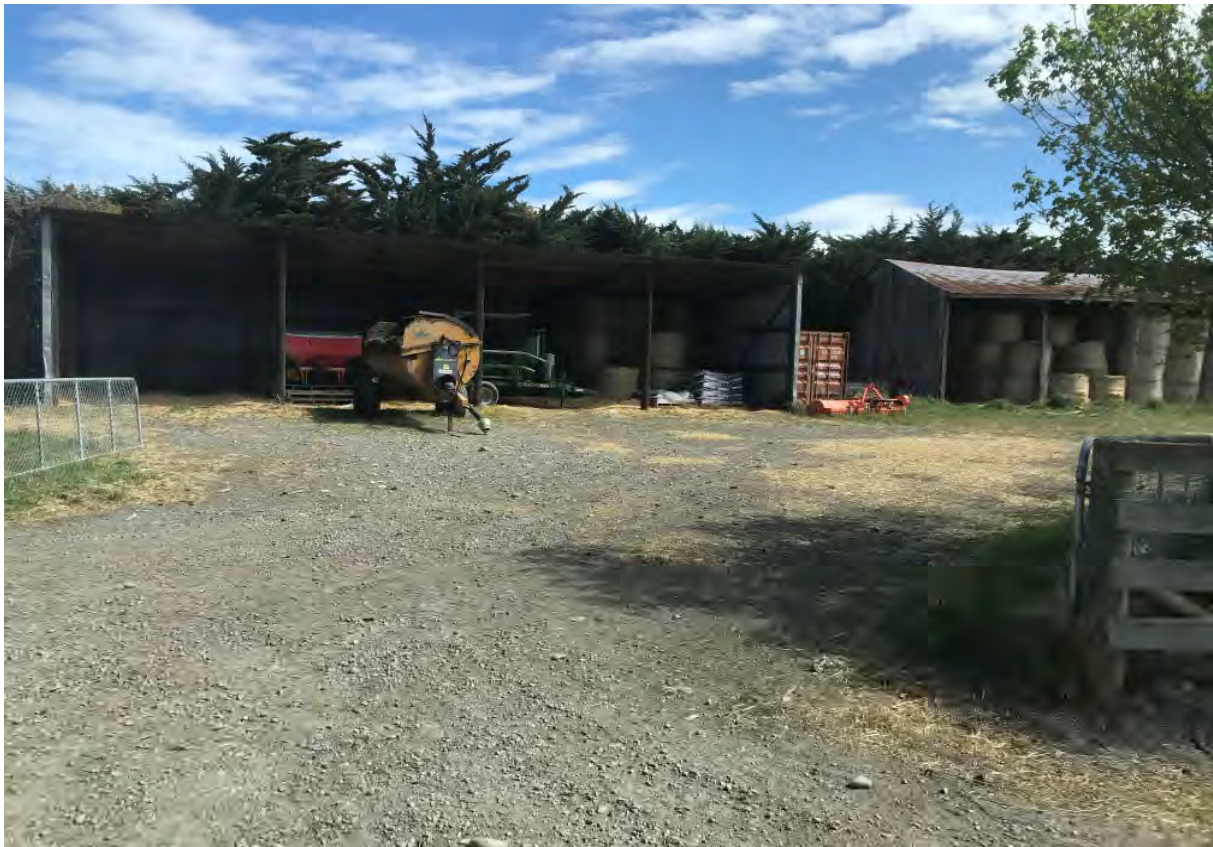
Photograph 5: General farm equipment and storage on hardfill.

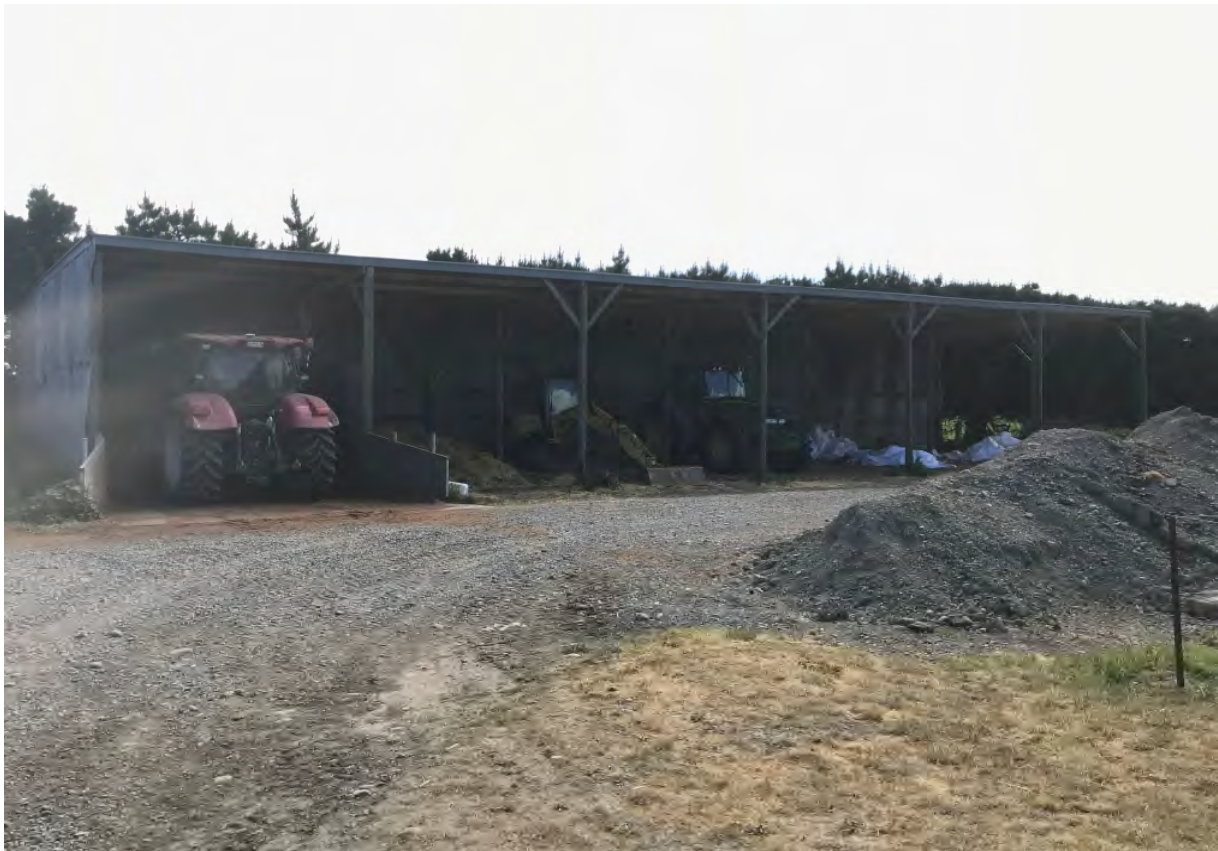
Photograph 6: Farm vehicle and equipment storage on hardfill.
