Selwyn District Council

**Desk-based Ground Contamination
Assessment
Plan Change 7 Area**

January 2011

T&T Ref: 51778

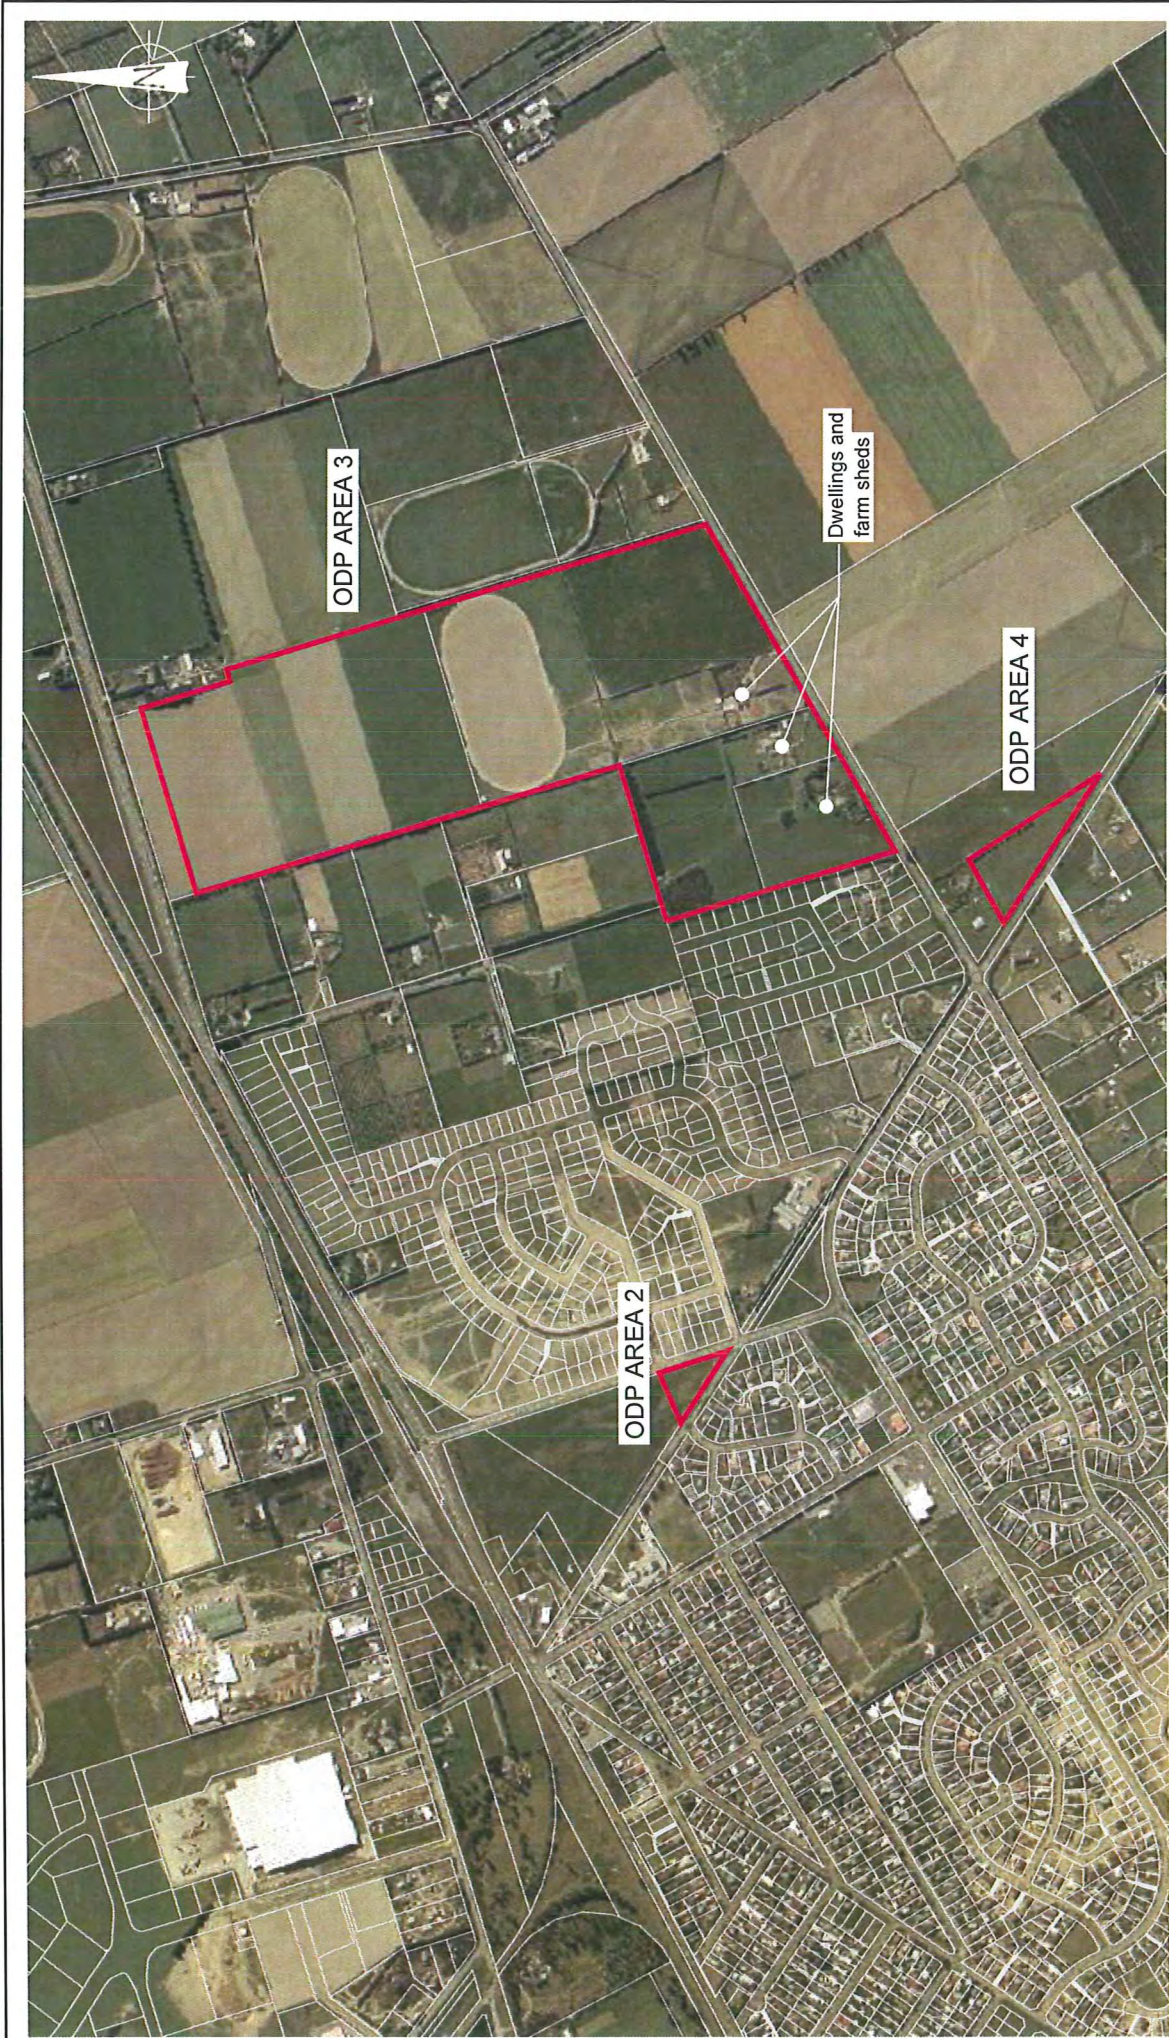
SELWYN DISTRICT COUNCIL		
DESK STUDY GROUND CONTAMINATION ASSESSMENT		
PLAN CHANGE 7 – ROLLESTON TOWNSHIP		
Site 1 Features – ODP Areas 2, 3 & 4		
FIG. No.	Figure 2a	REV. 0

Six sets of aerial photographs from New Zealand Aerial Mapping (1942, 1961, 1973, 1984 and 1994) and Terraview (2010) were reviewed to gain historical information for Site 1. The results are summarised in Table 1. Key features are shown on Figures 2a and b.

- Farm sheds, above ground storage tanks (ASTs), sheep yards and possibly a sheep dip were observed on the northern edge of RS12514 and Lot 1 DP 8833, adjacent to Dynes Road (within ODP area 6).
- An AST was observed adjacent to the farmhouse located within ODP area 6 adjacent to East Maddisons Road (Lot 1 DP 327430).
- Remnants of the foundations of a domestic dwelling were present on Lot 1 DP11863 on the corner of Burnham School Road and Brookside Road.

- Cropping and grain storage was being undertaken within ODP area 3.
- The remainder of the sites appeared to be utilised for dry stock grazing.
- A number of farm buildings and implement sheds were observed throughout the ODP areas.

As all sites within the PC7 area (Sites 1 and 2) have potential for some level of ground contamination, we would recommend that soil sampling should be undertaken to confirm the levels and nature of contaminants present in the soils. The sampling should aim to characterise the broad acre contamination as well as that in the vicinity of farm buildings, dwellings, waste pits or other discrete features. This could be undertaken at the subdivision consent stage. All investigations should be undertaken in accordance with the Ministry for the Environment's various Contaminated Land Management Guidelines. This approach is consistent with the proposed National Environmental Standards for Soil Contamination (currently in draft).
