Private Plan Change Request – Hughes Developments Limited Appendix D – Geotechnical Assessment

Hughes Developments Ltd Christchurch

RE: Geotechnical Summary Letter - Faringdon Far West, Rolleston, Christchurch

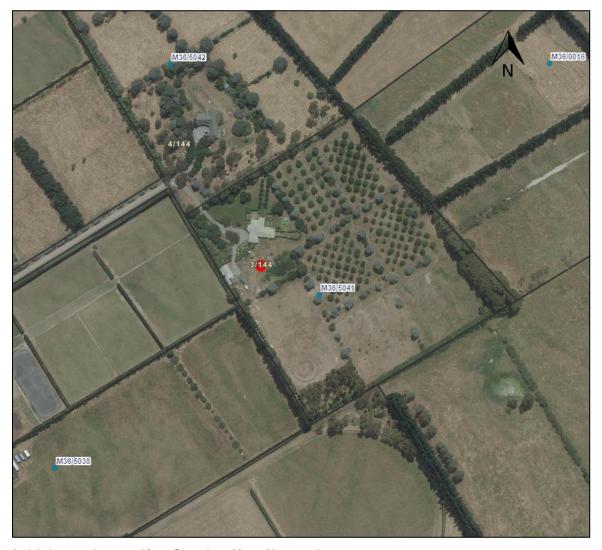
Figure 3: Nearby ECan Borehole Locations

ECan Borehole	Total Depth (m)	Water Level Below Ground Level (m)	Generalised Borelog as Logged by Driller
M36/5041	34	9.73	Gravel with silt and sand to 34 m depth.
M36/0016	15.2	9.85	Sandy gravel to 15.2 m depth.
M36/5042	32.5	9.97	Sandy gravel to 32.5 m depth.
M36/5038	32	9.58	Sandy gravel to 32 m depth.

Aerial photograph sourced from Canterbury Maps. Not to scale.

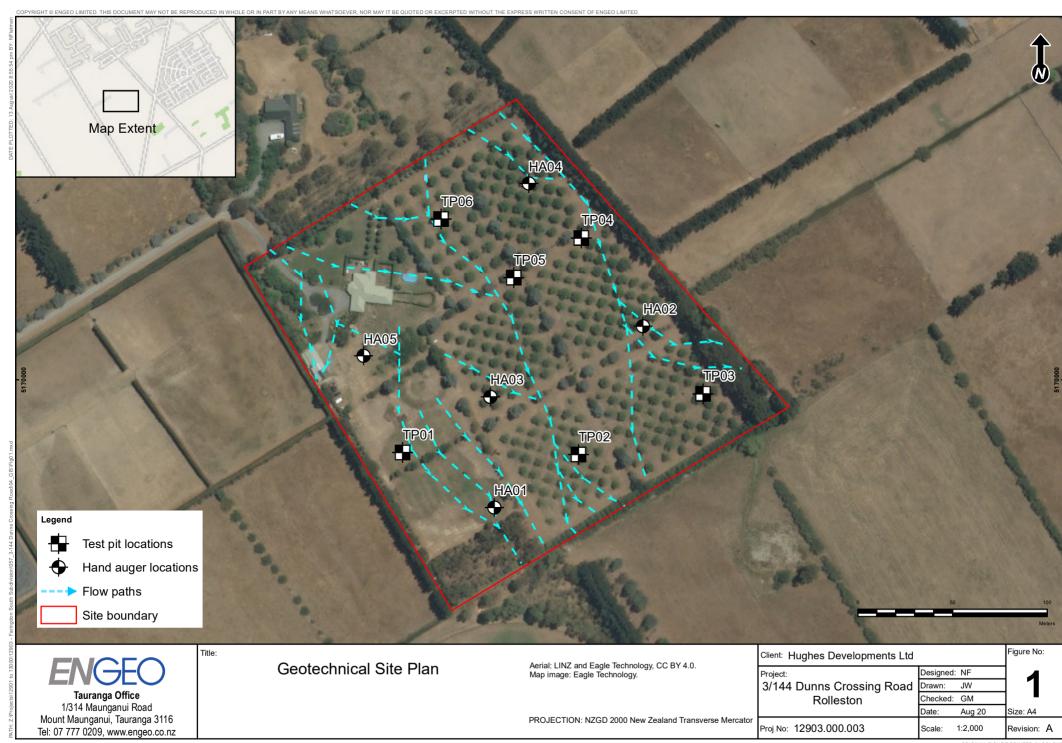
Site Plan and Inferred Paleo Channels

The site comprises relatively flat ground, with gentle undulations and depressions in some areas. As evident on aerial imagery (Canterbury Maps, 2019) and observed during our site walkover conducted on 5 August 2020, undulating and depressed ground can be attributed to paleo-channels, which traverse the site in a general northwest to southeast direction (Figure 2). Based on observations, sandy silt deposits with variable thickness are expected to have in-filled the paleo-channels where they have not remained as channel features. Inferred paleo-channels have been mapped to give an indication of areas with potential channel in-fill (Appendix 1).

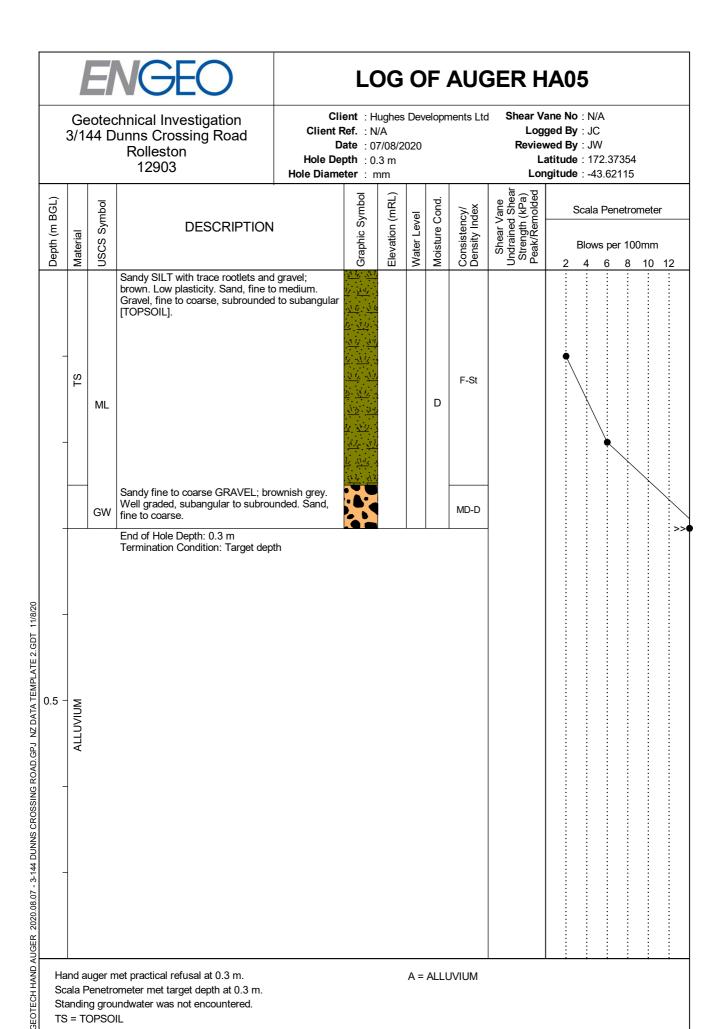
Hand auger met practical refusal at 0.3 m. Scala Penetrometer met target depth at 0.3 m. Standing groundwater was not encountered. TS = TOPSOIL

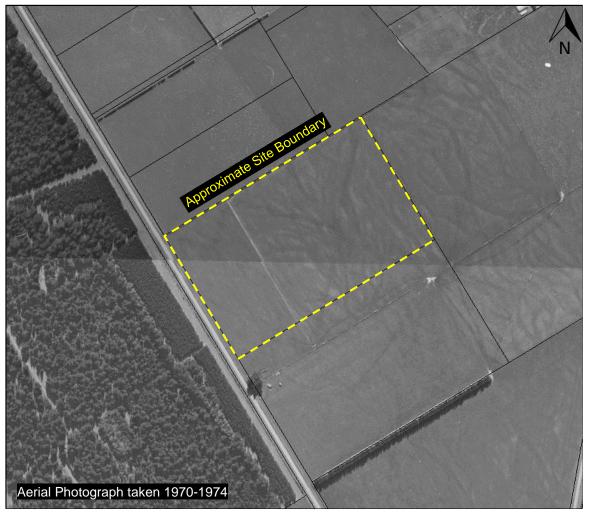
Figure 2: Historical Aerial Imagery – 1990 to 1994

The site comprises relatively flat ground, with gentle undulations and depressions in some areas. As evident on aerial imagery (Canterbury Maps, 2019) and observed during our site walkover conducted on 4 November 2019, undulating and depressed ground can be attributed to paleo-channels, which traverse the site in a general northwest to southeast trend (Figure 2). Based on observations, silty sand deposits with variable thickness (up to 0.8 m) are expected to have in-filled the paleo-channels where they have not remained as channel features. Inferred paleo-channels have been mapped to give an indication of areas with potential channel in-fill (Appendix 1).

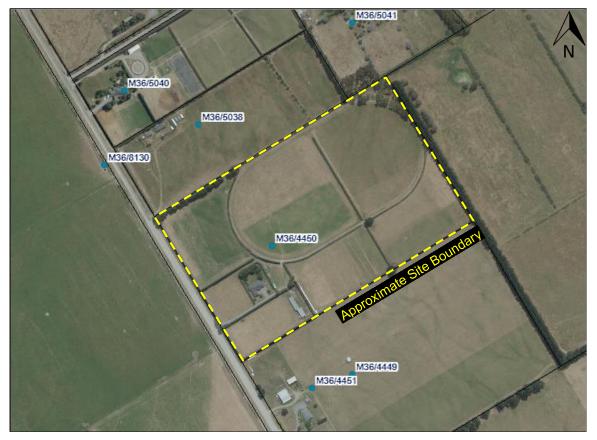
Figure 3: Nearby ECan Borehole Locations

ECan Borehole	Total Depth (m)	Water level (m)	Generalised borelog as logged by driller
M36/4449	24	7.7	Gravel to 24 m with a layer of clay from 12 to 14 m and sandy gravel from 14 to 18 m.
M36/4450	26	8.1	Gravel to 26 m with a layer of clay from 12 to 18 m, 22 to 24 m and 26 o 26.5 m.
M36/5038	32	8.5	Silt bound gravel to 4 m and gravel to 32 m with a layer of silty gravel 12 to 14.4 m.
M36/5041	34	8.6	Gravel to 34 m with layers of silt bound gravel from 2 to 5.4 m and 8.2 to 12.8 m.

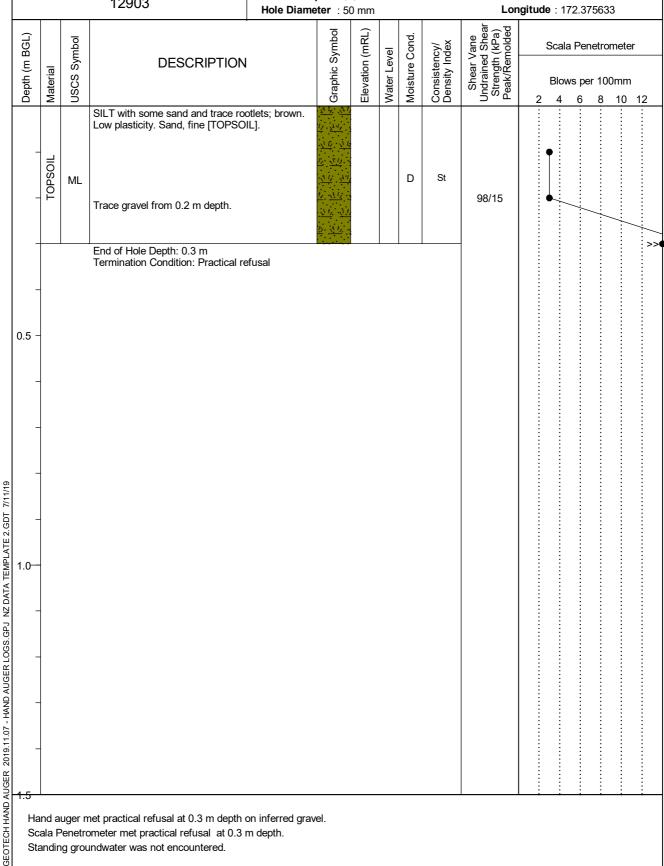
Hand auger met practical refusal at 0.3 m depth on inferred gravel.

Scala Penetrometer met practical refusal at 0.3 m depth.

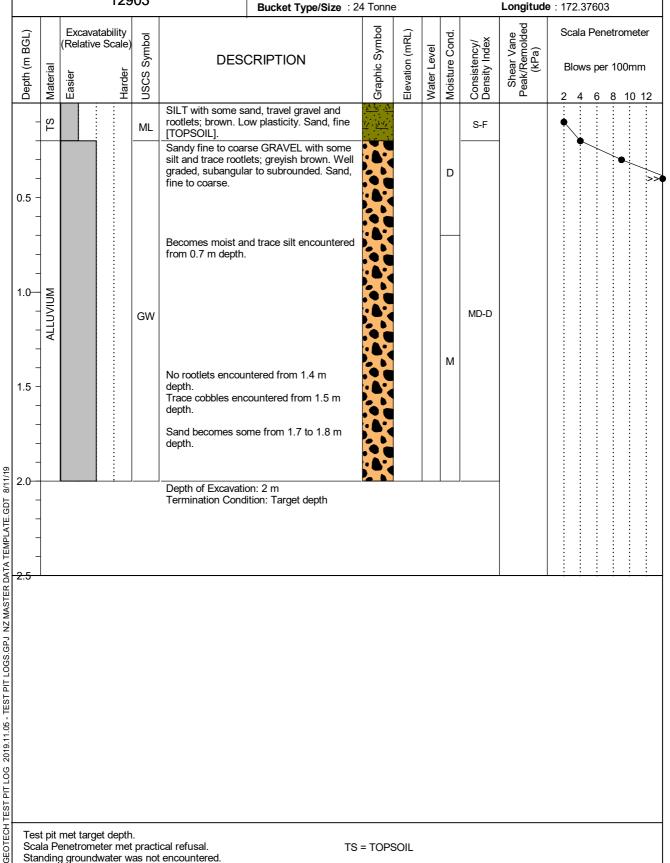
Test pit met target depth. Scala Penetrometer met practical refusal. Standing groundwater was not encountered

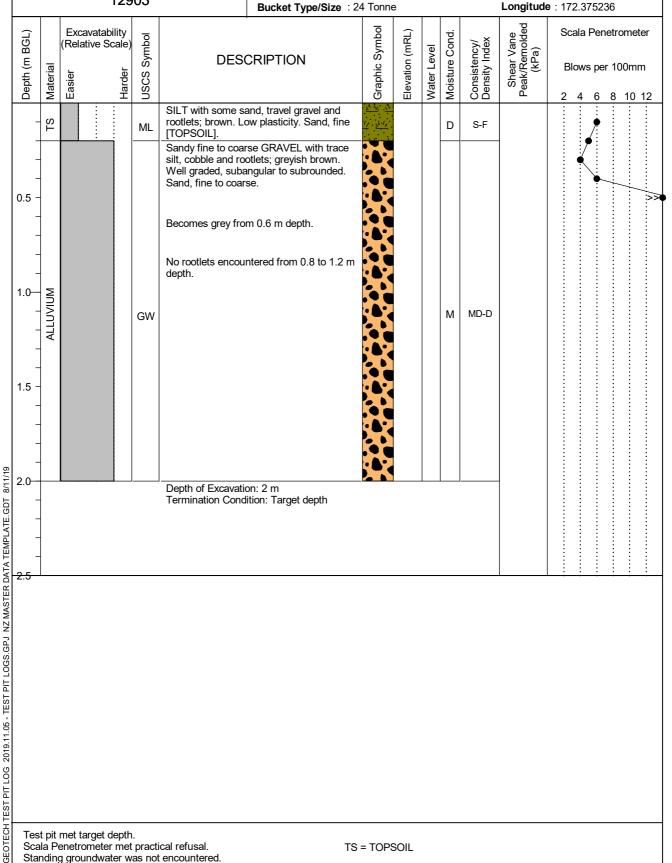
Test pit met target depth. Scala Penetrometer met practical refusal. Standing groundwater was not encountered

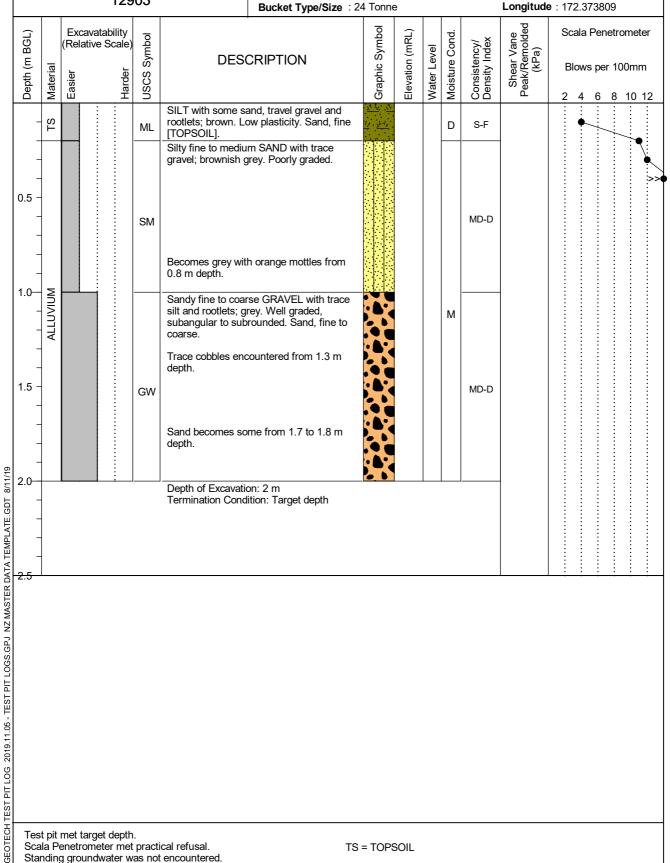
Test pit met target depth. Scala Penetrometer met practical refusal. Standing groundwater was not encountered

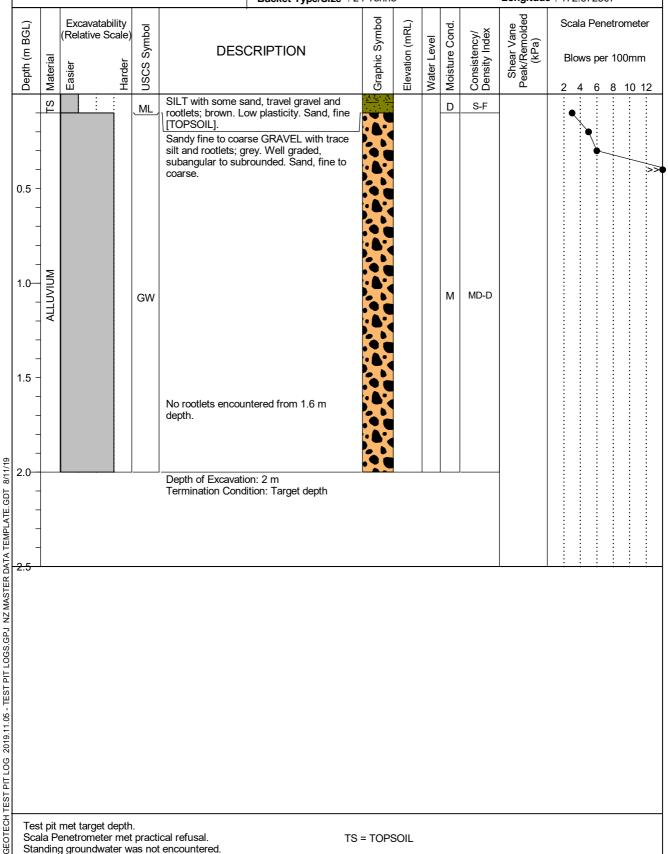
Test pit met target depth. Scala Penetrometer met practical refusal. Standing groundwater was not encountered

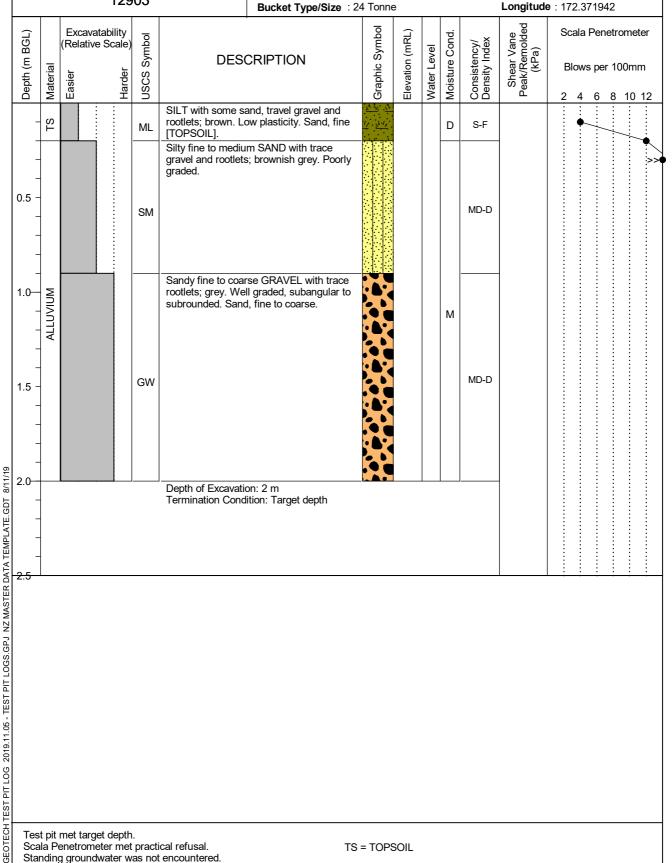
Test pit met target depth. Scala Penetrometer met practical refusal. Standing groundwater was not encountered

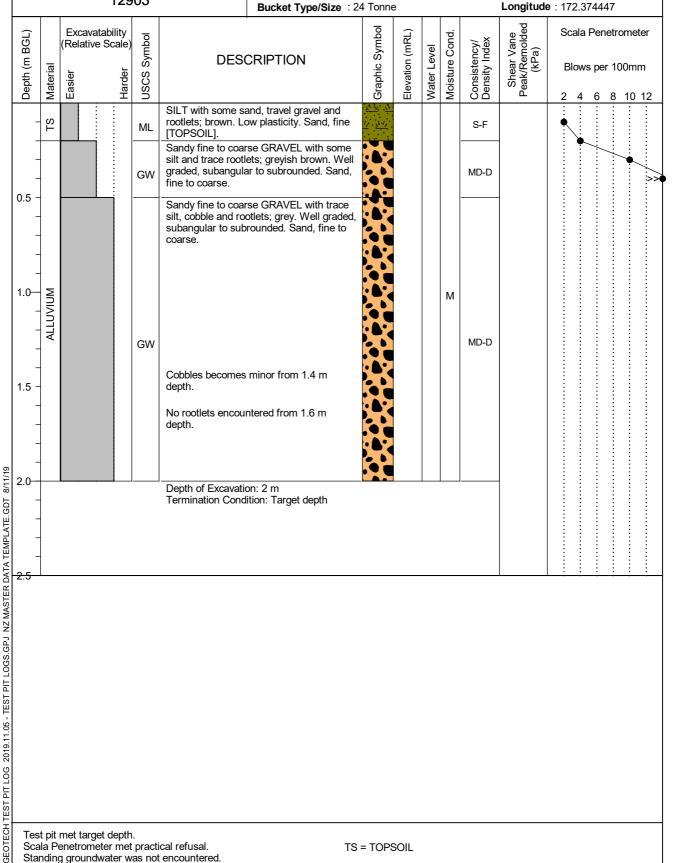
Test pit met target depth. Scala Penetrometer met practical refusal. Standing groundwater was not encountered

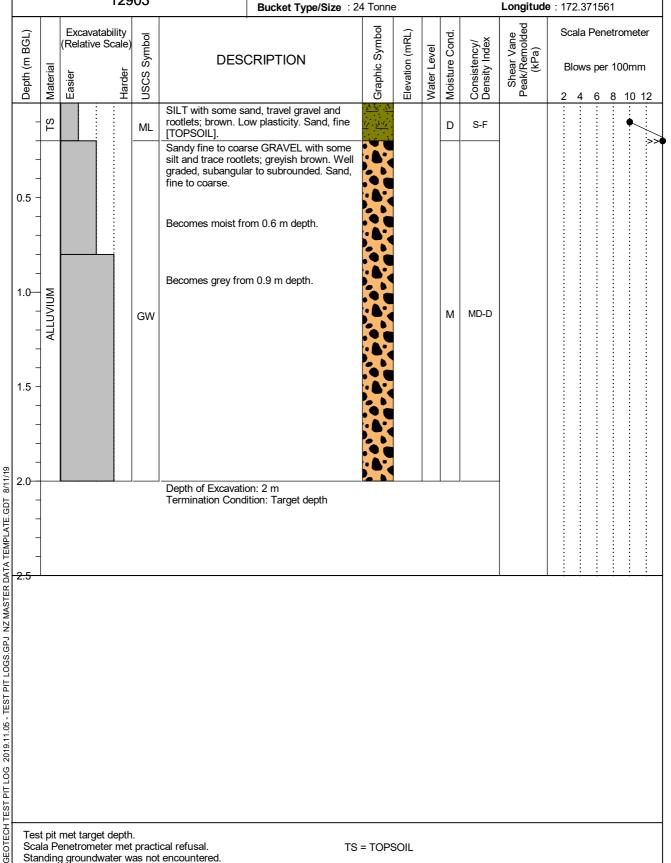
Test pit met target depth. Scala Penetrometer met practical refusal. Standing groundwater was not encountered

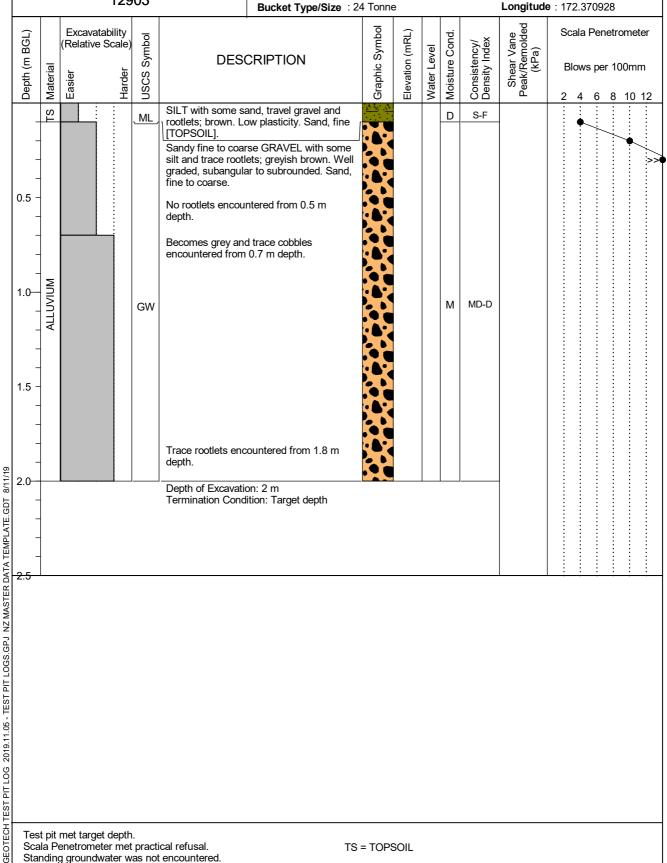
Test pit met target depth. Scala Penetrometer met practical refusal. Standing groundwater was not encountered

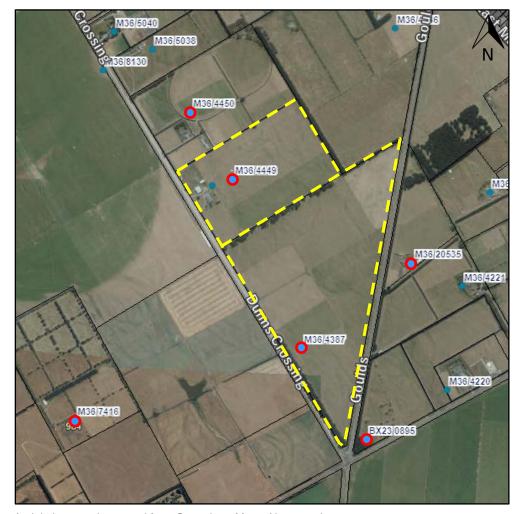
Figure 3: Nearby ECan Borehole Locations

ECan Borehole	Total Depth (m)	Water Level Below Ground Level (m)	Generalised Borelog as Logged by Driller
M36/4450	26	8.1	Gravel to 26 m with a layer of clayey gravel from 12 to 18 m, clay and sand from 22 to 24 m and 26 to 26.5 m.
M36/7416	47	5.18	Sandy gravel to 16.8 with a layer of clay-bound sandy gravel from 5.6 to 14.7 m, and predominant gravel to 23 m. Logs not available from 23 to 47 m.

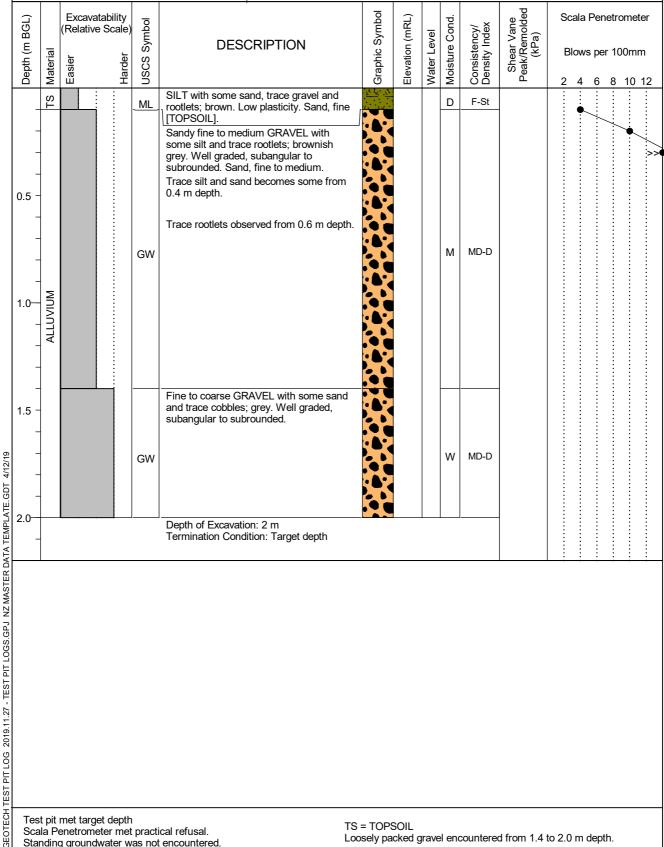
Test pit met target depth Scala Penetrometer met practical refusal. Standing groundwater was not encountered

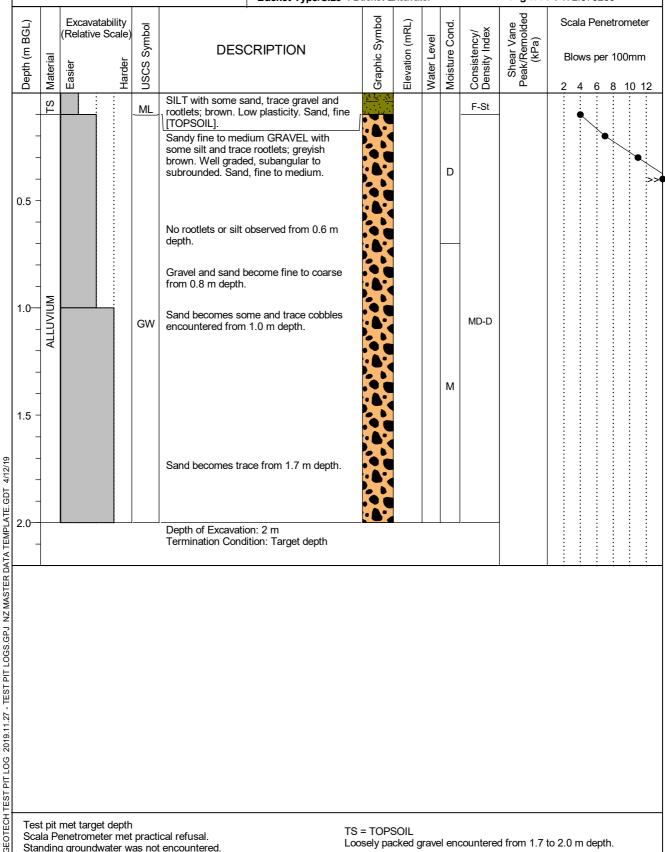
Test pit met target depth Scala Penetrometer met practical refusal. Standing groundwater was not encountered

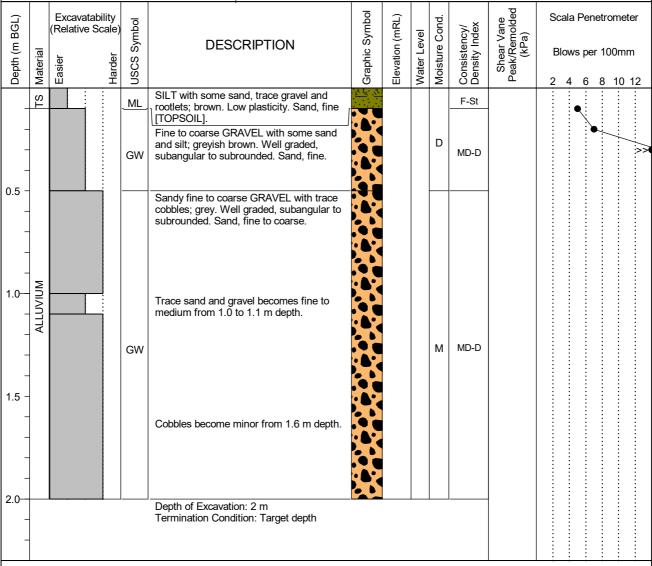
Test pit met target depth. Scala Penetrometer met target depth Standing groundwater was not encountered.

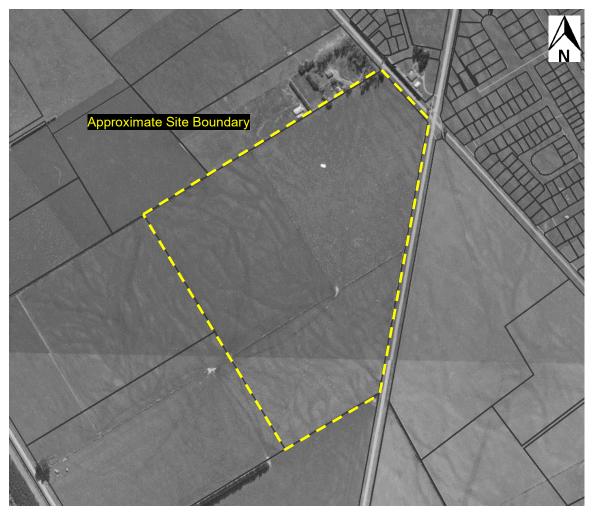
Figure 2: Historical Aerial Photo - 1970 - 1974

The site comprises relatively flat ground, with gentle undulations and depressions in some areas. As evident on aerial imagery (Canterbury Maps, 2019) and observed during our site walkover conducted on 25 August 2020, undulating and depressed ground can be attributed to paleo-channels, which traverse the site in a general northwest to southeast direction (Figure 2). Based on observations, sandy silt deposits with variable thickness are expected to have in-filled the paleo-channels where they have not remained as channel features. Inferred paleo-channels have been mapped to give an indication of areas with potential channel in-fill (Appendix 1).
