Appendix 11: Servicing Report

SERVICING REPORT

ROLLESTON RESIDENTIAL RE-ZONING

*139 Levi Road
294-232 Lincoln Rolleston Road
5-25 Nobeline Drive*

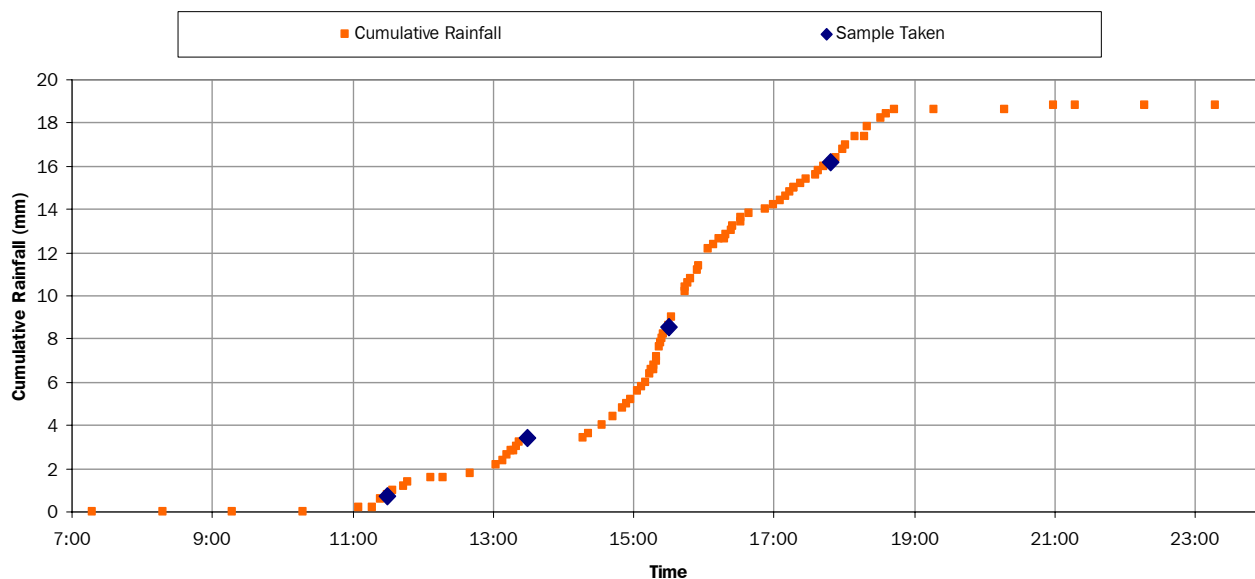
Figure 2: Plot of Cumulative Rainfall and Sampling Time
