## **GEOTECHNICAL INVESTIGATION REPORT**

### **FOR PROPOSED LAND USE CHANGE**

Lincoln Rolleston Road, Rolleston

Project Reference: LTC20265

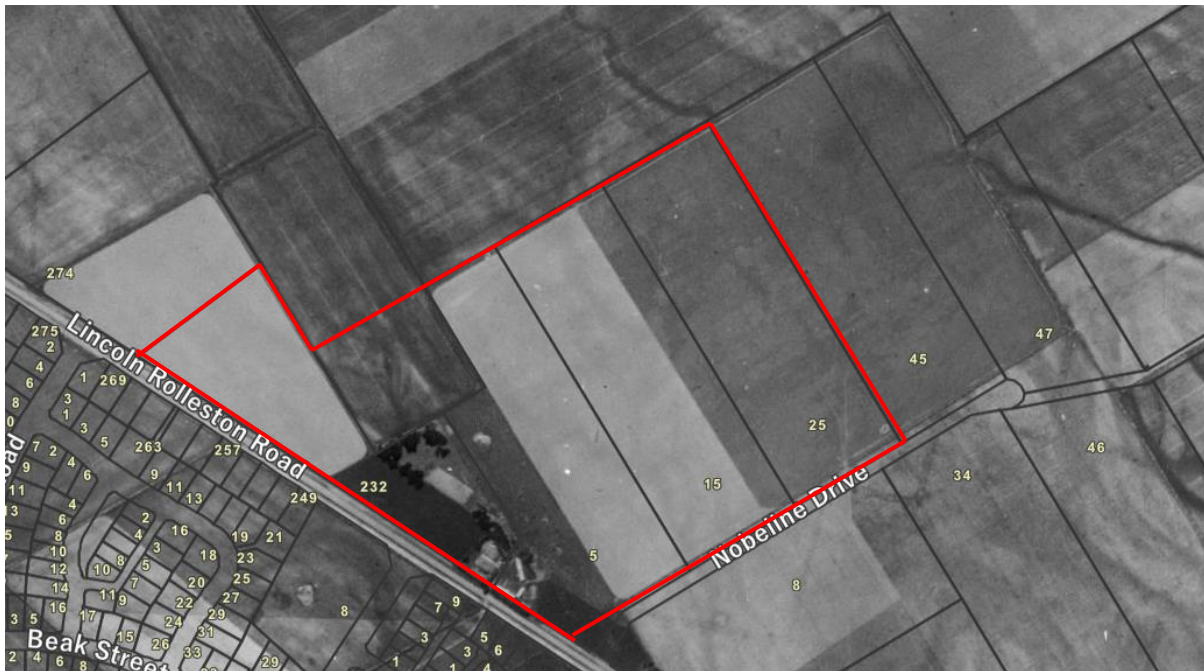
**Figure 3: Aerial photograph of investigation site** (source: <https://mapviewer.canterburymaps.govt.nz/>, accessed 07 September 2020)

- A review of historical photograph of the site from between 1940 and 2004 has been carried out on Canterbury Maps. Imagery from 1940 to 1944 (shown overleaf in Figure 3), shows evidence of paleo river channels near the northern corner of the site, it is possible additional channels are present within the investigation site. Some historic infilling of these paleo channels could have taken place as part of farming activities. However, our investigation found limited evidence of filling having taken place across the general subdivision site.
