Appendix 9: Preliminary Site Investigation Levi Road

Soil Contamination Risk Preliminary Site Investigation Report

131-139 Levi Road, 274 & 294 Lincoln Rolleston Road, Rolleston

January 2021
Revision 1

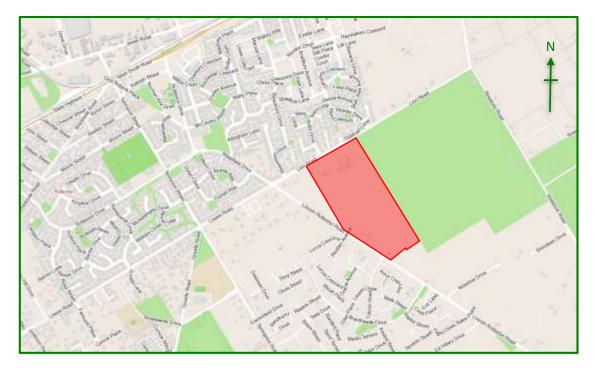
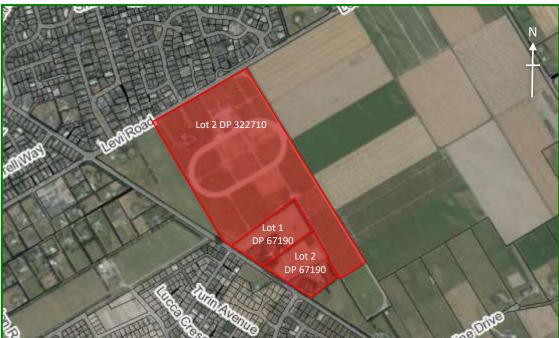
Figure 1 – Location Plan

The site lies between Levi Road and Lincoln Rolleston Road in Rolleston as shown on the plan in **Figure 1** below. The site consists of three rural residential lots and has a total area of 36.0910Ha. The street addresses, legal descriptions and areas of the lots included in the site are:

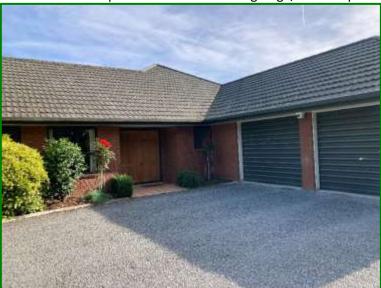
Photo 1 – Brick dwelling with metal roof tiles

The buildings toward the front of the site and to the north of the driveway are the weatherboard cottage and domestic garage constructed in 2005. At the end of the driveway is a brick dwelling that was constructed in 1994. To the south of the driveway is a 'Versatile' style 4-door garage. This appears to be the 'garage/workshop' constructed in 2005. There was no evidence of asbestos containing materials on the exterior of any of the buildings. The garage/workshop has

a concrete floor and does not appear to have a commercial use. There was no staining of the gravel driveway or the concrete apron at the front of the garage/workshop.

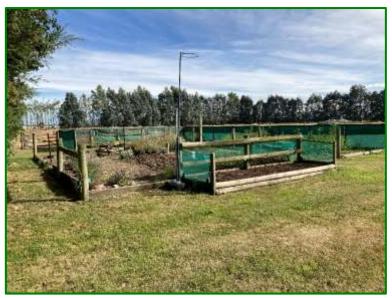
Photo 3 – Vegetable garden

To the rear of the dwelling curtilage area is a vegetable garden with some small sheds and a container. No bulk storage or chemicals or treated timber was seen in this area or anywhere else on the property. There was a pile of natural firewood and a small quantity of treated timber being stored off the ground on shelves.

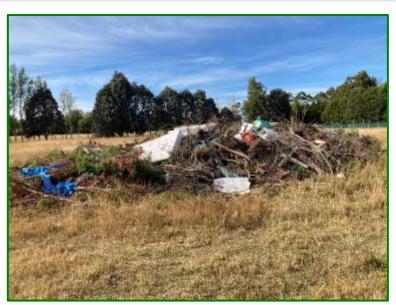
Photo 8 - Waste/burn pile

A waste/burn pile is present on the paddock north-east of the dwelling. The pile currently includes a combination of green waste, treated timber, polystyrene, plastic items, mattresses, cardboard and metal items. Although no charred items or ash were seen, it was not possible to view the underlying soils to assess whether any waste had previously been burnt.

A waste/burn pile was noted during the site inspection of 294 Lincoln Rolleston Road (Lot 1 DP 67190). The pile included waste items such as plastic, metal and furniture. No asbestos containing materials were visible. Another potential burn area was noted on Lot 1 DP 67190 on

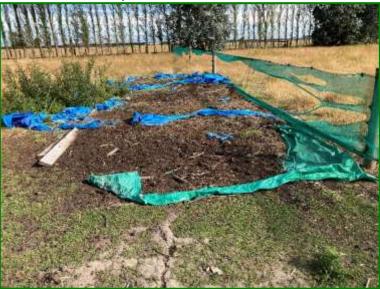
Photo 9 – Tarpaulins with sheep droppings and remains of feed

Tarpaulins that appear to have previously contained hay/fodder are present next to the fence between the western and northern paddocks.

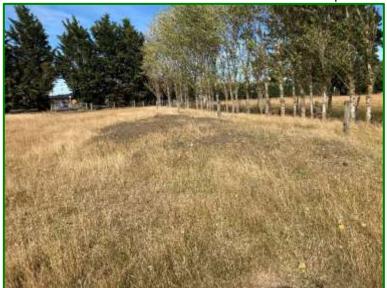
Photo 10 - Stockpile of sandy soil

A low stockpile of sandy soil is present towards the western end of the north-west boundary. No demolition debris or waste items were visible on the surface of the pile.

A stockpile of sandy soil is present on the western corner of Lot 1 DP 67190. No evidence of demolition debris or waste items were seen in this stockpile during the site inspection. It is considered likely that this is surplus material from the excavation of building foundations or landscaping works on the lot and is therefore unlikely to pose a risk to human health.

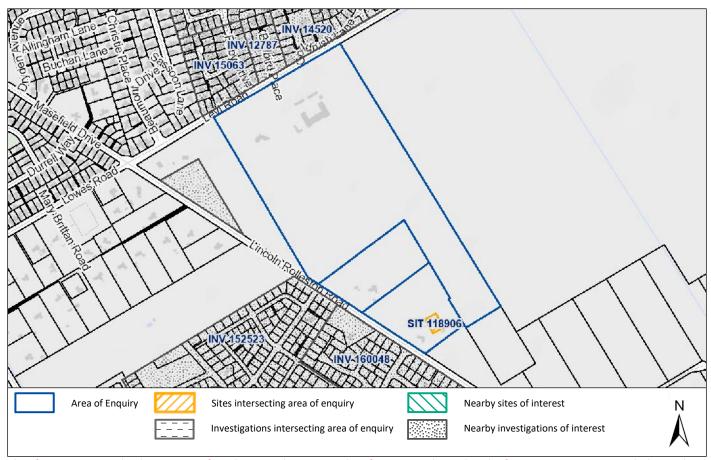
The information presented in this map is specific to the area within a 100m radius of property you have selected. Information on properties outside the serach radius may not be shown on this map, even if the property is visible.

5 Nov 2014 Area defined from 2000 to 2005 aerial photographs. Horticultural activities (persistent pesticides) were noted in aerial photographs

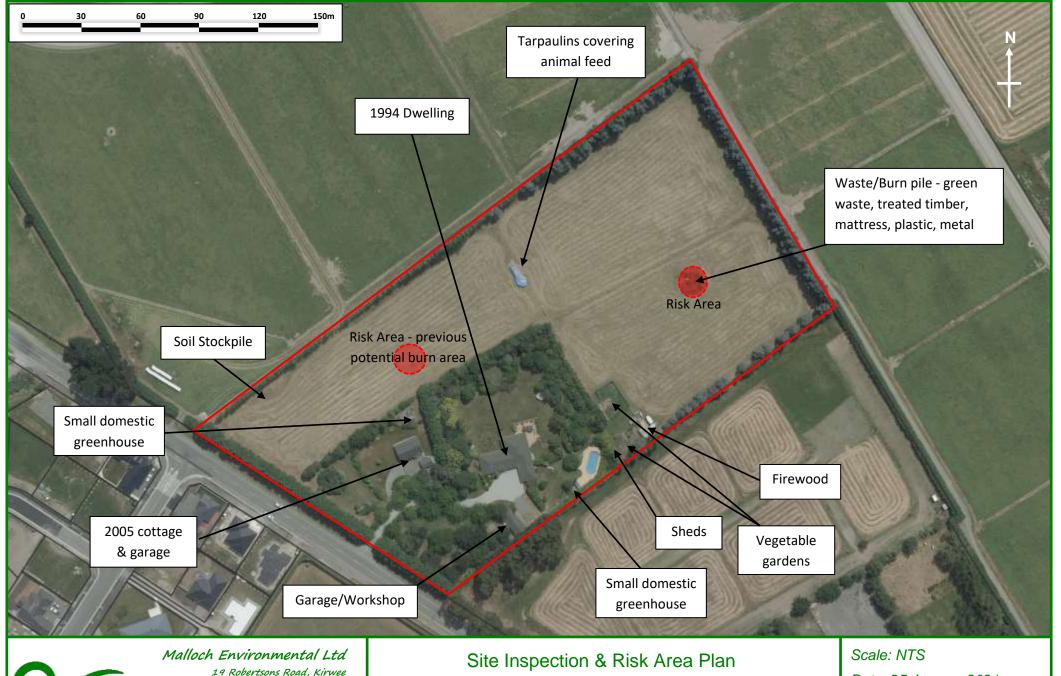
19 Robertsons Road, Kirwee RD1, Christchurch 7671 021 132 0321 www.mallochenviro.co.nz Site Inspection & Risk Area Plan 294 Lincoln Rolleston Road, Christchurch

294 Lincoln Rolleston Road was inspected in detail to characterise the potential sources of contamination noted on aerial photographs. A Site Inspection Plan of 294 Lincoln Rolleston Road is included in **Appendix D**. No likely sources of contamination have been identified for the other lots on the subject site by the desktop part of this investigation. Access to the other lots was more limited, despite prior notice. The stable yard on 131 Levi Road was accessed but is a working racing stables and at the time of the visit no-one was available to confirm that access further onto the property was safe or permitted. No burn or waste piles were noted on the paddocks at the front of the property. The buildings around the stable yard were modern. The yard had a clean appearance. 139 Levi Road could not be accessed as the electronic gate was locked and no-one responded to the bell.
