Appendix 8: Servicing Report

SERVICING REPORT

ROLLESTON RESIDENTIAL RE-ZONING

*139 Levi Road
294-232 Lincoln Rolleston Road
5-25 Nobeline Drive*

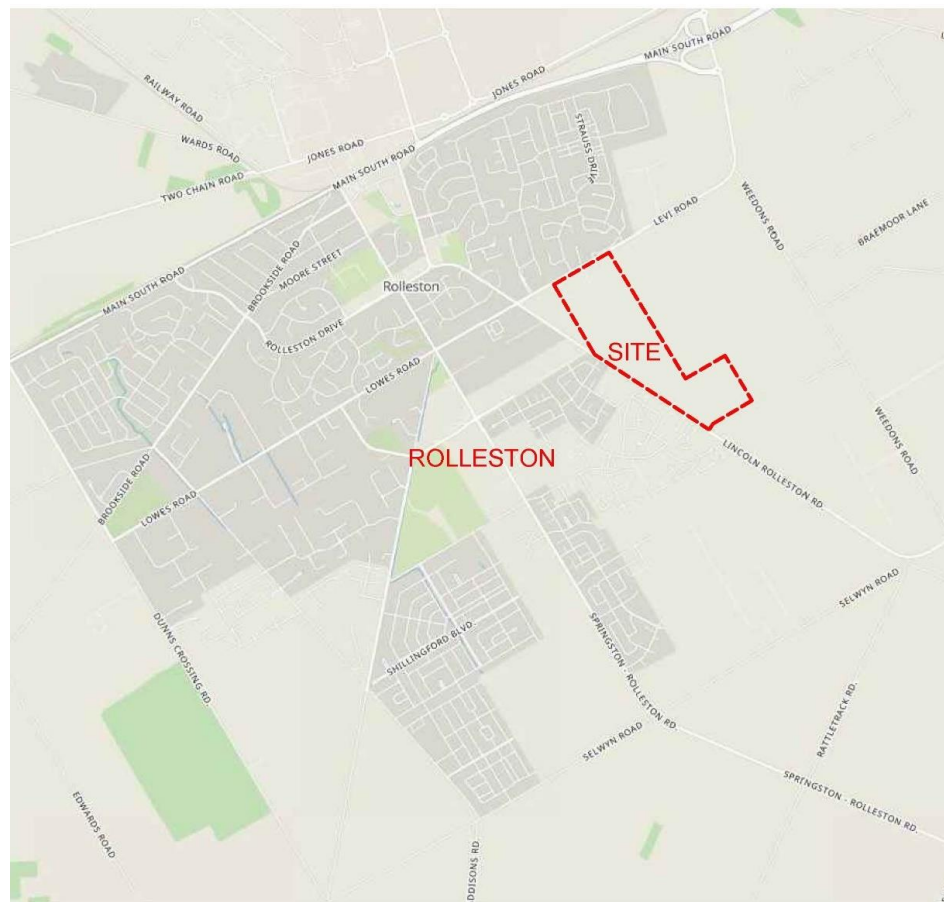
Paterson Pitts Group have been commissioned by Gould Developments Limited & Four Stars Development Limited to provide a services report for an application for residential rezoning of rural land as graphically shown below within Rolleston;

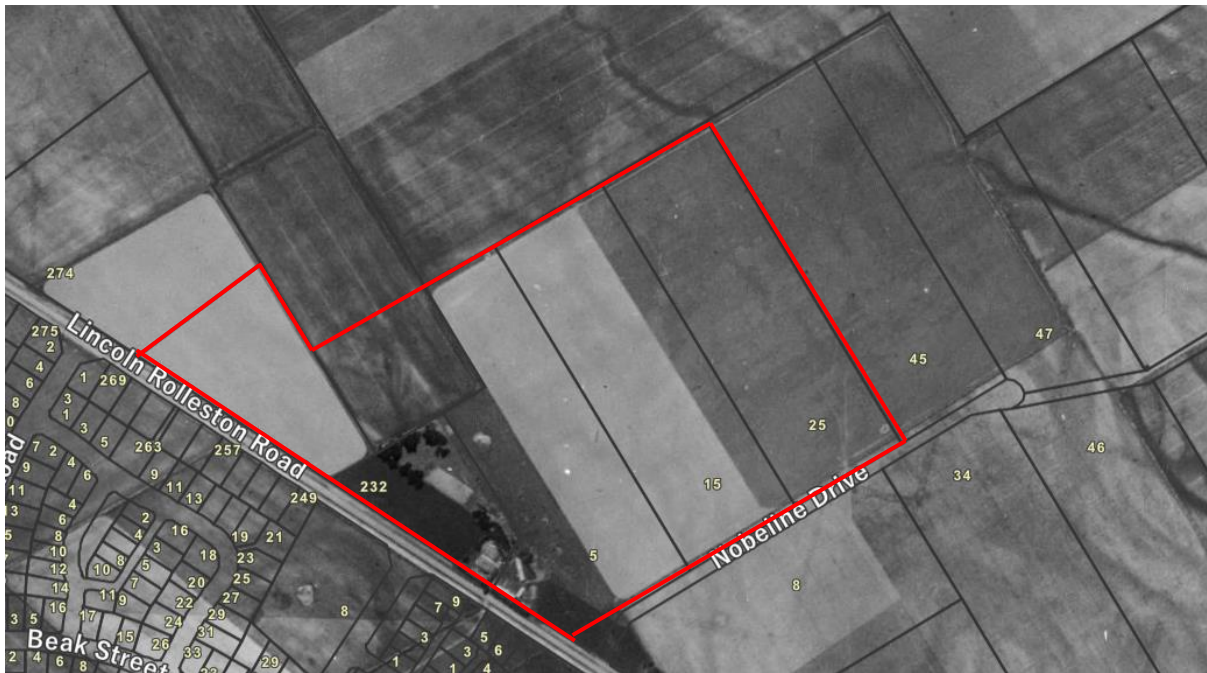
Figure 3: Aerial photograph of investigation site (source: <https://mapviewer.canterburymaps.govt.nz/>, accessed 07 September 2020)

- A review of historical photograph of the site from between 1940 and 2004 has been carried out on Canterbury Maps. Imagery from 1940 to 1944 (shown overleaf in Figure 3), shows evidence of paleo river channels near the northern corner of the site, it is possible additional channels are present within the investigation site. Some historic infilling of these paleo channels could have taken place as part of farming activities. However, our investigation found limited evidence of filling having taken place across the general subdivision site.

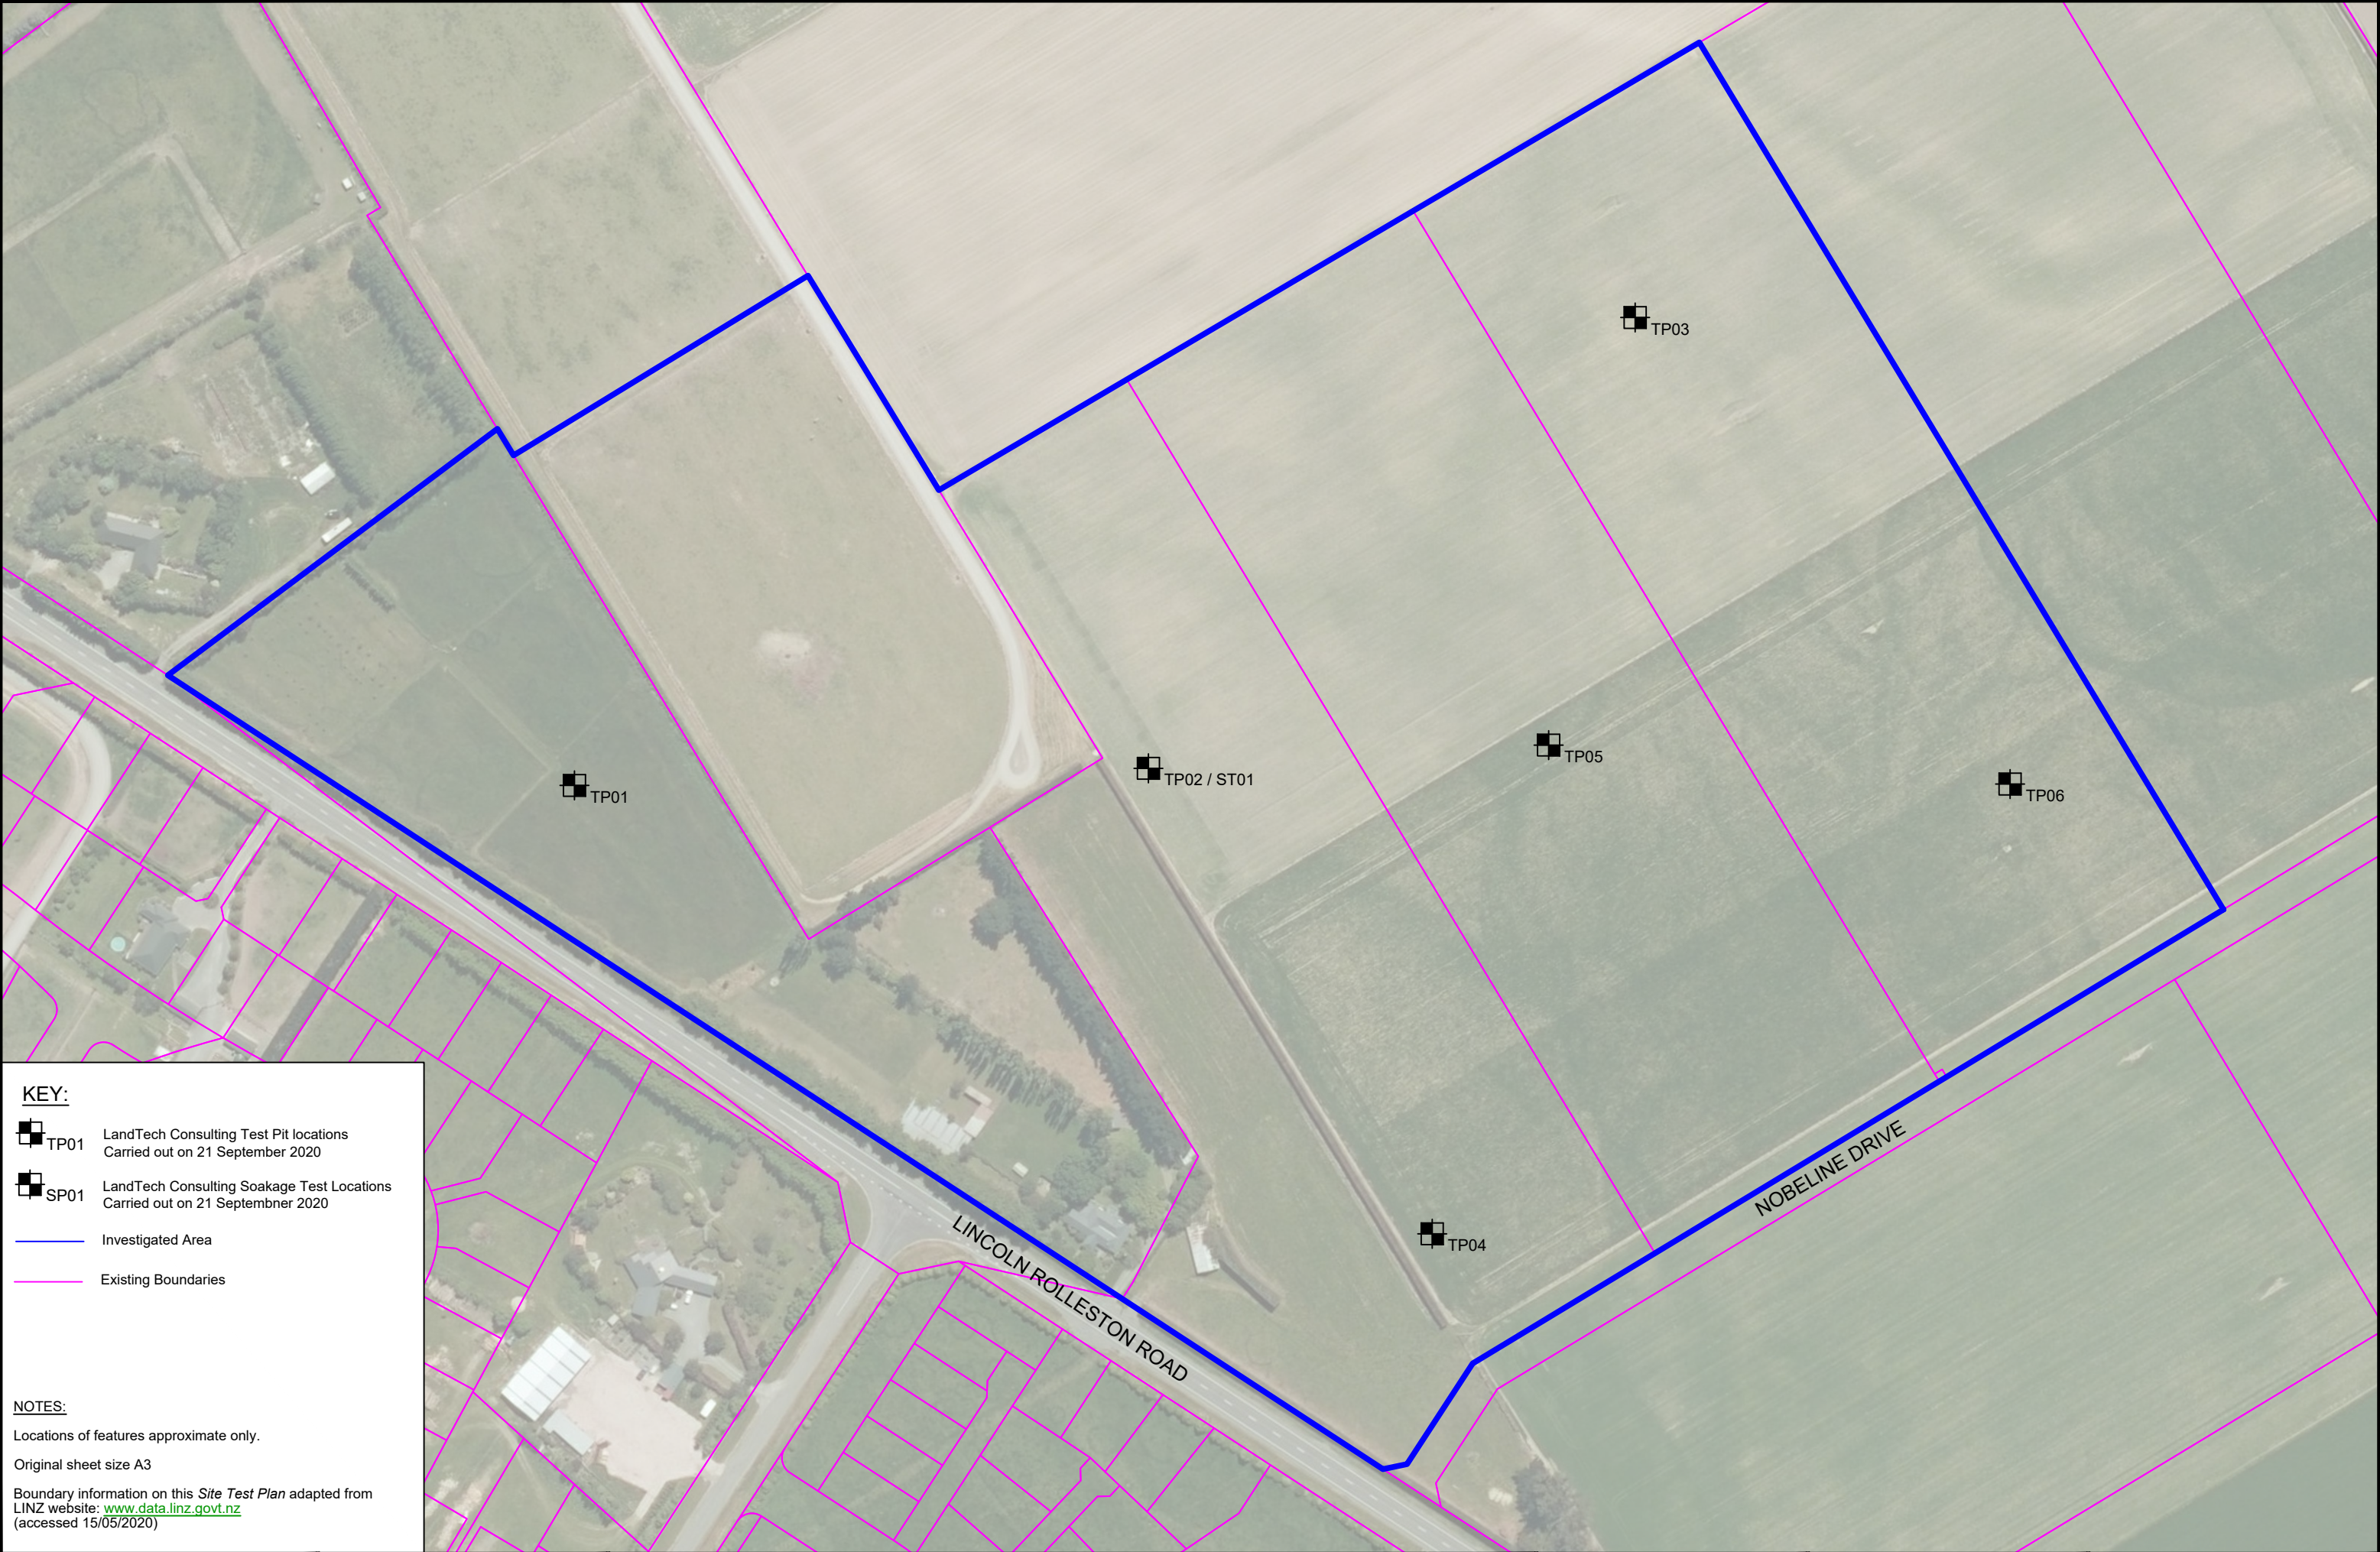
LandTech Site Test Plan

TP01 LandTech Consulting Test Pit locations
Carried out on 21 September 2020

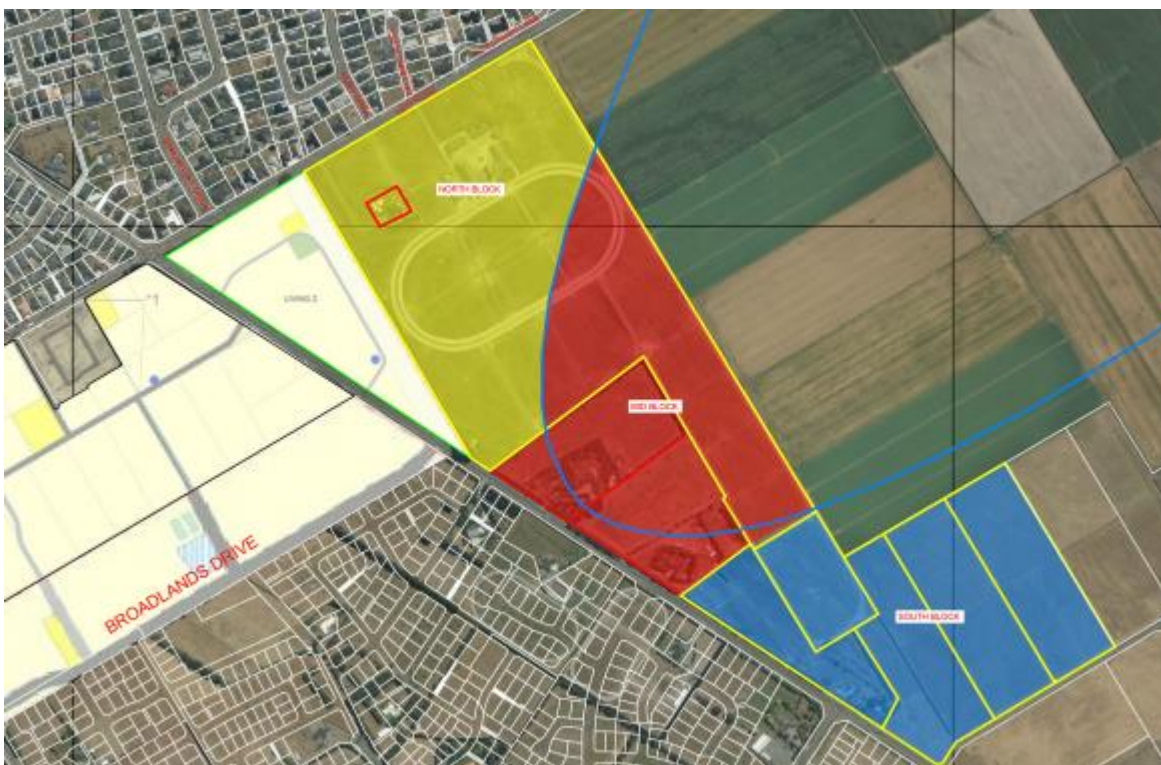
In the areas shown in red, yellow blue

Enable has the service capacity/ capability to fee this parcel of land. Feed can be provided, at standard network extension fees and Greenfield Development fees, from the existing Enable chamber 2320
