***Soil Contamination Risk
Preliminary Site Investigation Report***

***131-139 Levi Road,
274 & 294 Lincoln Rolleston Road,
Rolleston***

*January 2021
Revision 1*

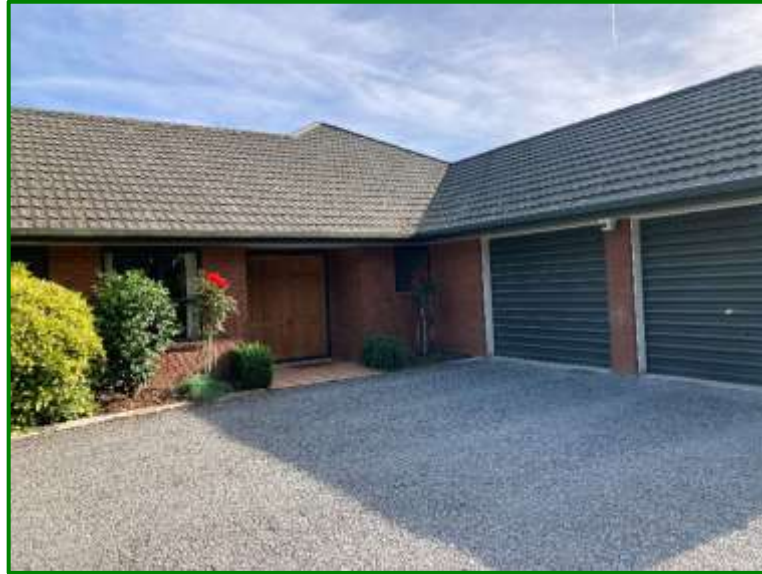
The buildings toward the front of the site and to the north of the driveway are the weatherboard cottage and domestic garage constructed in 2005. At the end of the driveway is a brick dwelling that was constructed in 1994. To the south of the driveway is a 'Versatile' style 4-door garage. This appears to be the 'garage/workshop' constructed in 2005. There was no evidence of asbestos containing materials on the exterior of any of the buildings. The garage/workshop has

Photo 1 – Brick dwelling with metal roof tiles

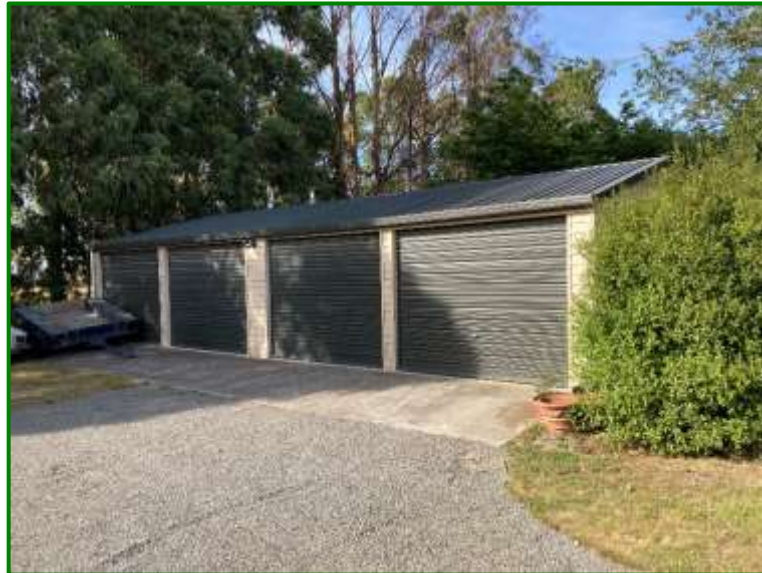
a concrete floor and does not appear to have a commercial use. There was no staining of the gravel driveway or the concrete apron at the front of the garage/workshop.

Photo 2 – Garage/workshop with concrete floor

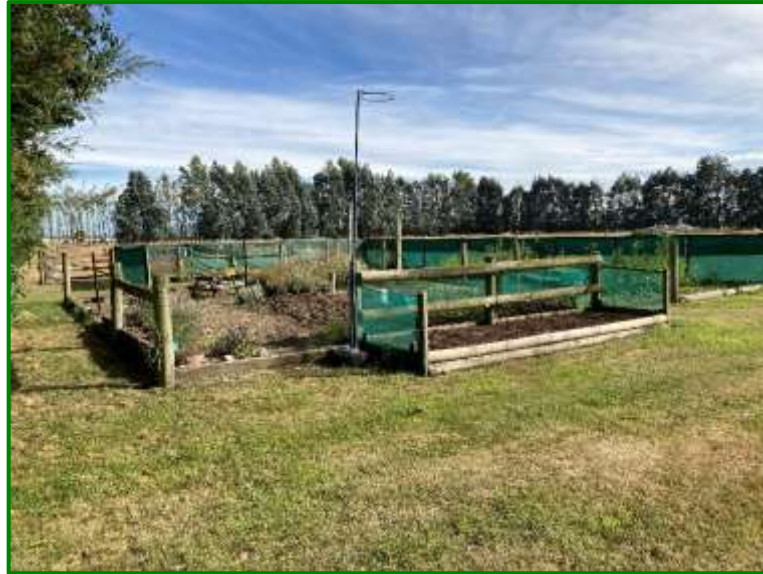
To the rear of the dwelling curtilage area is a vegetable garden with some small sheds and a container. No bulk storage or chemicals or treated timber was seen in this area or anywhere else on the property. There was a pile of natural firewood and a small quantity of treated timber being stored off the ground on shelves.

Photo 3 – Vegetable garden

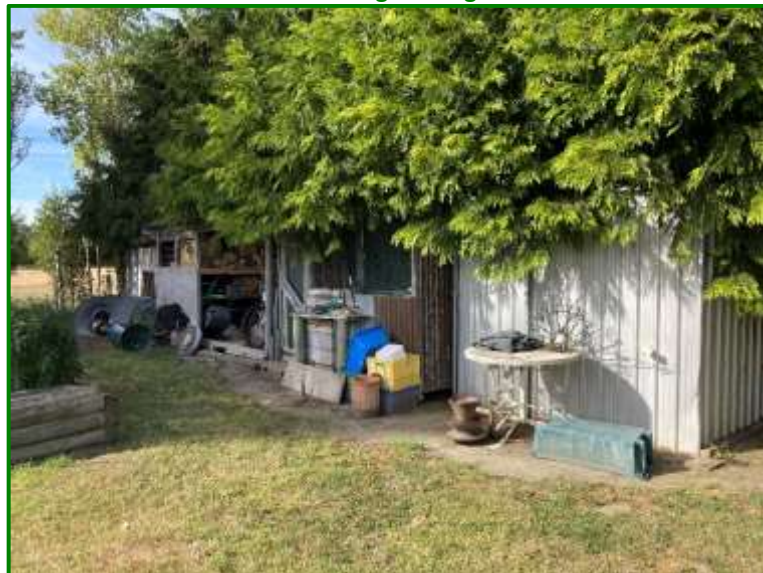
Photo 4 – Small sheds

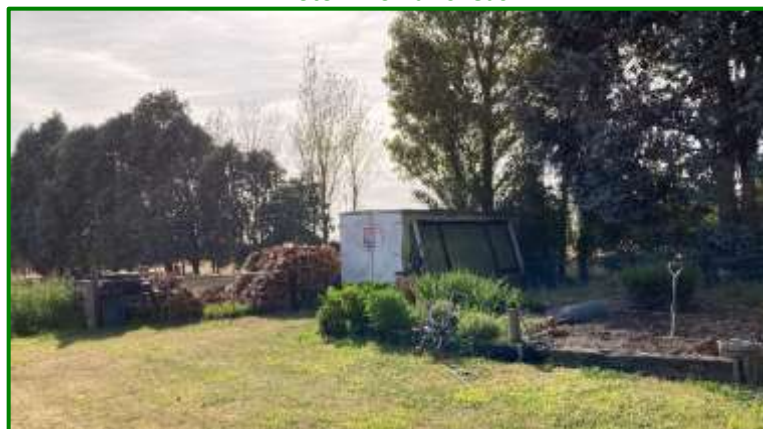
Photo 5 – Vegetable garden and refrigeration container

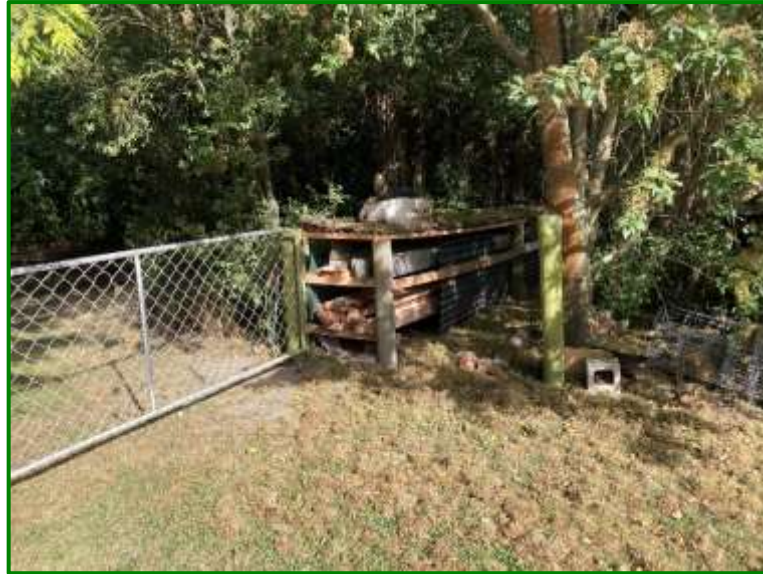
Photo 6 – Small quantity of treated timber, stored off the ground

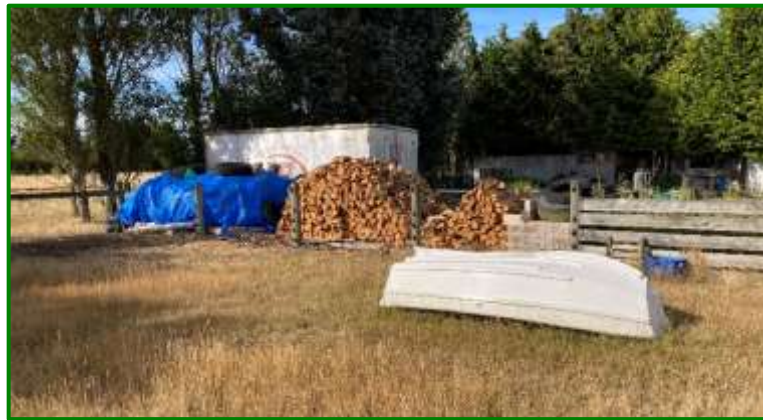
Photo 7 – Firewood, bricks and some tyres stored on top of bricks

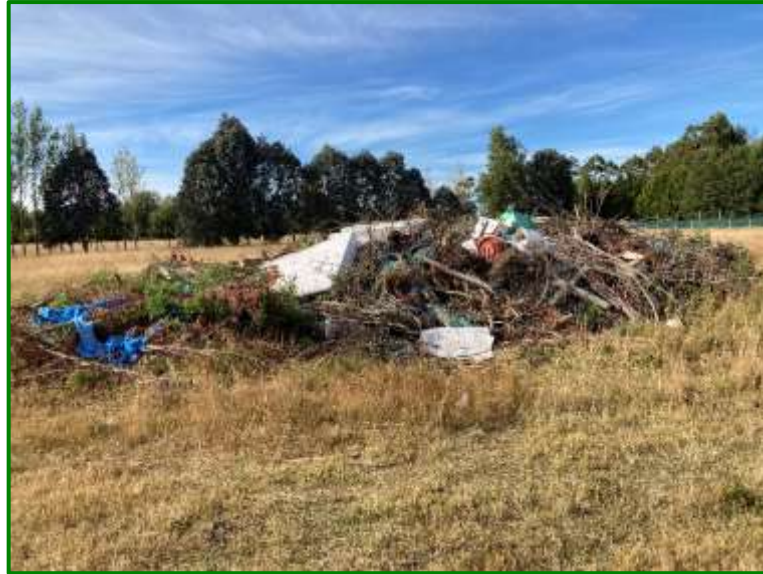
A waste/burn pile is present on the paddock north-east of the dwelling. The pile currently includes a combination of green waste, treated timber, polystyrene, plastic items, mattresses, cardboard and metal items. Although no charred items or ash were seen, it was not possible to view the underlying soils to assess whether any waste had previously been burnt.

Photo 8 – Waste/burn pile

A waste/burn pile was noted during the site inspection of 294 Lincoln Rolleston Road (Lot 1 DP 67190). The pile included waste items such as plastic, metal and furniture. No asbestos containing materials were visible. Another potential burn area was noted on Lot 1 DP 67190 on

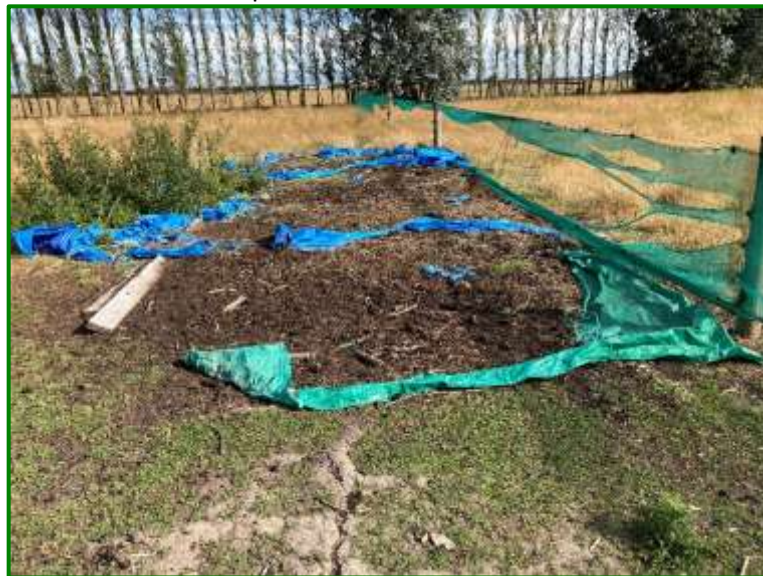
Tarpaulins that appear to have previously contained hay/fodder are present next to the fence between the western and northern paddocks.

Photo 9 – Tarpaulins with sheep droppings and remains of feed

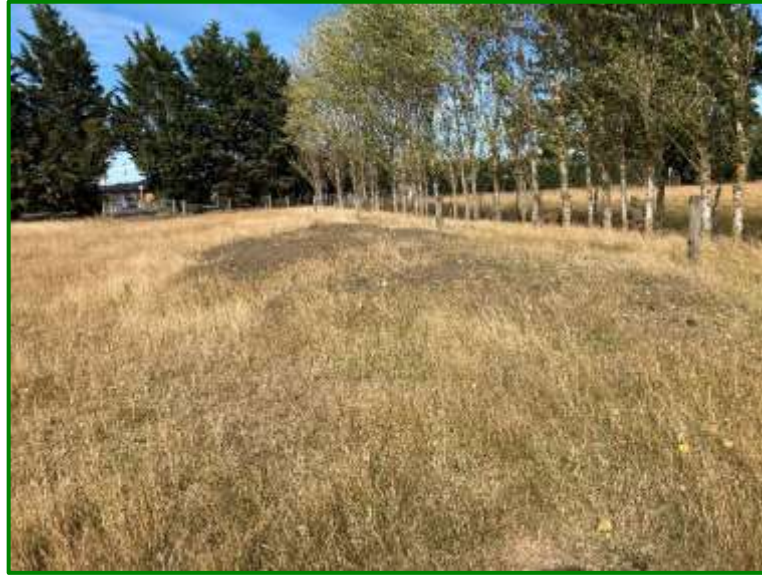
A low stockpile of sandy soil is present towards the western end of the north-west boundary. No demolition debris or waste items were visible on the surface of the pile.

Photo 10 – Stockpile of sandy soil

A stockpile of sandy soil is present on the western corner of Lot 1 DP 67190. No evidence of demolition debris or waste items were seen in this stockpile during the site inspection. It is considered likely that this is surplus material from the excavation of building foundations or landscaping works on the lot and is therefore unlikely to pose a risk to human health.
