# PRELIMINARY SITE INVESTIGATION – CONTAMINATION

# TRICES ROAD REZONING GROUP

PRIVATE PLAN CHANGE TO THE  
OPERATIVE SELWYN DISTRICT PLAN  
AND SUBMISSION ON SELWYN  
DISTRICT PLAN REVIEW,  
TRICES ROAD AREA,  
PREBBLETON

| Project No. | CH00417 | Approved for Issue | |

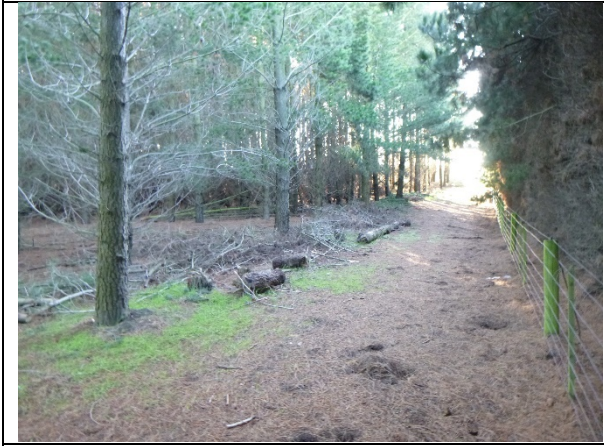
**P7:** Lot 2 DP 73583 Forest in south-east corner of site.

A small forestry block is located in the south-eastern corner of the site. An empty container which contained chlorhexidine gluconate (Hibitane Organic), was observed at the edge of this

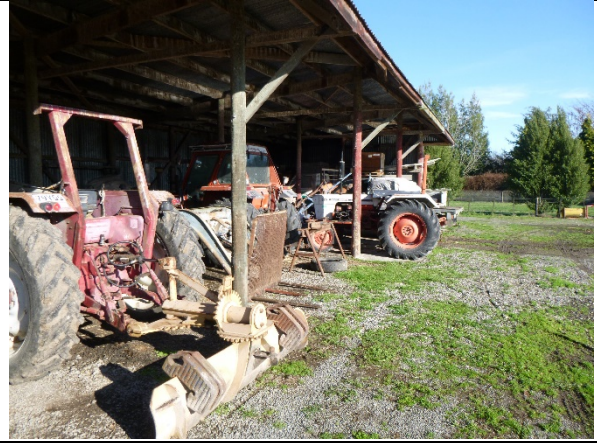
**P18:** Lot 1 DP 360577 311 Trices Road shed for storing vehicles and equipment. Small quantities of fertilizer are also stored here.

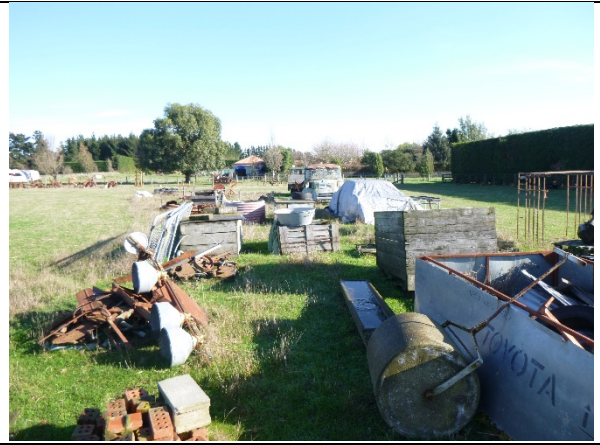
**P24:** Lot 1 DP 360577 311 Trices Road paddock to the south of dwelling used for storage of old equipment and general refuse.

- Rubbish and old machinery/car body remains on Lot 1 DP 73583, Lots 1 and 2 DP 360577, Pt RS 2423 (historical) These areas need to be cleared of rubbish and then the underlying ground inspected for signs of contamination (staining or odour). Soil sampling is likely to be required at this time to confirm the presence or absence of soil contamination.

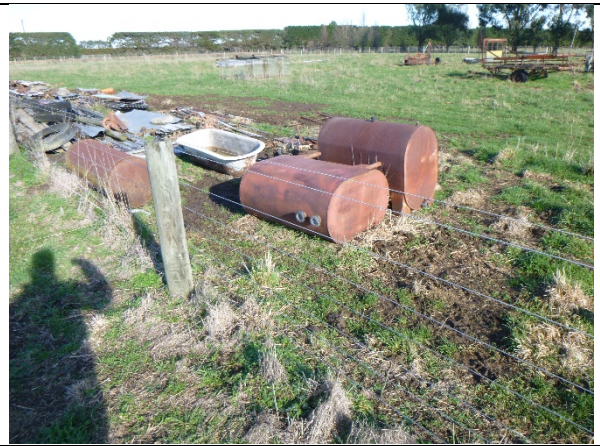
**P26:** Lot 2 DP 360577 311 Trices Road paddock in the south of site used for storage of old equipment and general refuse. The old tanks were for heating fuel.

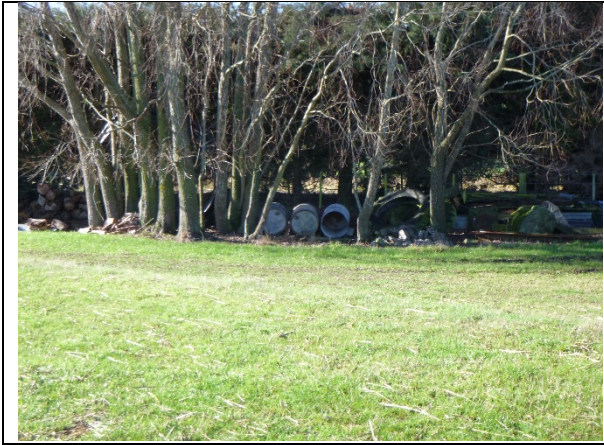
| <p><b>P27</b> Lot 2 DP 360577 Oil drums located in southern corner of site.</p> | <p><b>P28</b> Lot 2 DP 360577 Stockpiles of tree clippings and soil located in southern corner of site.</p> |

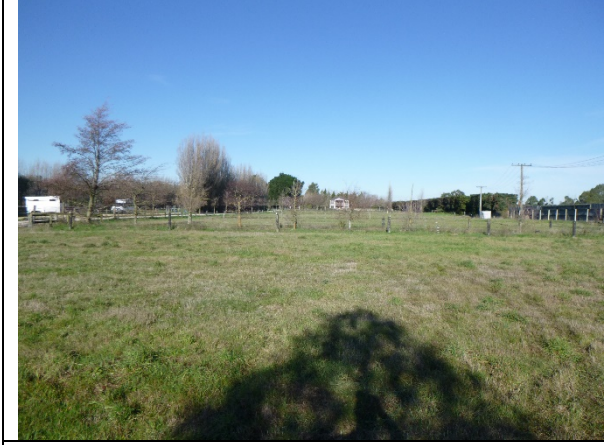
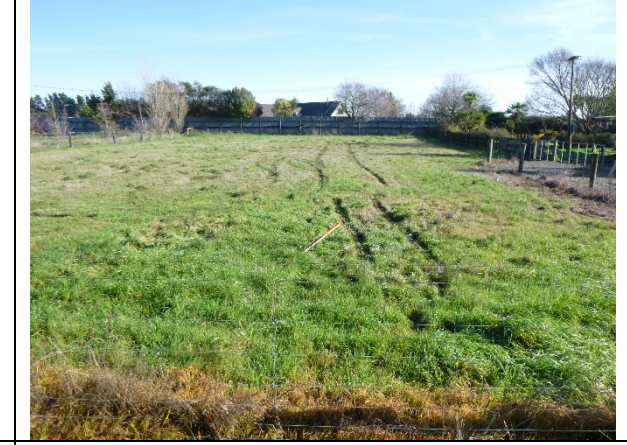
| <p><b>P29</b> Pt RS 2423 View of paddock in appoximate location of former sheds identified in aerial photography. No obvious demoliton materials present.</p> | <p><b>P30</b> Pt RS 2423 View of paddock in app<del>ro</del>ximate location of former sheds identified in aerial photography. No obvious demoliton materials present.</p> |

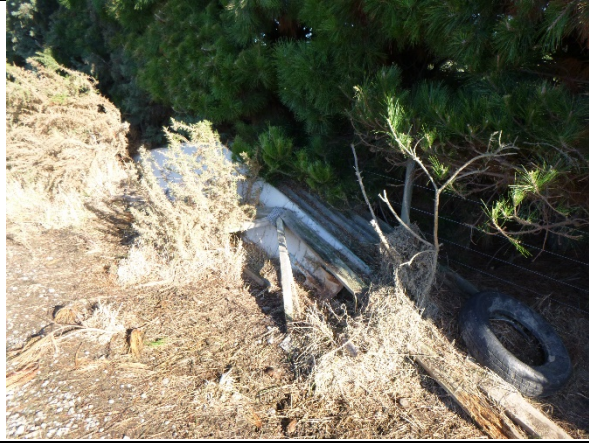
| <p><b>P35:</b> Pt RS 2423 299 Trices Road refuse along western boundary in southern half of site.</p> | <p><b>P36:</b> Pt RS 2423 299 Trices Road stockpiles of unknown origin in southern end of site.</p> |

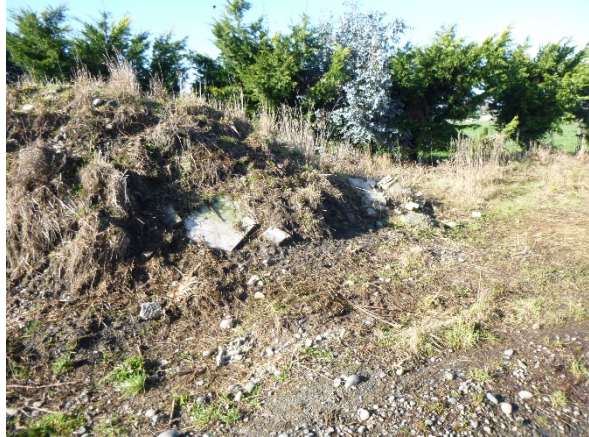
| <p><b>P37:</b> Pt RS 2423 299 Trices Road stockpiles of unknown origin in southern end of site.</p> | |
